## Building and Timber Pest Inspection Report

Inspection Date: Fri, 29 Apr 2022

Property Address: 5 Gilbert Pl, Frenchs Forest NSW 2086,  
Australia

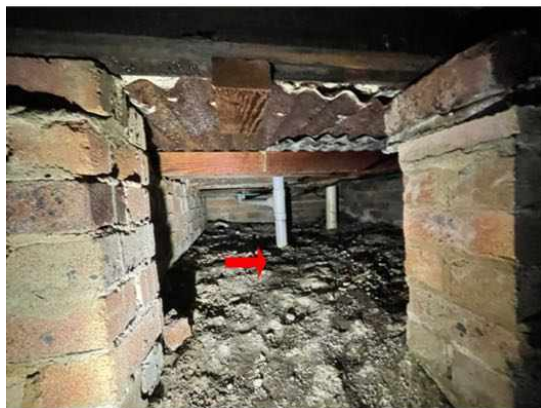
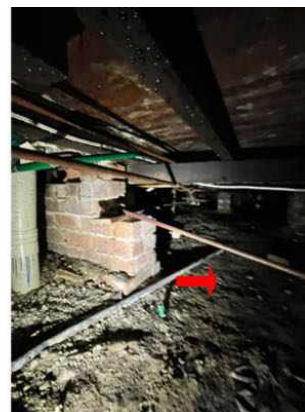
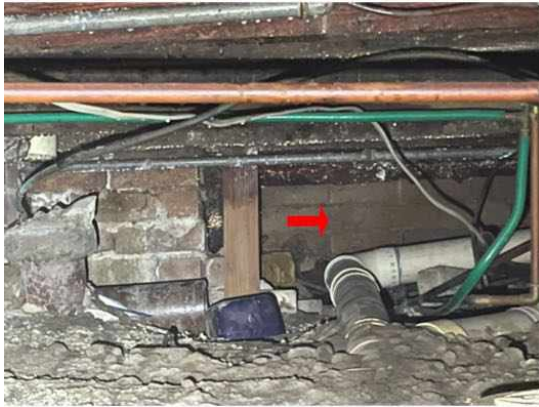
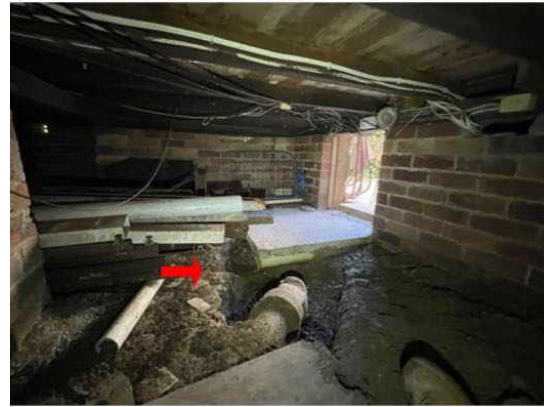
#### Defects 3.01

Building: Building 1  
Location: Subfloor  
Finding: Evidence of excessive moisture was present at the time of inspection  
Information: Excessive moisture can attract termites and produce conditions that promote termite attack fungal growth and wood decay.

Excessive moisture is generally caused by deteriorated inadequate or missing roof drainage leaking plumbing pipes or fixtures poorly plumbed HWS overflows or condenser units and poor site drainage.

It is highly recommended that all plumbing and drainage fixtures and fittings be maintained regularly in order to prevent excessive moisture being present in the external / internal property.

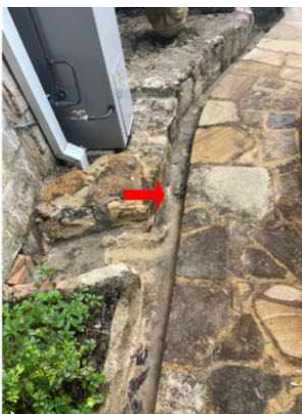
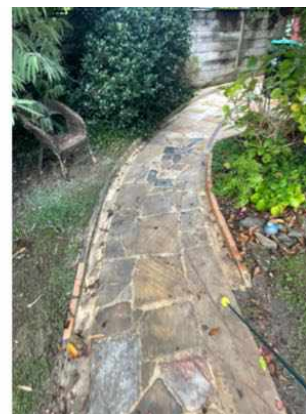
### Defects 3.02

Building:	Building 1
Location:	All Areas
Finding:	Site drainage - suspected Inadequate
Information:	The site drainage in this area was found to be inadequate at the time of inspection, creating potential for subsequent water damage to associated building elements.

It is important that water does not lie against the base of walls; surrounding paths and ground levels should be sloped to drain water away from walls. Downpipes should not discharge stormwater onto lower walls or plinths. Stormwater should be carried away by large, regularly cleaned drains. Ground levels may need to be lowered to expose a buried DPC.

Where site drainage is inadequate, installation of an Agricultural (Aggie) Drain may be required. A qualified plumber should be appointed to further inspect the property and perform any remedial works as necessary. Water damage and secondary defects are likely to occur if left unmanaged.

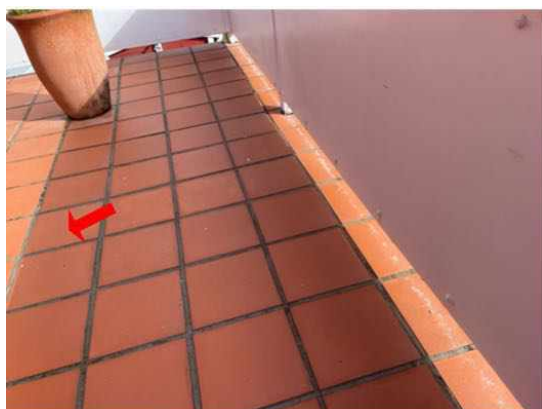
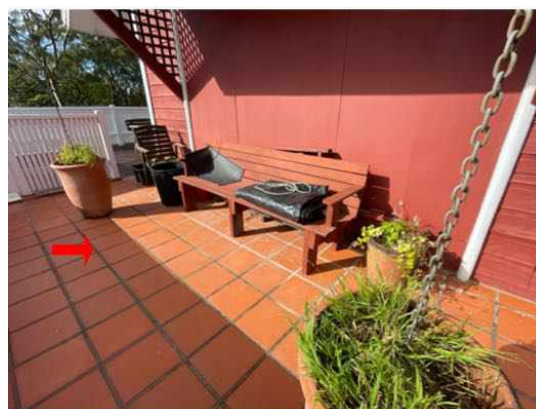
### Defects 3.03

Building:	Building 1
Location:	Balcony

Finding: Tiles - Drummy  
 Information: Drummy tiled areas were identified at the time of inspection. The term 'drummy' refers to tiles that have become detached from their fixing, despite otherwise being in relatively good condition. Such defects are generally caused by physical or moisture damage to the area. Drummy tiled areas may also be a direct result of poor workmanship during the construction process.

Tiled areas may swell and shrink with changes in air humidity if the area has sustained moisture damage. Any exposure to moisture is capable of causing tiled areas to become drummy and/or cracked over a prolonged period of time. Drummy tiled areas generally require removal and replacement of affected tiles, with adequate sealant and grouting.

Specialist trades are available for these types of services. A registered builder may be required to undertake works if damage is extensive or if secondary building defects have resulted. Otherwise, it is advised that a tiling contractor be appointed to perform works as necessary. Immediate action is recommended to ensure that no further damage is sustained in the affected area.

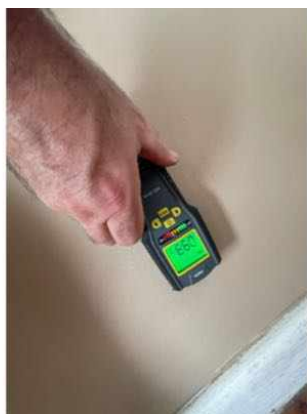
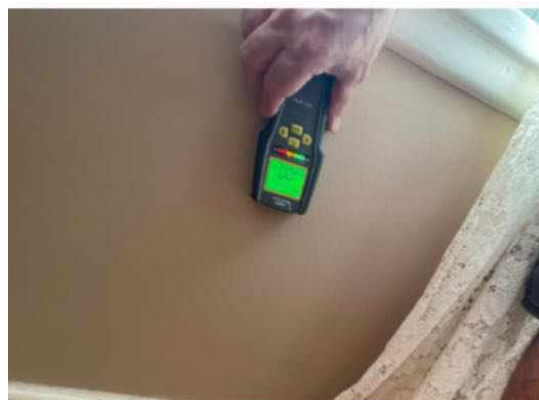
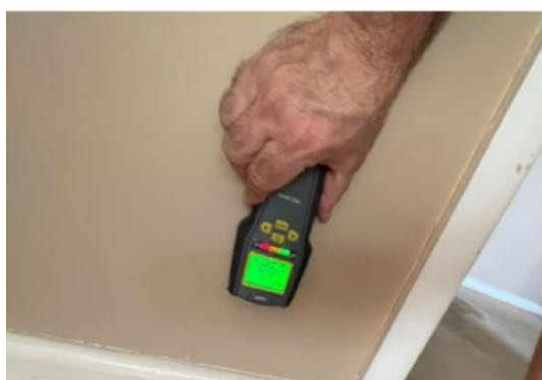
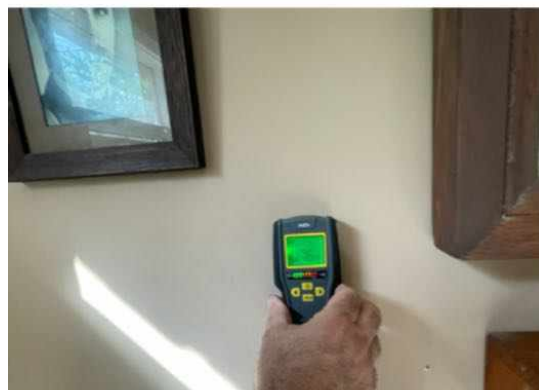
### Defects 3.04

Building: Building 1  
 Location: Bedroom  
 Finding: Evidence of excessive moisture was present at the time of inspection  
 Information: Probably due the amount of wet weather in the past few months.

Excessive moisture is generally caused by deteriorated inadequate or missing roof drainage leaking plumbing pipes or fixtures poorly plumbed HWS overflows or condenser units and poor site drainage.

It is recommended that all plumbing and drainage fixtures and fittings be maintained regularly in order to prevent excessive moisture being present in the external / internal property.

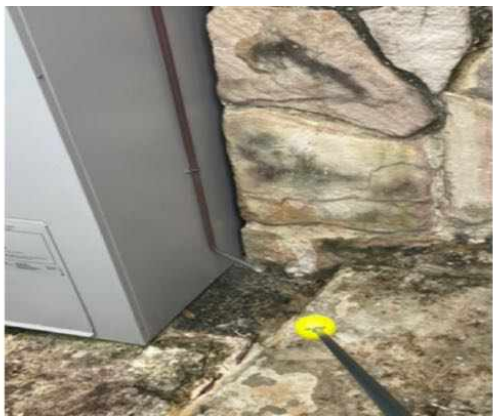
### Defects 3.05

Building: Building 1  
 Location: Yard - Side  
 Finding: HWS Overflow - Not Connected  
 Information: The Hot Water System (HWS) overflow was found to be disconnected from storm water draining and is creating excessive moisture in the surrounding area.

These damp conditions can lead to secondary defects such as rot, rust or corrosion of associated building elements, the formation of fungal decay, or even the creation of potential slip hazards. When coupled with poor site drainage, pooling of water may also attract termite activity to this area.

It is highly recommended that a licensed plumber be appointed to connect the HWS overflow in order to prevent such an environment from being created. These minor works should be carried out as soon as possible.

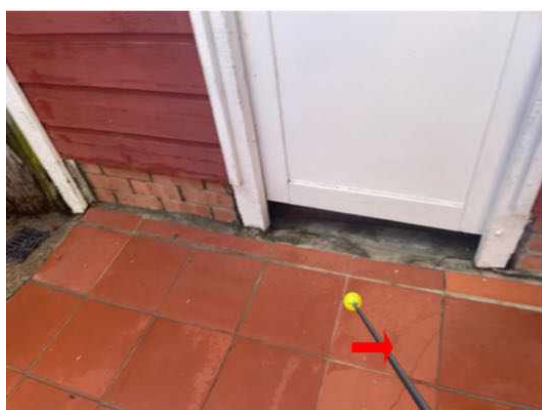
### Defects 3.06

Building:	Building 1
Location:	Yard - Side
Finding:	Tiles - Cracked or damaged
Information:	Cracking was evident to the tiling in this area at the time of inspection. While the cracking appears to be minor, this area is frequently exposed to water, allowing potential for water penetration into adjoining sections of walls or flooring.

If left unmanaged, water penetration to these areas may lead to subsequent water damage, which is likely necessitate repair work to affected building elements.

A tiling contractor should be appointed to ensure that no further water damage occurs. The re-application of silicone and grouting throughout remaining tile work is also advised, to further protect the area against water penetration.

Where water penetration has led to water damage, appointment of a relevant tradesperson may be required to repair damaged building elements.

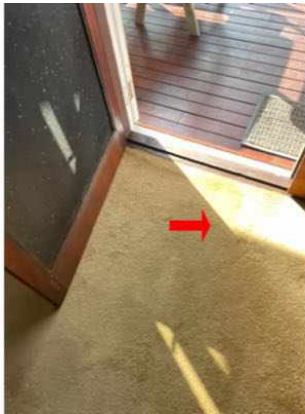
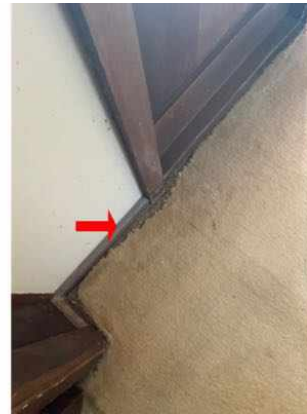
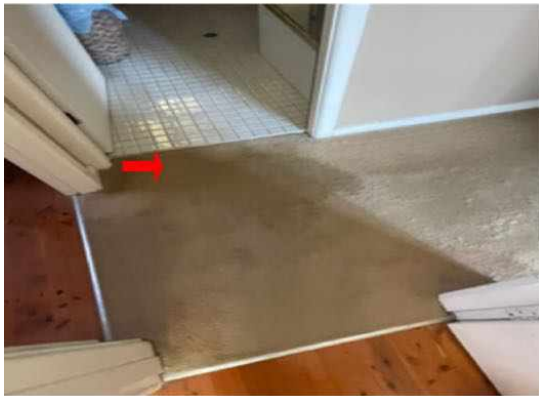
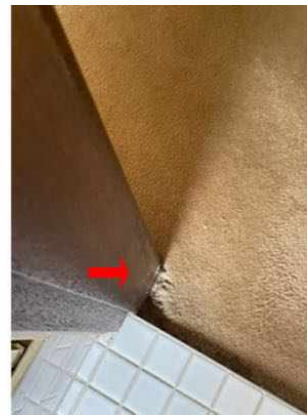
### Defects 3.07

Building:	Building 1
Location:	All Areas
Finding:	Carpet - Deteriorated

Information: Sections of the carpet floor covering appeared to be deteriorated due to wear and tear and age.

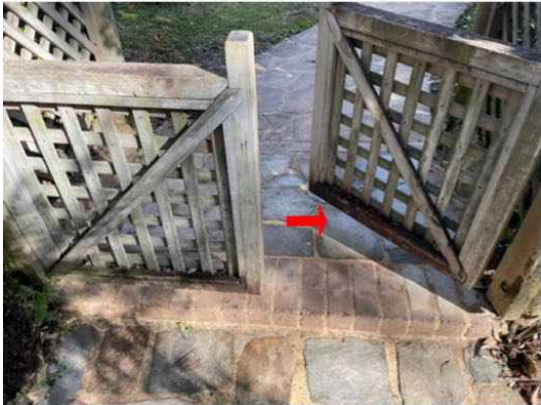
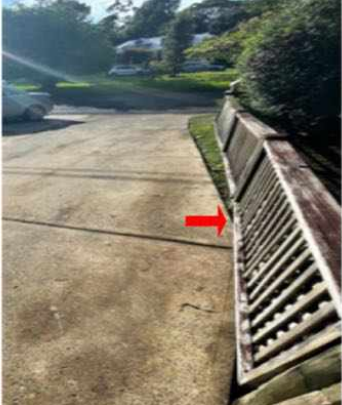
### Defects 3.08

Building: Building 1  
 Location: Fencing  
 Finding: Timber - exposed to weather  
 Information: External timbers that are frequently exposed to harsh weather conditions require adequate protection in order to maintain their condition. Where timbers have not been painted or treated adequately, general deterioration is likely to occur at an accelerated rate.

If left unattended, replacement of these timbers is likely to be necessary in the short-term future. Adequate treatment of these timbers is required as soon as possible by a painting contractor or general handyman.

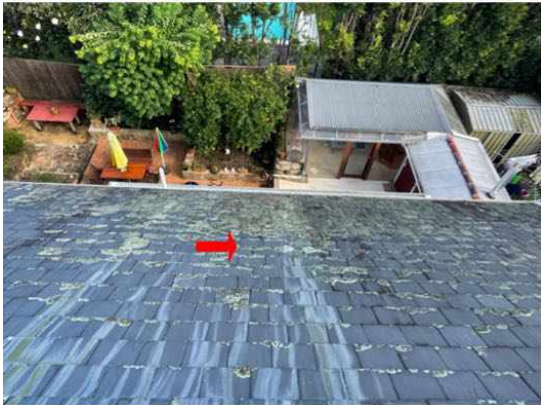
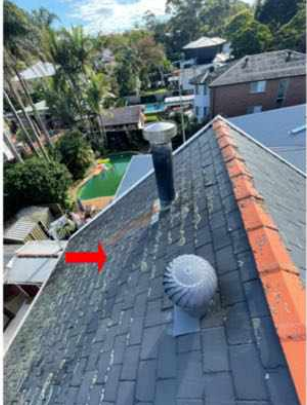
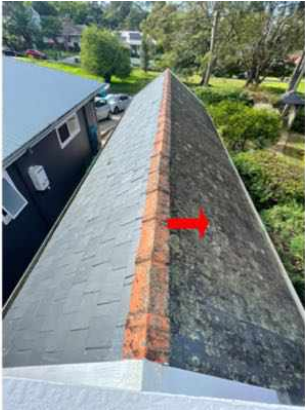
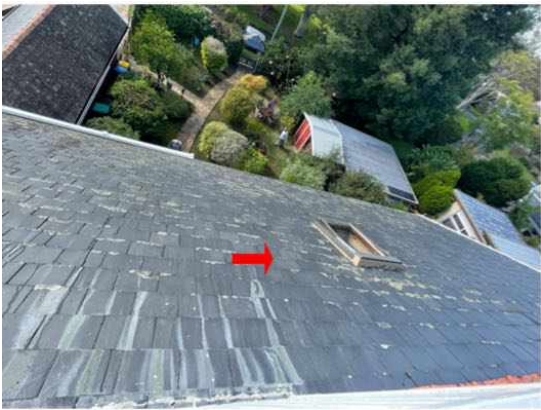
**Defects 3.09**

Building: Building 1  
Location: Roof Exterior  
Finding: Roof - Weathered  
Information: Upon inspection of the exterior roofing, the majority of the roof was considered to be in a fair condition. While weathering is consistent with the age of the property, maintenance works are required.

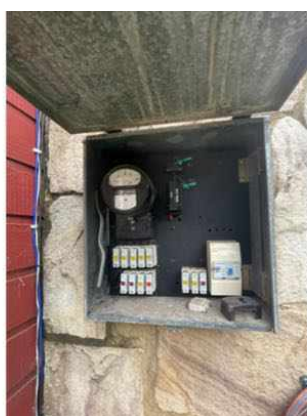
Building: Building 1  
 Location: All Areas  
 Finding: Termite Management System - no evidence of a chemical installation  
 Information: The application of a post-construction chemical termite barrier is highly recommended for all properties, particularly if live termite activity has been found on the site previously. Such barriers are highly effective in preventing termite attack on any timber building elements throughout the property.

A durable notice should be placed in the switchboard unit to indicate current termite barriers. At the time of inspection, it appeared as though no termite management system has been installed, with no evidence to suggest preventative works taking place.

The client may consider gaining further advice from a pest controller as to the costs and procedures involved with this application. It is recommended that obtaining such advice be a short-term priority.

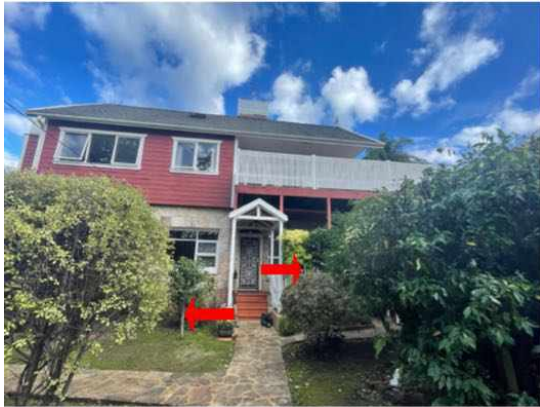
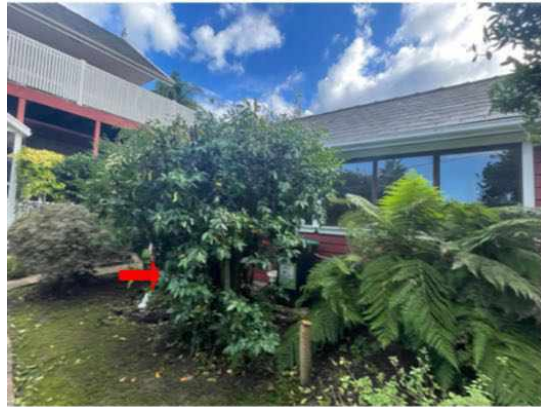
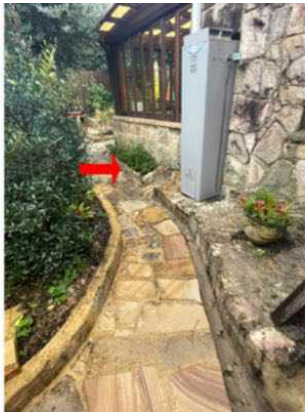
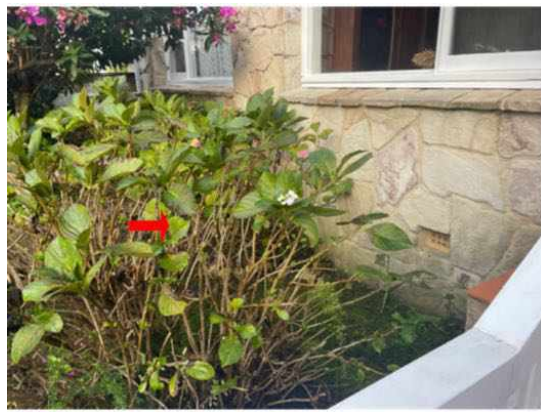
Building: Building 1  
 Location: All Areas

Finding: Garden Beds - Conditions Conducive to Termites  
Information: Garden beds were found to be evident in the garden area. These garden beds can include untreated timber, and with a combination of moisture from watering hosing can make conditions conducive to termite activity and termite ingress.
