## **VISUAL BUILDING & PEST INSPECTION REPORT**

Complies with Australian Standard 4349.1 & 4349.6

### **Vendor Report**

**7 Hurdis Avenue Frenchs Forest**

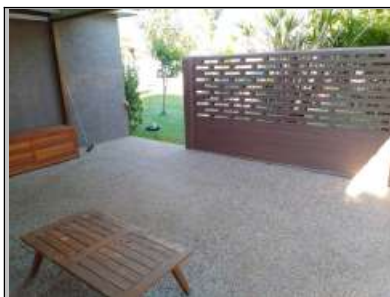
Front elevation.

Constructed from concrete or masonry. The general condition of this structure is fair.

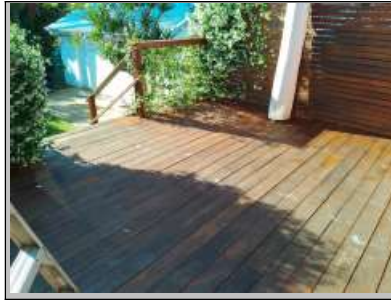
Rear elevation.

Where an external structure is constructed from timber or has significant timber components, and exposed to the elements, a suitably qualified engineer should inspect the structure to determine if it is structurally sound. We cannot determine or advise what weight the structure can hold, The general condition of this structure is fair.

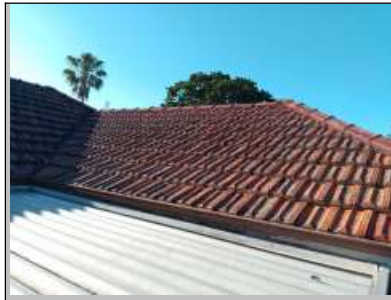
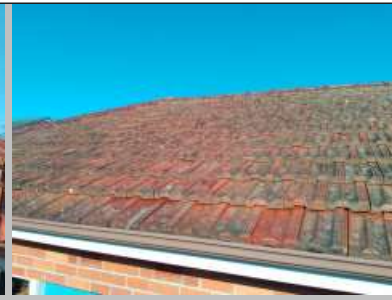
The overall condition of the valley metal is fair. Valley metals are rusting and should be treated or replaced as required.

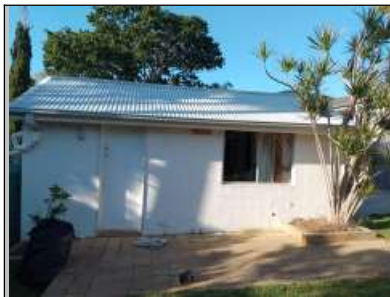
Eastern elevation.

The structure is generally in fair condition.

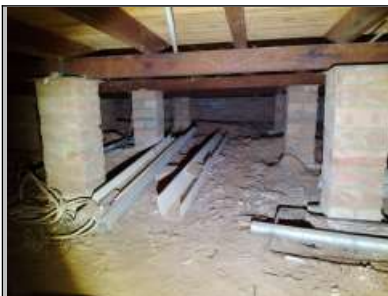
The building is constructed on a combination of strip footings and piers. The footings appear to be generally sound.

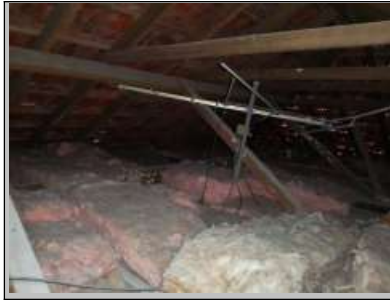
Insulation is present in the roof cavity. This restricted inspection to some roofing timbers. Removal of insulation is not within the scope of a standard visual inspection report, however as in accordance with "industry best standard" the inspector will lift insulation in 3 areas in roof void.

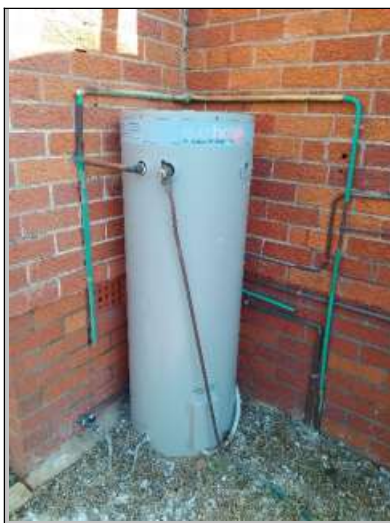
Mains electric hot water system: Mains pressure: Located externally: The hot water system appears to be in working condition. No specific tests other than running the hot water tap were carried out. No determination has been made as to the suitability or adequacy of the hot water system in relation to capacity or otherwise.
