# Building Inspection Report

Inspection Date: Wed, 29 Jan 2020

Property Address: 45 Dareen St, Frenchs Forest NSW 2086, Australia

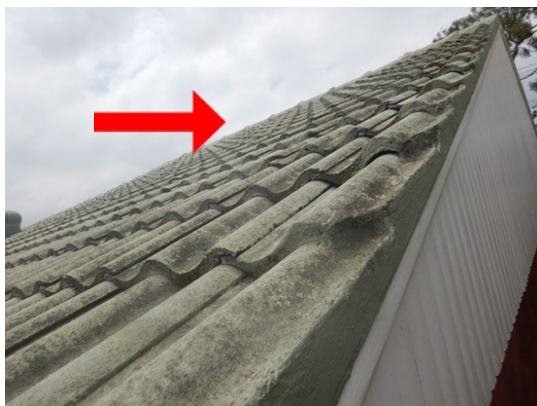
#### Defects 3.01

| Building: | Main Building |
| Location: | Roof Exterior |
| Finding: | Roof tiles - Weathered |
| Information: | Upon inspection of the exterior roofing, the majority of roof tiles were considered to be in a fair condition. While weathering of the tiles is consistent with the age of the property, maintenance works are required. |

Consultation with a roofing contractor is highly advised to gain advice on cost of remedial works that may be required in the short to medium term. Remedial works are likely to increase the longevity of the exterior roofing structure.

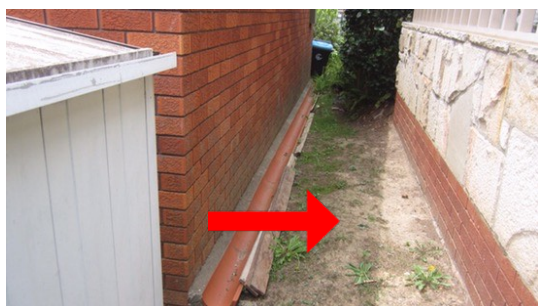
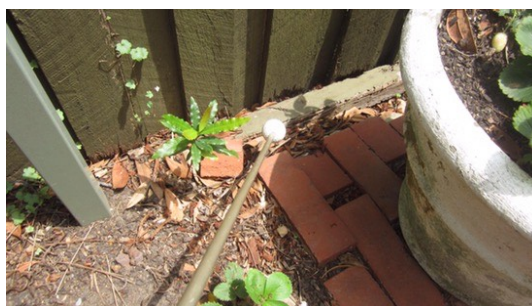
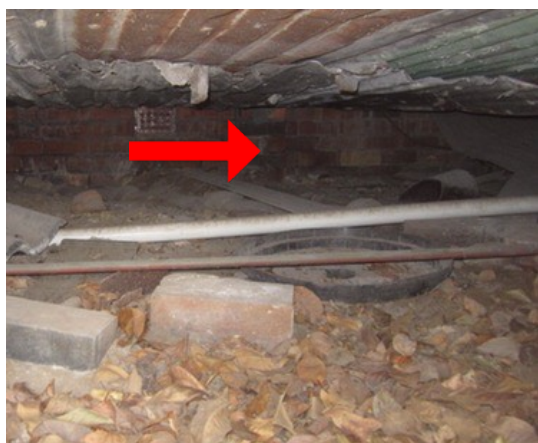
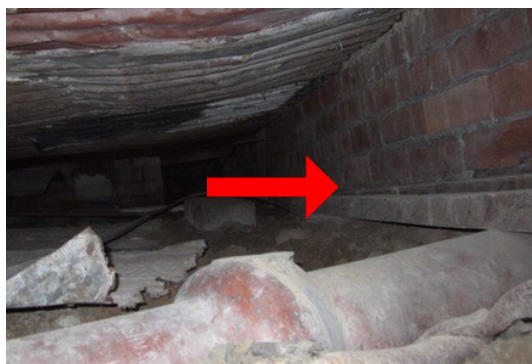
### Defects 3.02

Building: Main Building  
Location: Subfloor  
Finding: Evidence of excessive moisture was present at the time of inspection  
Information: Excessive moisture can attract termites and produce conditions that promote termite attack fungal growth and wood decay.

Excessive moisture is generally caused by deteriorated inadequate or missing roof drainage leaking plumbing pipes or fixtures poorly plumbed HWS overflows or condenser units and poor site drainage.

It is recommended that all plumbing and drainage fixtures and fittings be maintained regularly in order to prevent excessive moisture being present in the external / internal property.

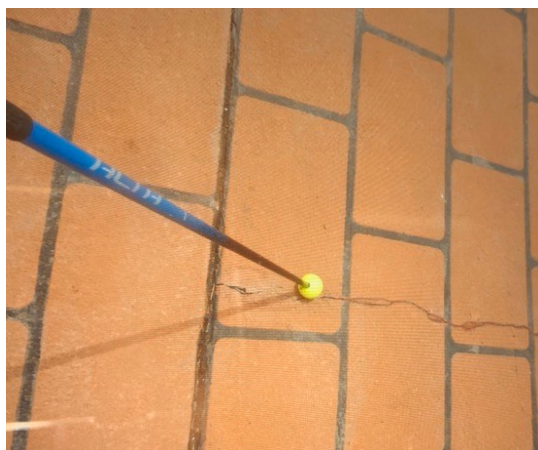
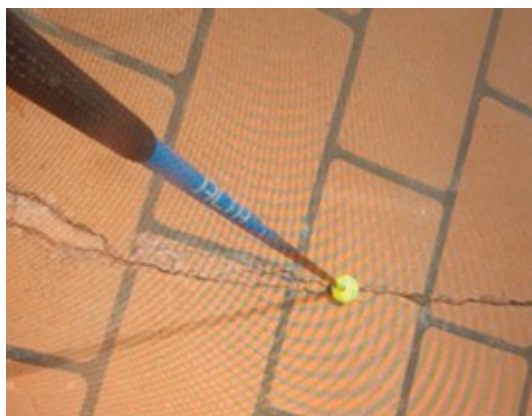
### Defects 3.03

| Building: | Main Building |
| Location: | All Areas |
| Finding: | Crack in concrete slab - Category 1 |
| Information: | A crack coded as Category 1 was identified in the slab. A Category 1 crack is described as a fine but noticeable crack, with the slab at an otherwise reasonable level. |

To be considered Category 1, the approximate width of the crack is  $<1.0\text{mm}$ , or a  $<10\text{mm}$  change in offset when a 3m straight edge is placed over the defect.

Category 1 cracks should be monitored for a period of 12 months. At the end of the monitoring period, identified cracks that are rated greater than Category 2 are considered defects, and require rectification.

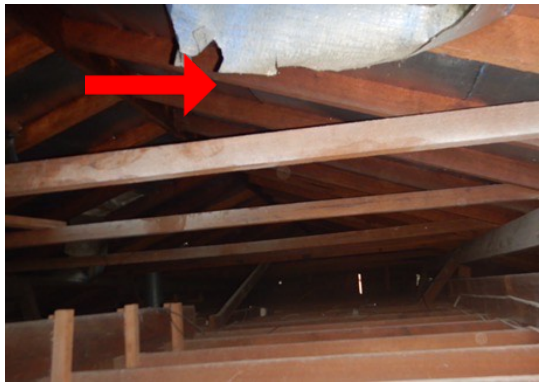
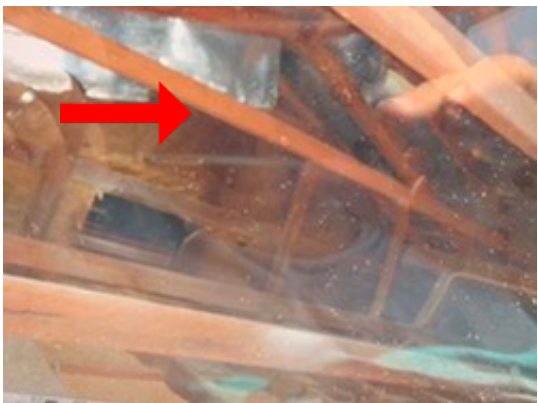
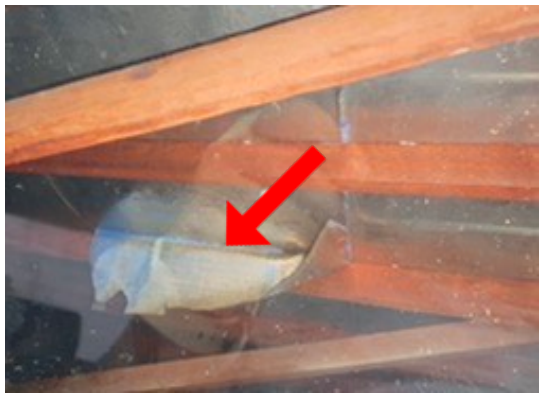
### Defects 3.04

| Building: | Main Building |
| Location: | Roof Void |
| Finding: | Sarking - Damaged |
| Information: | Sarking, a laminated aluminium foil applied to the interior of the roof covering, assists in insulating the property and acting as a vapour-barrier to the roof void and, subsequently, to the household. |

Where sarking is damaged, both insulation and moisture protection of the property are inhibited. This creates a loss of energy and thus negatively impacts the energy efficiency of the property, allowing potential for moisture ingress from condensation or leaking roof tiles.

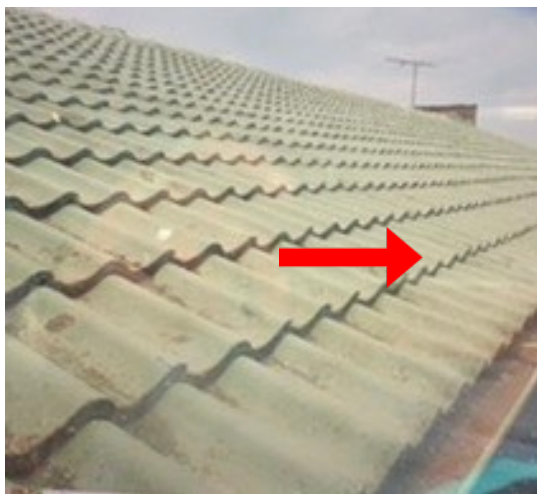
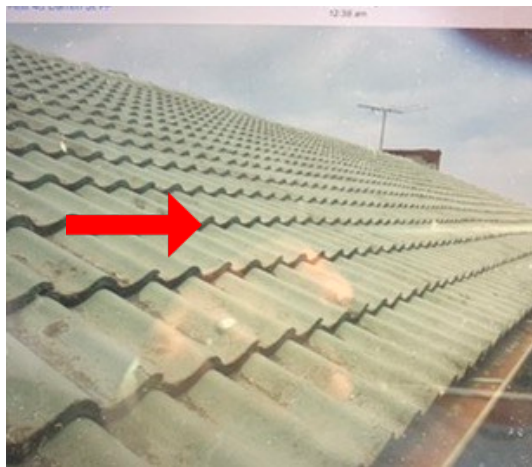
## Defects 3.05

Building: Main Building

Location: Roof Void

Finding: Sagging roof - identified

Information: The roofing structure was found to be sagging in sections at the time of inspection. This sagging is likely due to the lack of support to the roof members (rafters). These support members are referred to as under purlins and struts. While this type of construction is common for the era of building, additional support may be required.

Sagging roof structures are likely to create strain on associated building elements, creating potential for secondary damage including the deterioration of roof coverings. The roof is also unlikely to have sufficient support, which may lead to further sagging if left unmanaged.

It is advised that a Structural engineer be appointed to provide remedial advice which then could then be carried out by a licensed builder.

While it would appear that this defect has been present for a long period of time repair is recommended in the short term to ensure the longevity and structural integrity of the dwelling.

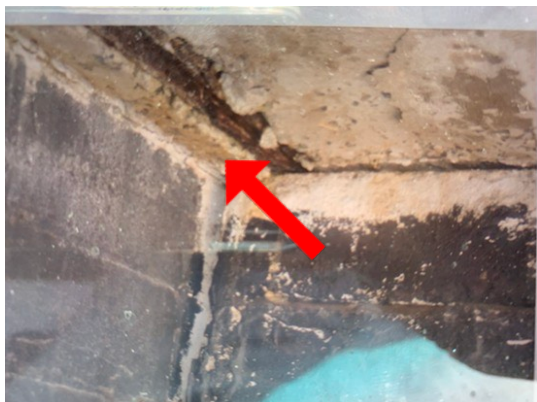
## Defects 3.06

Building: Main Building  
Location: Pool Area  
Finding: Concrete - Cancer  
Information:

The cause of the concrete cancer (e.g. poor water proofing) must also be addressed, otherwise the problem is likely to recur. Treatment of concrete cancer can be expensive and, left unmanaged, the problem is likely to worsen over time, potentially leading to the development of major structural defects or safety hazards.

The client is advised to exercise caution and to prepare for the potential cost of remedial and / or replacement works.

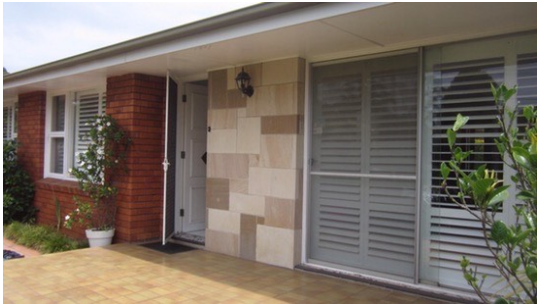
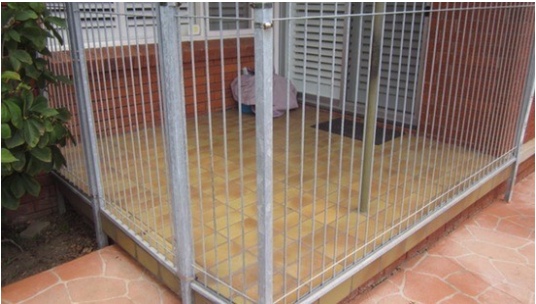
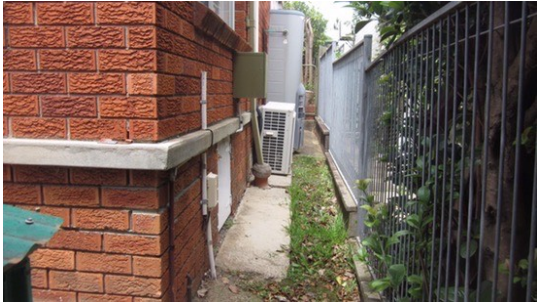
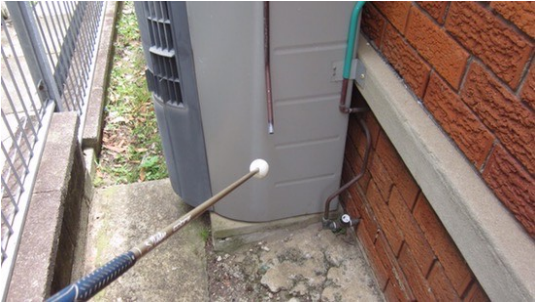
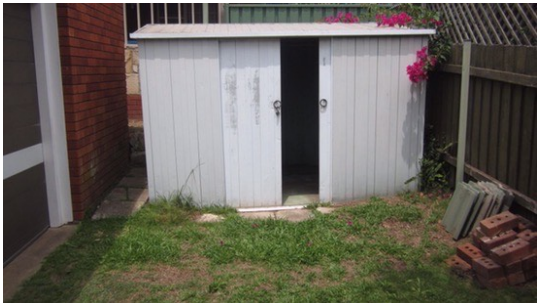
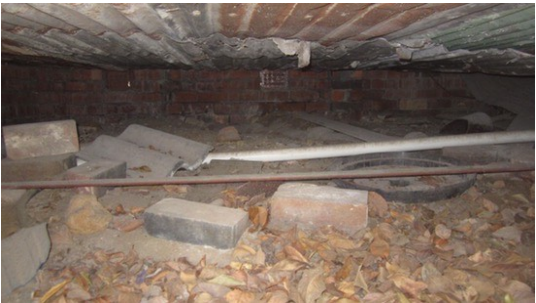
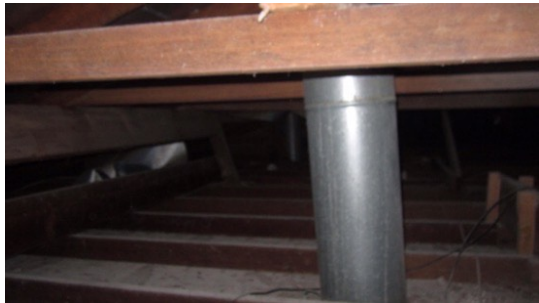
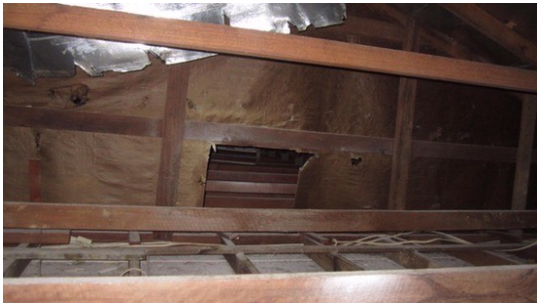
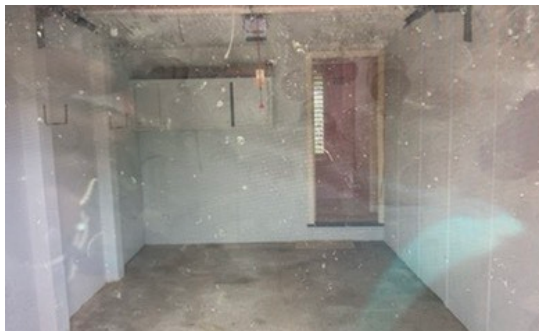
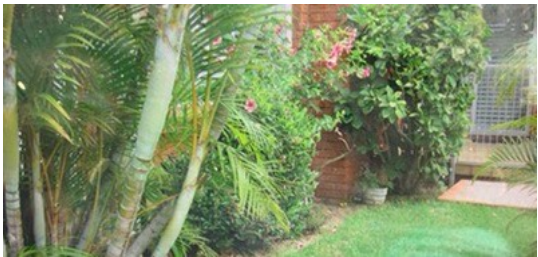
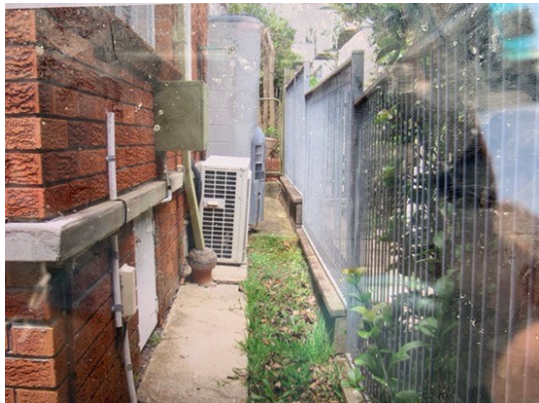
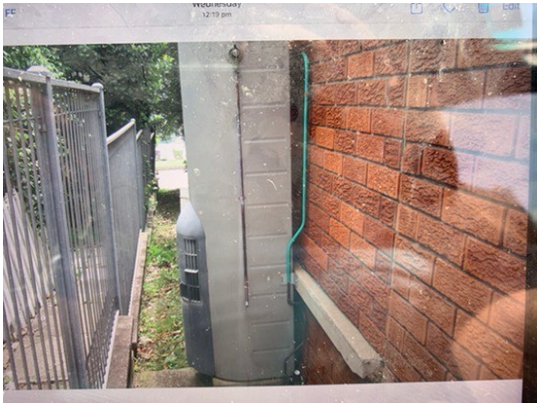
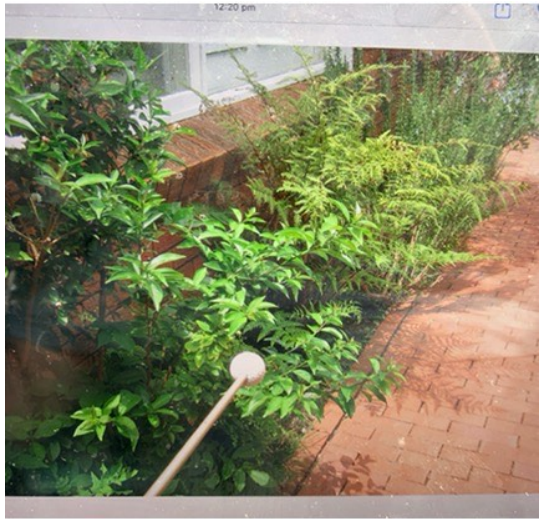
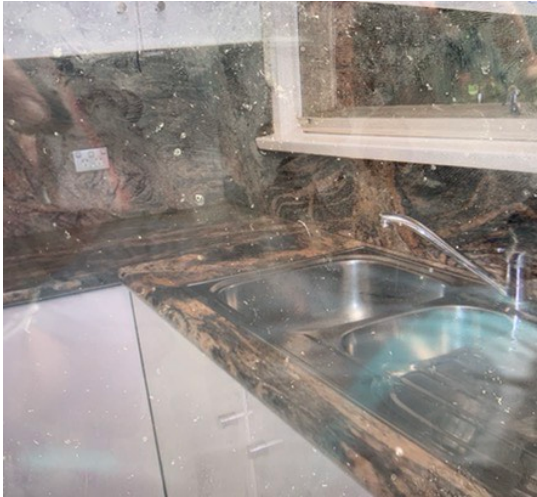
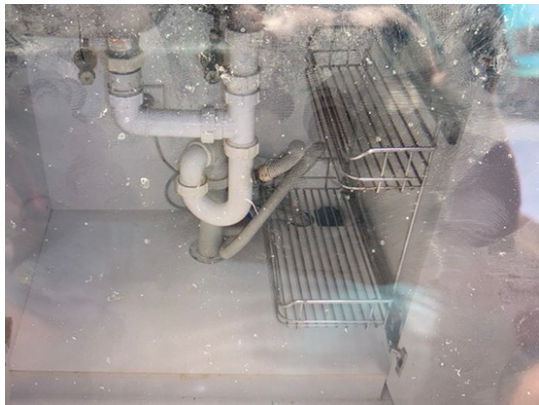
Additional Photos - Obstructions and Limitations

These photographs are an indication of the obstructions and limitations which impeded full inspection of the property at the time of inspection.

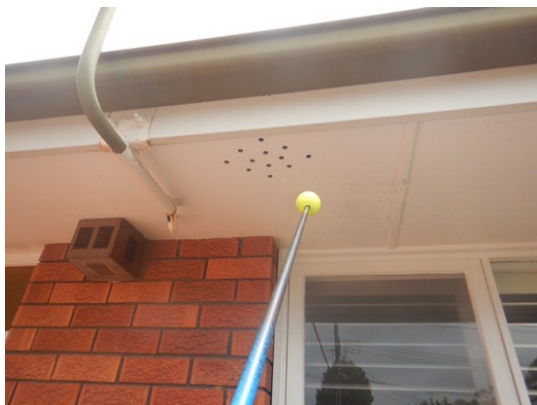
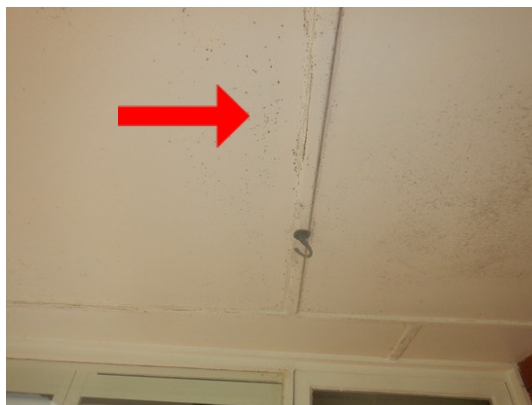
Building: Main Building

Location: All Areas

Finding: Asbestos - Suspected ACM Identified on Site

Information: Reporting on Asbestos is outside the Scope of this Report. This suspected defect is highlighted as a caution only. We suspect, based on our experience in the building industry, that there is a higher risk of the identified building element containing asbestos.

As Asbestos Reporting is outside the scope of this report, we advise that you consider a separate Asbestos Inspection and Condition Audit, which can include the taking of samples for definitive confirmation of the presence of Asbestos.

In the interim, the client is advised to act with caution, especially when considering any damage to building materials general wear and tear renovations extensions demolition and general maintenance activities due to the suspected presence of Asbestos.
