## Timber Pest Inspection Report

Inspection Date: Mon, 5 Jun 2023

Property Address: 8 Cotswold Cl, Belrose NSW 2085, Australia

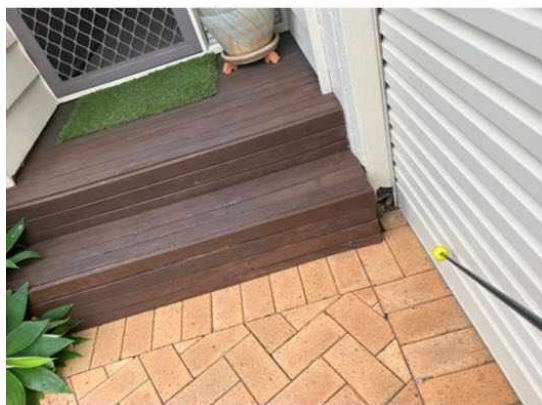
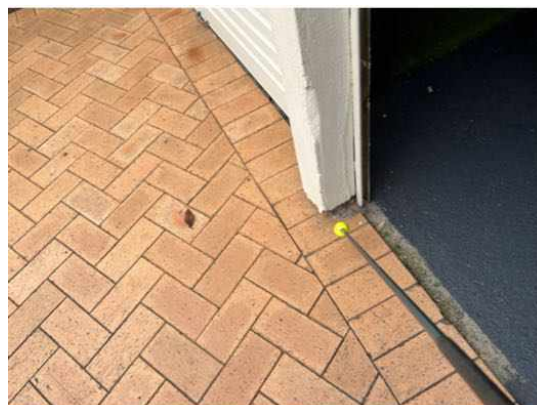
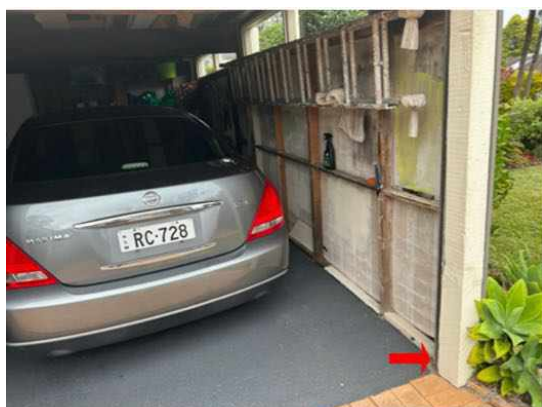
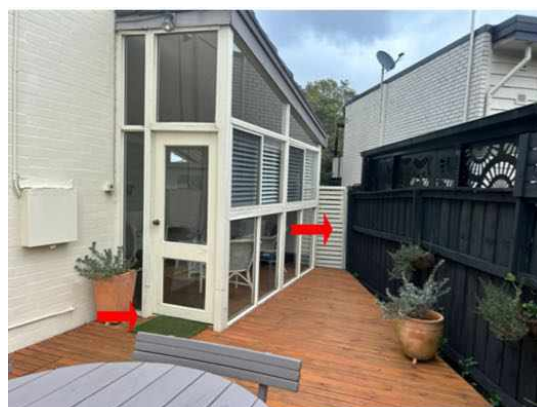
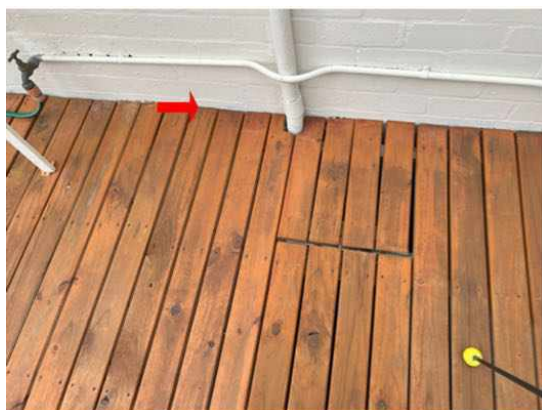
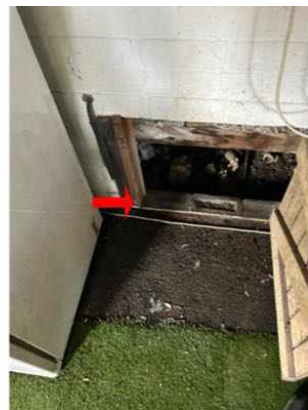
#### Termite and Timber Pest 1.01

| Finding: | Building materials in direct ground contact - conducive to termites |
| Information: | Where timber elements are in direct contact with the ground and consequently moisture or dampness they become conducive to termite activity. Whether timber is used as a building element part of a fencing structure or stored as an unused item they can provide an environment that is attractive to termite infestation. |

When met with excessive moisture timber begins to decay and develop wood rot. Any timbers that are in direct contact with external grounds especially if left untreated or non- durable also provide ingress for subterranean termites into that particular element.

The removal of any such materials that may be conducive to termite activity should be removed as soon as possible to minimise the risk of termite attack.

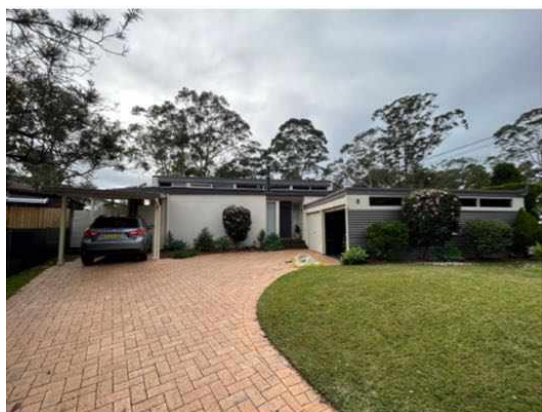
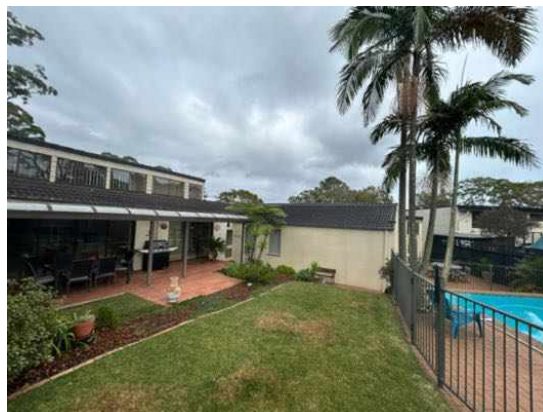
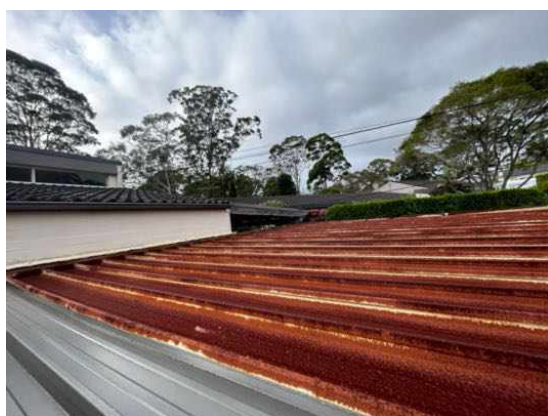
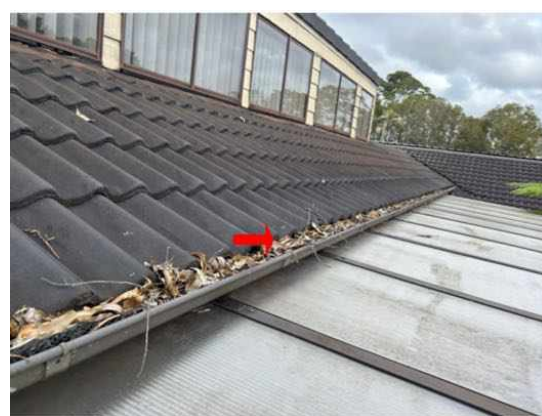
### Termite and Timber Pest 1.03

| Finding: | Trees - Overhanging and filling gutters |

Information: Overhanging trees often result in excessive amounts of leaf debris accumulating in gutters.

Gutters are a critical part of the building's management of storm water and rain. It is therefore important that they be kept clear to prevent secondary damage to associated building elements, including exterior and interior walls, ceiling linings and any adjoining building elements. Where gutters are blocked, pooling of rainwater is likely to occur, fast-tracking rust and corrosion of the roof plumbing elements.

It is highly advised that all overhanging tree branches be removed as soon as possible to prevent any further damage. Repair and/or replacement of sections of damaged guttering may also be required where the extent of the damage necessitates.

Such works should be performed by the homeowner; however, appointment of a landscape contractor or an arborist may be required. Consultation with a licensed roof plumber is required where guttering has been damaged.

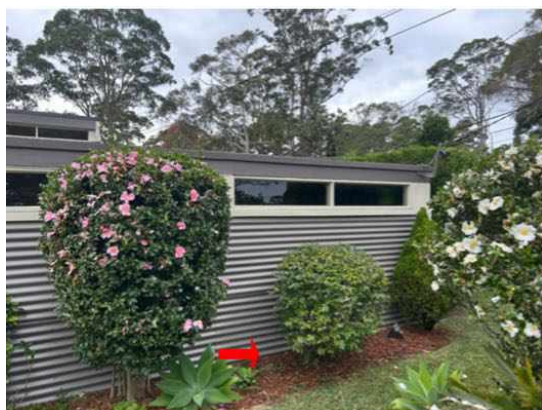
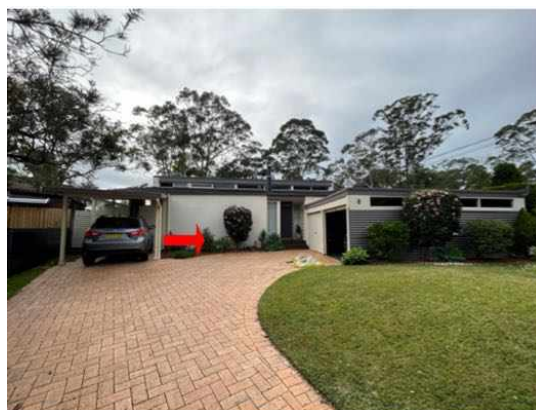
### Termite and Timber Pest 1.04

Building: Building 1  
 Location: All Areas  
 Finding: Garden Beds - Conditions Conducive to Termites  
 Information: Garden beds were found to be evident in the garden area. These garden beds can

include untreated timber, and with a combination of moisture from watering hosing can make conditions conducive to termite activity and termite ingress.

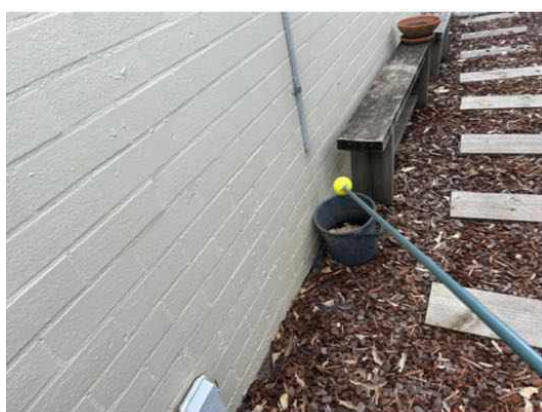
### Termite and Timber Pest 1.05

| Finding: | Overflow - Not plumbed for drainage |
| Information: | The overflow is not plumbed or connected to suitable drainage, which has resulted in the surrounding area becoming excessively damp. These damp conditions can lead to secondary defects such as rot, rust or corrosion of associated building elements, the formation of fungal decay, or even the creation of potential slip hazards. |

When coupled with poor site drainage, pooling of water may also attract termite activity to this area. It is highly recommended that a qualified plumber be appointed to install adequate drainage to the overflow.

These works will ensure that the area remains dry and free of any secondary defects.

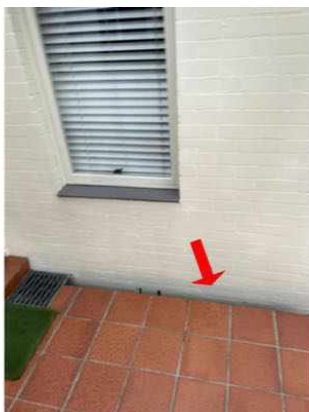
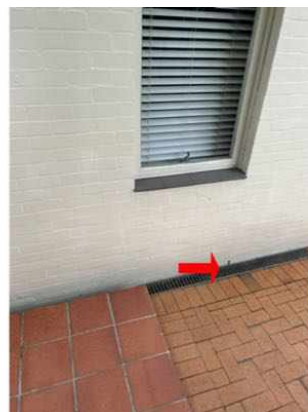
### Termite and Timber Pest 1.06

| Finding: | Site drainage - suspected inadequate in areas |
| Information: | Where site drainage is inadequate, installation of an Agricultural (Aggie) Drain may be required. A qualified plumber should be appointed to further inspect the property and perform any remedial works as necessary. Water damage and secondary defects are likely to occur if left unmanaged. |

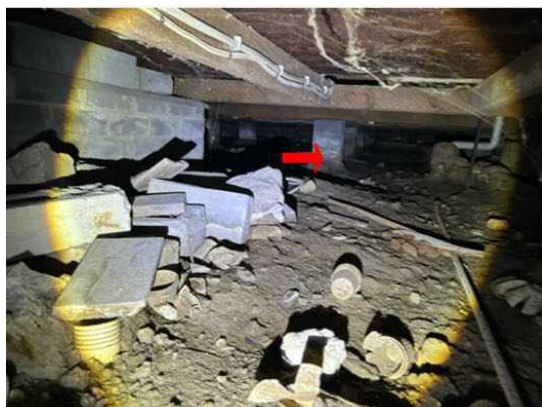
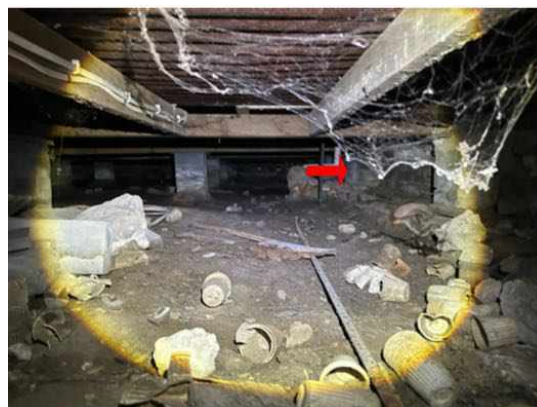
### Termite and Timber Pest 1.07

| Finding: | Evidence of excessive moisture was present at the time of inspection |
| Information: | Excessive moisture can attract termites and produce conditions that promote termite attack fungal growth and wood decay. |

Excessive moisture is generally caused by deteriorated inadequate or missing roof drainage leaking plumbing pipes or fixtures poorly plumbed HWS overflows or condenser units and poor site drainage.

It is recommended that all plumbing and drainage fixtures and fittings be maintained regularly in order to prevent excessive moisture being present in the external / internal property.

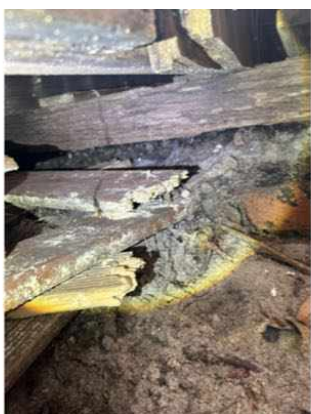
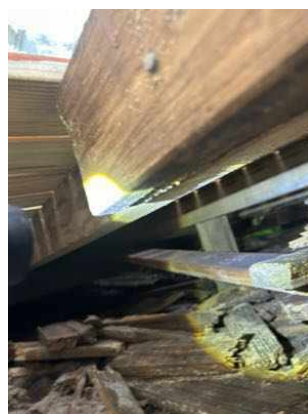
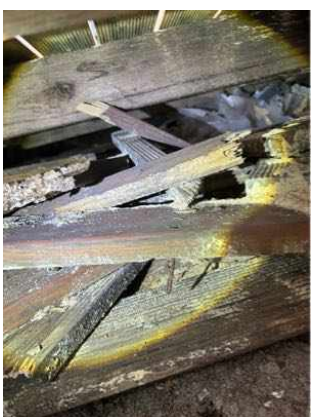
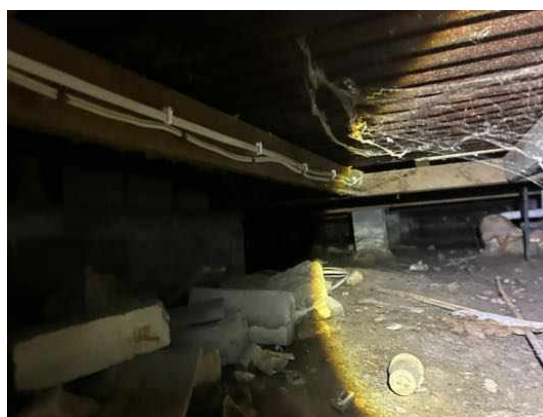
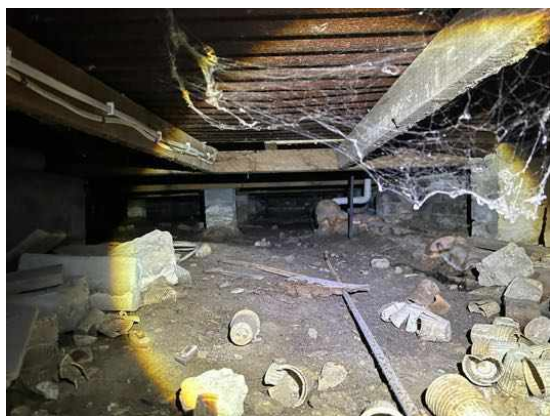
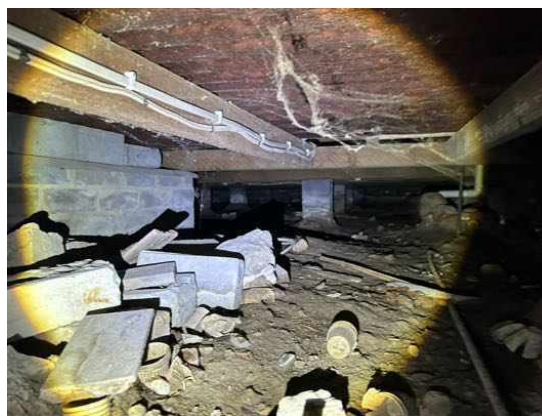
### Termite and Timber Pest 1.08

Building: Building 1  
Location: Subfloor  
Finding: Subfloor - Debris  
Information:

An array of debris was found in the subfloor area at the time of inspection. Debris in this area restricts subfloor ventilation and creates potential for concealed pest entry. Stored timbers and other materials may also make the area susceptible to termite activity and wood rot.

A clear and empty subfloor will be better ventilated and easier to maintain in a dry condition. The removal of any timber debris is vital in minimising the risk of termite or wood borer activity.

Debris in the subfloor should be removed as soon as possible. Depending on the location and amount of debris and stored items, the homeowner may elect to undertake this task. Alternatively there are a large number of rubbish removal subcontractors that could undertake these works.

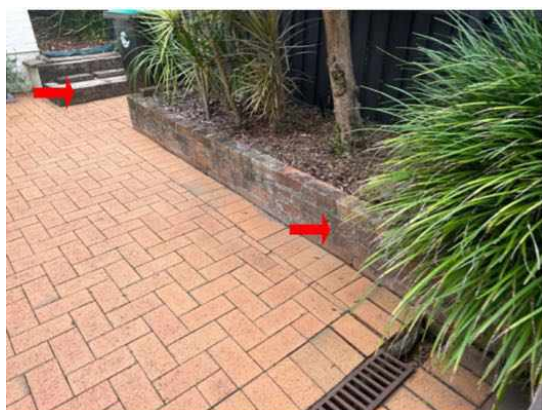
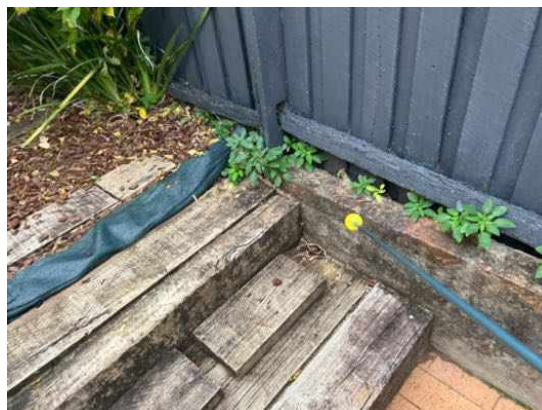
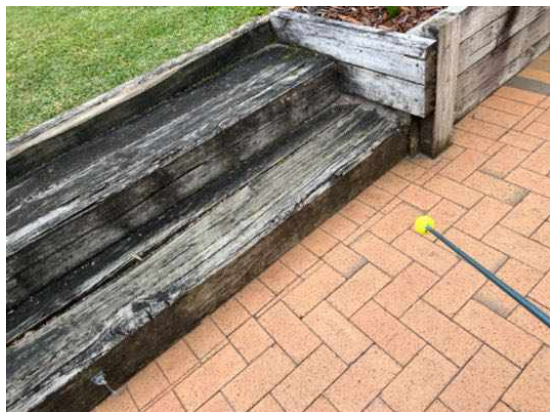
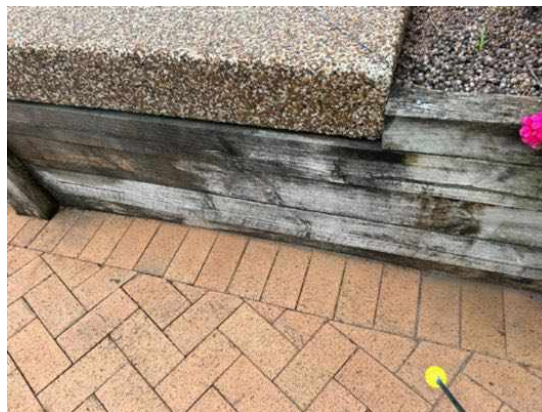
### Termite and Timber Pest 1.09

| Finding: | Evidence of excessive moisture was present at the time of inspection |
| Information: | Excessive moisture can attract termites and produce conditions that promote termite attack fungal growth and wood decay. |

Excessive moisture is generally caused by deteriorated inadequate or missing roof drainage leaking plumbing pipes or fixtures poorly plumbed HWS overflows or condenser units and poor site drainage.

It is recommended that all plumbing and drainage fixtures and fittings be maintained regularly in order to prevent excessive moisture being present in the external / internal property.

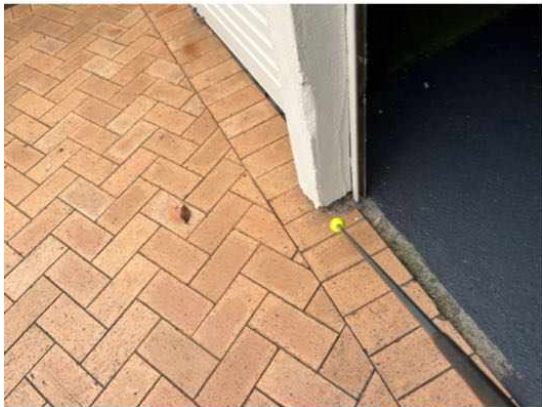
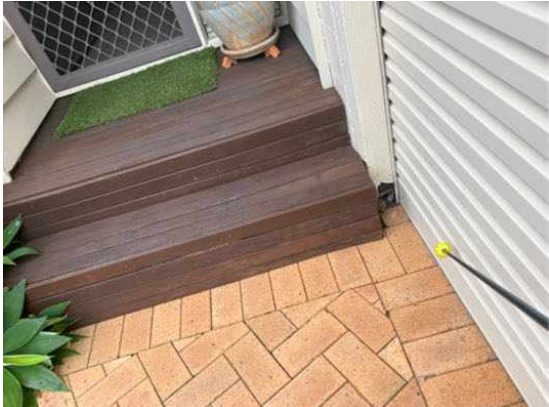
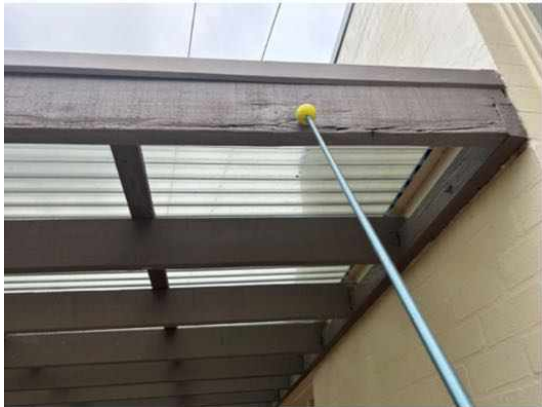
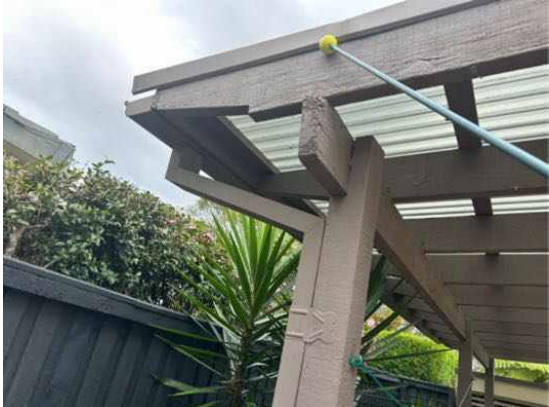
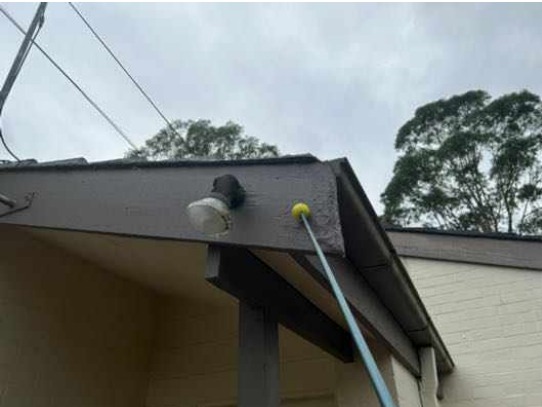
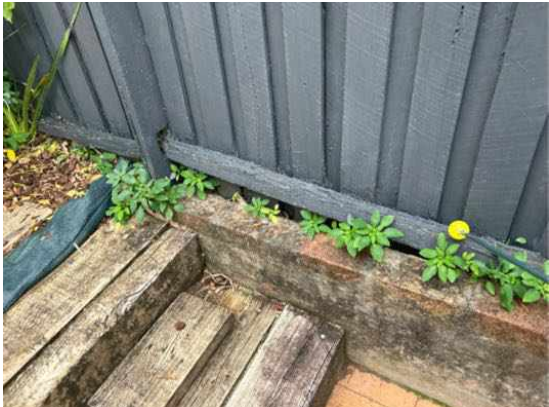
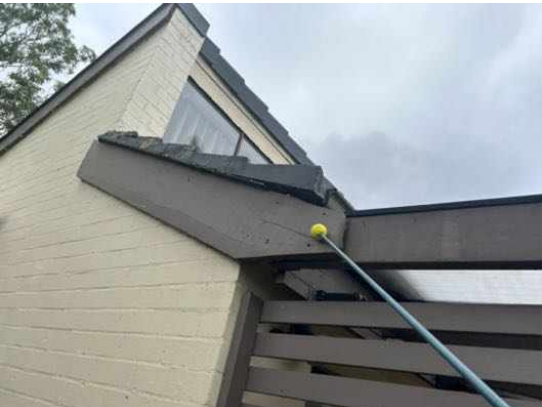
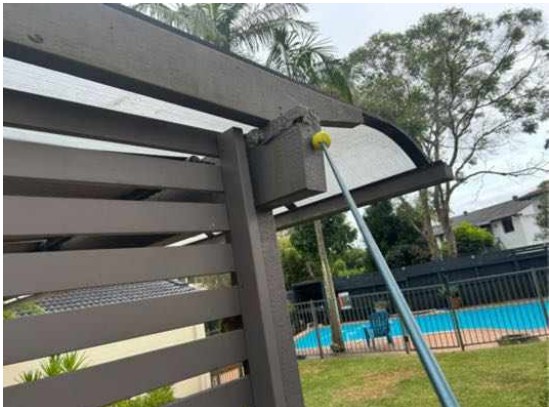
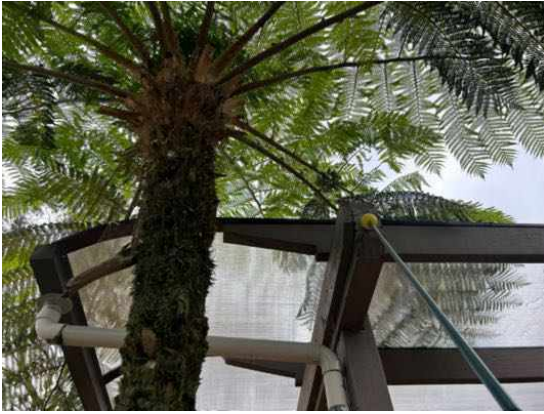
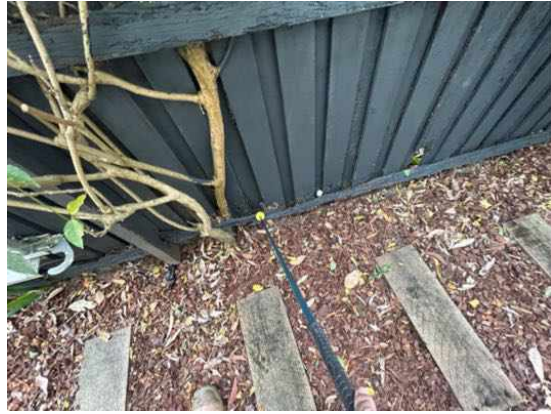
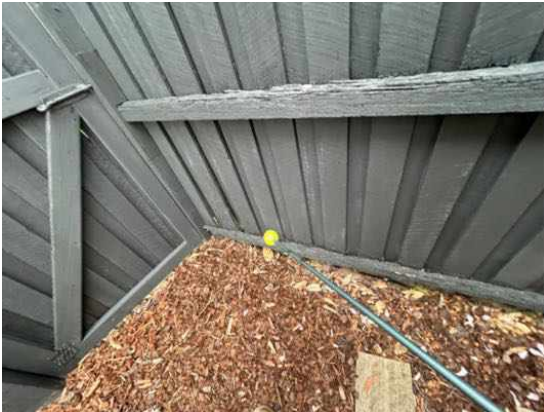
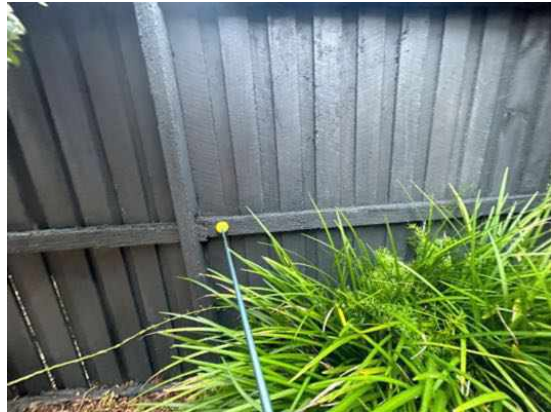
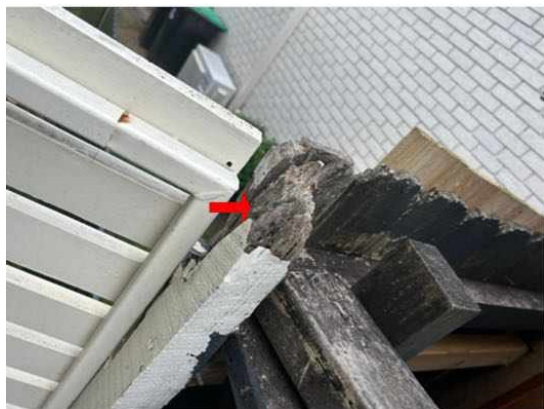
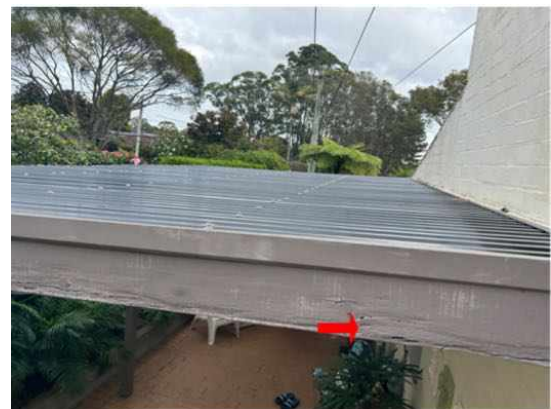
### Termite and Timber Pest 7.01

| Finding: | Wood rot |
| Information: | This building element shows evidence of wood rot. Wood rot, also known as Fungal Decay, occurs when timbers and other cellulose building materials are exposed to damp conditions on an ongoing basis. This could be the result of exposure to weathering over a prolonged period of time, or the attraction of excessive moisture from other abutting building materials. Contributing factors also include poor air ventilation in the area. |

Early intervention and regular maintenance, particularly of exterior timbers, will prolong the useful life of these building elements. Prior to any works being performed, the cause of the moisture that has created the visible wood rot should be identified and addressed in a suitable manner. Replacement of affected timbers may then be a necessary step in protecting surrounding building elements from such deterioration.

A qualified carpenter or registered builder may also be required to replace affected building materials.

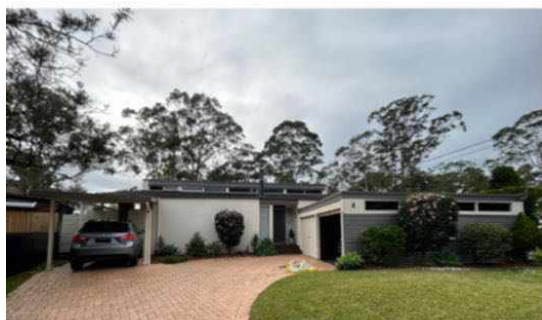
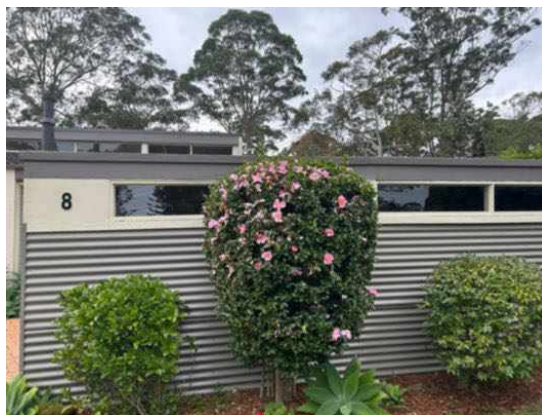
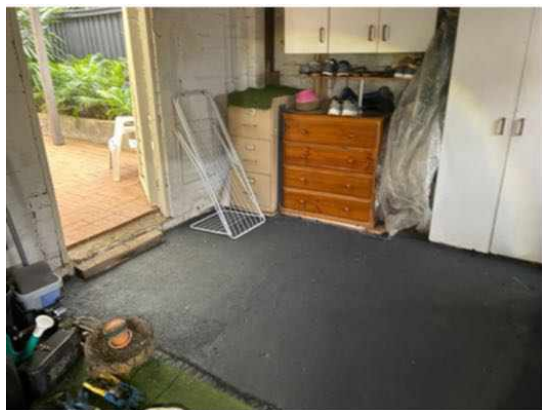
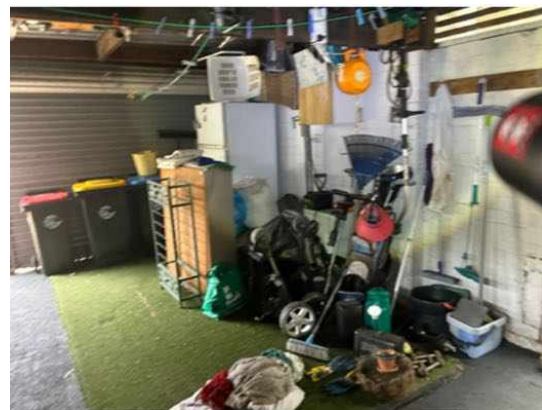
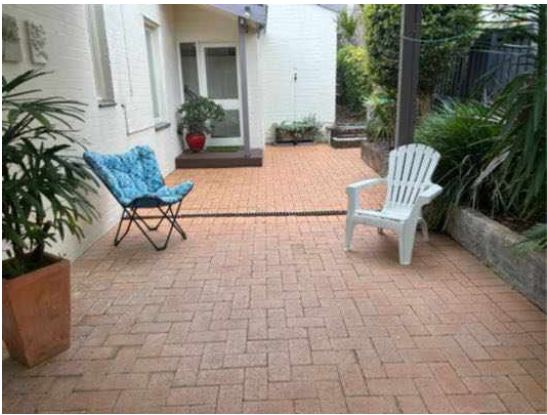
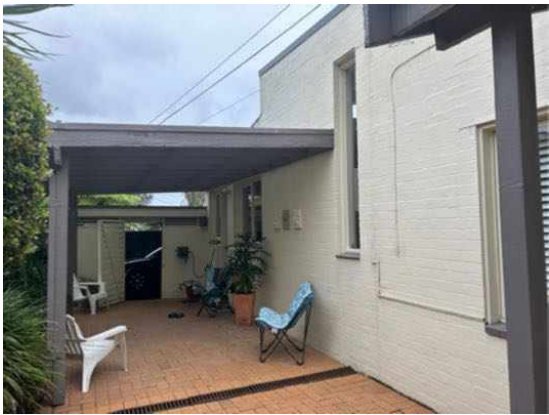
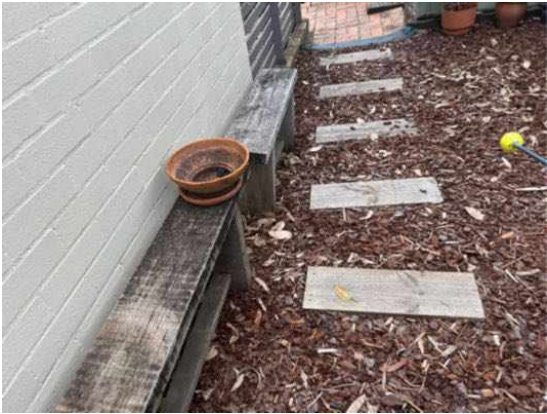
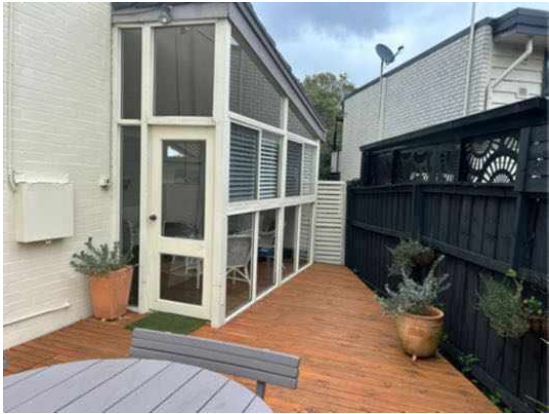
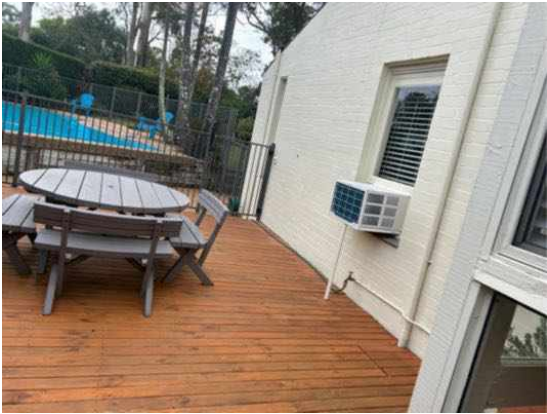
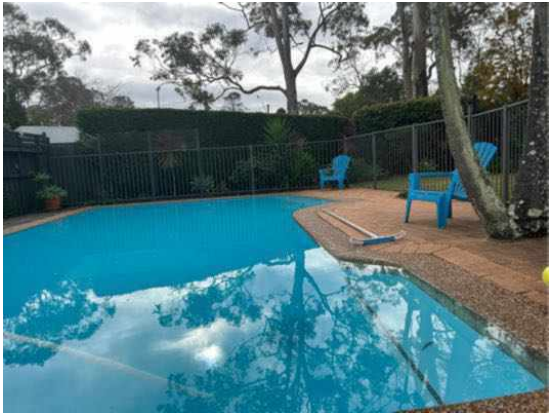
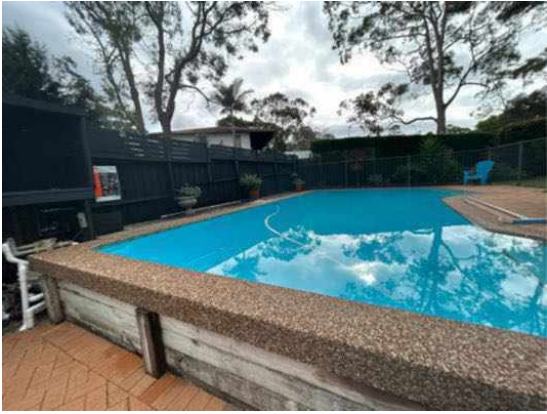
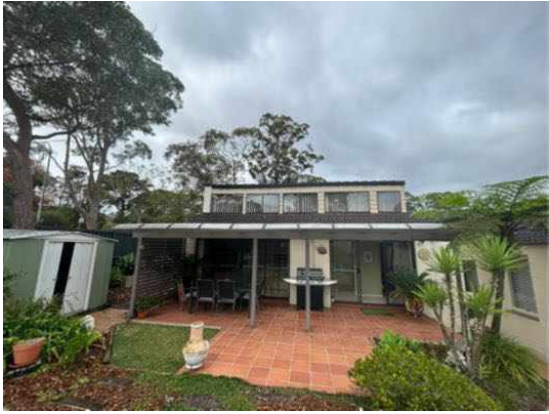
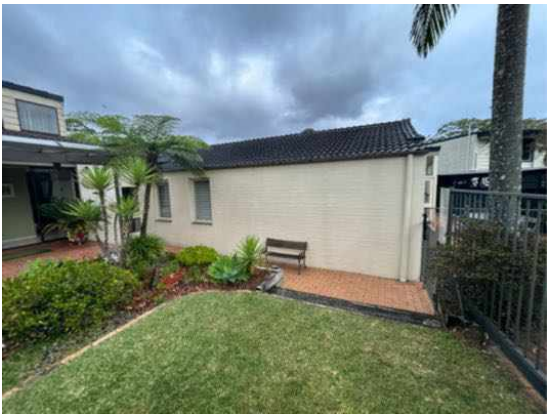
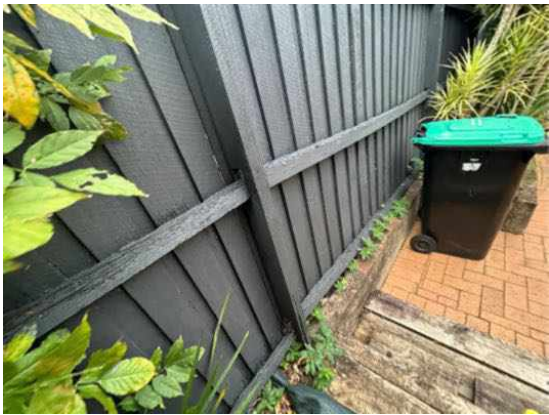
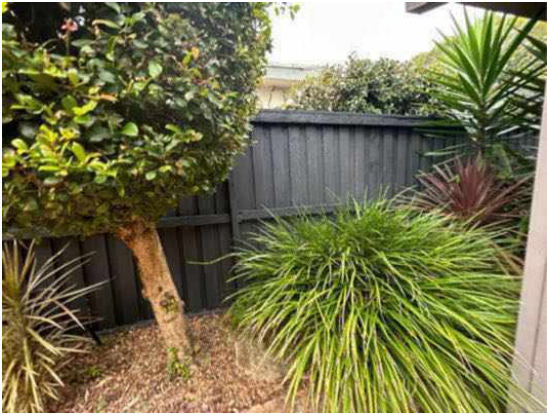
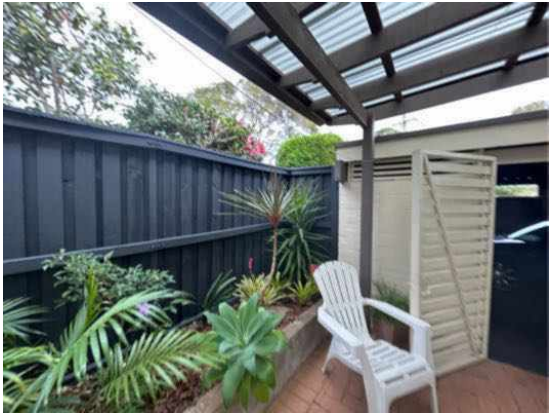
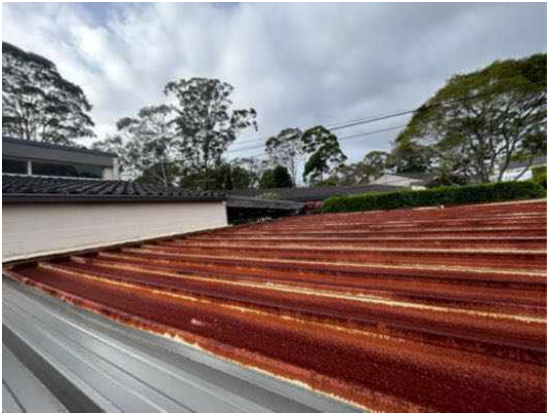
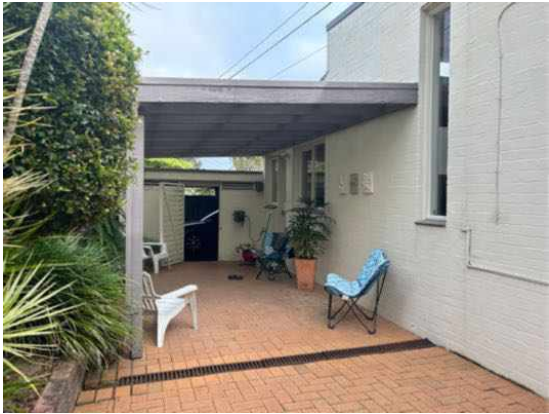
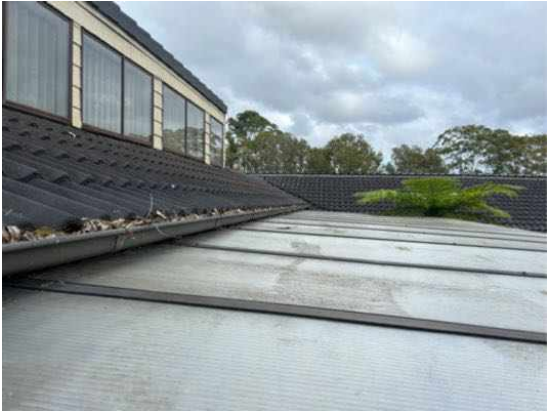
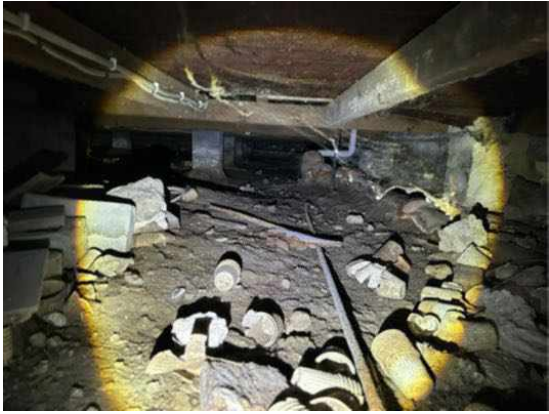
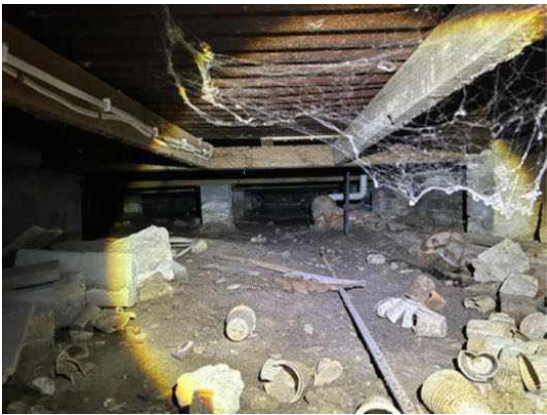
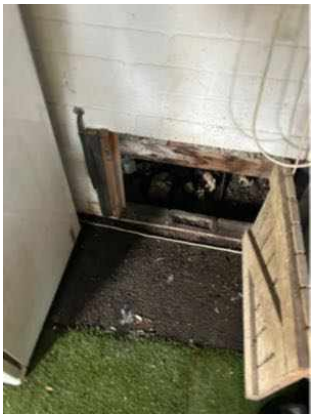
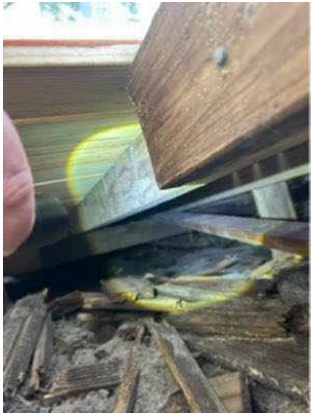
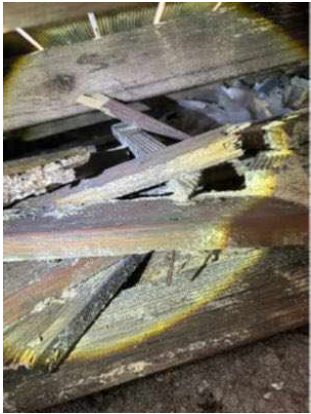
### Noted Item

| Finding: | Additional Photos - Obstructions and Limitations |
| Information: | These photographs are an indication of the obstructions and limitations which impeded full inspection of the property at the time of inspection. These obstructions can hide an array of defects and should be removed to allow full inspection to be carried out. A re-inspection is recommended once the areas are made accessible. |
