## Building and Timber Pest Inspection Report

Inspection Date: Fri, 17 Jun 2022

Property Address: 39 Aranda Dr, Davidson NSW 2085,  
Australia

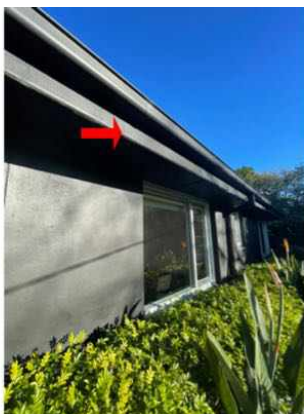
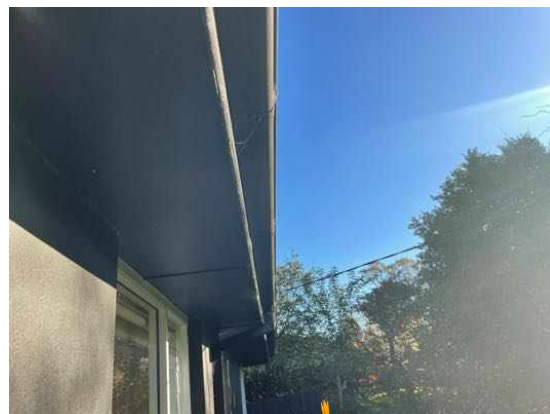
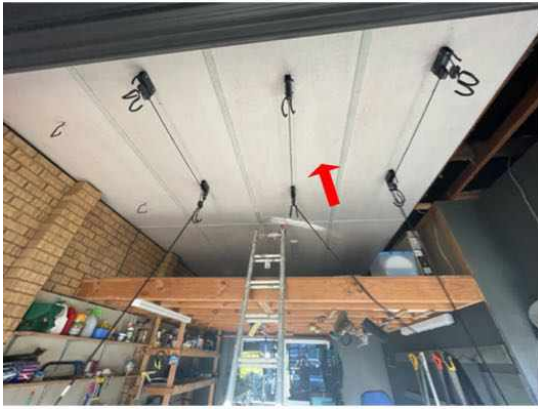
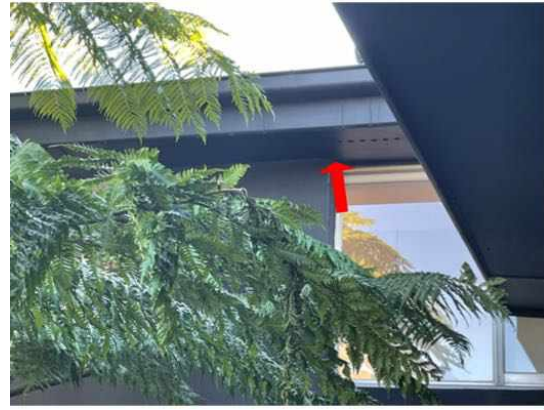
#### Defects 1.01

Building:	Building 1
Location:	All External Areas
Finding:	ACM (Asbestos) Visually Identified
Information:	This material has been visually identified as been constructed with the use of asbestos-containing materials (ACM). The material appears to have no obvious signs of damage or deterioration, indicating that the asbestos is currently encapsulated and contained. Damaged and deteriorated ACMs have a higher probability of releasing airborne asbestos fibres, creating a significant health safety risk.

Removal by a Licensed Asbestos Removal firm would be recommended.

Where the client elects to retain the ACM, the client should regularly monitor the condition to identify any further damage or deterioration. Such monitoring should be conducted at least annually, but more frequently should damage or evidence of deterioration occur.

No works should be carried out to the ACM or associated building elements without further specialist advice. Furthermore, areas with suspected ACMs should be avoided by all persons to minimise potential for health safety risk.

Samples for lab analysis to confirm the presence of asbestos should be taken.

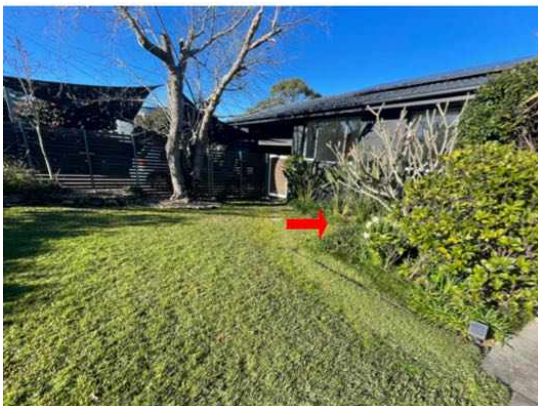
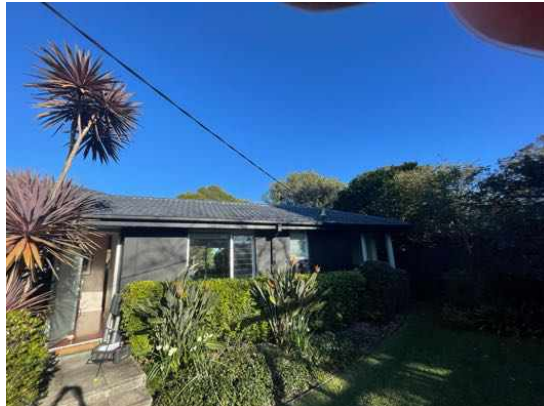
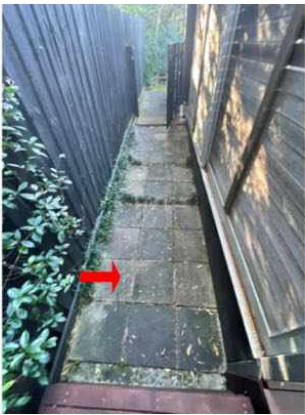
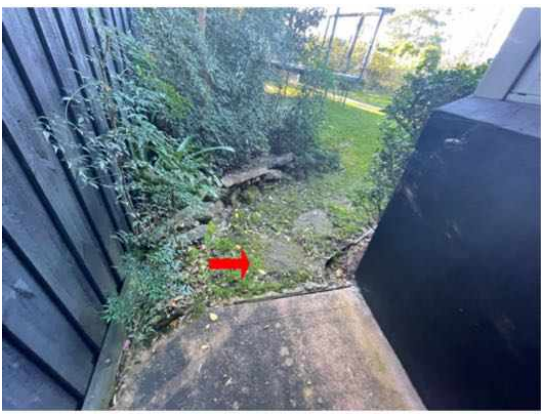
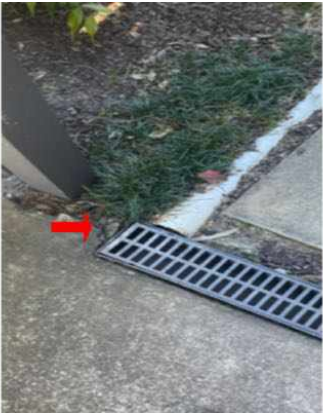
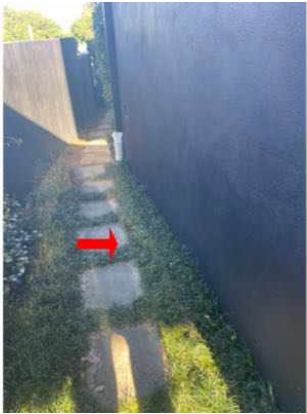
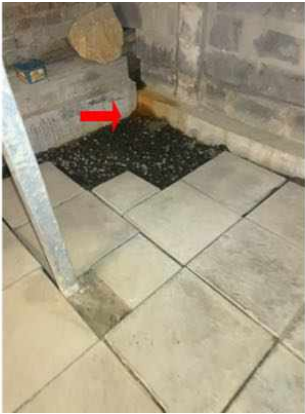
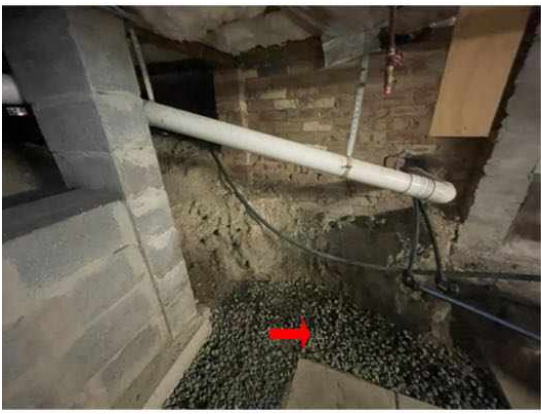
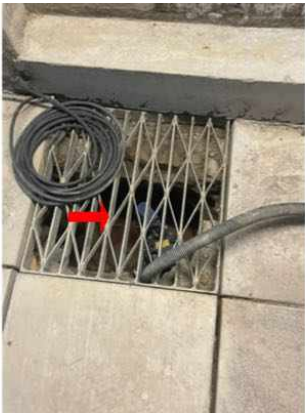
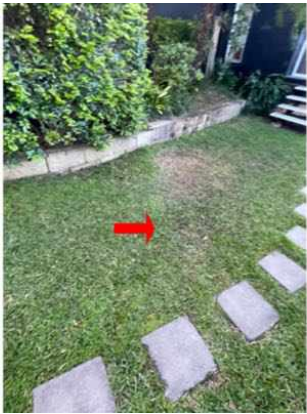
### Defects 3.01

Building: Building 1  
 Location: All External Areas  
 Finding: Evidence of excessive moisture was present at the time of inspection  
 Information: Excessive moisture can attract termites and produce conditions that promote termite attack fungal growth and wood decay.

Excessive moisture is generally caused by deteriorated inadequate or missing roof drainage leaking plumbing pipes or fixtures poorly plumbed HWS overflows or condenser units and poor site drainage.

It is highly recommended that all plumbing and drainage fixtures and fittings be maintained regularly in order to prevent excessive moisture being present in the external / internal property.

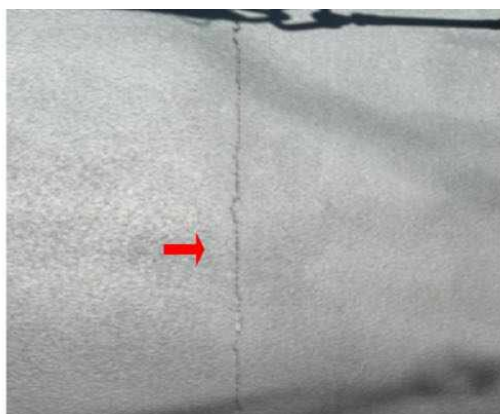
Defects 3.02

Building:	Building 1
Location:	All Areas
Finding:	Cracks to render - Category 0
Information:	It has been observed that cracking to rendered surfaces has occurred. The degree of damage falls within Category 0, and is described as hairline cracking, which is less than 0.1mm in width. Damage of this category is not considered a defect for rectification.

No rectification is required at this time. Always contact your building should cracks widen, lengthen, or become more numerous.

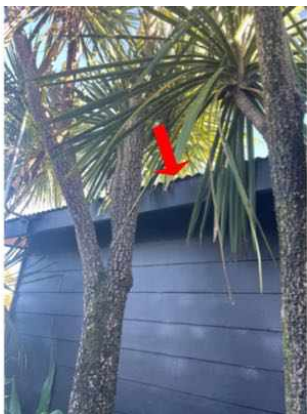
### Defects 3.03

Building:	Building 1
Location:	Yard - Side
Finding:	Roof plumbing - Missing
Information:	Some sections of the roof are not adequately drained via gutters and downpipes. Gutters and downpipes that are not installed adequately are likely to result in excessively damp conditions against the exterior surfaces and around the base perimeter of the building.

Excessive moisture creates an environment which accelerates the deterioration of building elements in the area, as well as being conducive to termite and pest infestation. Such an environment is likely to necessitate repair and/or replacement of building elements, which are prone to sustaining wood rot, rust or corrosion.

A roofing plumber should be appointed as soon as possible to install relevant roof plumbing materials. Depending on the extent of the damage, repair and/or replacement of damaged building elements may be required.

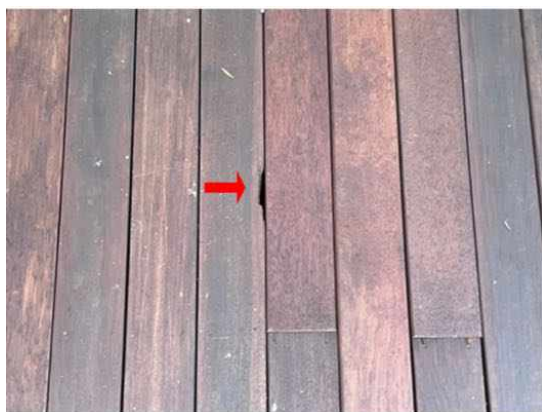
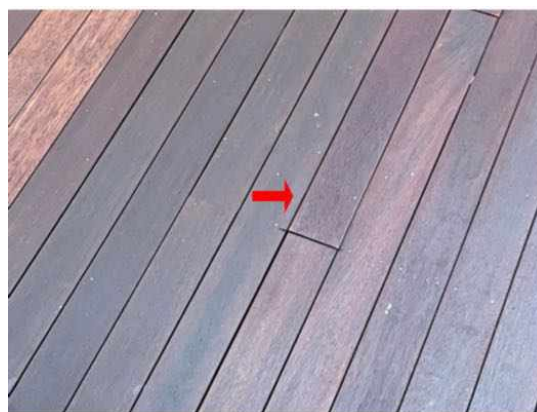
### Defects 3.04

Building:	Building 1
Location:	Yard - Back
Finding:	Incomplete or substandard works deck
Information:	The works to this area appear to be incomplete or have been completed to a substandard level.

Works that have not been completed to a satisfactory level create potential for the development of building defects and may impede on the safety and integrity of the overall structure.

It is recommended that the relevant trades be appointed to complete these works and ensure the safety of the area and the longevity of all associated building elements.

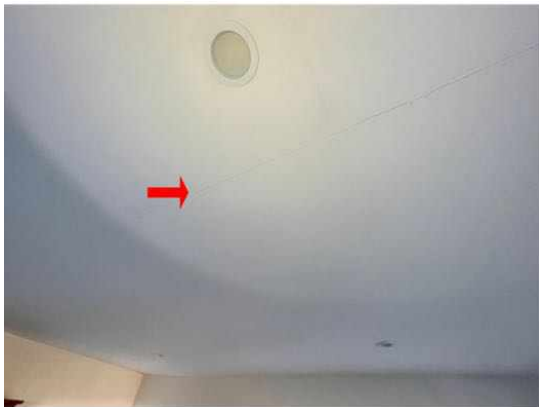
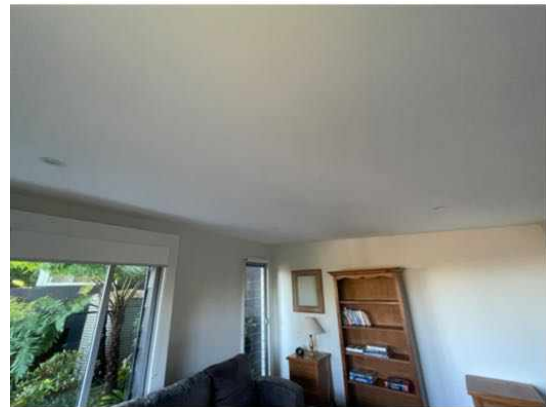
### Defects 3.05

Building:	Building 1
Location:	Studio
Finding:	Cracking - Damage Category 1 - Fine (up to 1mm)
Information:	Although fine cracks are quite noticeable, they are often only considered to be an appearance defect, and usually do not indicate any structural damage. Generally, the cause of a fine crack is indicative of a separation between building materials and

finishes (e.g. paint, plaster, etc.) along joins.

Cracking of this nature can generally be repaired with minor sanding, filling and/or repainting. Such works should be performed by a qualified painter or a general handyman.

Monitoring of all cracking should be conducted frequently. Always contact a building inspector should cracks widen, lengthen, or become more numerous.

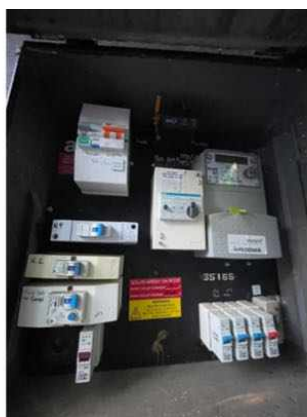
Building: Building 1  
 Location: Yard - Side  
 Finding: Termite Management System - no evidence of a chemical installation  
 Information: The application of a post-construction chemical termite barrier is highly recommended for all properties, particularly if live termite activity has been found on the site previously. Such barriers are highly effective in preventing termite attack on any timber building elements throughout the property.

A durable notice should be placed in the switchboard unit to indicate current termite barriers. At the time of inspection, it appeared as though no termite management system has been installed, with no evidence to suggest preventative works taking place.

The client may consider gaining further advice from a pest controller as to the costs and procedures involved with this application. It is recommended that obtaining such advice be a short-term priority.

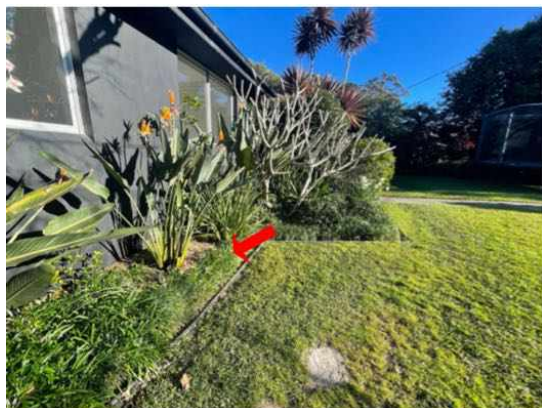
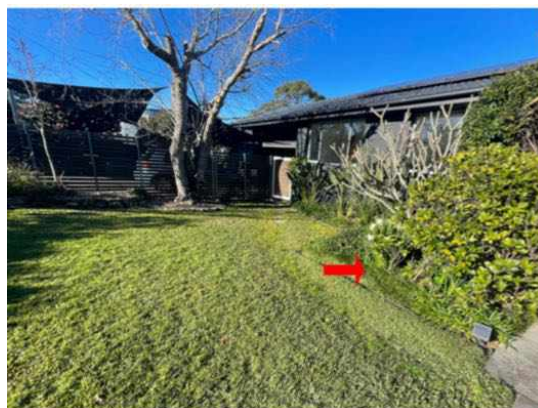
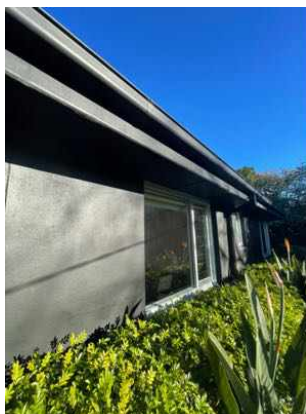
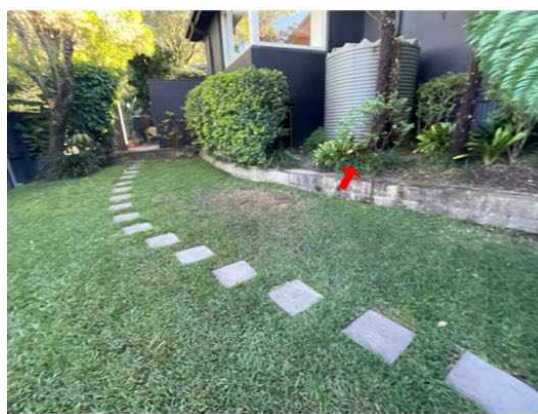
Building: Building 1  
 Location: All Areas  
 Finding: Garden Beds - Conditions Conducive to Termites  
 Information: Garden beds were found to be evident in the garden area. These garden beds can include untreated timber, and with a combination of moisture from watering hosing can make conditions conducive to termite activity and termite ingress.

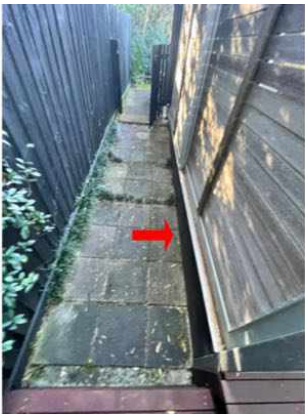
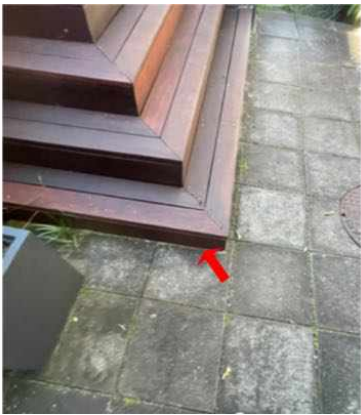
Building:	Building 1
Location:	All External Areas
Finding:	Building materials in direct ground contact - conducive to termites
Information:	Where timber elements are in direct contact with the ground and consequently moisture or dampness they become conducive to termite activity.

Whether timber is used as a building element part of a fencing structure or stored as an unused item they can provide an environment that is attractive to termite infestation.

When met with excessive moisture timber begins to decay and develop wood rot. Any timbers that are in direct contact with external grounds especially if left untreated or non- durable also provide ingress for subterranean termites into that particular element.

The removal of any such materials that may be conducive to termite activity should be removed as soon as possible to minimise the risk of termite attack.

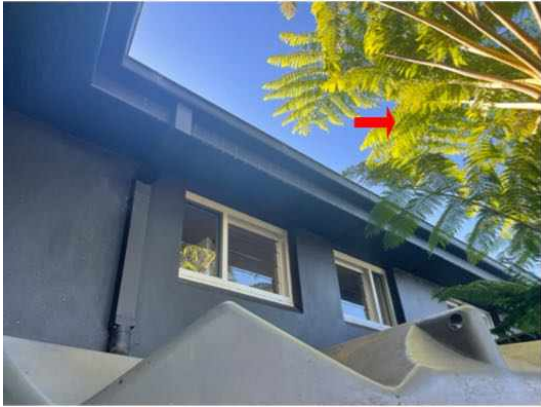
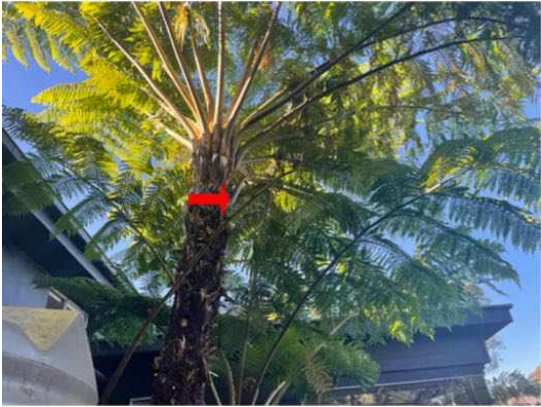
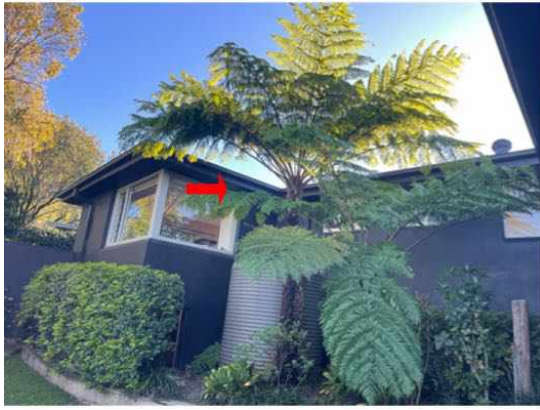
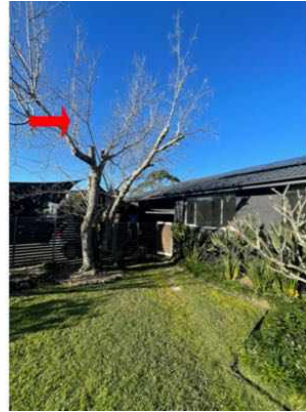
Building: Building 1  
Location: All External Areas  
Finding: Trees - Overhanging and filling gutters  
Information: Overhanging trees often result in excessive amounts of leaf debris accumulating in gutters.

Gutters are a critical part of the building's management of storm water and rain. It is therefore important that they be kept clear to prevent secondary damage to associated building elements, including exterior and interior walls, ceiling linings and any adjoining building elements. Where gutters are blocked, pooling of rainwater is likely to occur, fast-tracking rust and corrosion of the roof plumbing elements.

It is highly advised that all overhanging tree branches be removed as soon as possible to prevent any further damage. Repair and/or replacement of sections of damaged guttering may also be required where the extent of the damage necessitates.

Such works should be performed by the homeowner; however, appointment of a landscape contractor or an arborist may be required. Consultation with a licensed roof plumber is required where guttering has been damaged.

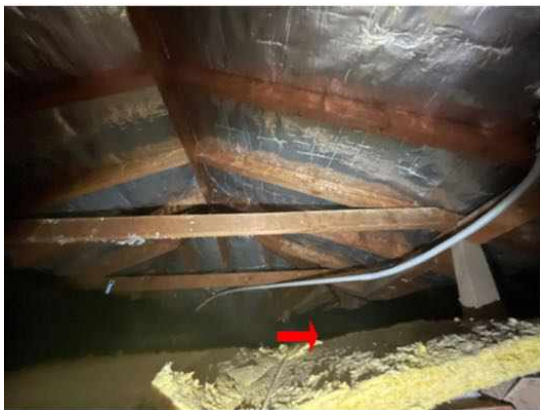
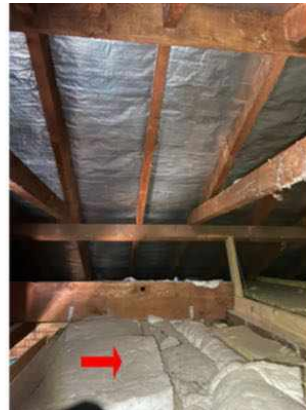
Building: Building 1  
 Location: Roof Void  
 Finding: Insulation- installed  
 Information: Insulation is under the roof sheeting. Insulation acts as an insulator that helps with heat reduction.

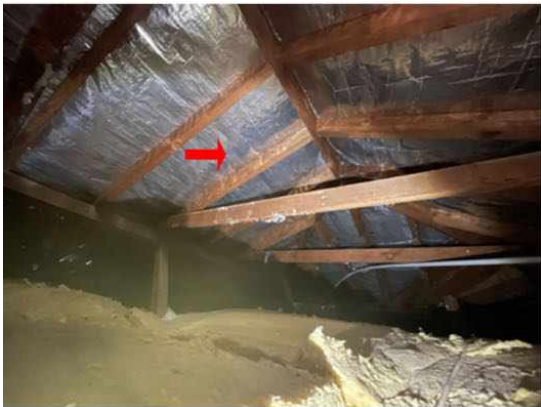
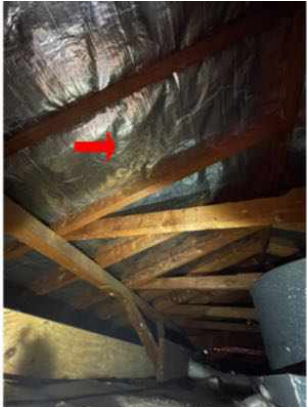
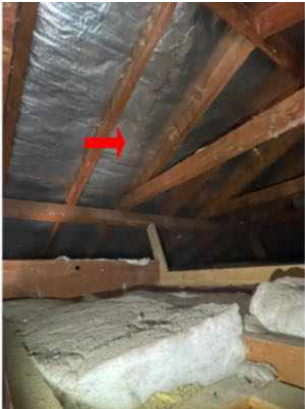
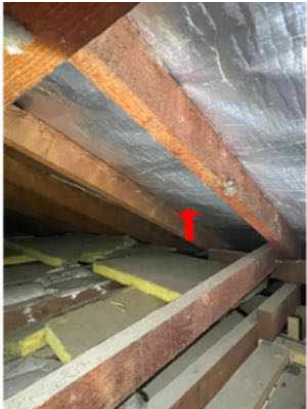
Building: Building 1  
 Location: Roof Void  
 Finding: Sarking - installed  
 Information: Sarking is under the roof sheeting. Sarking acts as an insulator that helps with noise reduction and protects against water penetration. Sarking plays a key role in the operation and function of the overall roofing structure and its performance.

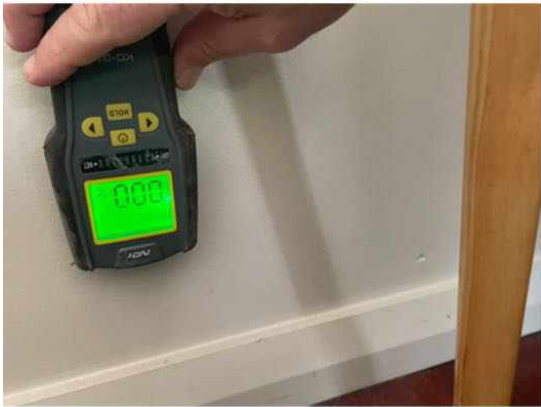
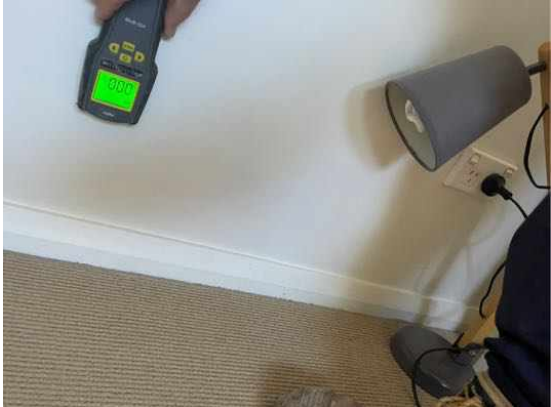
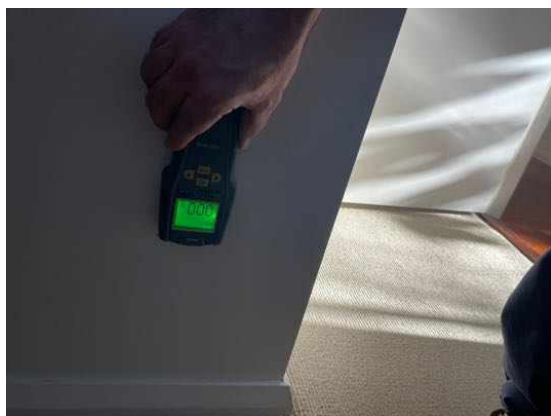
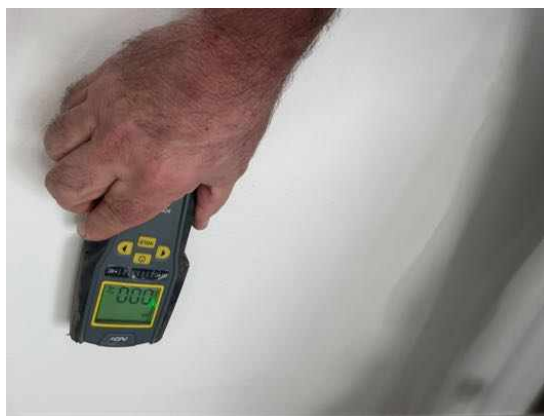
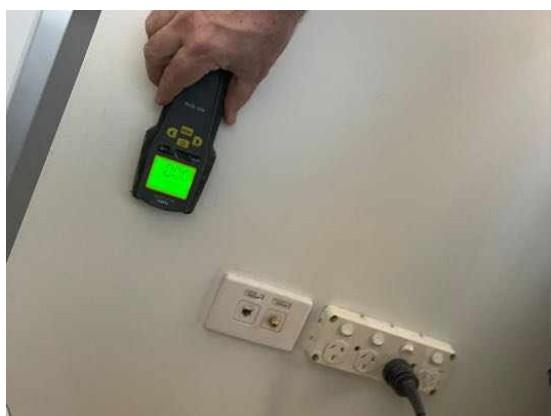
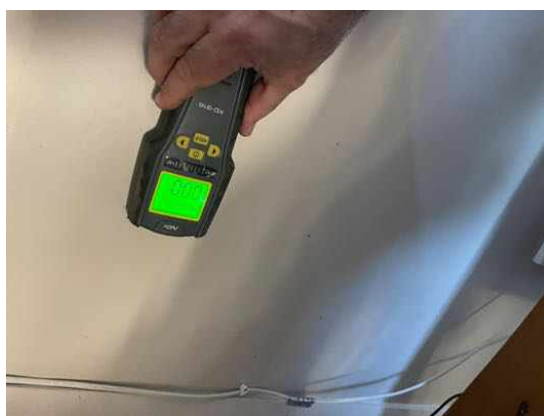
Building: Building 1  
 Location: All Internal Areas  
 Finding: Moisture meter readings  
 Information: The moisture meter result for the areas inspected.

The moisture reading of 0-15% is quite normal and gives no cause for concern. However, moisture readings in excess of 15% indicate the need for further inspection.

Levels between 25-30% indicate that there may be water ingress, meaning that remedial work could be required.

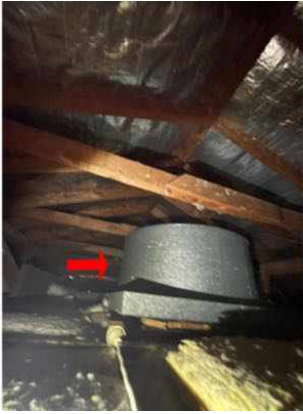
Building:	Building 1
Location:	Roof Void
Finding:	Gravity-Fed HWS - Disconnected
Information:	It was noted at the time of inspection that a disconnected gravity-fed hot water system (HWS) remains in this area.

Despite this plumbing structure being unused, it is likely to be storing residual water, and is therefore susceptible to rust and corrosion. If allowed to continue, rust and corrosion is likely to lead to damage to adjoining building elements, and may also make the area susceptible to termite or timber pest activity.

While it is a costly exercise to remove the disused gravity-fed HWS, it is advisable in the short-term future to prevent any further damage to the area. Further consultation with a licensed plumber is required to gain further advice on removal of the structure.
