VISUAL BUILDING & PEST INSPECTION REPORT

Vendor Report

2 Naree Road Frenchs Forest

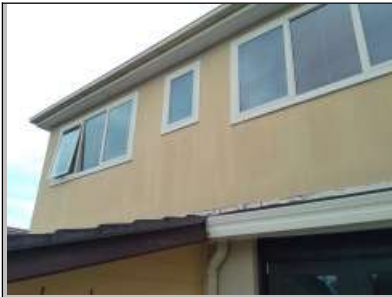
The condition of the walls is generally fair. Some maintenance required to upper level sheets.

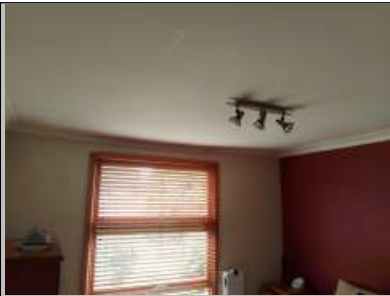
Main bedroom.

The condition of the ceilings is generally fair. Sagging was noted to the ceiling lining. This may be the result of lack of adhesion to joists and re fixing is advised.

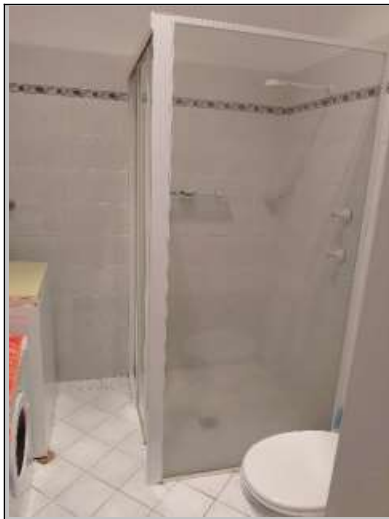
Rear.

The shower recess was tested and found to be leaking. Continued leaking may allow damage and decay to surrounding components. Rectification will be required and evaluation of extent of works should be requested from a Licensed Builder.

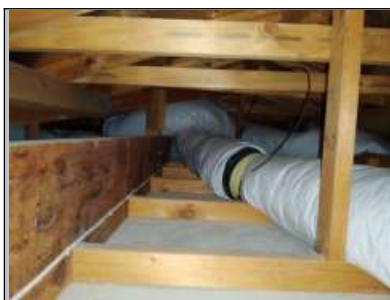
Ducting associated with air-conditioning or heating restricted inspection.

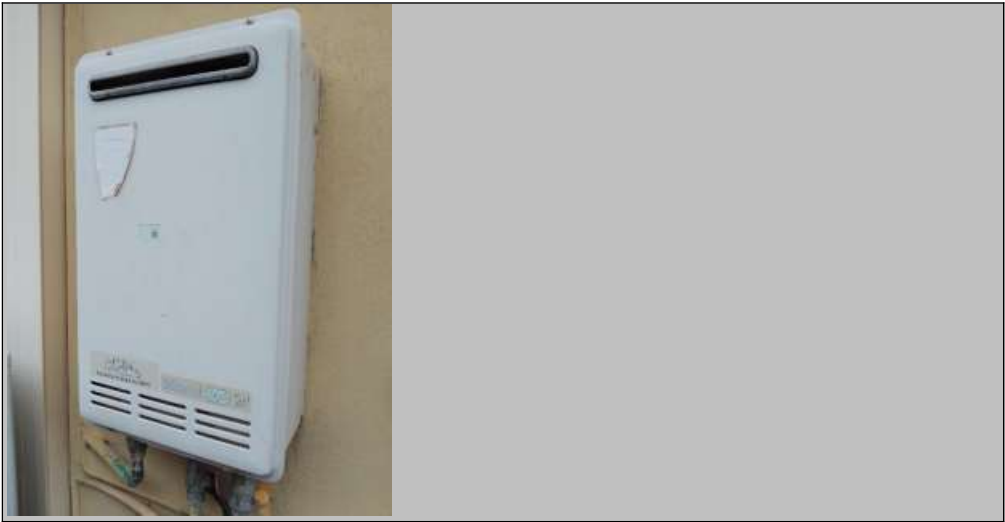
Gas hot water system: Mains pressure: Instantaneous: Located externally: The hot water system appears to be in working condition. No specific tests other than running the hot water tap were carried out. No determination has been made as to the suitability or adequacy of the hot water system in relation to capacity or otherwise.

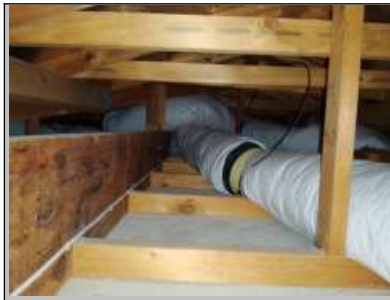
Ducting associated with air-conditioning or heating restricted inspection.
