Building Inspection Report

Inspection Date: Mon, 13 May 2024

Property Address: 35 Parni Pl, Frenchs Forest NSW 2086,
Australia

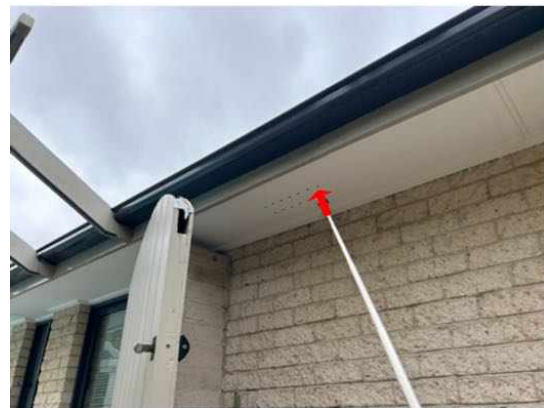
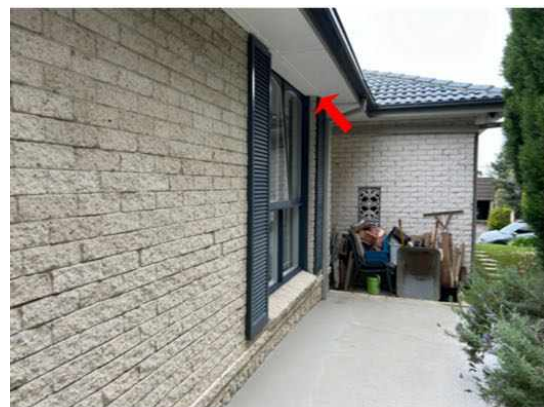
Defects 1.01

Building:	Building 1
Location:	All Areas
Finding:	Asbestos - Suspected ACM Identified on Site
Information:	Reporting on Asbestos is outside the Scope of this Report. This suspected defect is highlighted as a caution only. We suspect, based on our experience in the building industry, that there is a higher risk of the identified building element containing asbestos.

As Asbestos Reporting is outside the scope of this report, we advise that you consider a separate Asbestos Inspection and Condition Audit, which can include the taking of samples for definitive confirmation of the presence of Asbestos.

In the interim, the client is advised to act with caution, especially when considering any damage to building materials general wear and tear renovations extensions demolition and general maintenance activities due to the suspected presence of Asbestos.

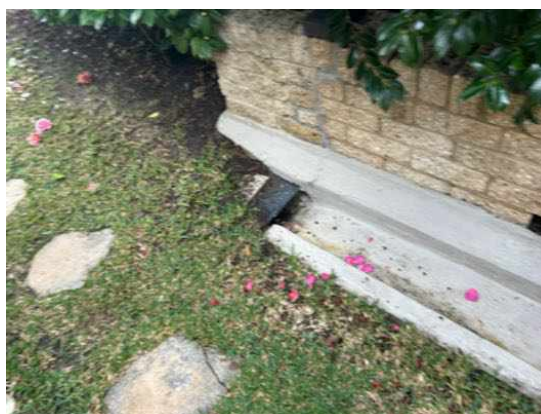
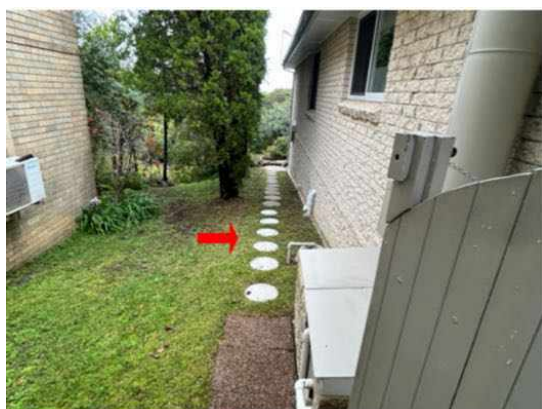
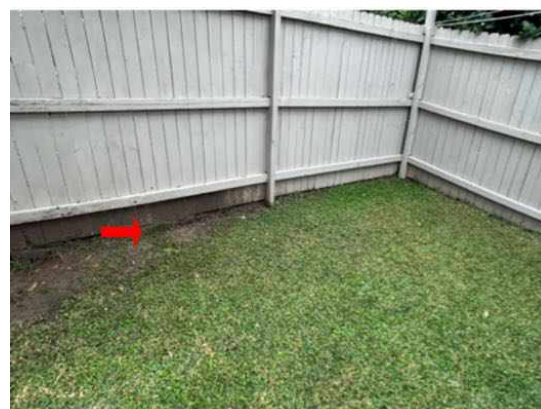
Defects 3.01

Building: Building 1
 Location: All Areas
 Finding: Evidence of excessive moisture was present at the time of inspection
 Information: Excessive moisture is generally caused by deteriorated inadequate or missing roof drainage leaking plumbing pipes or fixtures poorly plumbed HWS overflows or condenser units and poor site drainage.

Excessive moisture can attract termites and produce conditions that promote termite attack fungal growth and wood decay.

It is recommended that all plumbing and drainage fixtures and fittings be maintained regularly in order to prevent excessive moisture being present in the external / internal property.

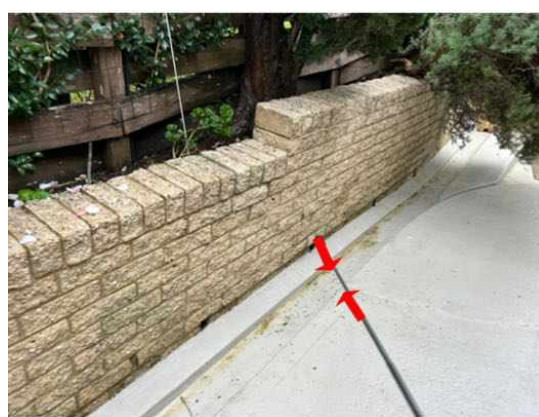
Defects 3.02

Building: Building 1
 Location: All Areas
 Finding: Site drainage - suspected Inadequate
 Information: The site drainage in this area was found to be inadequate at the time of inspection, creating potential for subsequent water damage to associated building elements.

It is important that water does not lie against the base of walls; surrounding paths and ground levels should be sloped to drain water away from walls. Downpipes should not discharge stormwater onto lower walls or plinths. Stormwater should be carried away by large, regularly cleaned drains. Ground levels may need to be lowered to expose a buried DPC.

Where site drainage is inadequate, installation of an Agricultural (Aggie) Drain may be required. A qualified plumber should be appointed to further inspect the property and perform any remedial works as necessary. Water damage and secondary defects are likely to occur if left unmanaged.

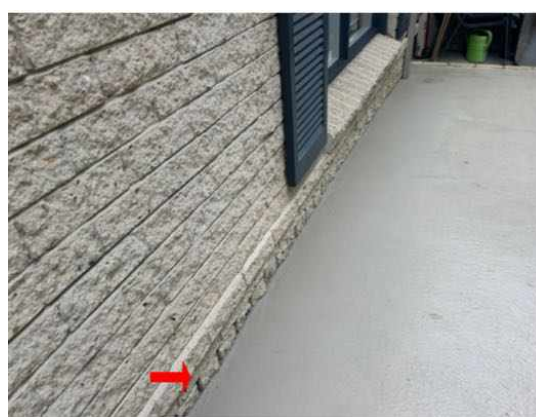
Defects 3.03

Building: Building 1
 Location: All External Areas
 Finding: Weep holes - particularly obstructed
 Information: It was noted during the time of inspection that some of the weep holes to the

brickwork were particularly obstructed. Weep holes are designed to allow water from leaks or seepages in brickwork to be directed to the external environment, prior to entering the wall cavity or associated building materials. Weep holes should therefore be kept clean and free of debris or blockages.

Particular obstruction weep holes are likely to result in the presence of excessive moisture within the brickwork and associated structures, creating potential for water damage and moisture problems.

Depending on the nature of the blockage, the homeowner may be able to undertake remedial works.

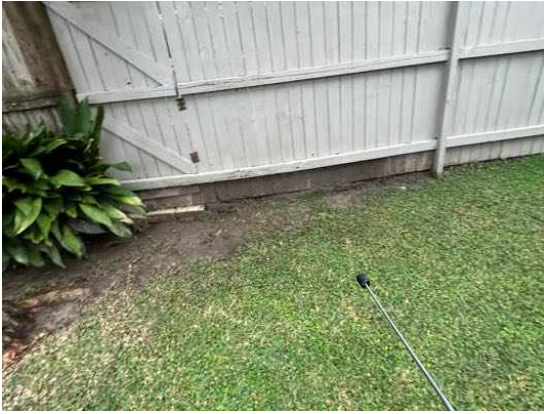
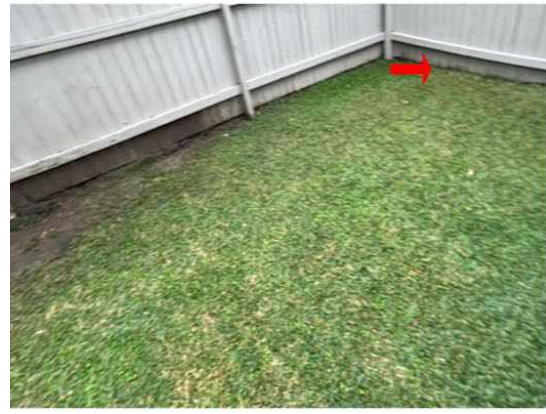
Defects 3.05

Building: Building 1
Location: All External Areas
Finding: Fencing - Deteriorated
Information: It was noted at the time of inspection that sections of the fencing throughout the property have deteriorated. Typically fencing deteriorates due to age and or wear, rot and or rust which is generally expected for a structure of this age, due to prolonged exposure to weather conditions.

If left unattended, it is may develop further damage will occur.

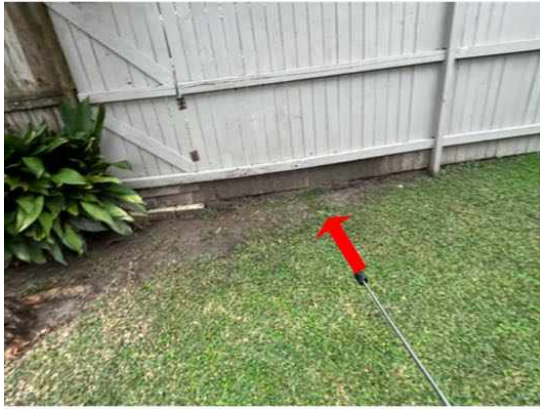
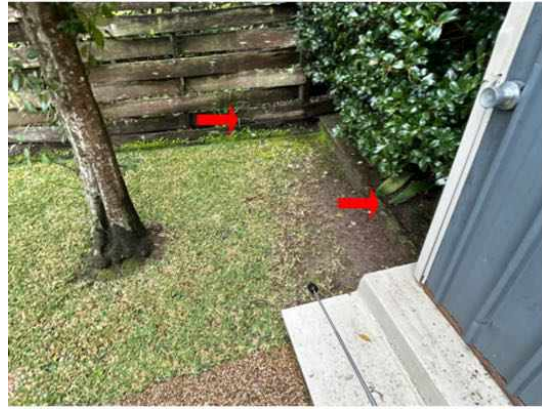
Defects 3.08

Finding: Wood rot

Information: This building element shows evidence of wood rot. Wood rot, also known as Fungal Decay, occurs when timbers and other cellulose building materials are exposed to damp conditions on an ongoing basis. This could be the result of exposure to weathering over a prolonged period of time, or the attraction of excessive moisture from other abutting building materials. Contributing factors also include poor air ventilation in the area.

Wood rot is often associated with general damp problems and is evidenced by a 'musty' smell or mould and mildew occurring on surfaces. If left unmanaged, damp conditions can lead to further health problems and the decay of timbers will continue.

Early intervention and regular maintenance, particularly of exterior timbers, will prolong the useful life of these building elements. Prior to any works being performed, the cause of the moisture that has created the visible wood rot should be identified and addressed in a suitable manner. Replacement of affected timbers may then be a necessary step in protecting surrounding building elements from such deterioration.

A qualified plumber may be appointed to assess the cause of excessive moisture and to provide advice on any remedial works as required. A qualified carpenter or registered builder may also be required to replace affected building materials.

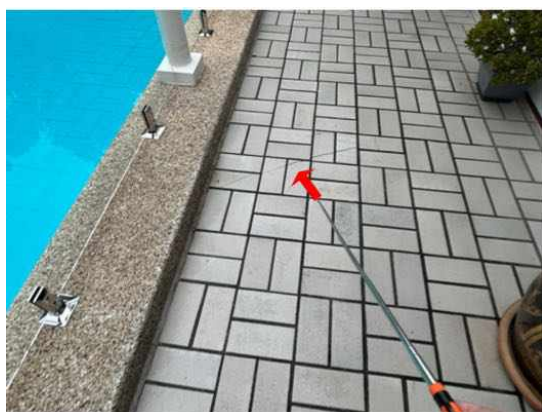
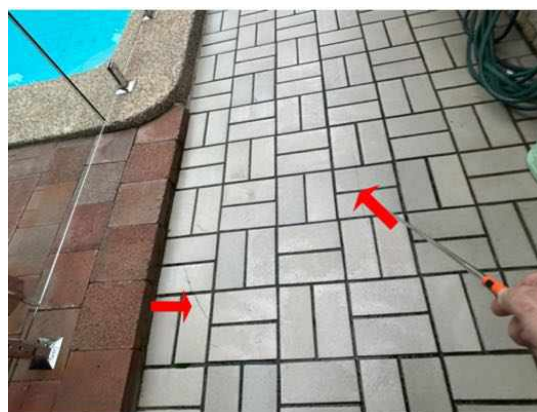
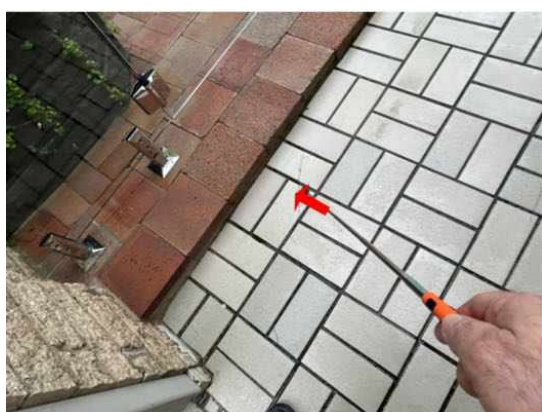
Defects 3.10

Finding: Floor tiles - Cracked

Information: Cracking in the floor tiles was evident in this area at the time of inspection. It is suspected that this cracking has occurred as a result of the floor being uneven and lacking a solid or suitable foundation for the tiles to be laid on. Settlement in the floor foundations may also have caused movement and resulted in the cracking of tiles in this area.

Cracked tiles throughout the household detract from the overall appearance of the affected areas, as well as creating potential for water penetration to adjoining building elements. If left unmanaged, water damage may occur as a result of constant water penetration over a prolonged period of time.

While not considered a matter of urgency, replacement of cracked floor tiles is advised as a solution. A tiling contractor or general handyperson may be appointed to perform these works at client discretion. Where cracks become more numerous, consultation with a registered builder specialising in re-stumping may be required.

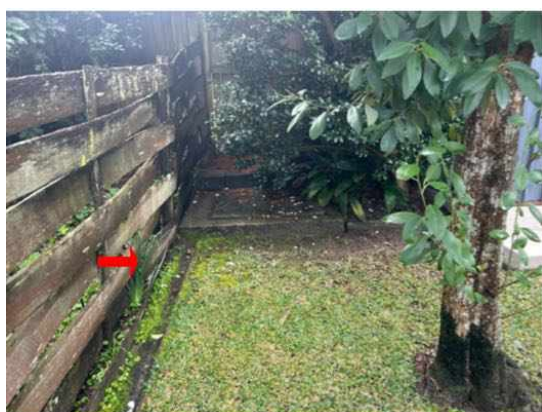
Defects 3.11

Information: Where evidence of growth was noted, there may be environmental, biological or health

Generally, the client is advised to ensure that the general environment is free of moisture and humidity to aid in the prevention of mould formation and development. Any mould found during the inspection should be cleaned immediately by a cleaning contractor or the homeowner as applicable.

Please note that severely affected building elements may require replacement by a registered builder or qualified carpenter.

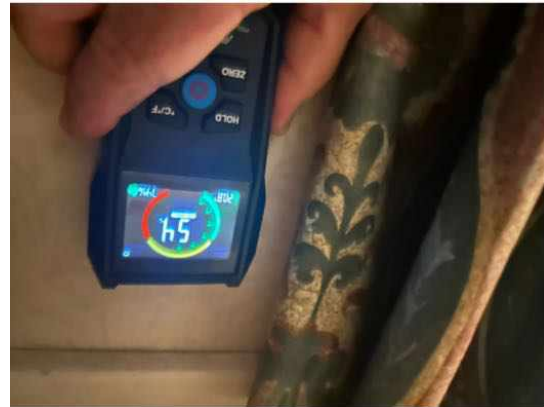
Defects 3.13

Building:	Building 1
Location:	Bedroom 2
Finding:	Moisture meter readings - medium to high
Information:	The moisture meter result for the areas inspected were medium to high at the time of inspection.

The moisture reading of 0-15% is quite normal and gives no cause for concern. However, moisture readings in excess of 15% indicate the need for further inspection.

Excessive moisture is generally caused by deteriorated inadequate or missing roof drainage leaking plumbing pipes or fixtures poorly plumbed HWS overflows or condenser units and poor site drainage.

Excessive moisture - medium to high moisture reading found in the internal wall of one of the bedrooms at the time of inspection and may require further invasive inspection.

It is highly recommended that all plumbing and drainage fixtures and fittings be maintained regularly in order to prevent excessive moisture being present in the external / internal property.

Monitoring of the area should be done over the near future to look for any indication the moisture content has changed.

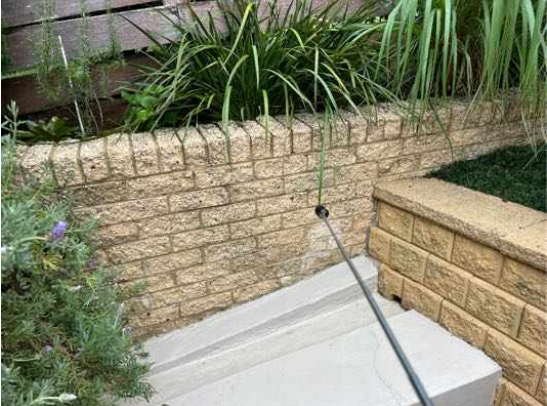
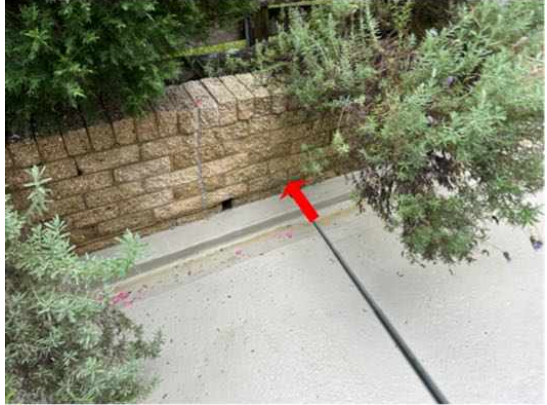
Defects 3.15

Building:	Building 1
Location:	All Areas
Finding:	Subsidence - Local trees and vegetation
Information:	Trees and other vegetation can have a significant local effect on drying of soils. Over a number of years, especially during drought conditions, adjacent trees and vegetation may draw excessive moisture from the soils. The opposite may also occur, where swelling of the soil results when the trees decline or are removed.

As the cumulative moisture deficient is reversed, the surface level around the tree (and adjoining subfloor) will rise and expand laterally. This is often damaging to buildings unless the foundations have been strengthened or designed to cope with the effect.

Subsidence can have complex and varying causes, which will influence the required remedial works. It is advised to begin by consulting a structural engineer to determine the required scope of works. This generally includes some form of underpinning, as well as addressing the underlying cause. Consultation with a geotechnical engineer

may also be necessary.

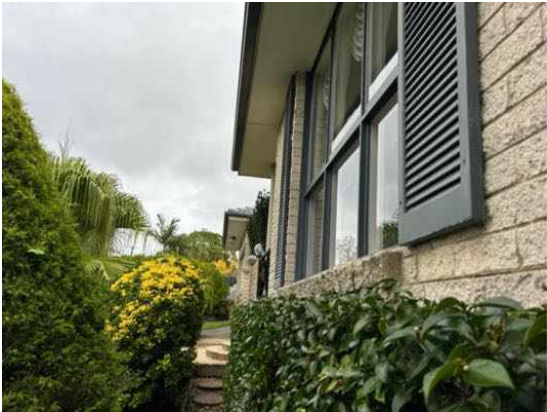
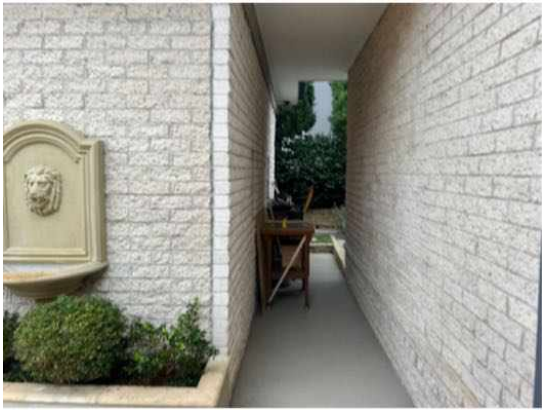
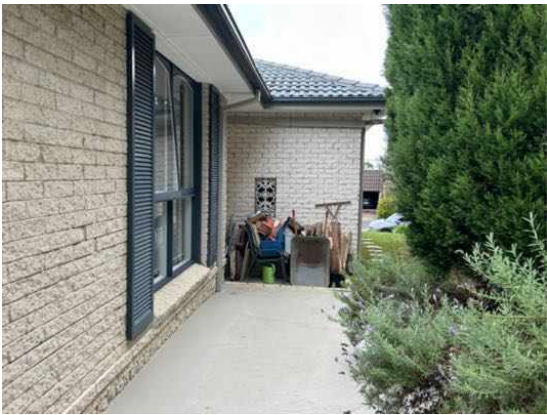
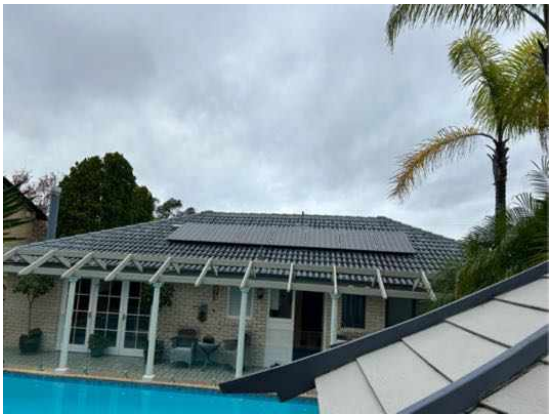
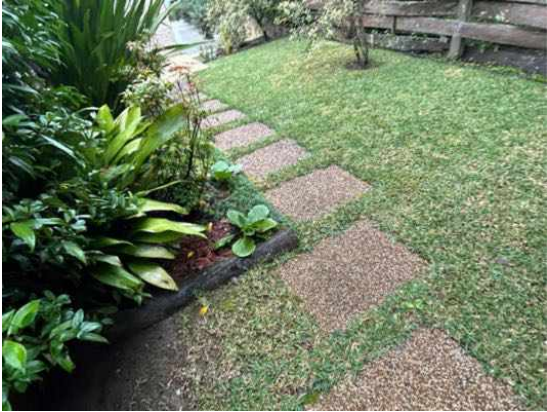
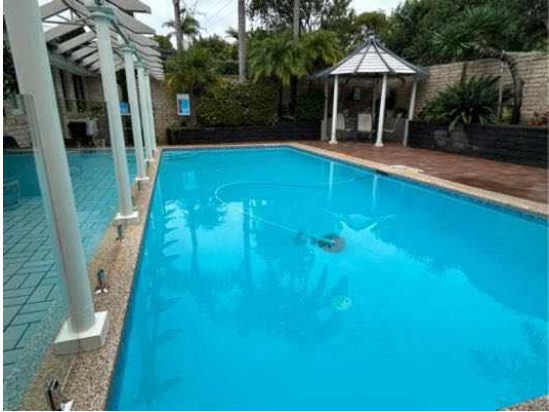
Building: Building 1
Location: All Areas
Finding: Additional Photos - Obstructions and Limitations
Information: These photographs are an indication of the obstructions and limitations which impeded full inspection of the property at the time of inspection. These obstructions can hide an array of defects and should be removed to allow full inspection to be carried out.

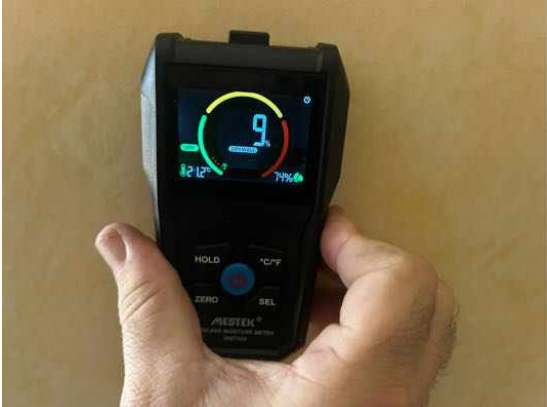
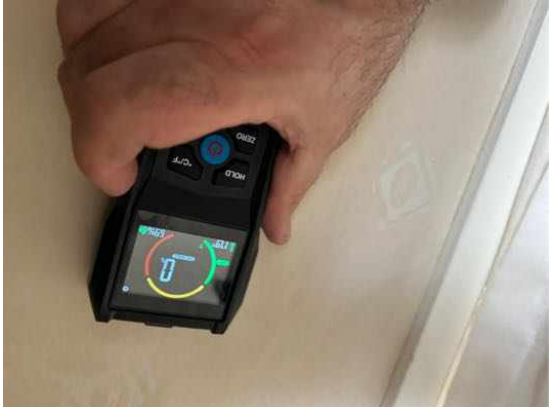
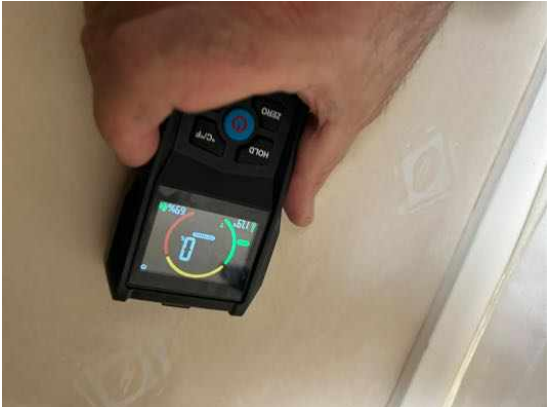
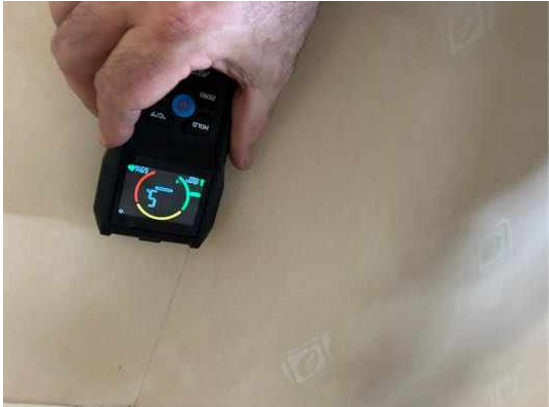
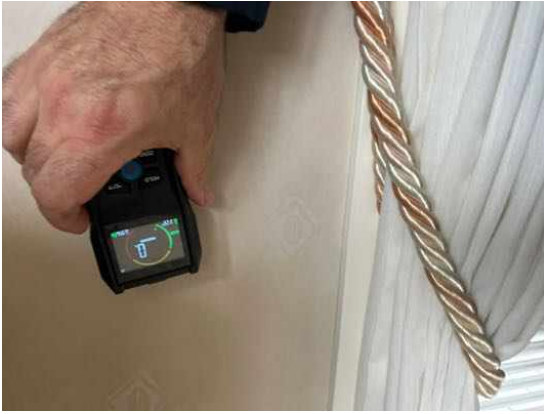
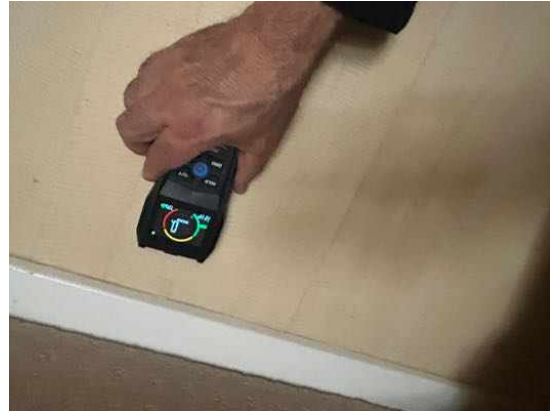
Building: Building 1
Location: All Areas
Finding: Moisture meter readings - low
Information: The moisture meter result for the areas inspected.

The moisture reading of 0-15% is quite normal and gives no cause for concern. However, moisture readings in excess of 15% indicate the need for further inspection.

Levels between 25-30% indicate that there may be water ingress, meaning that remedial work could be required.

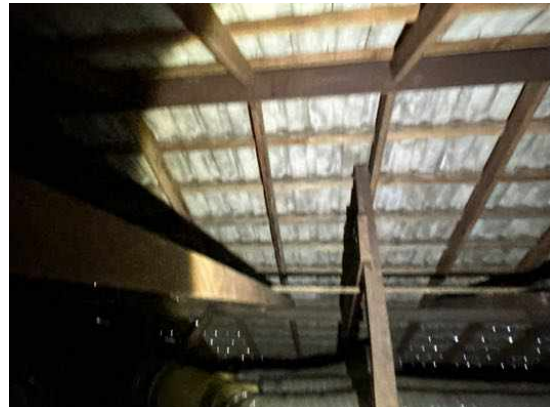
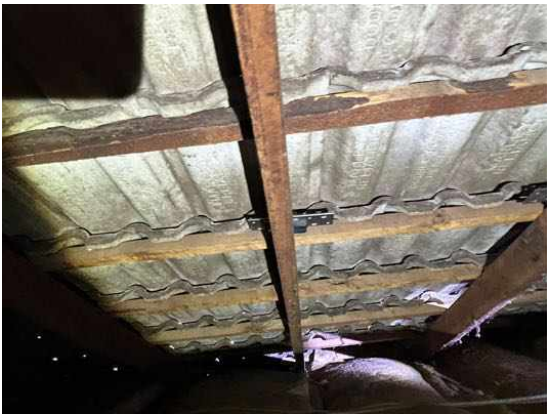
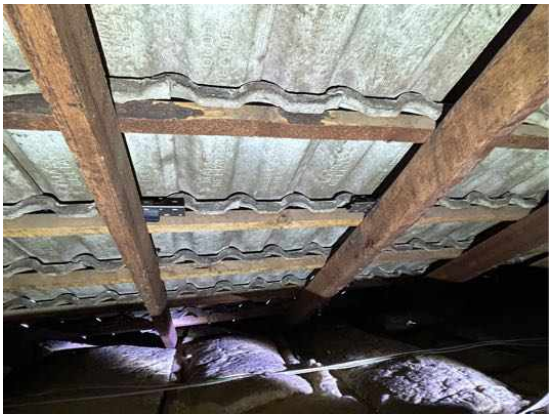
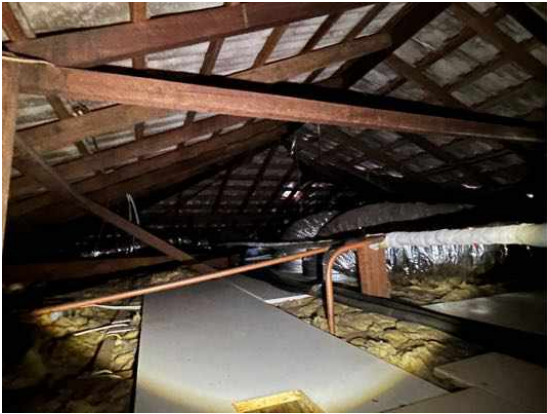
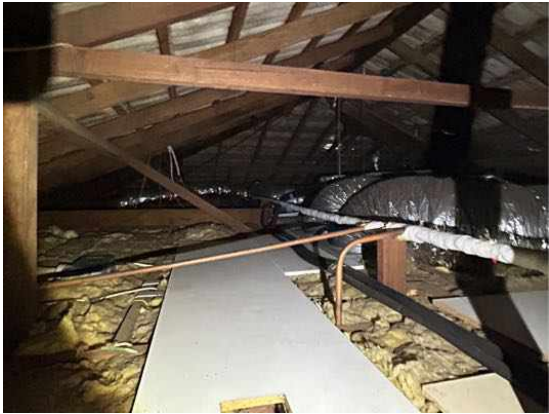
Building: Building 1
 Location: Roof Void
 Finding: Sarking - Not installed
 Information: Sarking is missing under the roof sheeting. Sarking acts as an insulator that helps with noise reduction and protects against water penetration. Sarking plays a key role in the operation and function of the overall roofing structure and its performance.

Although not a requirement at the time of construction, replacement of any missing building element is advisable (although this can be quite expensive to do after the time of construction). Where sarking is missing, regular inspections of the roof tiles for cracking and potential moisture penetration is required.

Sarking may be retrospectively fitted by a registered builder at the discretion of the client.

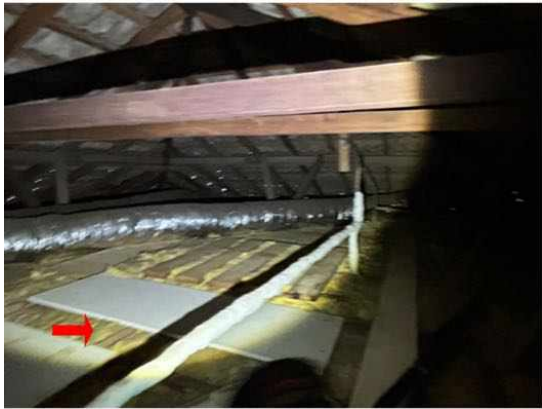
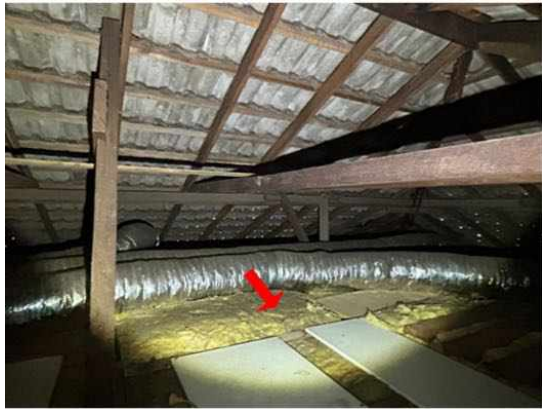
Building: Building 1
Location: Roof Void
Finding: Insulation- installed
Information: Insulation was evident in the ceiling void at the time of inspection. Insulation acts as an insulator that helps with heat reduction.

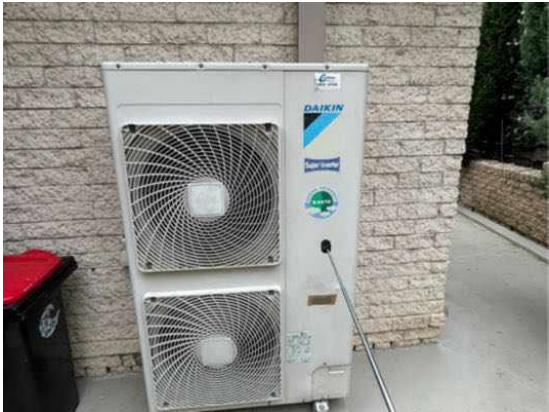
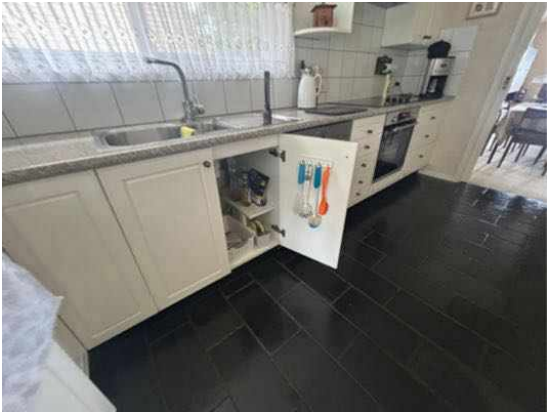
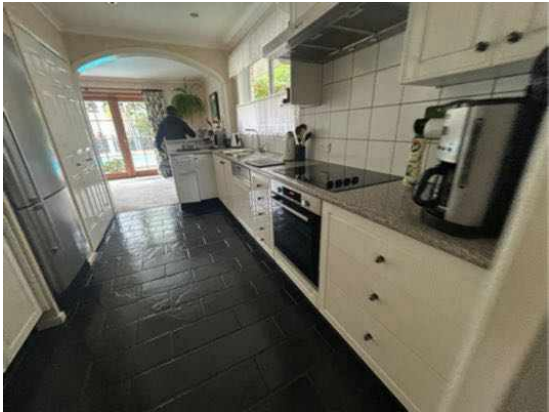
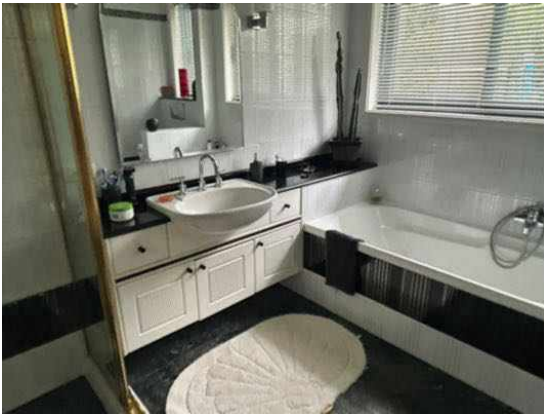
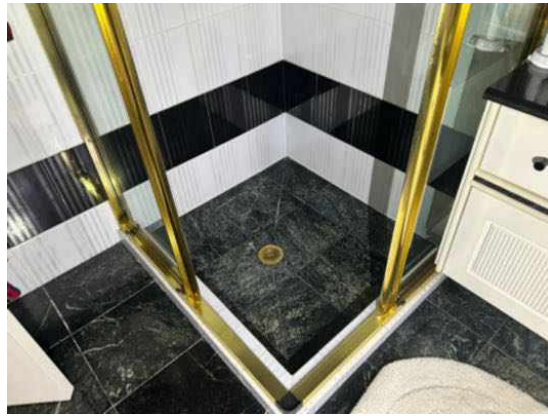
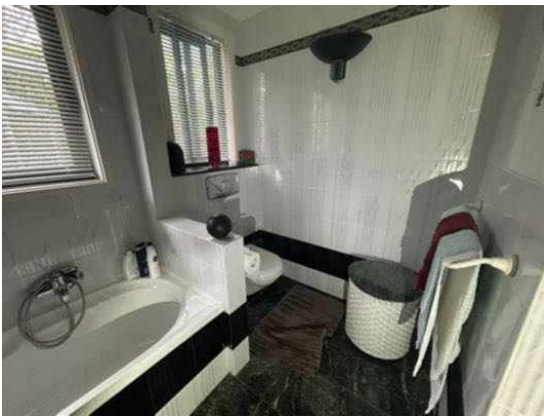
Building: Building 1
 Location: All Areas
 Finding: Plumbing and Electrical
 Information: Plumbing and electrical inspections are outside the scope of the building inspection and must be conducted by a Licensed and registered Trades person.

Whilst we note and comment of visually apparent defects that present during the building inspection, legislation requires the checking and documenting of compliance for plumbing and electrical requirements be done by licensed electrician and plumbers respectively to ensure they are functioning correctly.

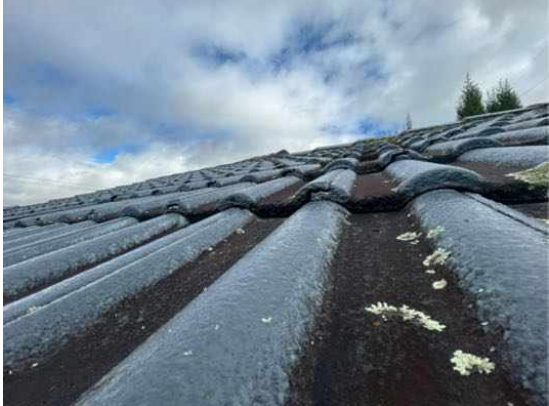
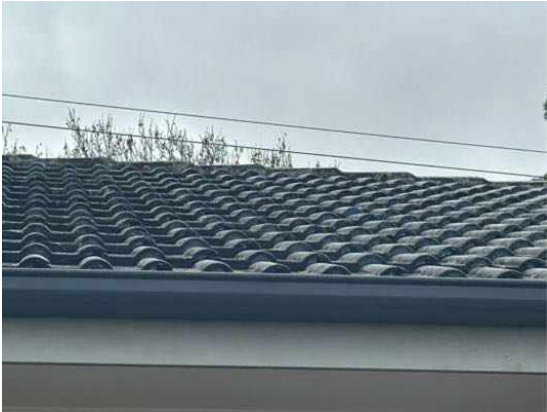
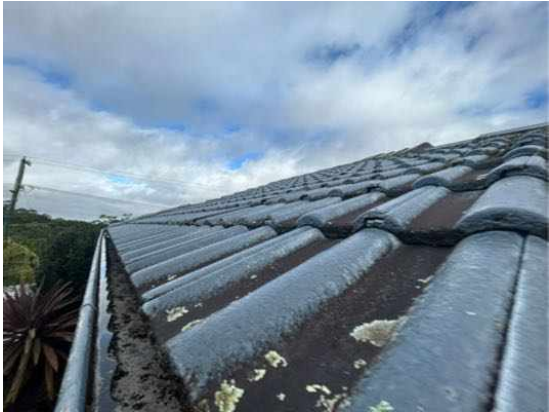
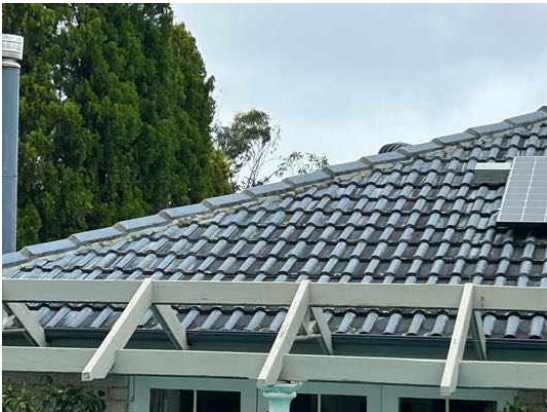
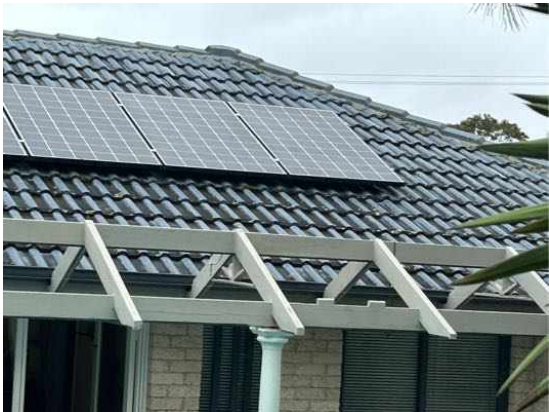
Building:	Building 1
Location:	Roof Exterior
Finding:	Roof tiles - Weathered
Information:	Upon inspection of the exterior roofing, the majority of roof tiles were considered to be in a fair condition. While weathering of the tiles is consistent with the age of the property, maintenance works are required.

Where left unmanaged, deteriorating roof tiles are likely to lead to a number of secondary defects, including minor water leaks and weather exposure to internal roofing structures.

Consultation with a roofing contractor is highly advised to gain advice on cost of remedial works that may be required in the short to medium term. Remedial works are likely to increase the longevity of the exterior roofing structure.
