Building Inspection Report

Inspection Date: Fri, 31 Jan 2020

Property Address: 10 Sylvia Pl, Frenchs Forest NSW 2086, Australia

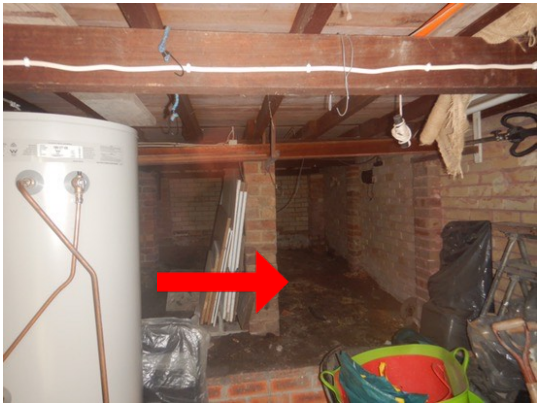
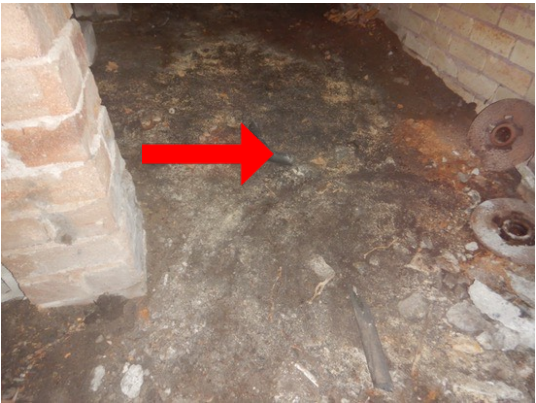
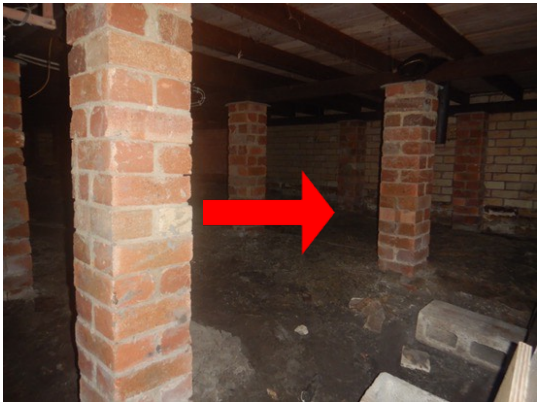
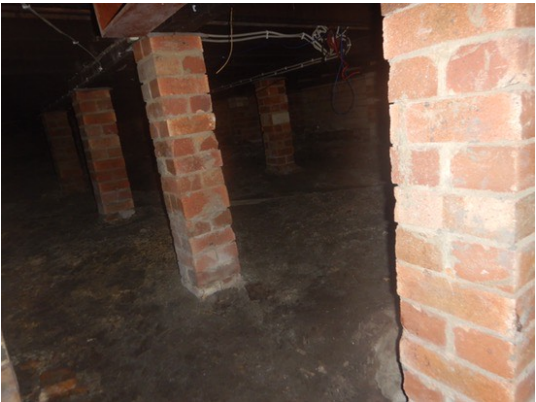
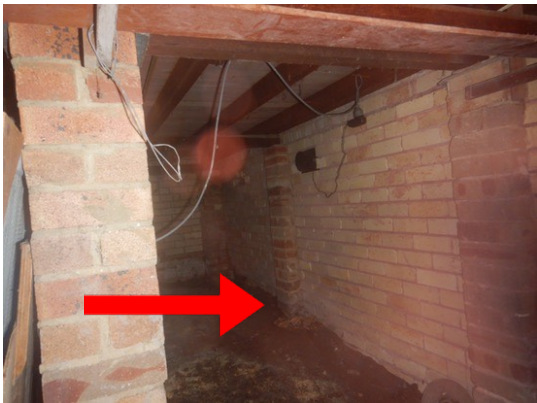
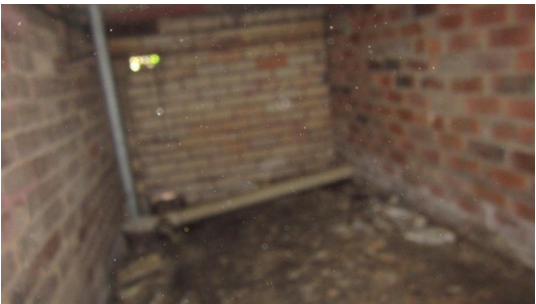
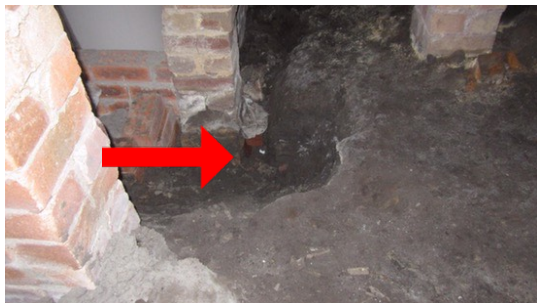
Defects 3.01

Building:	Main Building
Location:	Subfloor
Finding:	Evidence of excessive moisture was present at the time of inspection
Information:	Excessive moisture can attract termites and produce conditions that promote termite attack fungal growth and wood decay.

Excessive moisture is generally caused by deteriorated inadequate or missing roof drainage leaking plumbing pipes or fixtures poorly plumbed HWS overflows or condenser units and poor site drainage.

It is recommended that all plumbing and drainage fixtures and fittings be maintained regularly in order to prevent excessive moisture being present in the external / internal property.

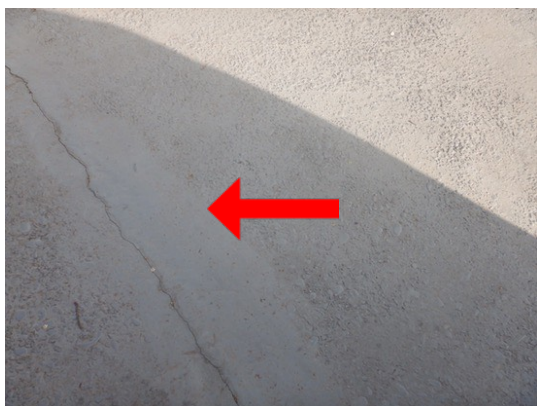
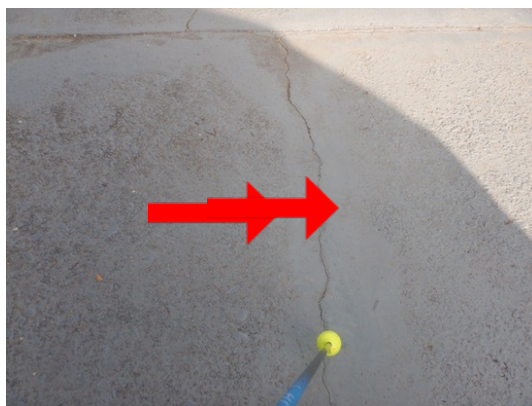
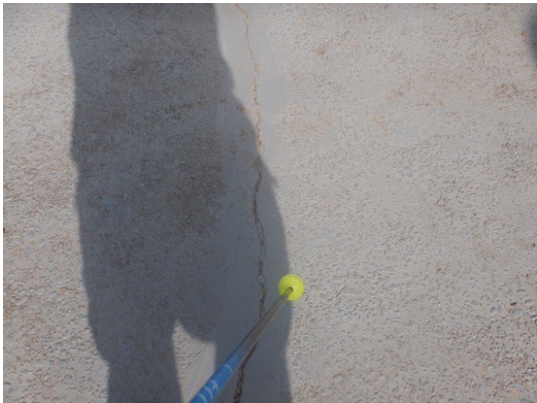
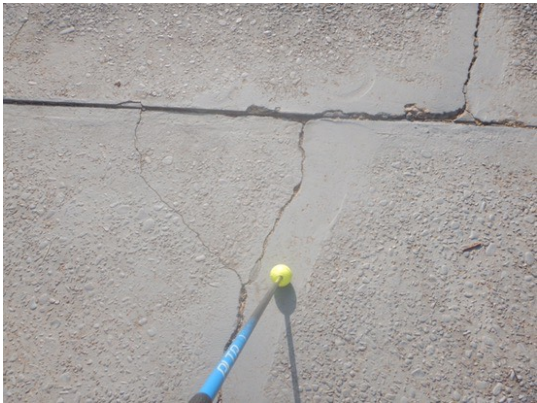
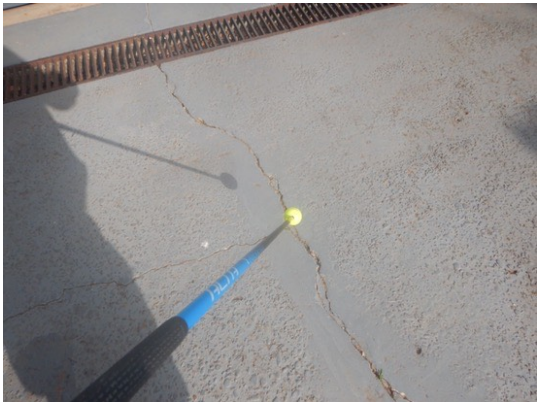
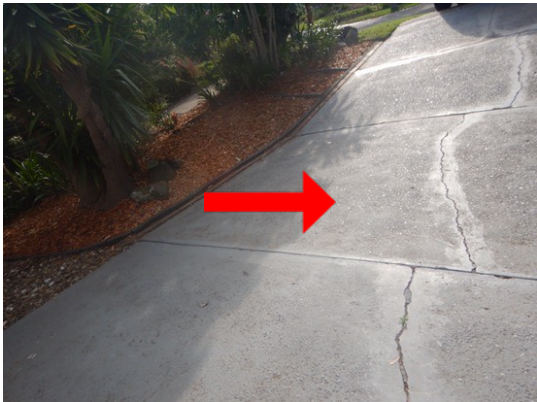
Defects 3.02

Finding: Crack in concrete slab - Category 2

Information: A crack coded as Category 2 was identified in the slab. A Category 2 crack is described as a distinct crack, with the slab being noticeably curved or changed in level.

To be considered Category 2, the approximate width of the crack is $<1.0\text{mm}$, or a change in offset of $<10\text{mm}$ when a 3m straight edge is placed over the defect.

Category 2 cracks to slabs should be monitored for a period of 12 months. At the end of the monitoring period, cracks rated greater than Category 2 are considered defects that require rectification.

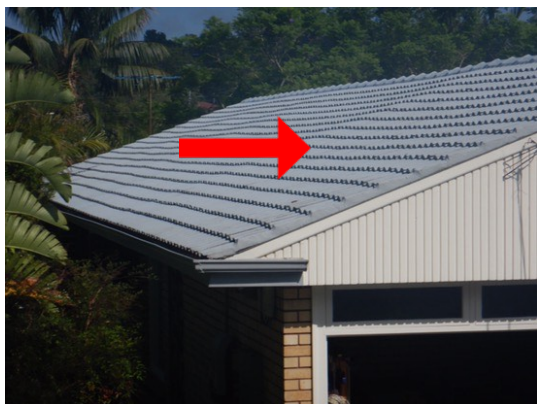
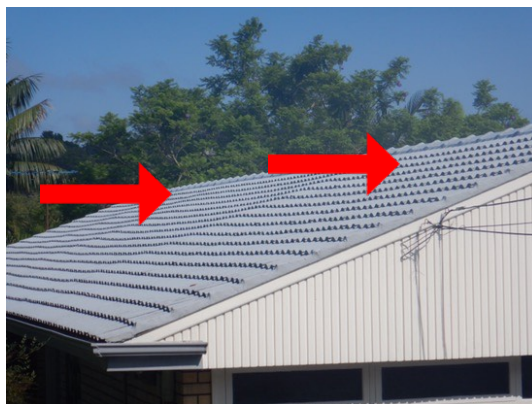
Defects 3.03

Building: Main Building
 Location: Roof Void
 Finding: undulating roofline- identified
 Information: The line of the roof structure is undulating probably due to uneven settling of the roof members.

A prospective buyer may want to engage a structural engineer to provide advice as to whether remediation is necessary,

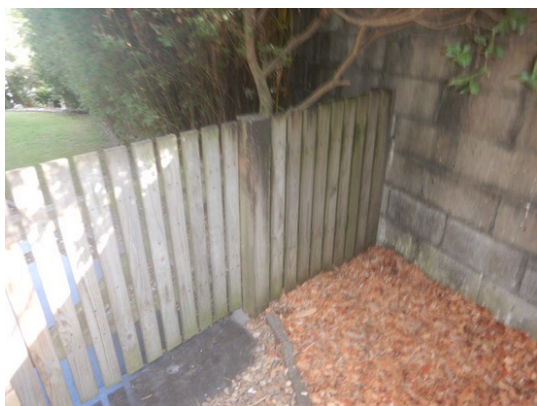
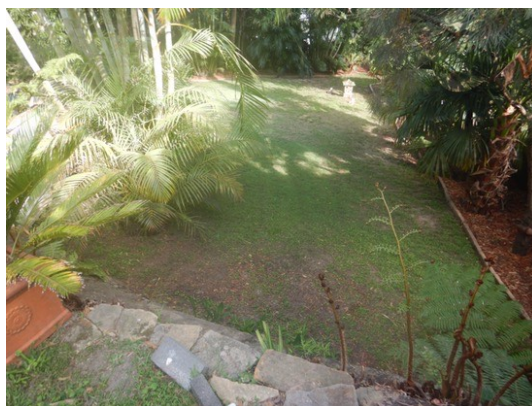
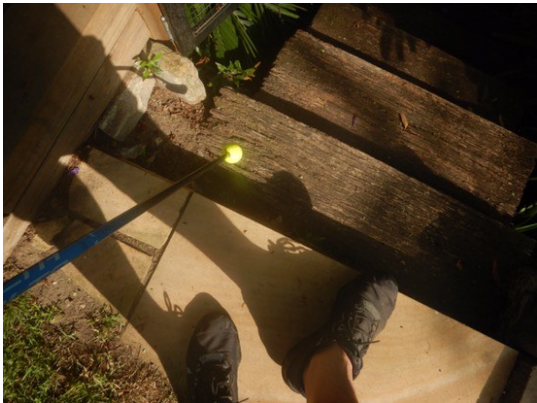
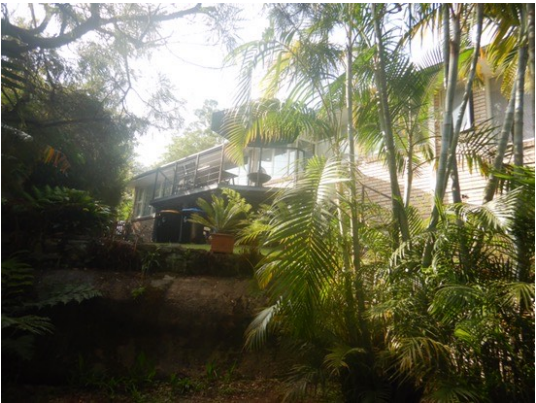
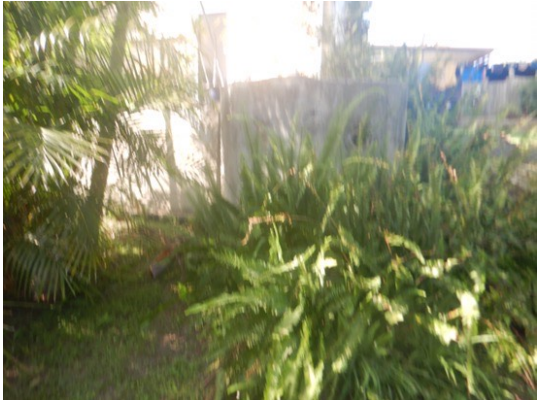
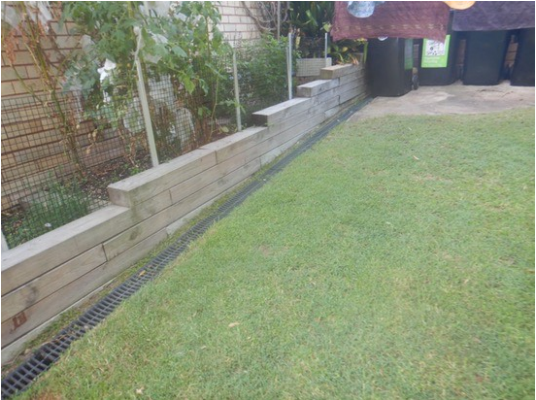
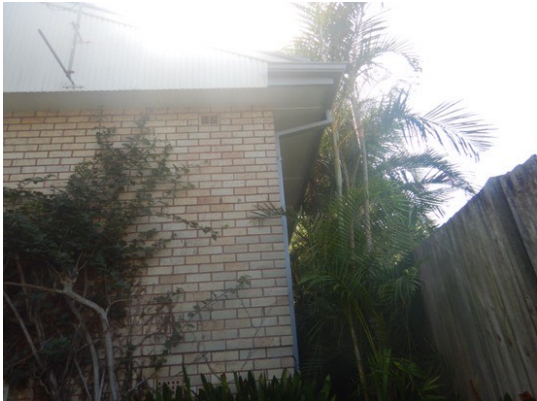
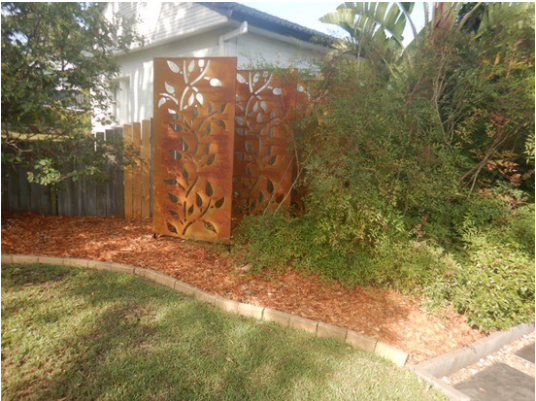
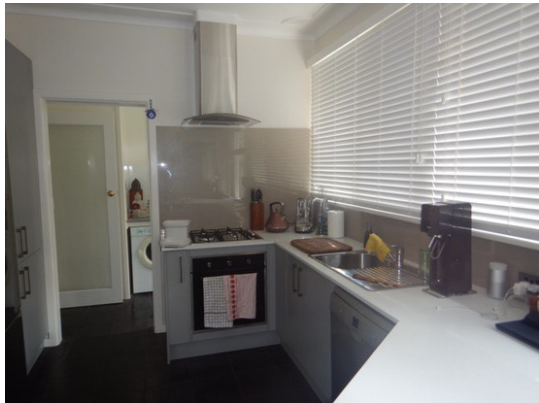
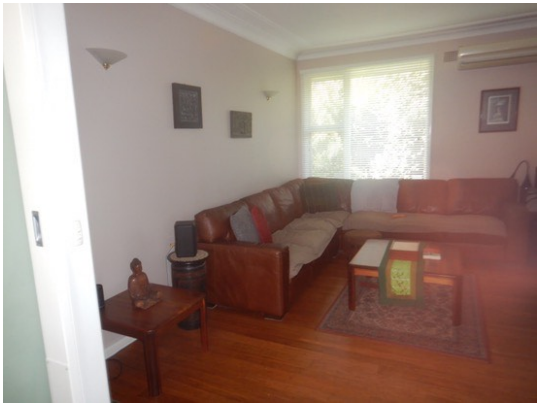
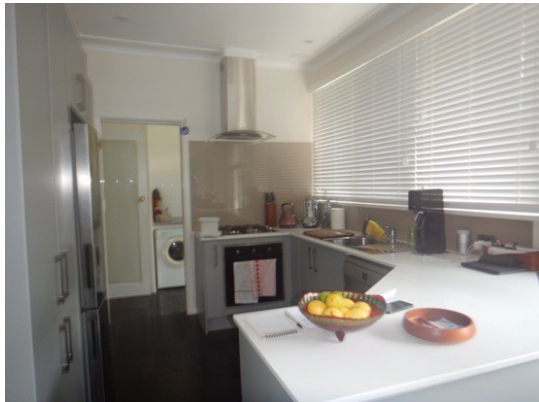
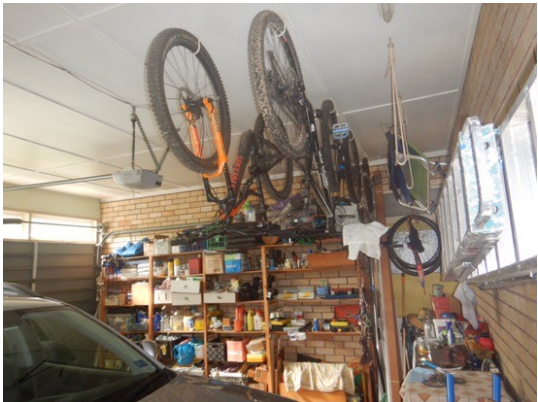
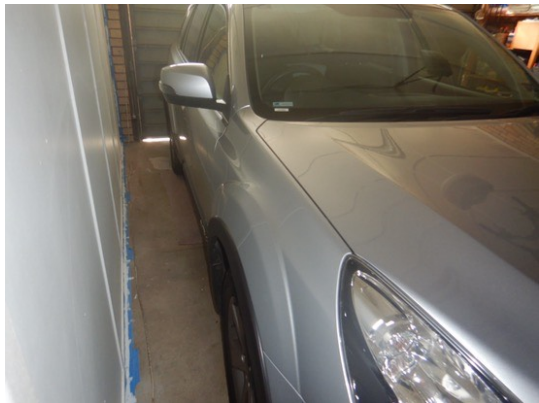
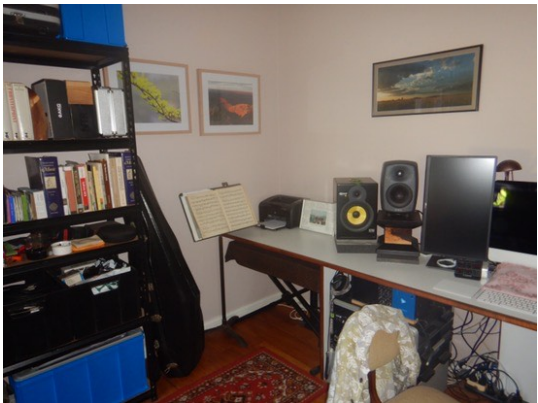
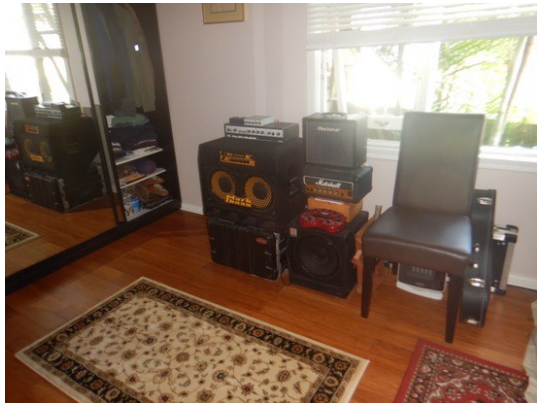
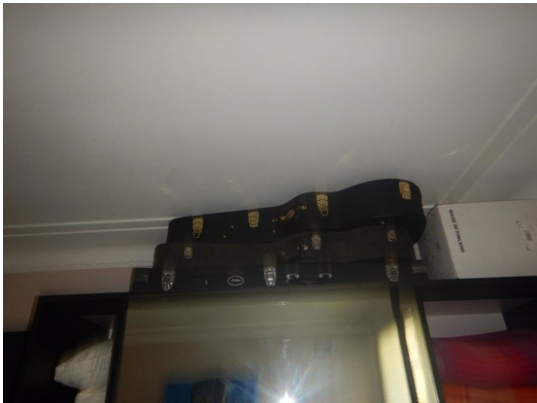
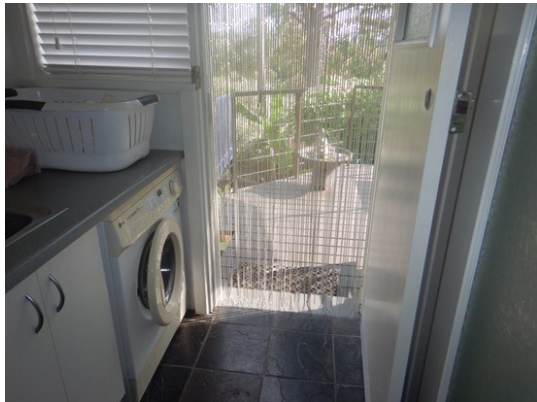
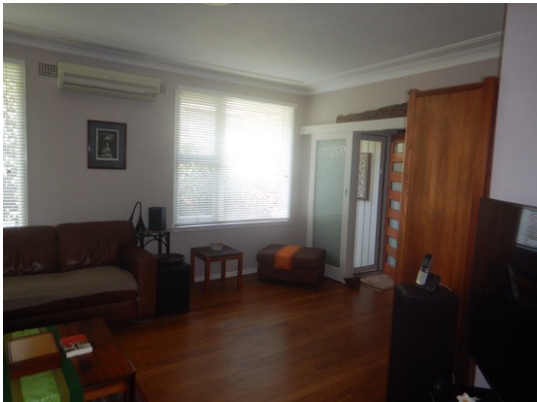
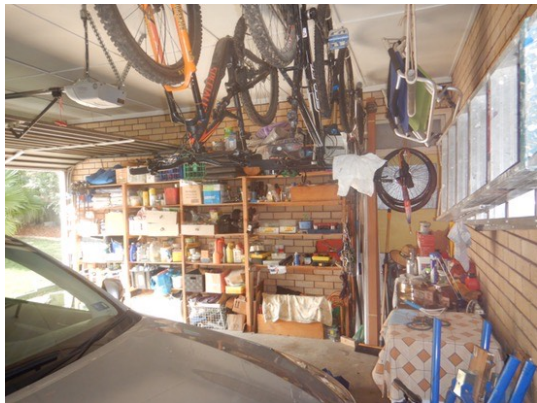
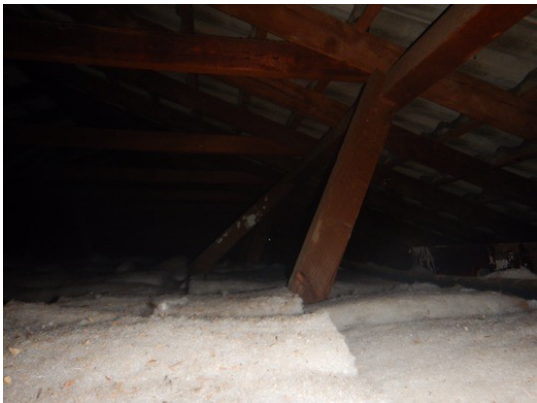
Additional Photos - Obstructions and Limitations

These photographs are an indication of the obstructions and limitations which impeded full inspection of the property at the time of inspection.

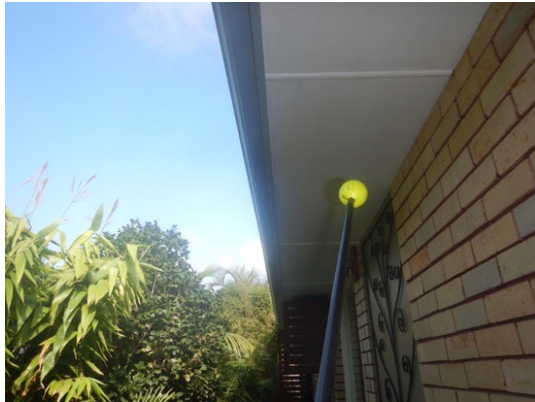
Building: Main Building
Location: All Areas
Finding: Asbestos - Suspected ACM Identified on Site
Information: Reporting on Asbestos is outside the Scope of this Report. This suspected defect is highlighted as a caution only. We suspect, based on our experience in the building industry, that there is a higher risk of the identified building element containing asbestos.

As Asbestos Reporting is outside the scope of this report, we advise that you consider a separate Asbestos Inspection and Condition Audit, which can include the taking of samples for definitive confirmation of the presence of Asbestos.

In the interim, the client is advised to act with caution, especially when considering any damage to building materials general wear and tear renovations extensions demolition and general maintenance activities due to the suspected presence of Asbestos.

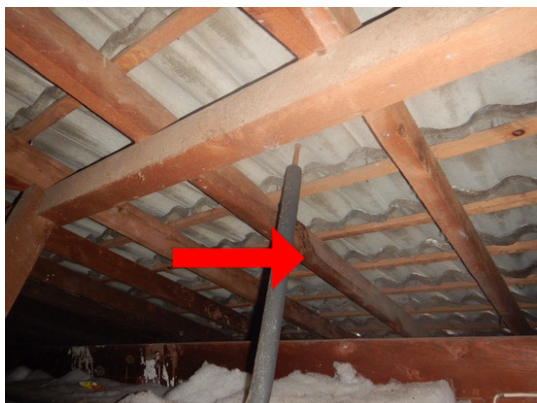
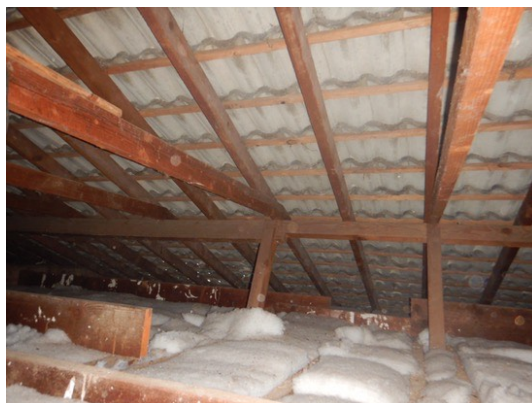
Building: Main Building
Location: Roof Void
Finding: Sarking - Missing
Information: Sarking is missing under the roof sheeting. Sarking acts as an insulator that helps with noise reduction and protects against water penetration. Sarking plays a key role in the operation and function of the overall roofing structure and its performance.

Although not a requirement at the time of construction, replacement of any missing building element is advisable (although this can be quite expensive to do after the time of construction). Where sarking is missing, regular inspections of the roof tiles for cracking and potential moisture penetration is required.

Sarking may be retrospectively fitted by a registered builder at the discretion of the client.

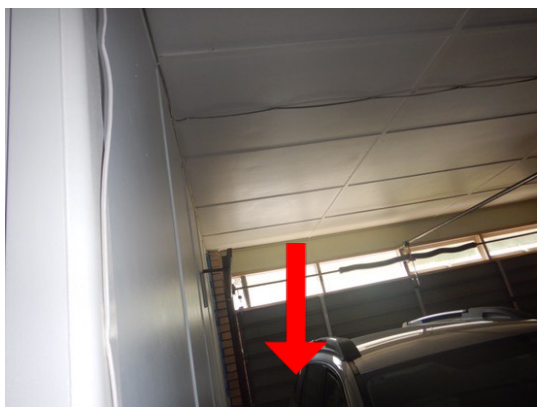
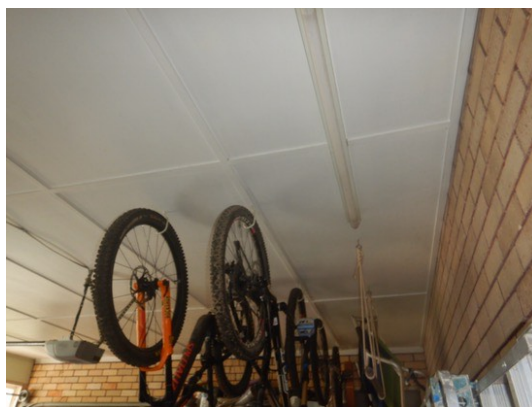
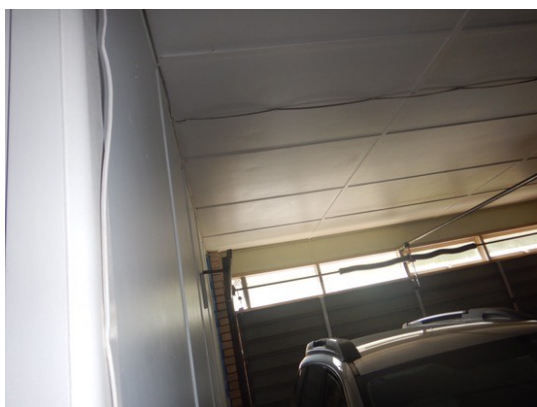
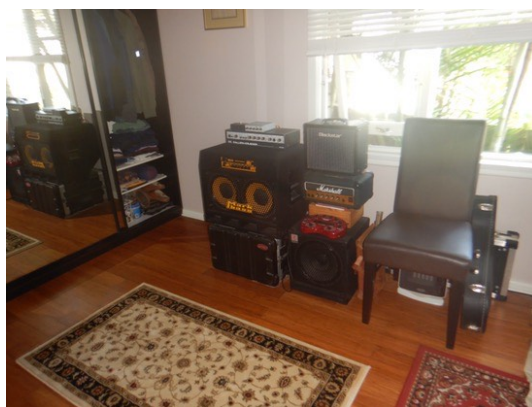
Building: Main Building
Location: Garage
Finding: Asbestos - Suspected ACM Identified on Site
Information: As Asbestos Reporting is outside the scope of this report, we advise that you consider a separate Asbestos Inspection and Condition Audit, which can include the taking of samples for definitive confirmation of the presence of Asbestos.

In the interim, the client is advised to act with caution, especially when considering any damage to building materials general wear and tear renovations extensions demolition and general maintenance activities due to the suspected presence of Asbestos.
