Building Inspection Report

Inspection Date: Thu, 16 Mar 2023

Property Address: 17 Kurrajong Rd, Frenchs Forest NSW
2086, Australia

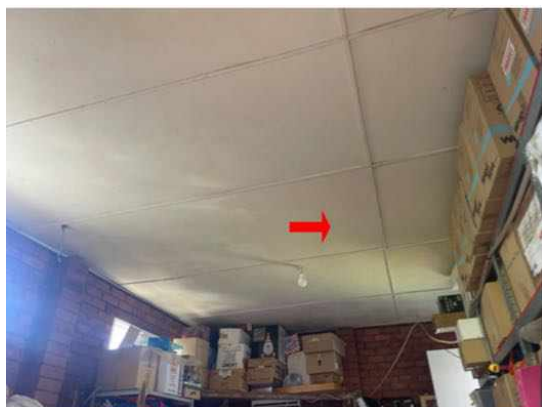
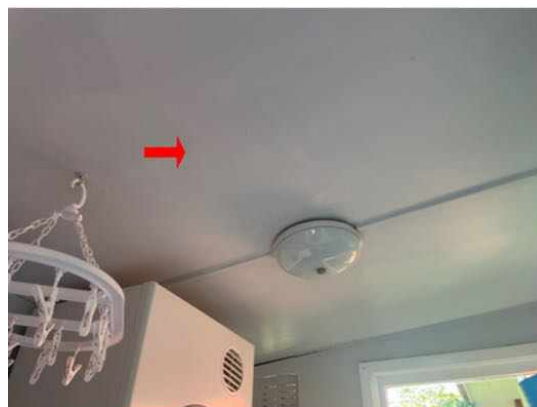
Defects 1.01

Building:	Building 1
Location:	All Areas
Finding:	Asbestos - Suspected ACM Identified on Site
Information:	Reporting on Asbestos is outside the Scope of this Report. This suspected defect is highlighted as a caution only. We suspect, based on our experience in the building industry, that there is a higher risk of the identified building element containing asbestos.

As Asbestos Reporting is outside the scope of this report, we advise that you consider a separate Asbestos Inspection and Condition Audit, which can include the taking of samples for definitive confirmation of the presence of Asbestos.

In the interim, the client is advised to act with caution, especially when considering any damage to building materials general wear and tear renovations extensions demolition and general maintenance activities due to the suspected presence of Asbestos.

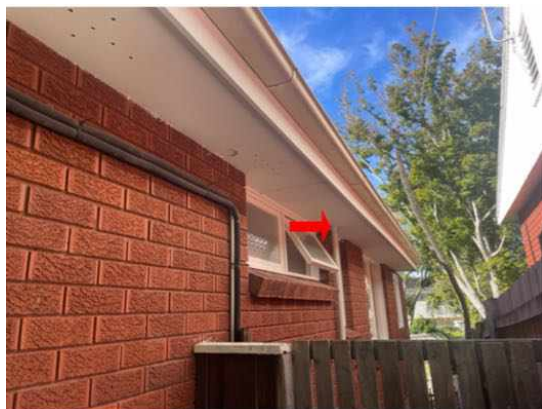
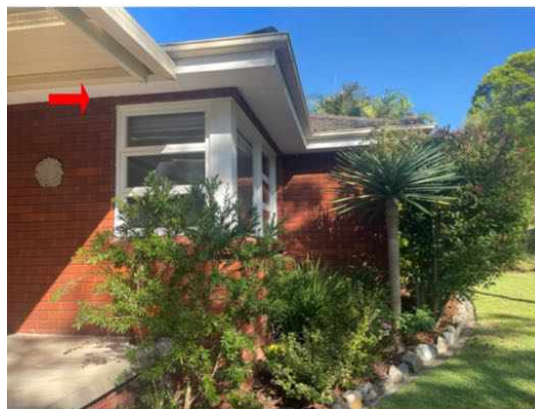
Defects 1.02

Building:	Building 1
Location:	All Areas
Finding:	Asbestos - Suspected ACM Identified on Site
Information:	Reporting on Asbestos is outside the Scope of this Report. This suspected defect is highlighted as a caution only. We suspect, based on our experience in the building industry, that there is a higher risk of the identified building element containing asbestos.

As Asbestos Reporting is outside the scope of this report, we advise that you consider a separate Asbestos Inspection and Condition Audit, which can include the taking of

samples for definitive confirmation of the presence of Asbestos.

In the interim, the client is advised to act with caution, especially when considering any damage to building materials general wear and tear renovations extensions demolition and general maintenance activities due to the suspected presence of Asbestos.

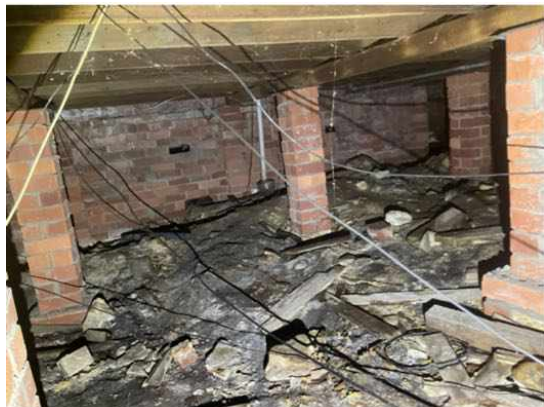
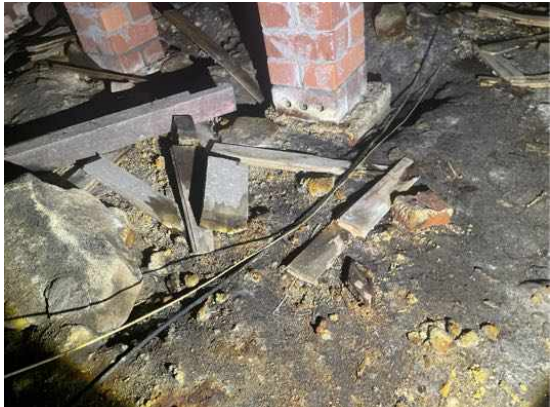
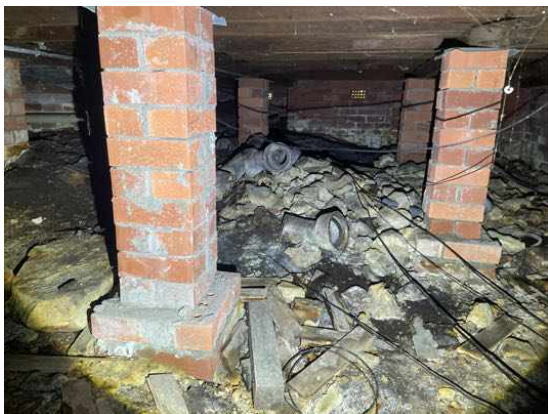
Defects 1.03

Building:	Building 1
Location:	Subfloor
Finding:	Mould - Present
Information:	Where evidence of mould growth was noted, there may be environmental, biological or health issues associated with the report. A specialist inspection by a suitably qualified environmental health inspector is warranted, where mould is extensive or where any queries regarding air quality spores or other related issues apply.

Generally, the client is advised to ensure that the general environment is free of moisture and humidity to aid in the prevention of mould formation and development. Any mould found during the inspection should be cleaned immediately by a cleaning contractor or the homeowner as applicable.

Please note that severely affected building elements may require replacement by a builder or carpenter.

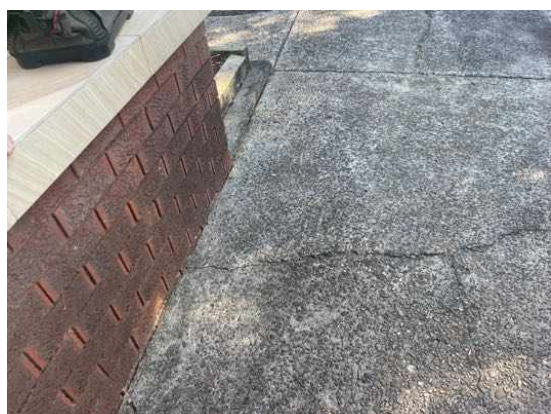
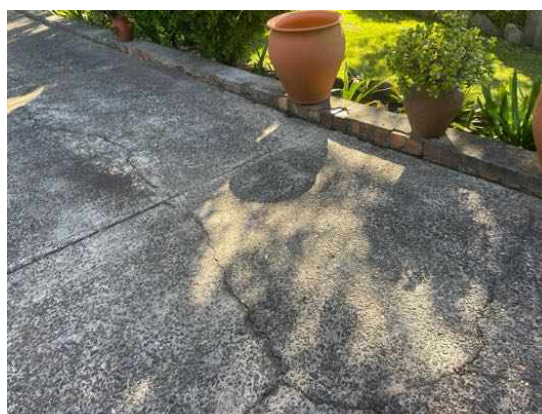
Defects 3.01

Building:	Building 1
Location:	All External Areas
Finding:	Cracking - External Concrete Paving Damage Category 3 - Wide Cracks (2mm - 4mm)
Information:	Wide cracks were identified in external concrete paving Wide cracks are significant and are likely to lead to the development of safety hazards and secondary defects if left unmanaged.

General age and expected deterioration of the paved areas is a common cause of this type of cracking. However, expansion and contraction of the slab may also have occurred due to environmental factors. Such factors include variable moisture and weather conditions, the presence of trees and their roots having a settling or lifting affect on the soil, or the effect of load bearing, e.g. heavy vehicles over a sustained period of time.

Cracking to this degree may also be due to poor original installation of the concrete. Factors such as poor compaction of the sub surface and/or inadequate reinforcing of the slab may create cracking and other secondary defects. Wide cracks may also have a more significant structural cause, such as subsidence of soils.

Where the crack is located adjacent to structural elements of the building, the advice of a Structural Engineer is advisable before undertaking repairs. Significant repair and likely replacement of the concrete paving is probable.

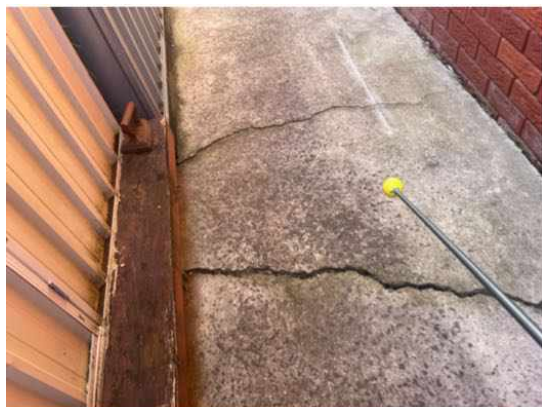
Defects 3.02

Building:	Building 1
Location:	All External Areas
Finding:	Subsidence
Information:	General subsidence is usually initiated by changes in soil moisture content. The most critical factor is identifying the specific causes, and identifying if this is a recurring or ongoing problem, or one that has been resolved by previous works in the past.

Subsidence can have complex and varying causes, which will influence the required remedial works. It is advised to begin by consulting a structural engineer to determine the required scope of works. This generally includes some form of underpinning, as well as addressing the underlying cause. Consultation with a geotechnical engineer

may also be necessary where changes to soil moisture content is apparent.

A builder would then generally carry out works as advised by an Engineer.

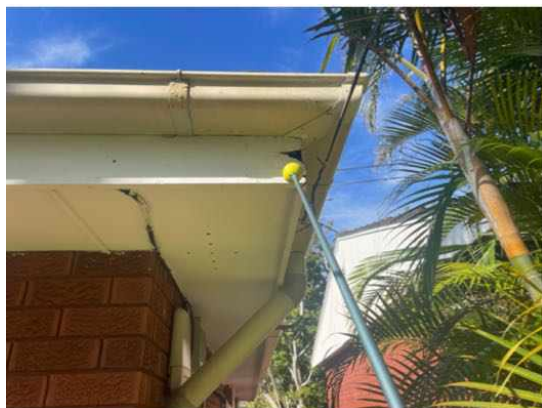
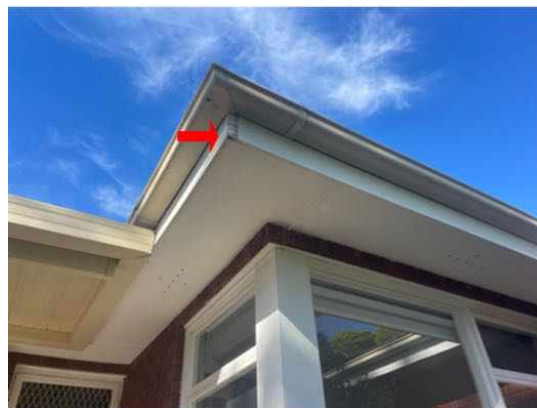
Defects 3.03

Building:	Building 1
Location:	Roof Exterior
Finding:	Fascias - Wood rot
Information:	Wood rot was found to be affecting fascias and barges in this area, evidenced by the presence of mould on the surface in some areas. Wood rot, also known as Fungal Decay, occurs when timbers and other cellulose building materials are exposed to damp conditions on an ongoing basis.

It is likely that this wood rot has developed as a result of faults in the roof plumbing, creating excessive moisture in this areas. Frequent exposure to rain and other weather conditions also make fascias and barges susceptible to accelerated deterioration.

It is advised that a roof plumber be appointed to inspect all roof plumbing and subsequently identify the cause of the wood rot. Replacement of affected fascias and barges may then be a necessary step in protecting surrounding building elements from such deterioration.

A qualified plumber may be appointed to assess the cause of excessive moisture and to provide advice on any remedial works as required. A qualified carpenter or builder may also be required to replace affected building materials.

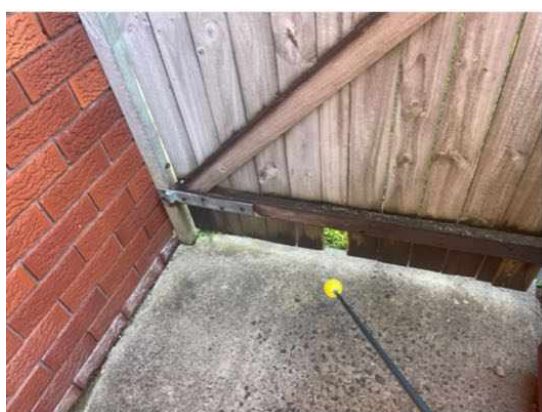
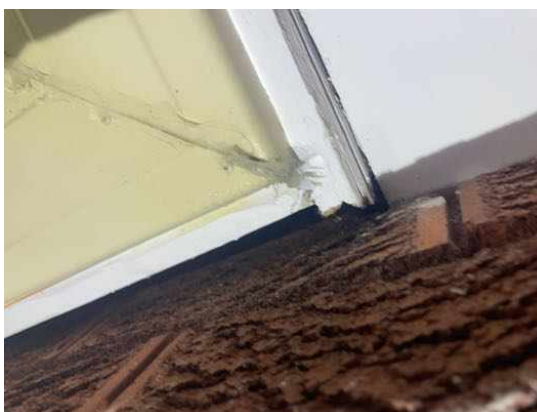
Defects 3.04

Finding: Wood rot

Information: Wood rot is often associated with general damp problems and is evidenced by a 'musty' smell or mould and mildew occurring on surfaces. If left unmanaged, damp conditions can lead to further health problems and the decay of timbers will continue.

Early intervention and regular maintenance, particularly of exterior timbers, will prolong the useful life of these building elements. Prior to any works being performed, the cause of the moisture that has created the visible wood rot should be identified and addressed in a suitable manner. Replacement of affected timbers may then be a necessary step in protecting surrounding building elements from such deterioration.

A qualified plumber may be appointed to assess the cause of excessive moisture and to provide advice on any remedial works as required. A qualified carpenter or builder may also be required to replace affected building materials.

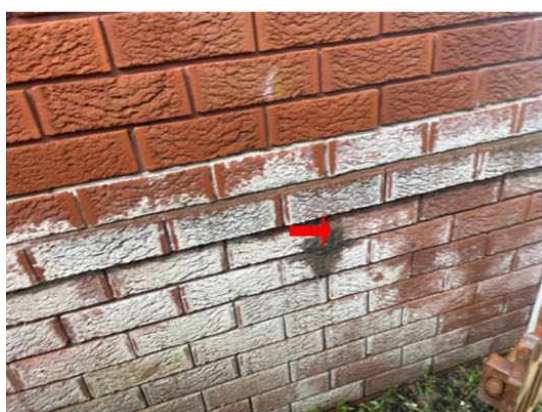
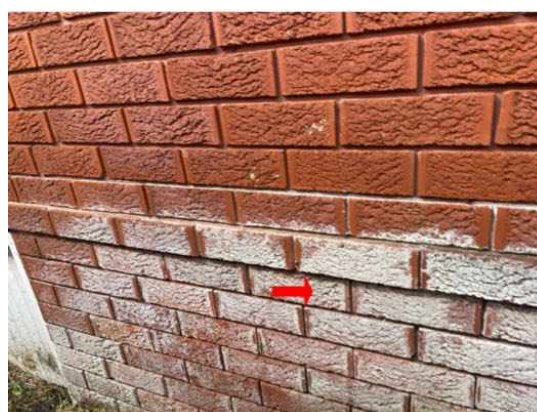
Defects 3.05

It is typically seen as white salt deposits on the surfaces of concrete pavement or mortar between bricks or tiles. While detracting from the overall appearance of the affected area, efflorescence is not likely to develop into secondary damage if left unmanaged.

Generally, soluble salt deposits can be removed by dry brushing with a stiff-bristled brush. Repeated dry brushing is an ideal treatment for eliminating this forming of efflorescence. A cleaning contractor or general handyperson may be appointed to perform these works at the discretion of the client.

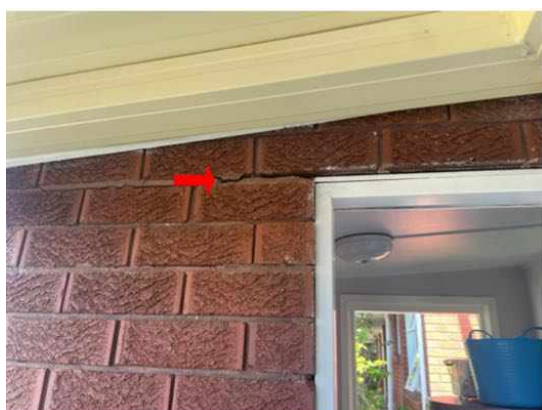
Defects 3.06

Building:	Building 1
Location:	All Areas
Finding:	Brickwork - Deteriorated mortar
Information:	Mortar, or 'bedding', is the material which fills joins and intersections between bricks in masonry walls and structures. Sections of mortar in this brickwork were identified as having deteriorated, which is generally expected for a property of this age and condition.

Mortar may deteriorate as a result of age of building materials, minor movement of bricks, or frequent exposure to weathering. Mortar should be replaced to ensure that bricks remain in their intended location and to prevent gaps, which would allow water or moisture ingress and secondary damage as a result.

Mortar deterioration can be addressed by a bricklayer where areas of deterioration are localised and easily accessible. Alternatively, appointment of a registered builder is advised, to repoint large areas of decaying mortar. Where secondary structural defects have become evident, consultation with a structural engineer may be required.

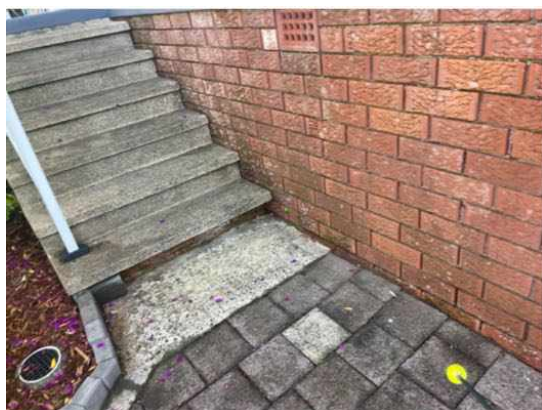
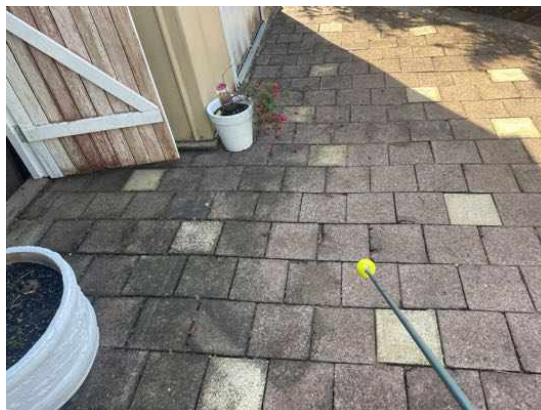
Defects 3.07

Finding: Cracked pavers
 Information: Cracking in the pavers was evident in this area at the time of inspection. It is suspected that this cracking has occurred as a result of minor settlement .

Cracked pavers detract from the overall appearance of the affected areas however it is unlikely to create or lead to any secondary defects.

While not considered a matter of urgency, replacement of pavers is recommended at the clients discretion.

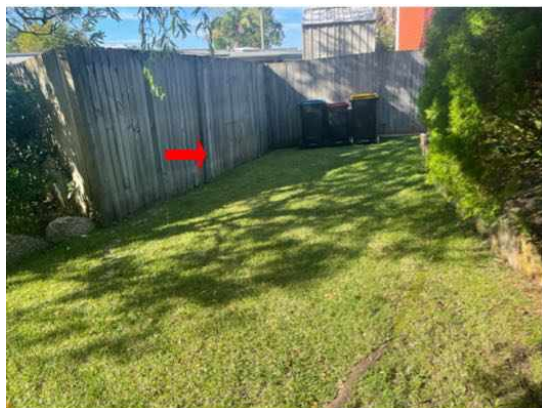
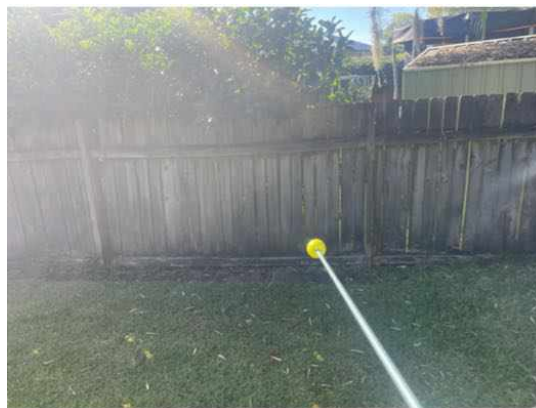
Defects 3.08

Building: Building 1
 Location: Fencing
 Finding: Fencing - Deteriorated
 Information: It was noted at the time of inspection that sections of the fencing throughout the property have deteriorated. Typically fencing deteriorates due to age and or wear, rot and or rust which is generally expected for a structure of this age, due to prolonged exposure to weather conditions. Sometimes inadequate installation or maintenance can be to blame.

If left unattended, it is likely that further damage will occur. It is suspected that repair of several elements of the fencing may be required however replacement may be a consideration of the client also.

A licensed fencing contractor should be appointed to provide further advice and perform rectification works as necessary.

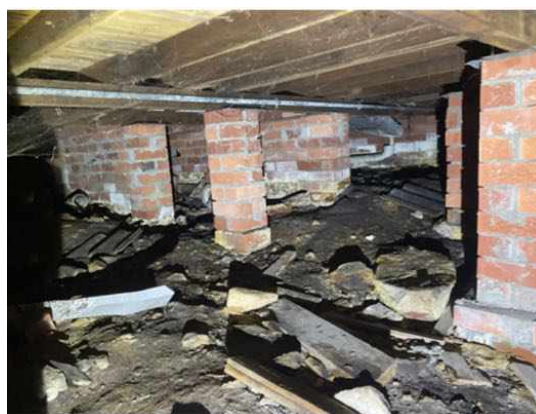
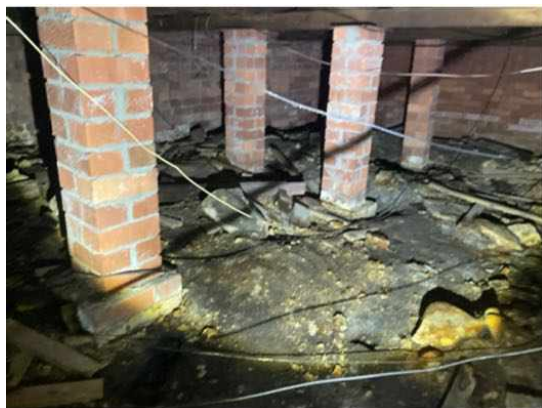
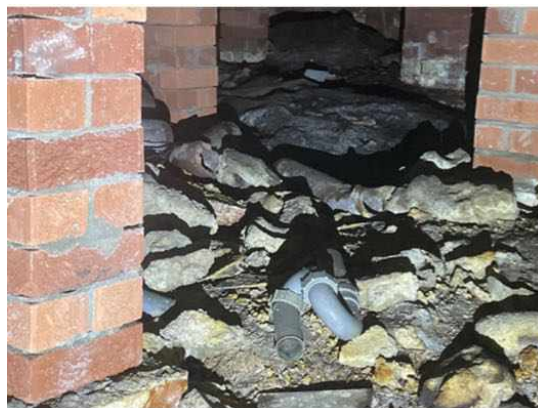
Defects 3.09

Building:	Building 1
Location:	Subfloor
Finding:	Evidence of excessive moisture was present at the time of inspection
Information:	Excessive moisture can attract termites and produce conditions that promote termite attack fungal growth and wood decay.

Excessive moisture is generally caused by deteriorated inadequate or missing roof drainage leaking plumbing pipes or fixtures poorly plumbed HWS overflows or condenser units and poor site drainage.

It is highly recommended that all plumbing and drainage fixtures and fittings be maintained regularly in order to prevent excessive moisture being present in the external / internal property.

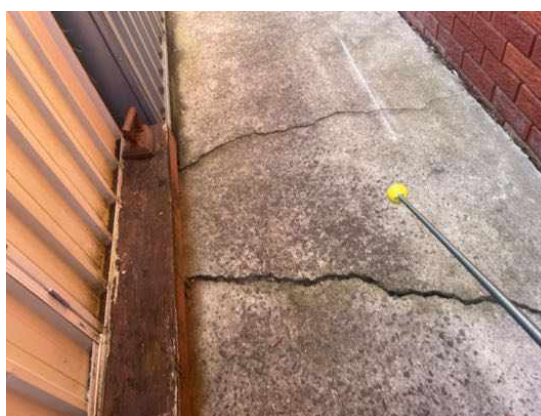
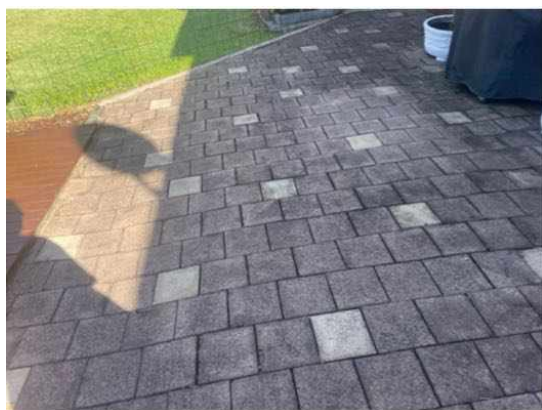
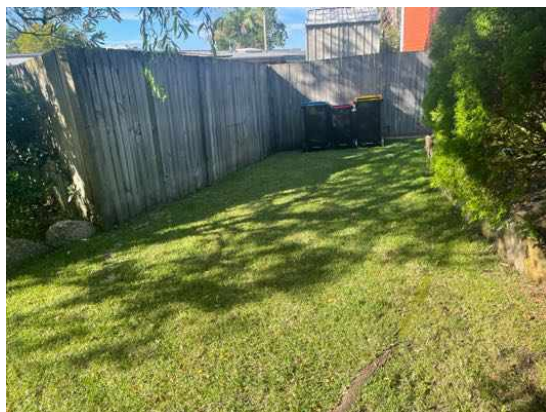
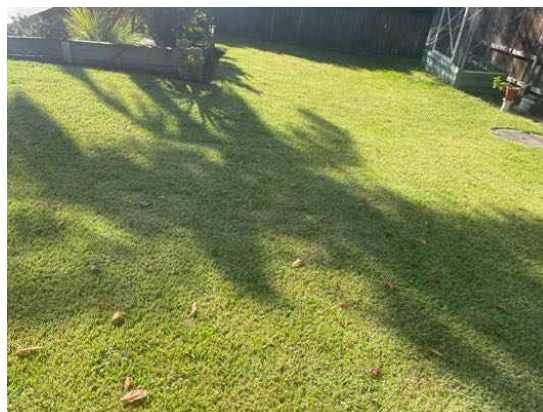
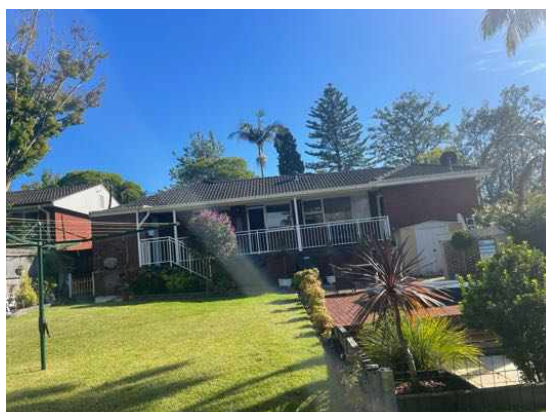
Defects 3.10

Building:	Building 1
Location:	All External Areas
Finding:	Site drainage - suspected Inadequate
Information:	The site drainage in this area was suspected inadequate at the time of inspection, creating potential for subsequent water damage to associated building elements.

It is important that water does not lie against the base of walls; surrounding paths and ground levels should be sloped to drain water away from walls. Downpipes should not discharge stormwater onto lower walls or plinths. Stormwater should be carried away by large, regularly cleaned drains. Ground levels may need to be lowered to expose a buried DPC.

Where site drainage is inadequate, installation of an Agricultural (Aggie) Drain may be required. A qualified plumber should be appointed to further inspect the property and perform any remedial works as necessary. Water damage and secondary defects are likely to occur if left unmanaged.

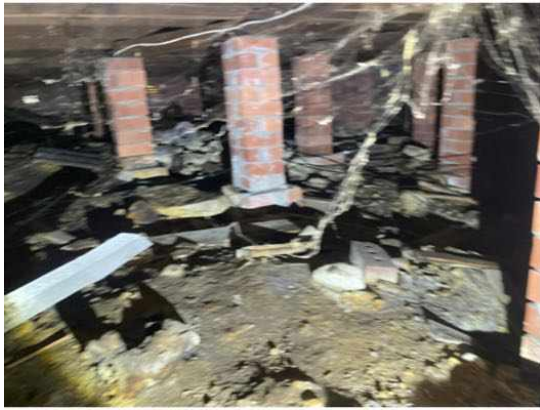
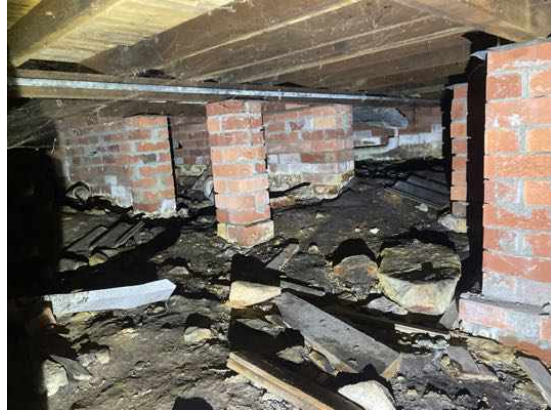
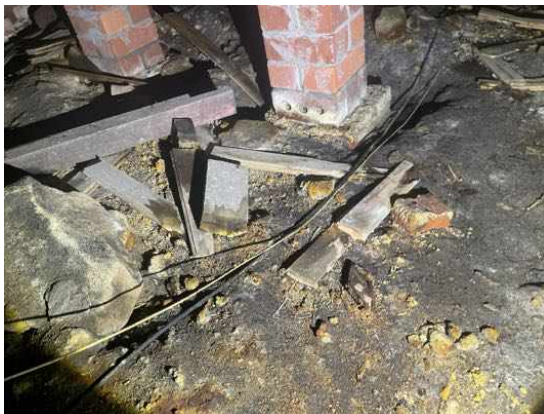
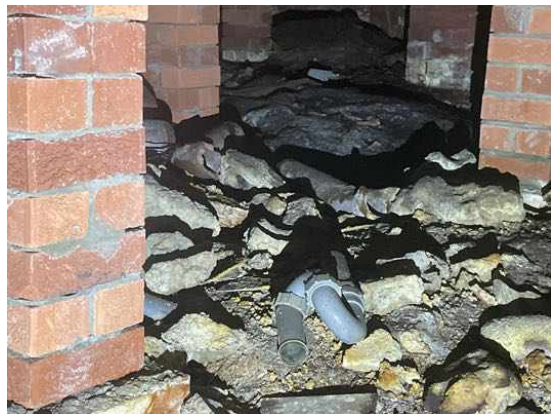
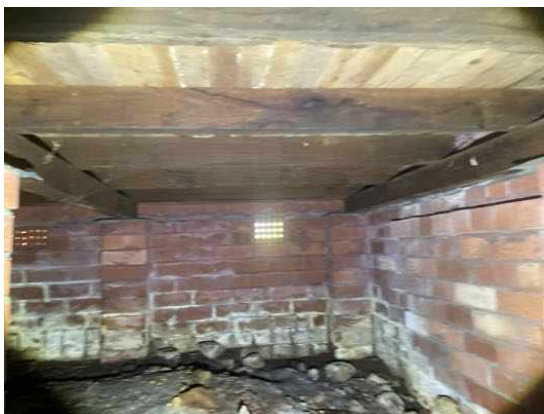
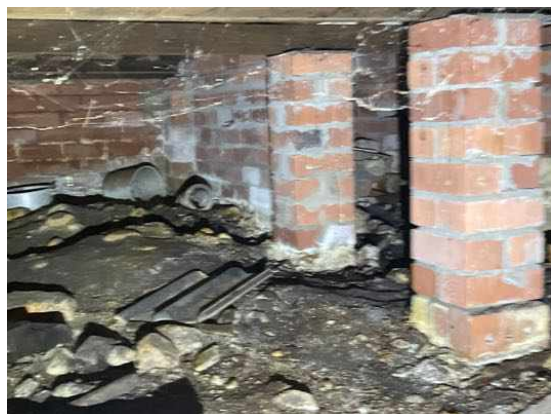
Defects 3.11

Building:	Building 1
Location:	Subfloor
Finding:	Subfloor ventilation - Inadequate
Information:	Adequate subfloor ventilation aids in preventing excessive moisture wood rot and termite activity by ensuring a dry subfloor environment.

Where ventilation is substandard it is usually caused by factors such as failure to install adequate vents during construction subsequent building works or earth and vegetation covering over vents low subfloor clearance and items or debris in the subfloor restricting airflow.

Subfloor ventilation can be improved in most cases by addressing the causes such as exposing subfloor vents installing additional new vents installing mechanical (forced airflow) ventilation and removing debris from the subfloor.

A builder should be appointed as soon as possible to perform these works as necessary.

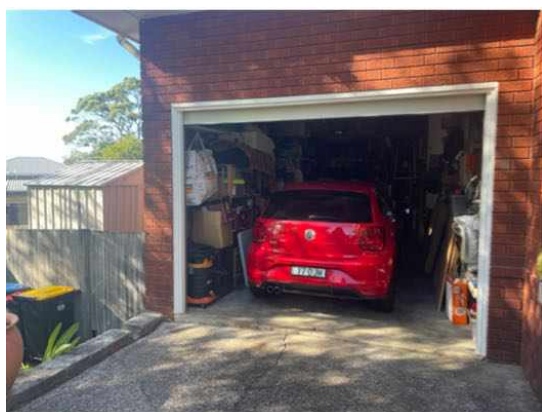
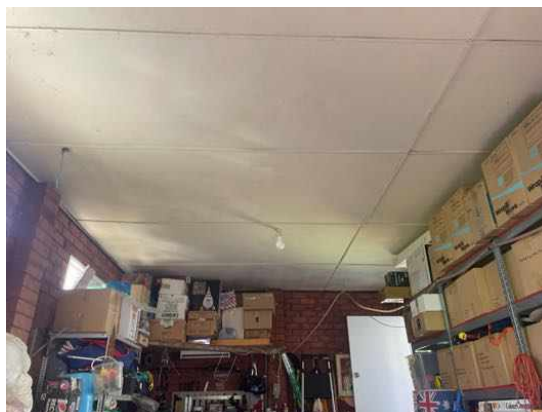
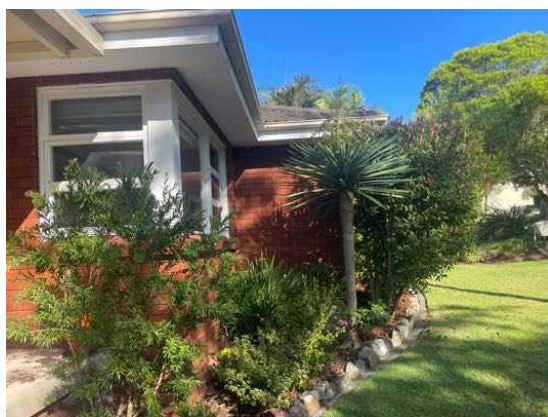
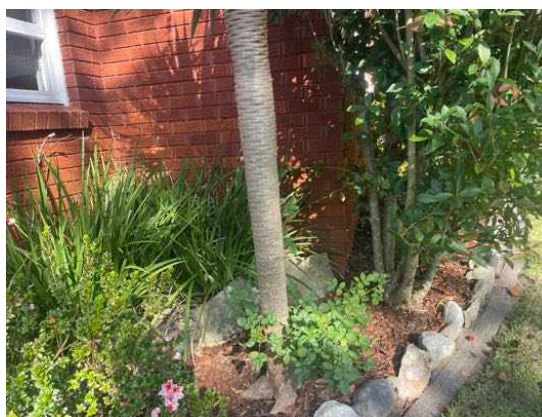
Building:	Building 1
Location:	All Areas
Finding:	Additional Photos - Obstructions and Limitations
Information:	These photographs are an indication of the obstructions and limitations which impeded full inspection of the property at the time of inspection. These obstructions can hide an array of defects and should be removed to allow full inspection to be carried out. A re-inspection is recommended once the areas are made accessible.

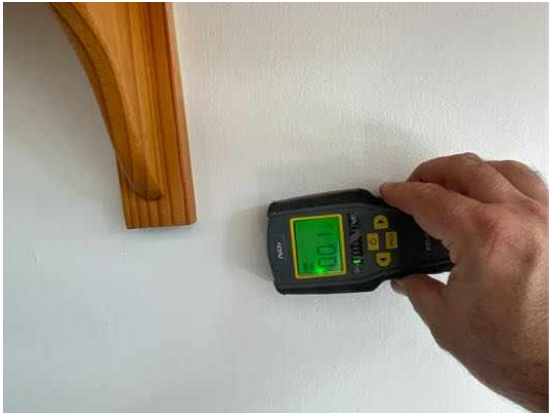
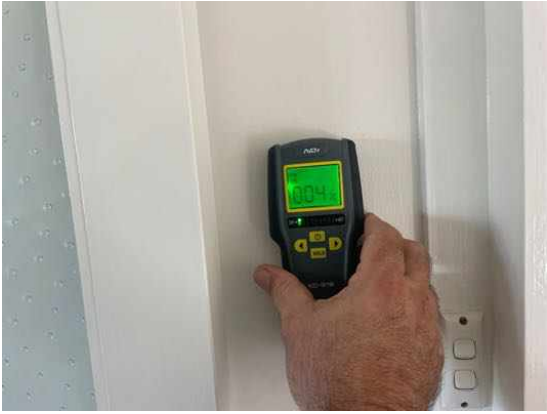
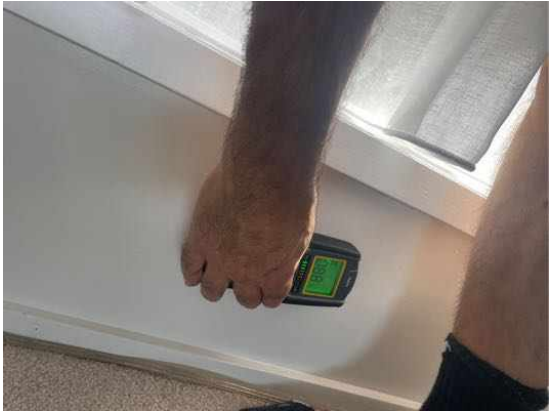
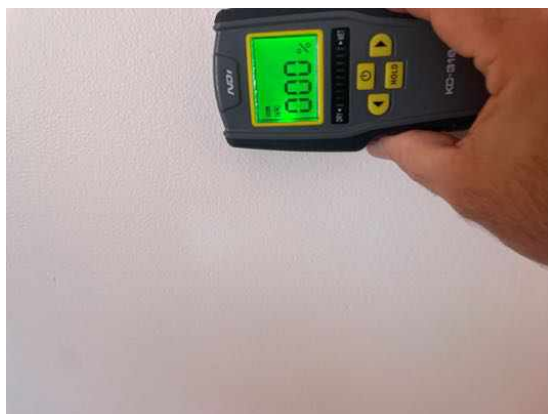
Building: Building 1
 Location: All Areas
 Finding: Moisture meter readings - low
 Information: The moisture meter result for the areas inspected.

The moisture reading of 0-15% is quite normal and gives no cause for concern. However, moisture readings in excess of 15% indicate the need for further inspection.

Levels between 25-30% indicate that there may be water ingress, meaning that remedial work could be required.

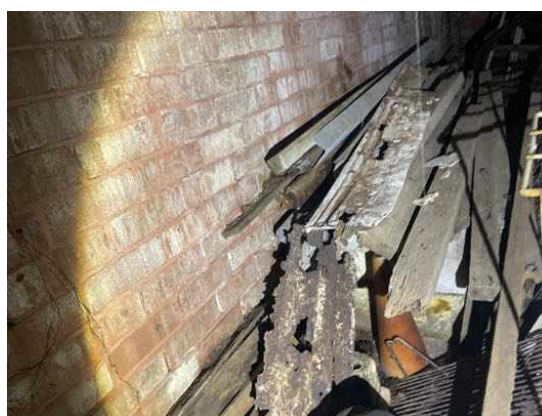
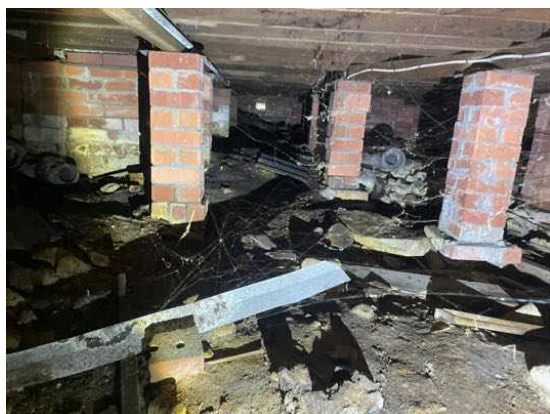
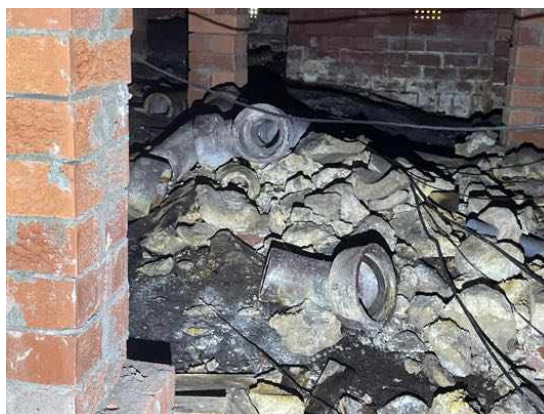
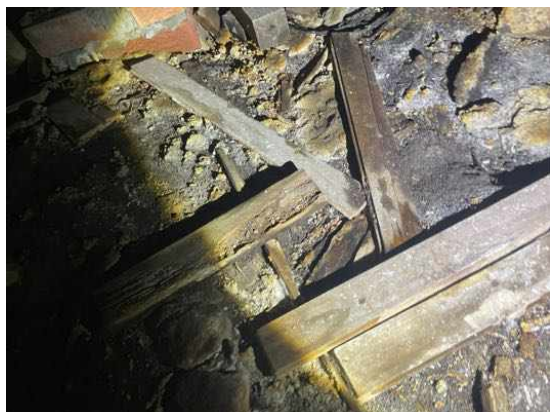
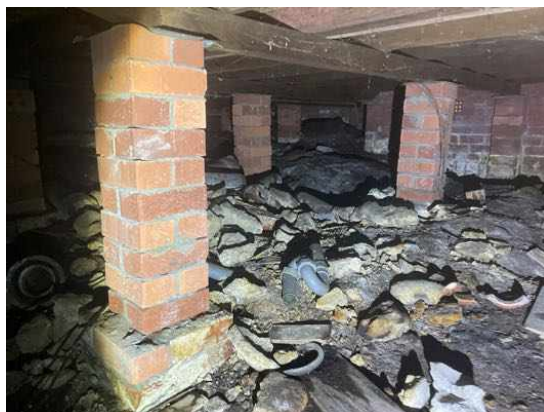
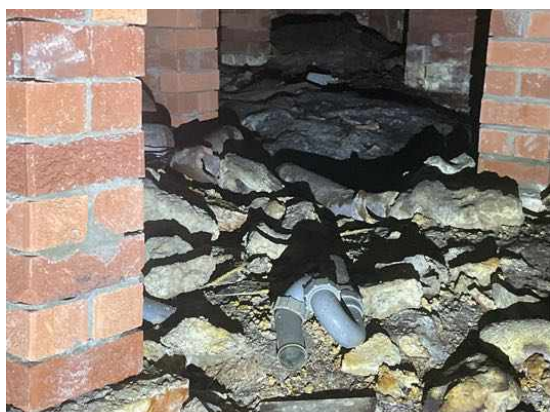
Information: An array of debris was found in the subfloor area at the time of inspection. Debris in this area restricts subfloor ventilation and creates potential for concealed pest entry. Stored timbers and other materials may also make the area susceptible to termite activity and wood rot.

A clear and empty subfloor will be better ventilated and easier to maintain in a dry condition. The removal of any timber debris is vital in minimising the risk of termite or wood borer activity.

Debris in the subfloor should be removed as soon as possible. Depending on the location and amount of debris and stored items, the homeowner may elect to undertake this task. Alternatively there are a large number of rubbish removal subcontractors that could undertake these works.

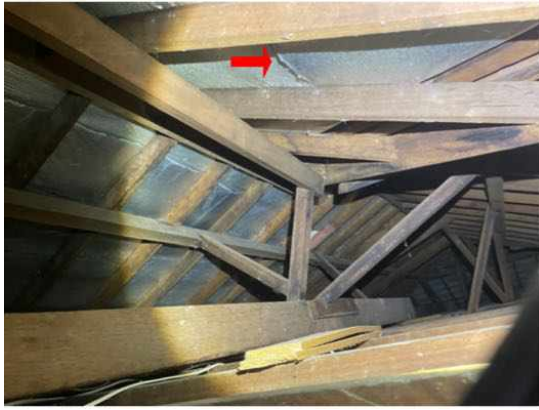
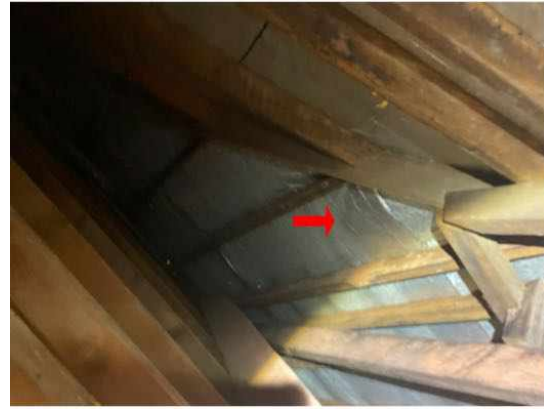
Building:	Building 1
Location:	Roof Void
Finding:	Sarking - installed
Information:	Sarking is under the roof sheeting. Sarking acts as an insulator that helps with noise reduction and protects against water penetration. Sarking plays a key role in the operation and function of the overall roofing structure and its performance.
