Timber Pest Inspection Report

Inspection Date: Fri, 31 Jan 2020

Property Address: 10 Sylvia Pl, Frenchs Forest NSW 2086, Australia

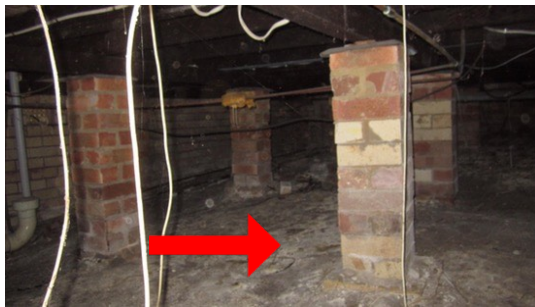
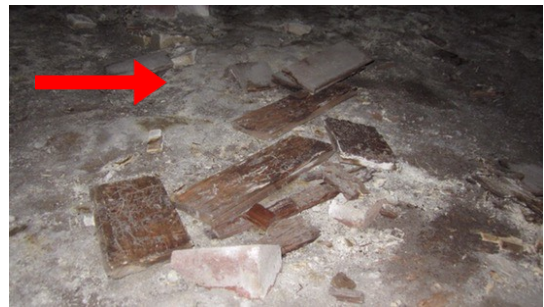
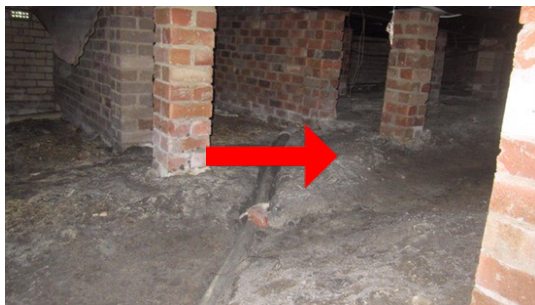
Location: Subfloor

Finding: Mould - Present

Information: Generally, the client is advised to ensure that the general environment is free of moisture and humidity to aid in the prevention of mould formation and development. Any mould found during the inspection should be cleaned immediately by a cleaning contractor or the homeowner as applicable.

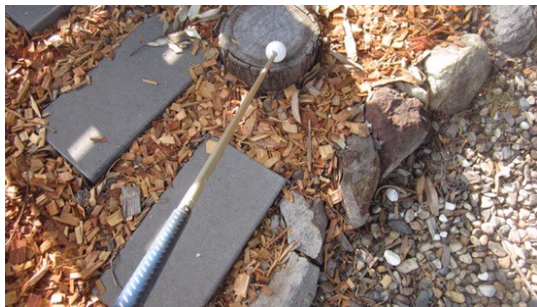
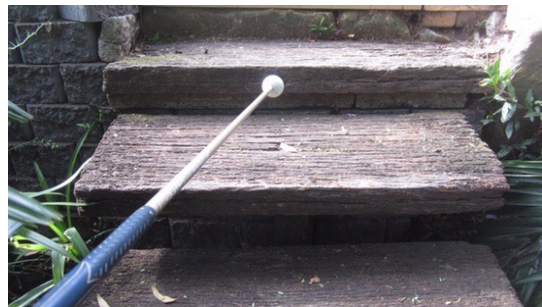
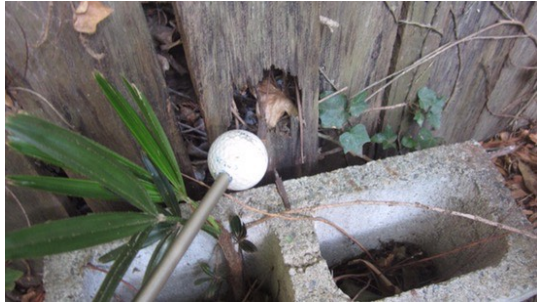
Location: All Areas

Finding: In ground contact

Information: Any timbers in direct ground contact provide opportunity for concealed termite entry and are likely to be subject to premature rot and decay as the soil retains moisture or damp conditions against the timbers.

Remove untreated timber that is in direct contact with external grounds. Consider replacement with more durable materials i.e. treated timber or non timber elements. Frequent pest inspections are advised to readily identify any termite activity in these areas.

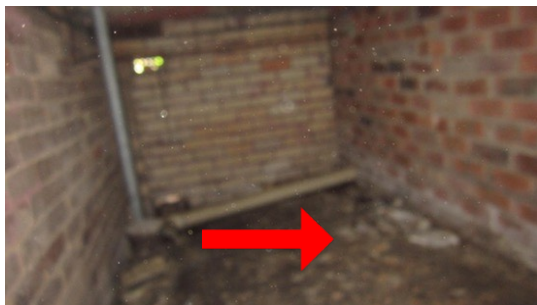
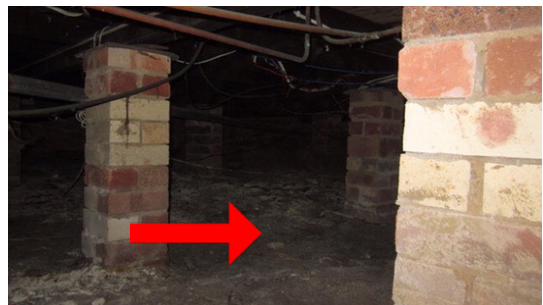
Building: Main Building
Location: Subfloor
Finding: Evidence of excessive moisture was present at the time of inspection
Information: Excessive moisture can attract termites and produce conditions that promote termite attack fungal growth and wood decay.

Excessive moisture is generally caused by deteriorated inadequate or missing roof drainage leaking plumbing pipes or fixtures poorly plumbed HWS overflows or condenser units and poor site drainage.

It is recommended that all plumbing and drainage fixtures and fittings be maintained regularly in order to prevent excessive moisture being present in the external / internal property.

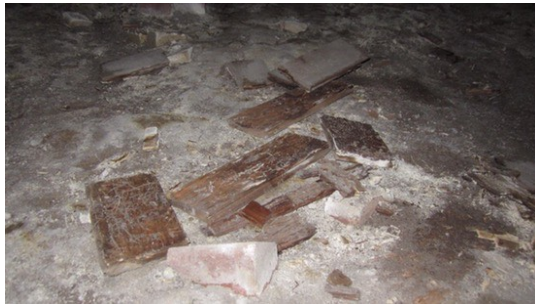
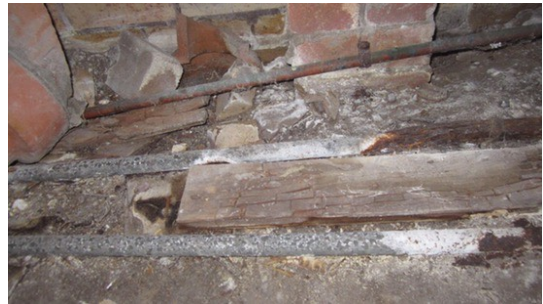
Building:	Main Building
Location:	Subfloor
Finding:	Subfloor - Debris
Information:	An array of debris was found in the subfloor area at the time of inspection. Debris in this area restricts subfloor ventilation and creates potential for concealed pest entry. Stored timbers and other materials may also make the area susceptible to termite activity and wood rot.

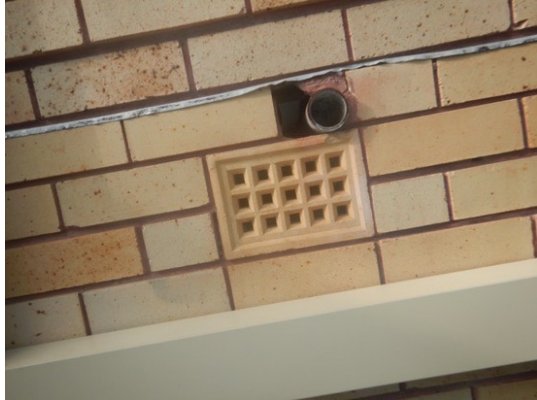
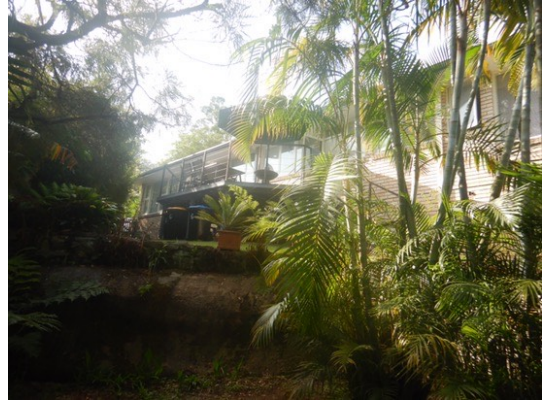
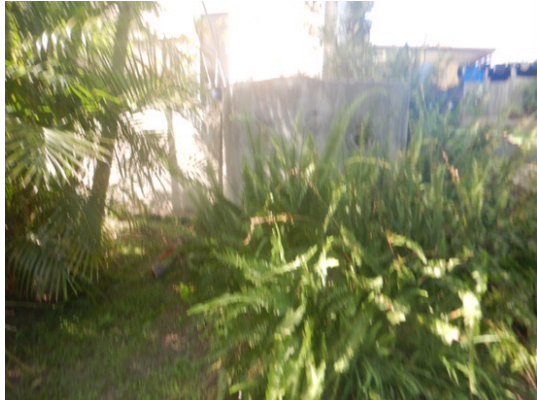
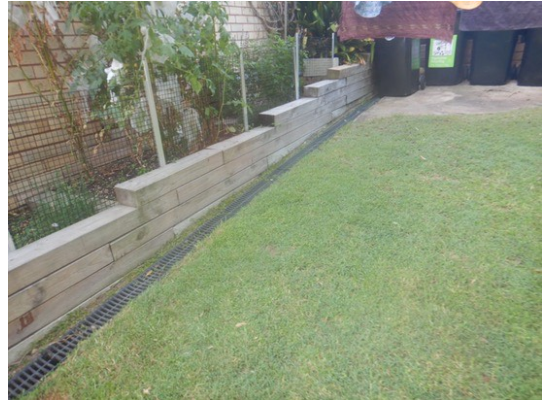
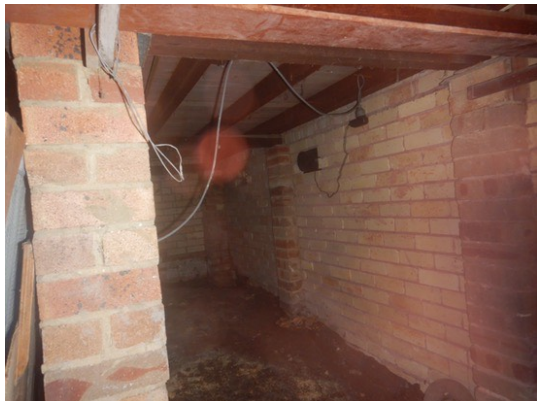
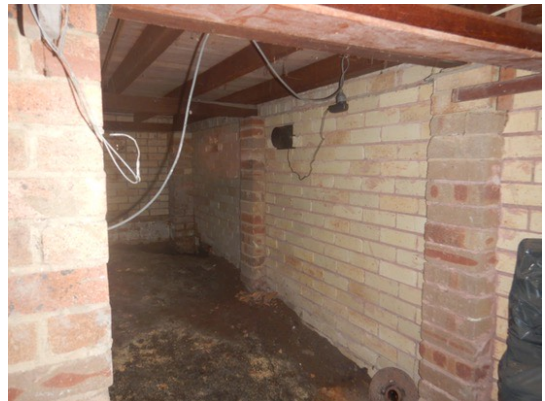
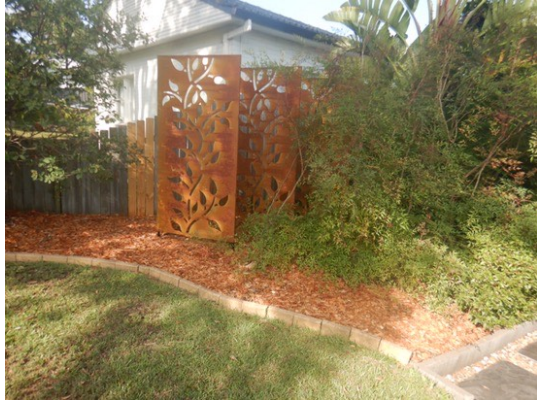
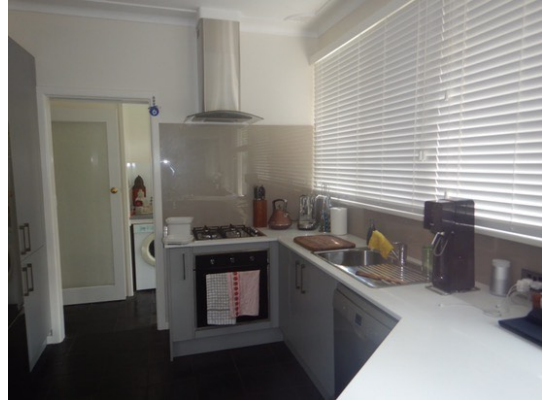
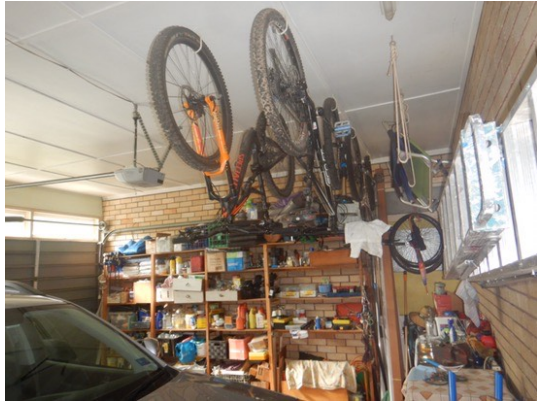
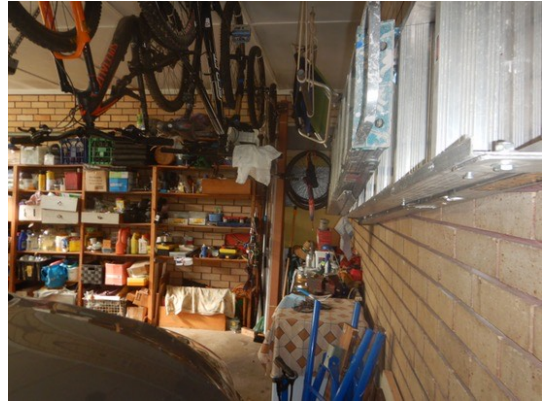
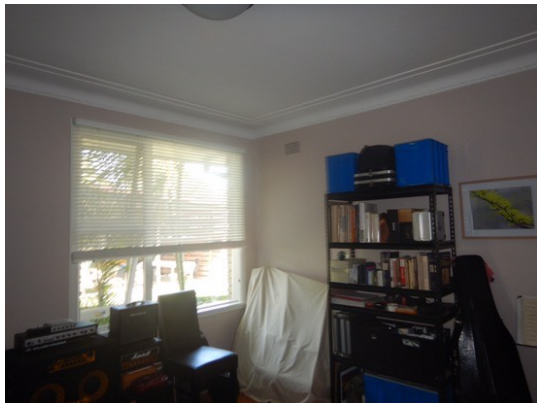
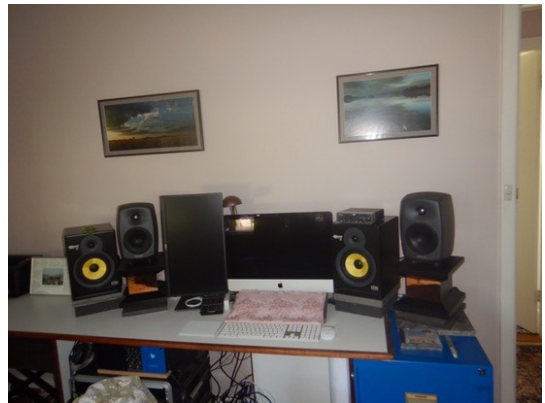
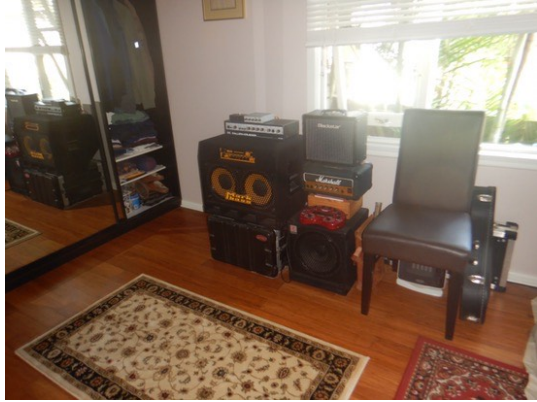
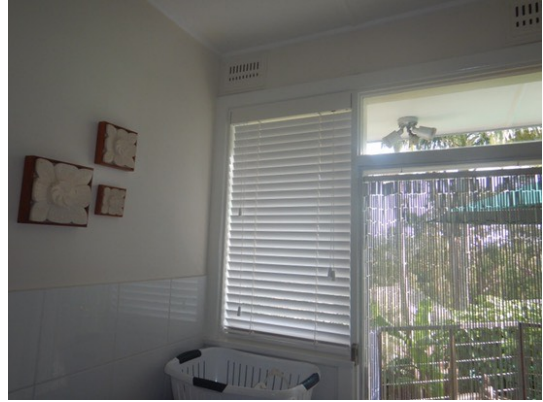
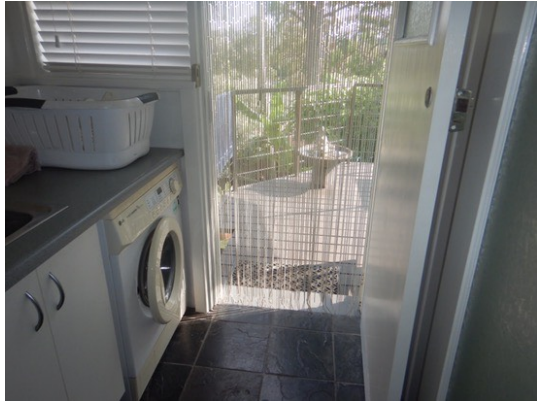
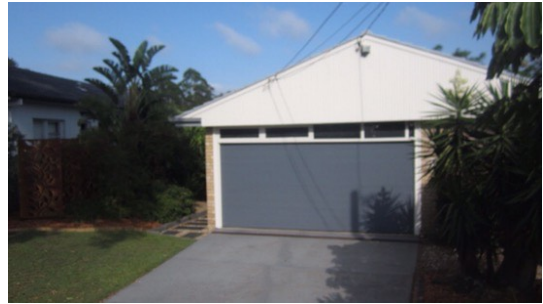
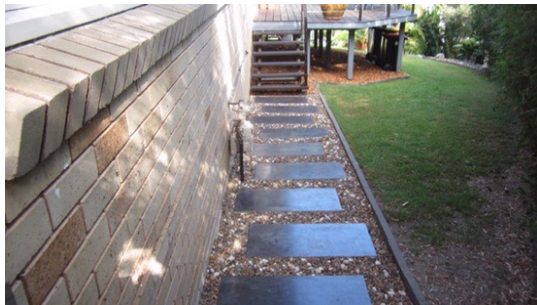
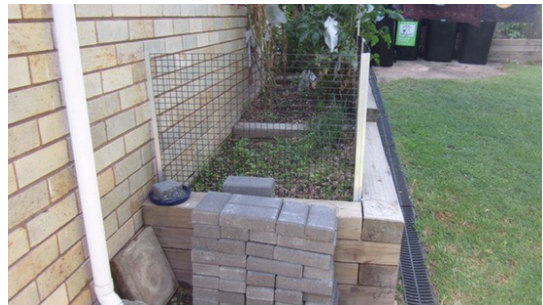
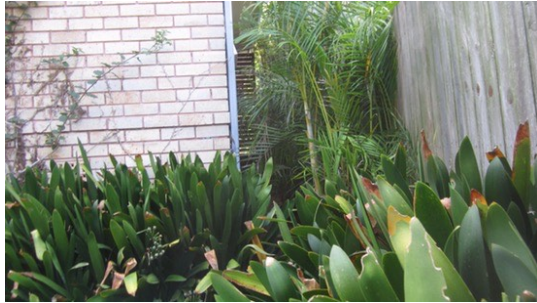
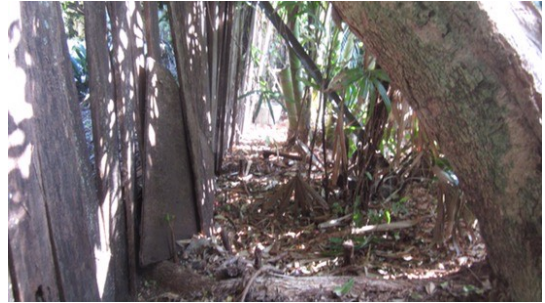
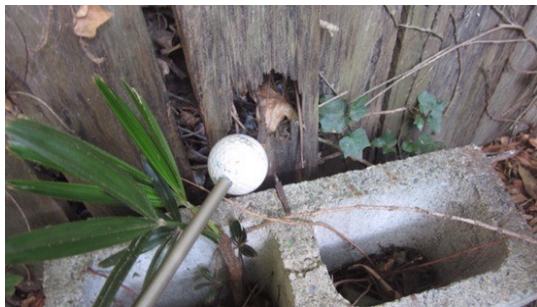
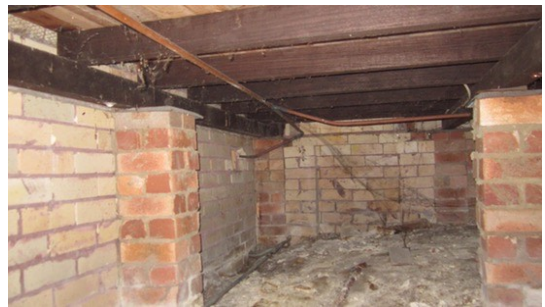
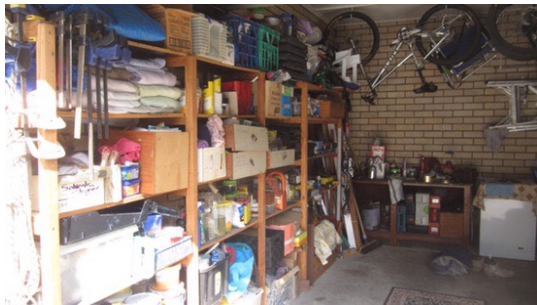
Building:	Main Building
Location:	All Areas
Finding:	Additional Photos - Obstructions and Limitations
Information:	These photographs are an indication of the obstructions and limitations which impeded full inspection of the property at the time of inspection.

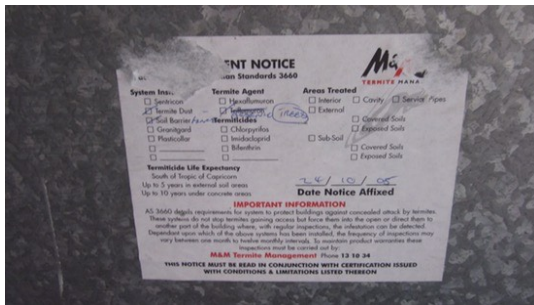
Building: Main Building
Location: Yard - Side
Finding: Termite Management System - out of date
Information: The application of a post-construction chemical termite barrier is highly recommended for all properties, particularly if live termite activity has been found on the site previously. Such barriers are highly effective in preventing termite attack on any timber building elements throughout the property.

A durable notice should be placed in the switchboard unit to indicate current termite barriers. At the time of inspection, it appeared as though no termite management system has been installed, with no evidence to suggest preventative works taking place.

The client may consider gaining further advice from a pest controller as to the costs and procedures involved with this application. It is recommended that obtaining such advice be a short-term priority.o
