VISUAL BUILDING & PEST INSPECTION REPORT

Complies with Australian Standard 4349.1 & 4349.6

Vendor Report

30 Mathews Street Davidson

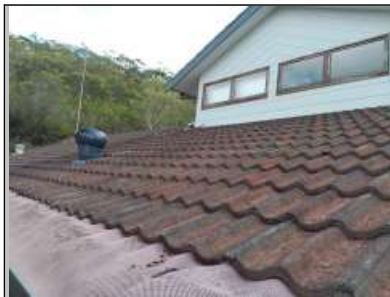
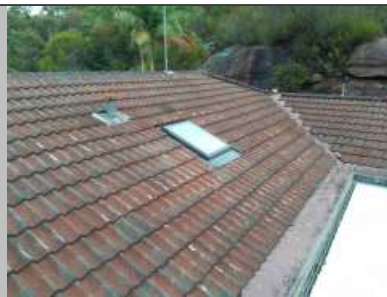
Roof Covering Condition

The overall condition of the roof coverings is fair. Surface of the concrete tiles is deteriorating and the area requires sealing.

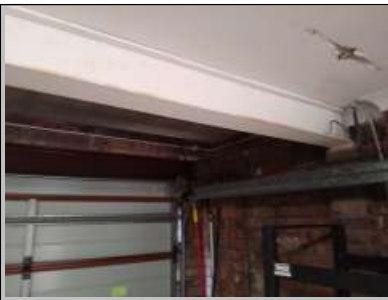
Lintel type noted: Mild steel. The condition of the lintels is generally fair. Rust is evident to some steel lintels. Rusted areas should be treated to prevent further deterioration.

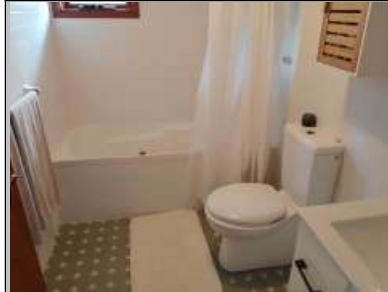
Level one.

The shower is located over the bathtub. The area will need to be kept well sealed to prevent water penetration to surrounding areas.

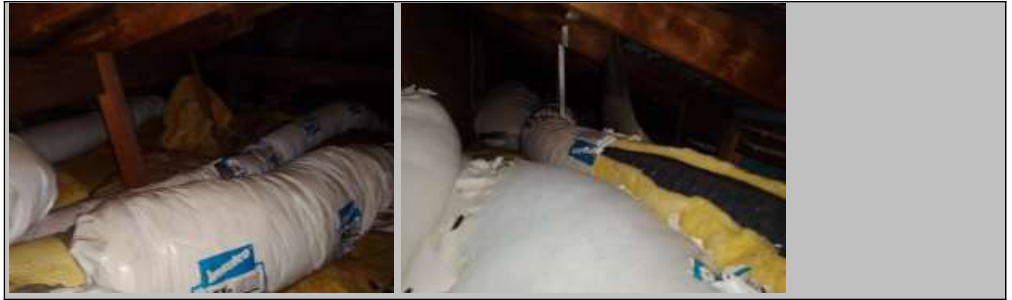
Insulation is present in the roof cavity. This restricted inspection to some roofing timbers. Removal of insulation is not within the scope of a standard visual inspection report, however as in accordance with "industry best standard" the inspector will lift insulation in 3 areas in roof void.

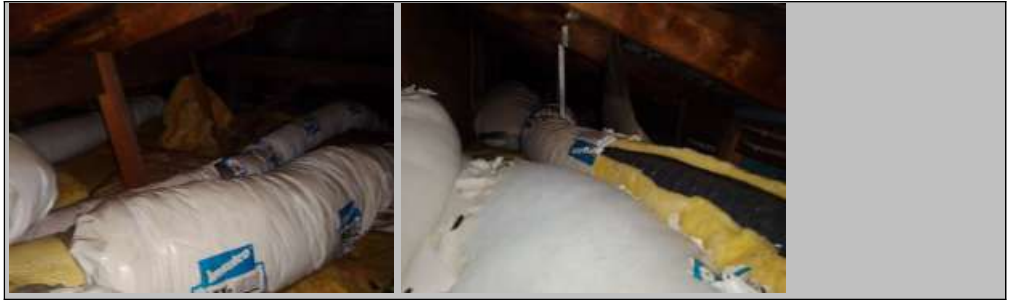
Insulation is present in the roof cavity. This restricted inspection to some roofing timbers. Removal of insulation is not within the scope of a standard visual inspection report, however as in accordance with "industry best standard" the inspector will lift insulation in 3 areas in roof void.
