## **VISUAL BUILDING INSPECTION REPORT**

Complies with Australian Standard 4349.1

Vendor Report

514 Warringah Road, Frenchs Forest

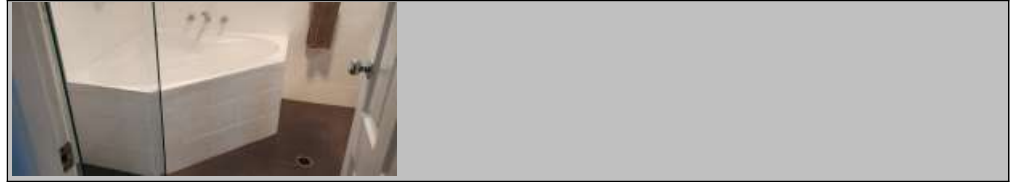
Adjacent to hall.

The shower recess was tested and there was no visible water penetration to surrounding areas. IMPORTANT NOTE: This test may not reveal water leaks until the shower is put into constant use and surrounding areas monitored over a period of time.

The condition of the tiles is generally fair.

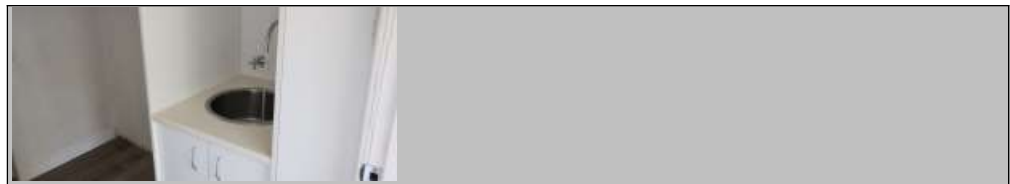
Rear.

The tub and taps appear serviceable. Drain appears serviceable.

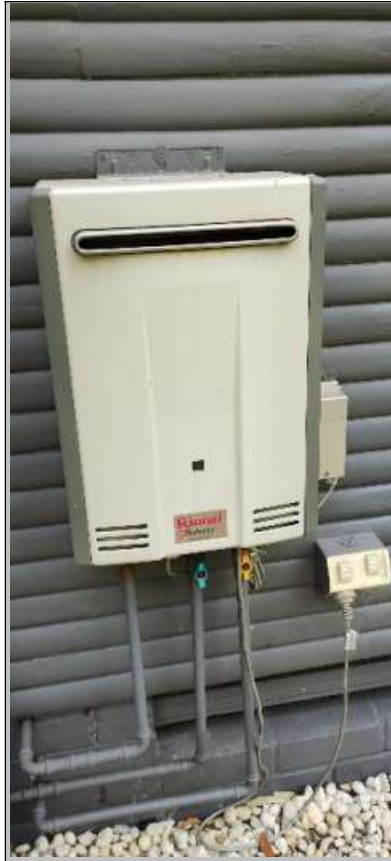
Gas hot water system: Mains pressure: Instantaneous: Located externally: The hot water system appears to be in working condition. No specific tests other than running the hot water tap were carried out. No determination has been made as to the suitability or adequacy of the hot water system in relation to capacity or otherwise.

We were unable to determine the age of the unit.
