Timber Pest Inspection Report

Inspection Date: Sat, 25 Jul 2020

Property Address: 25 Dareen St, Beacon Hill NSW 2100, Australia

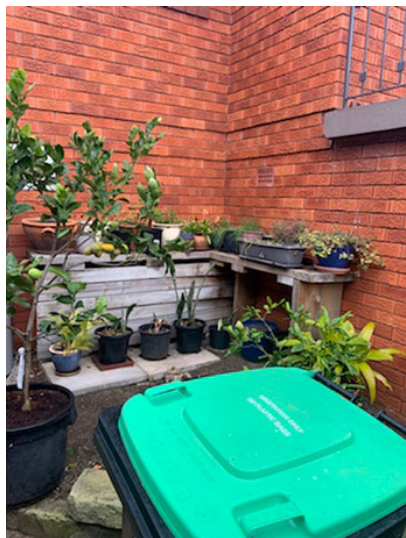
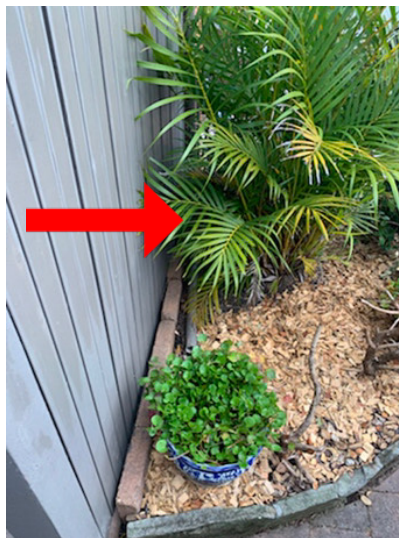
Building:	Building 1
Location:	Yard - Side
Finding:	Evidence of excessive moisture was present at the time of inspection
Information:	Excessive moisture can attract termites and produce conditions that promote termite attack fungal growth and wood decay.

Excessive moisture is generally caused by deteriorated inadequate or missing roof drainage leaking plumbing pipes or fixtures poorly plumbed HWS overflows or condenser units and poor site drainage.

It is highly recommended that all plumbing and drainage fixtures and fittings be maintained regularly in order to prevent excessive moisture being present in the external / internal property.

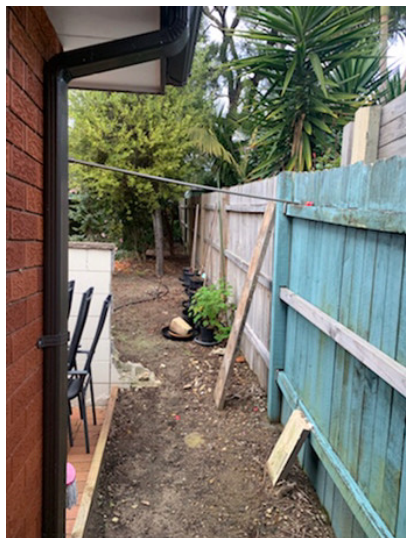
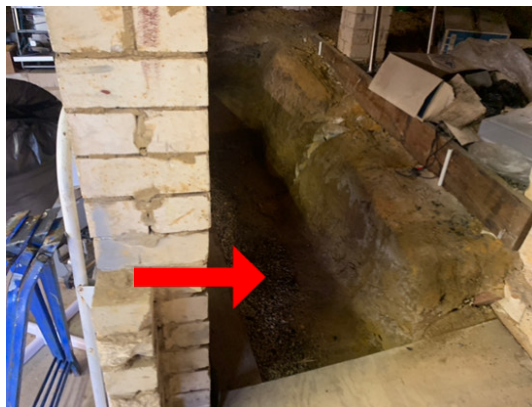
Building:	Building 1
Location:	Yard - Side
Finding:	Overflow - Not plumbed for drainage
Information:	The overflow is not plumbed or connected to suitable drainage, which has resulted in the surrounding area becoming excessively damp.

These damp conditions can lead to secondary defects such as rot, rust or corrosion of associated building elements, the formation of fungal decay, or even the creation of potential slip hazards. When coupled with poor site drainage, pooling of water may also attract termite activity to this area.

It is highly recommended that a qualified plumber be appointed to install adequate drainage to the overflow. These works will ensure that the area remains dry and free of any secondary defects.

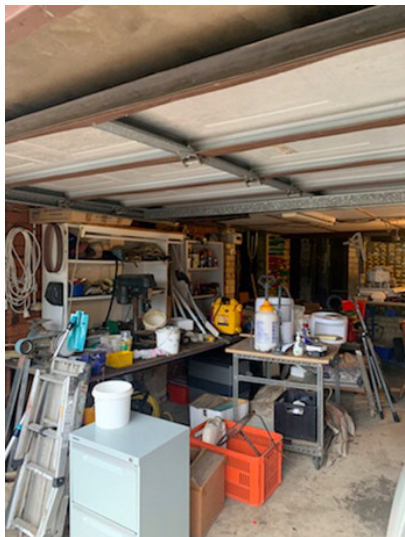
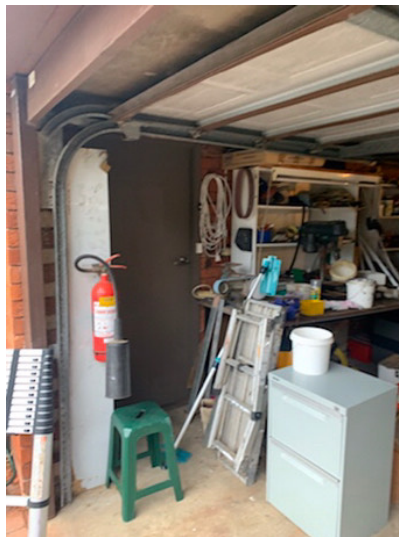
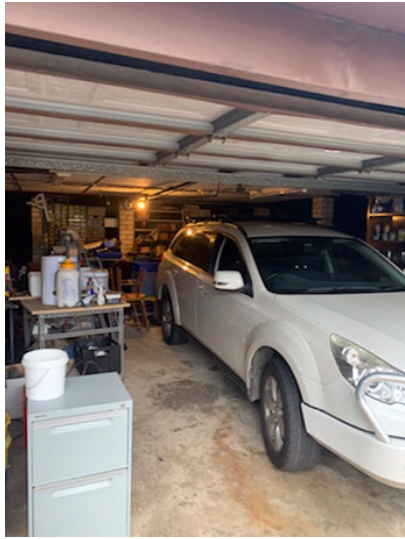
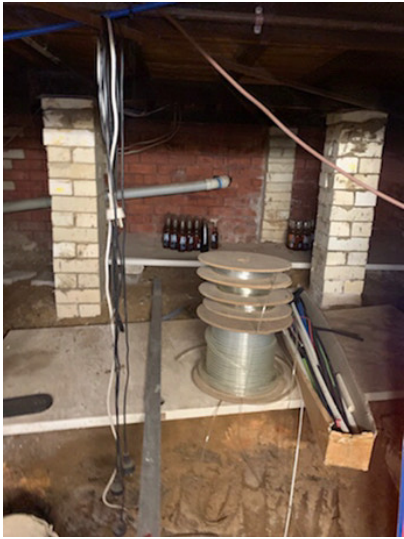
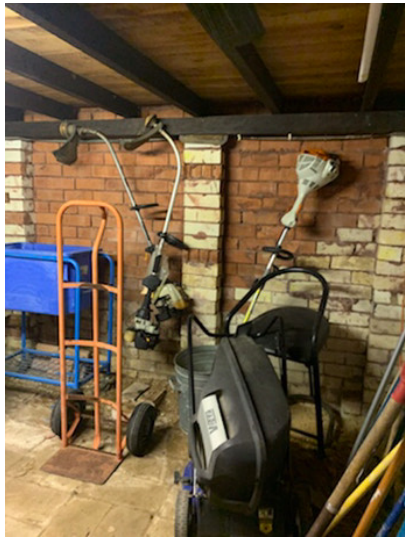
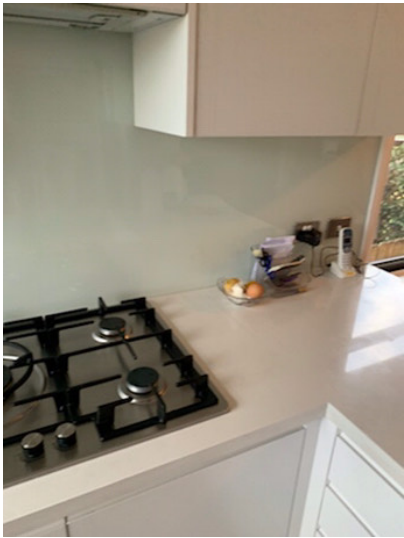
Building: Building 1
Location:
Finding: Additional Photos - Obstructions and Limitations
Information: These photographs are an indication of the obstructions and limitations which impeded full inspection of the property at the time of inspection.

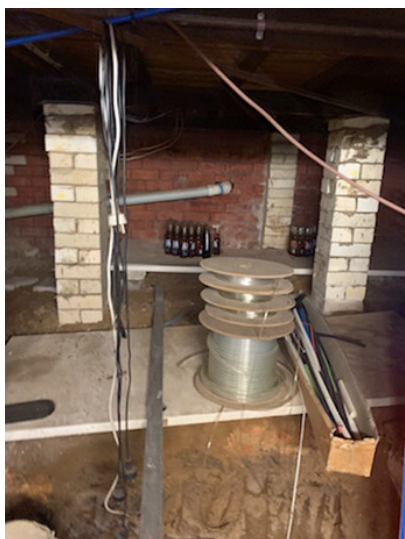
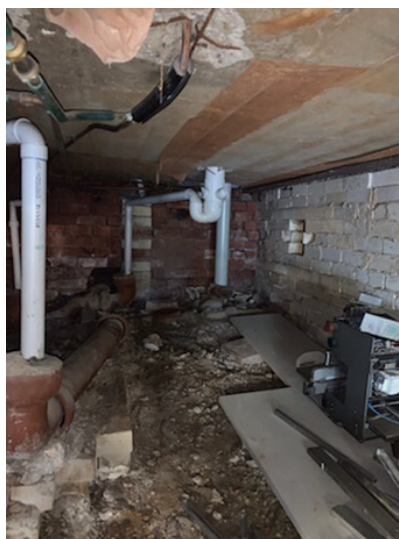
Finding: Subfloor - Debris

Information: An array of debris was found in the subfloor area at the time of inspection. Debris in this area restricts subfloor ventilation and creates potential for concealed pest entry. Stored timbers and other materials may also make the area susceptible to termite activity and wood rot.

A clear and empty subfloor will be better ventilated and easier to maintain in a dry condition. The removal of any timber debris is vital in minimising the risk of termite or wood borer activity.

Debris in the subfloor should be removed as soon as possible. Depending on the location and amount of debris and stored items, the homeowner may elect to undertake this task. Alternatively there are a large number of rubbish removal subcontractors that could undertake these works.

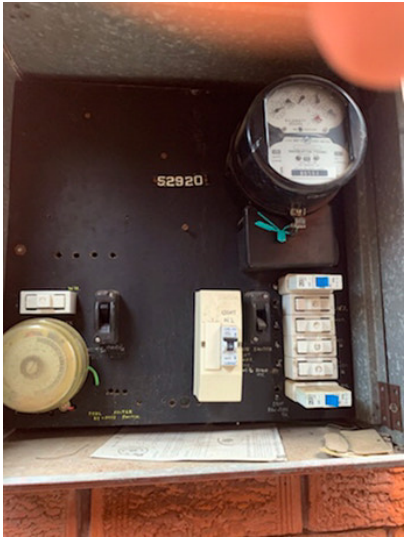
Building: Building 1
 Location: Yard - Side
 Finding: Termite Management System - no evidence of installation
 Information: The application of a post-construction chemical termite barrier is highly recommended for all properties, particularly if live termite activity has been found on the site previously. Such barriers are highly effective in preventing termite attack on any timber building elements throughout the property.

A durable notice should be placed in the switchboard unit to indicate current termite barriers. At the time of inspection, it appeared as though no termite management system has been installed, with no evidence to suggest preventative works taking place.

The client may consider gaining further advice from a pest controller as to the costs and procedures involved with this application. It is recommended that obtaining such advice be a short-term priority.
