## Building Inspection Report

Inspection Date: Wed, 28 Aug 2019

Property Address: 18 Holland Crescent, Frenchs Forest NSW, Australia

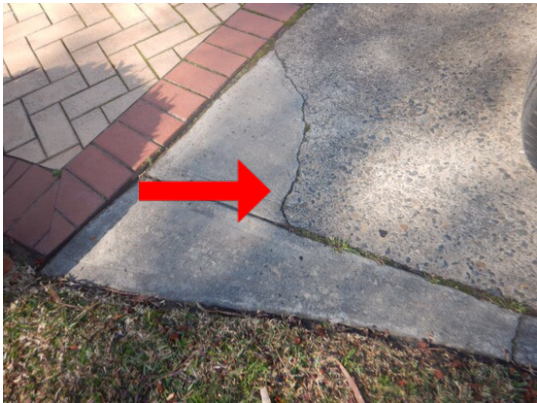
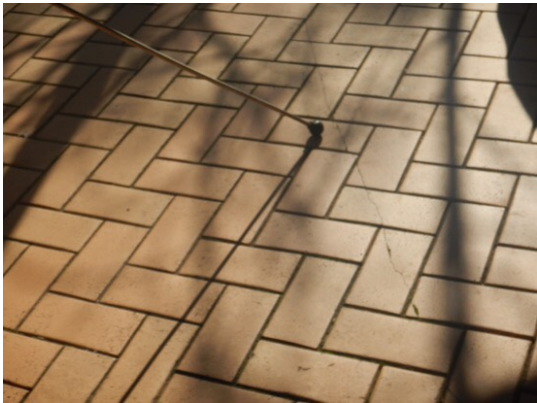
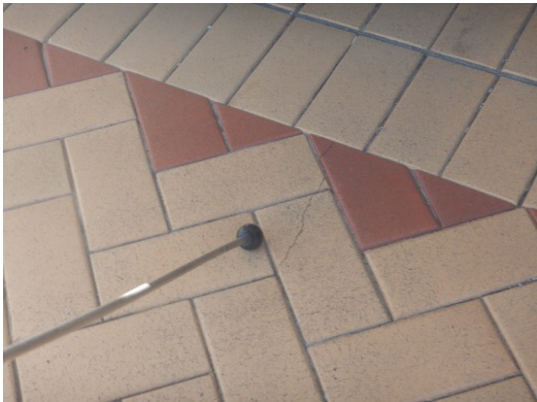
#### Defects 3.01

Building:	Main Building
Location:	Driveway
Finding:	Cracking - External Concrete Paving Damage Category 1 - Fine (less than 2mm)
Information:	Fine cracks were identified in external concrete paving. Although fine cracks are quite noticeable, they are often only considered to be an appearance defect, and usually do not indicate any structural damage. To be considered a Category 1 or fine crack, the crack is found to be <2mm in width.

Generally the cause of a hairline crack in existing concrete paving such as driveways and pathways is indicative of the expansion and contraction of the concrete. Such causes are generally due to environmental factors, such as moisture levels, weather conditions, root systems of nearby trees or the soil types on which they are laid.

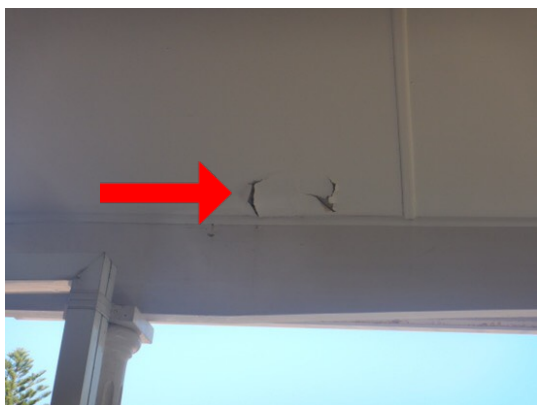
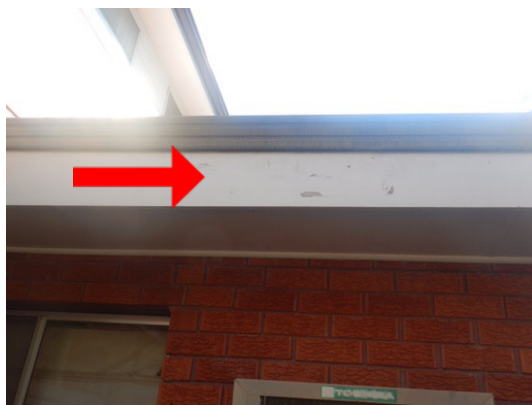
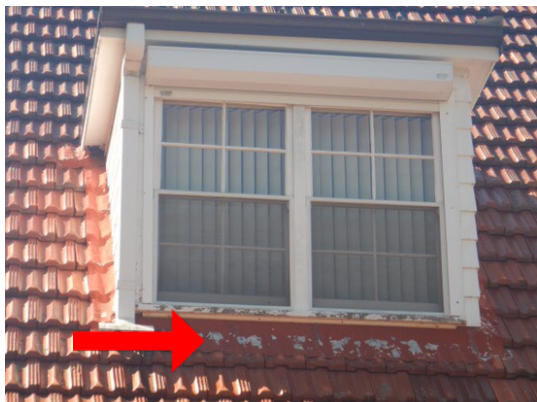
## Defects 3.02

Building: Main Building

Location: All Areas

Finding: External painting deteriorated

Information: Whilst incomplete or deteriorated paint finish is generally an appearance defect, it can also lead to the development of secondary building defects over time. Incomplete areas of paint finish exposes the area to moisture, potentially accelerating the deterioration of underlying building materials.

Degraded paint finishes should be sanded back, filled, leveled and painted, as applicable. Where inadequate or missing paint protection has led to the deterioration of the associated building element, repair and/or replacement of this building element may be required.

A painting contractor should be appointed to perform necessary works to aid the appearance of the affected area and to ensure the area is protected against further deterioration. Alternatively, the homeowner following manufacturer instructions may perform these works.

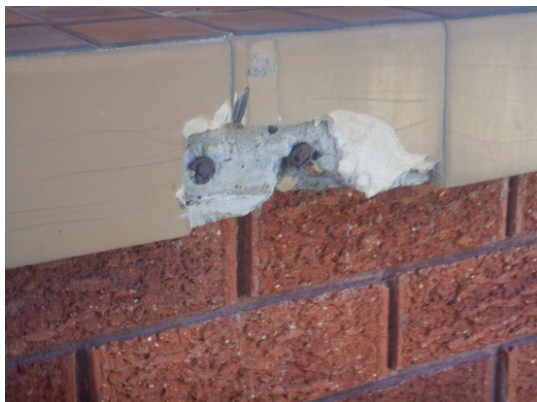
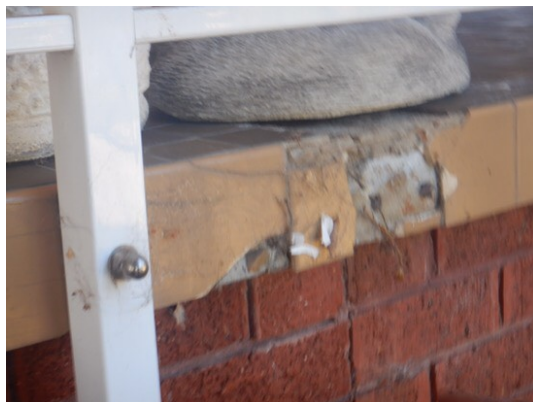
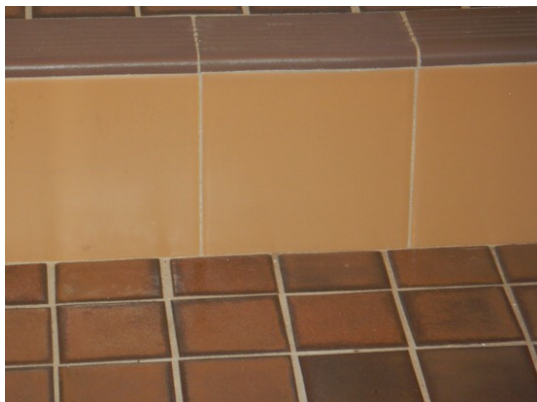
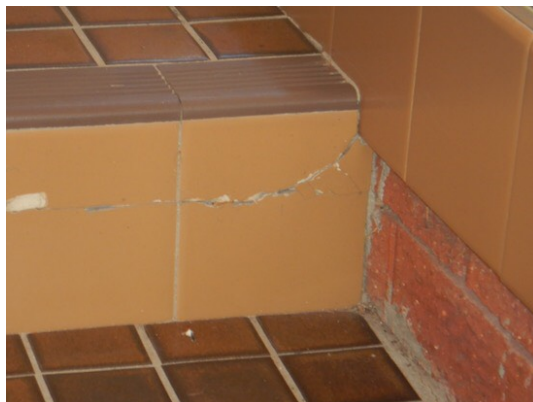
### Defects 3.03

Building: Main Building

Location: Entry

Finding: Tiles - Cracked or damaged

Information: Cracking was evident to the tiling in this area at the time of inspection. While the cracking appears to be minor, this area is frequently exposed to water, allowing potential for water penetration into adjoining sections of walls or flooring.

If left unmanaged, water penetration to these areas may lead to subsequent water damage, which is likely necessitate repair work to affected building elements.

A tiling contractor should be appointed to ensure that no further water damage occurs.

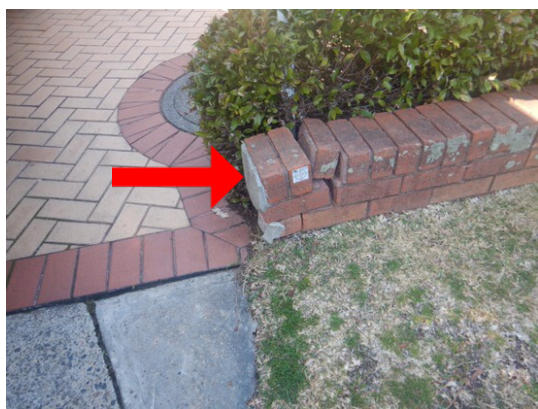
### Defects 3.04

Building:	Main Building
Location:	Yard - Front
Finding:	Damage to Masonry fence
Information:	It has been observed that damage to masonry walls caused by movement of slabs, footings, or other causes, has occurred.

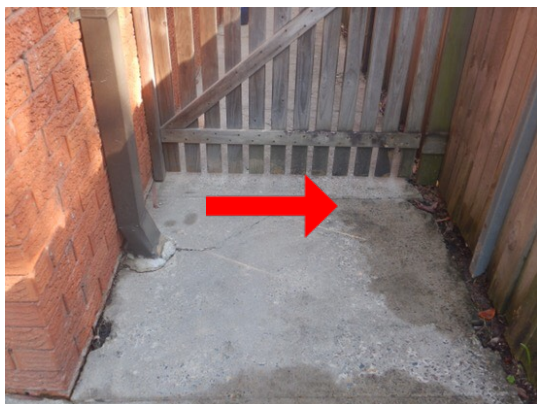
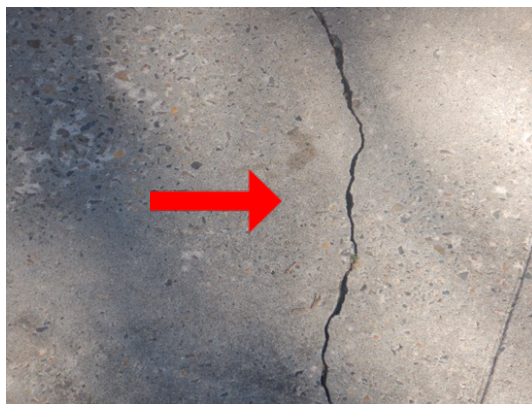
## Defects 3.05

Building:	Main Building
Location:	All Areas
Finding:	Cracking - External Concrete Paving Damage Category 1 - Fine (less than 2mm)
Information:	Fine cracks were identified in external concrete paving. Although fine cracks are quite noticeable, they are often only considered to be an appearance defect, and usually do not indicate any structural damage. To be considered a Category 1 or fine crack, the crack is found to be <2mm in width.

Generally the cause of a hairline crack in existing concrete paving such as driveways and pathways is indicative of the expansion and contraction of the concrete. Such causes are generally due to environmental factors, such as moisture levels, weather conditions, root systems of nearby trees or the soil types on which they are laid.

Monitoring of all cracking should be conducted frequently. Always contact a builder should cracks widen, lengthen, or become more numerous.

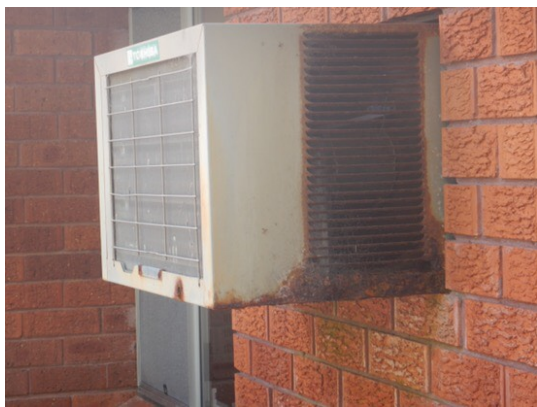
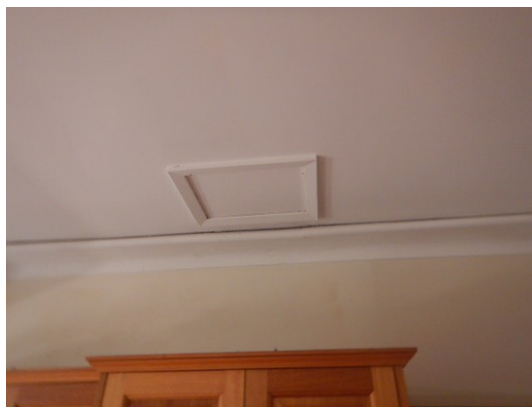
## Defects 3.06

Building:	Main Building
Location:	Yard - Back
Finding:	A/C- Rusted or corroded
Information:	This building element shows evidence of rusting and corrosion, which is likely to have developed as a result of excessive exposure to moisture and or inadequate coatings..

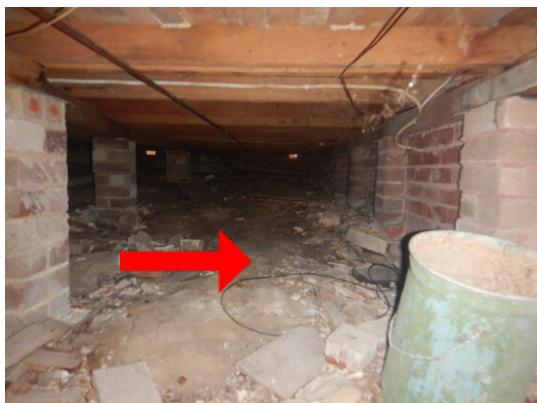
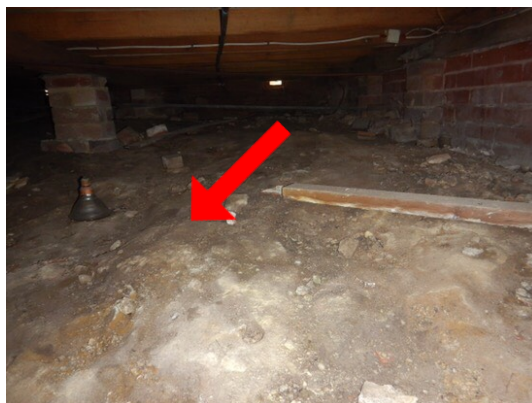
## Defects 3.07

Building:	Main Building
Location:	Subfloor
Finding:	Evidence of excessive moisture was present at the time of inspection
Information:	Excessive moisture is generally caused by deteriorated inadequate or missing roof drainage leaking plumbing pipes or fixtures poorly plumbed HWS overflows or condenser units and poor site drainage.

It is recommended that all plumbing and drainage fixtures and fittings be maintained regularly in order to prevent excessive moisture being present in the external / internal property.

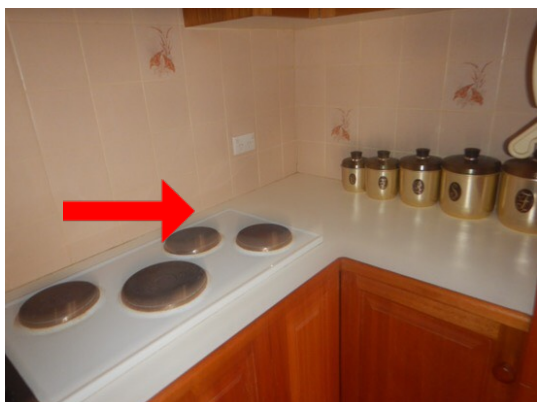
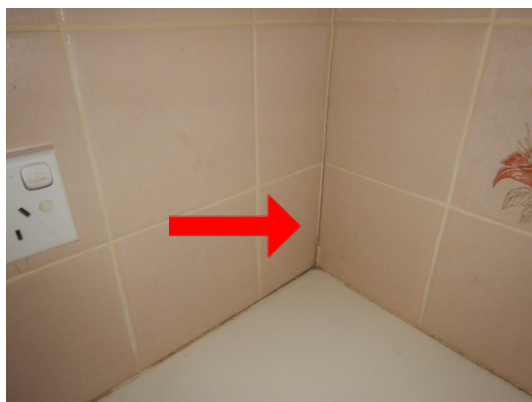
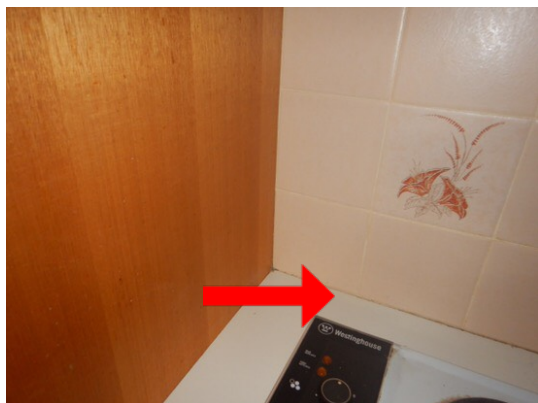
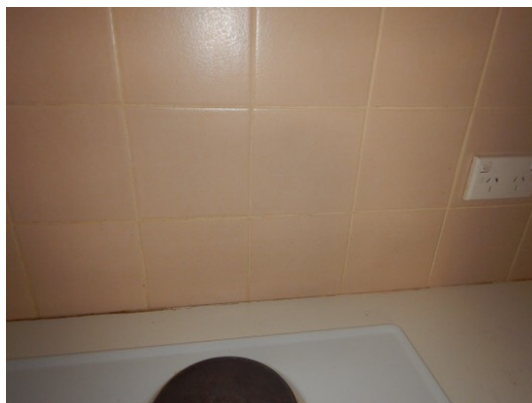
### Defects 3.08

Building: Main Building

Location: Kitchen

Finding: Sealant and grouting - Missing or damaged

Information: Regular maintenance and replacement of damage or missing or damaged sealant and grout is recommended to the wet areas, as this is a regular wear and tear defect.

Sealant and grouting in areas that come into regular contact with water should be maintained for the long term care of your property.

A sealant specialist or tiling contractor should be appointed to complete these works.

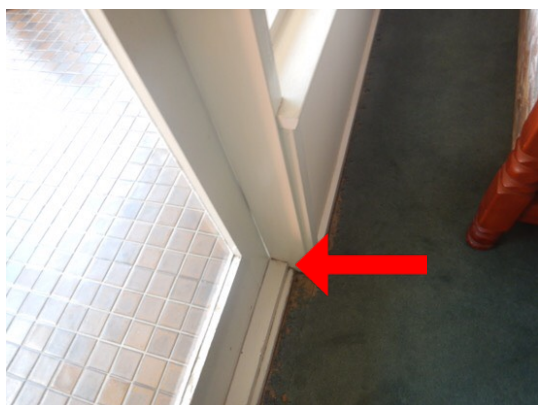
### Defects 3.09

Building: Main Building  
Location: Lounge Room  
Finding: Deteriorated components  
Information: It was identified of the carpet has deteriorated over time and may need replacing in the future.

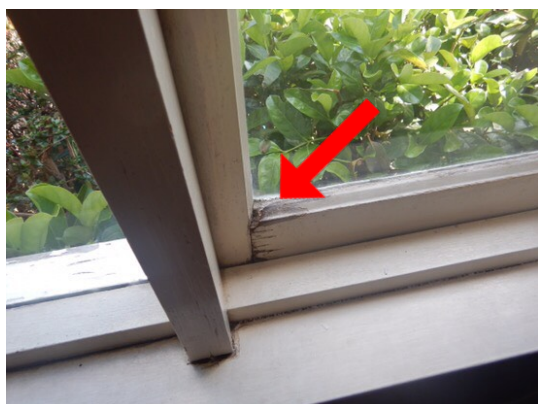
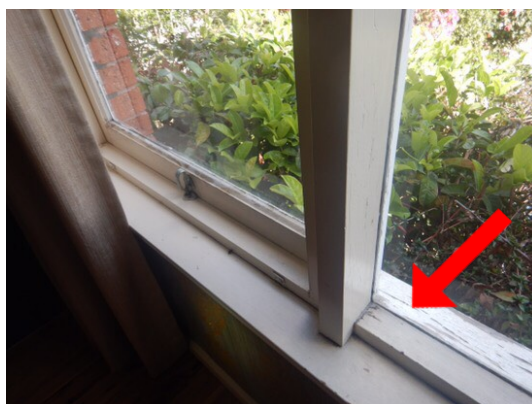
### Defects 3.1

Building: Main Building  
Location: All Areas  
Finding: Window - Wood rot  
Information: Wood rot was found to be affecting this window.

Repair of affected window frames may be a necessary step in protecting surrounding building elements from such deterioration. Remedial works should be performed by a qualified carpenter to prevent any further damage.

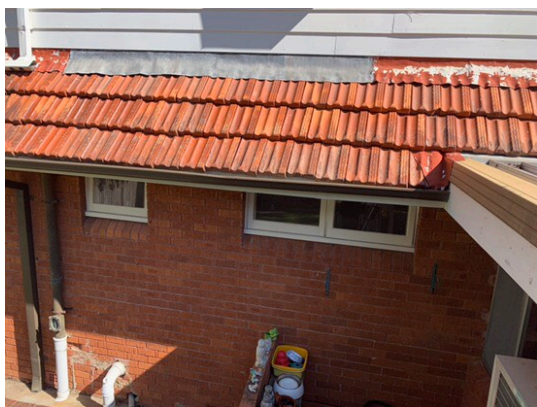
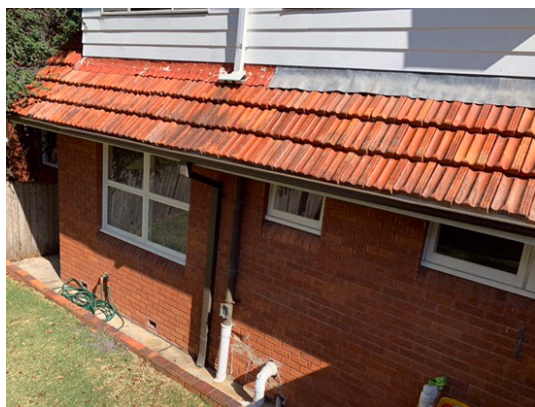
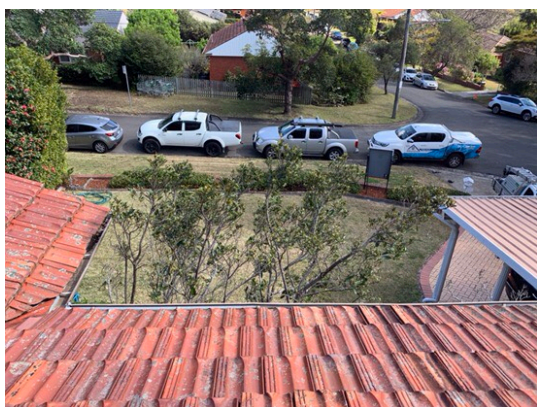
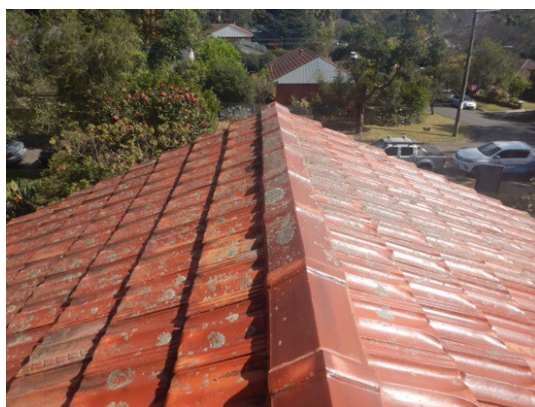
## Defects 3.11

Building: Main Building

Location: Roof Exterior

Finding: Roof tiles - Weathered

Information: Upon inspection of the exterior roofing, the majority of roof tiles were considered to be in a fair condition. While weathering of the tiles is consistent with the age of the property, maintenance works maybe required.

Consultation with a roofing contractor is advised to gain advice on cost of any remedial works that may be required in the short to medium term. Remedial works are likely to increase the longevity of the exterior roofing structure.

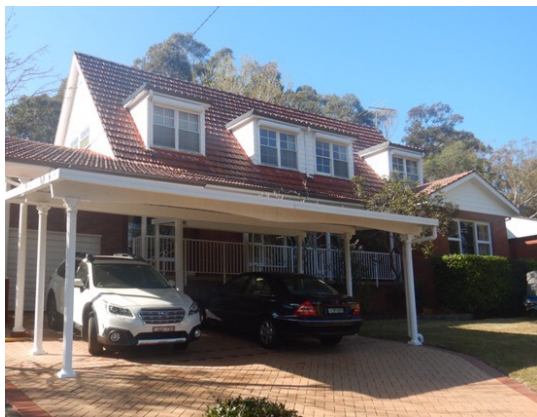
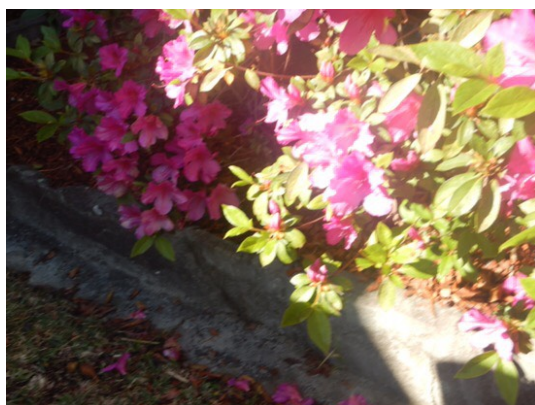
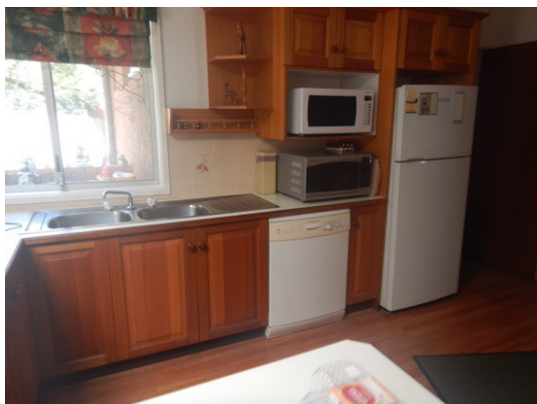
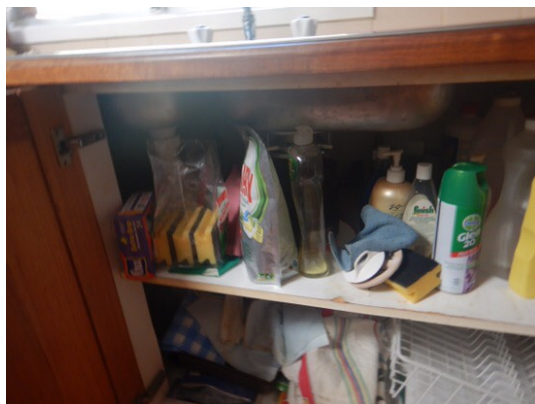
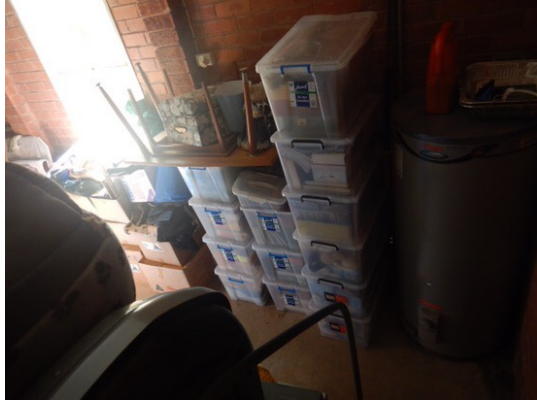
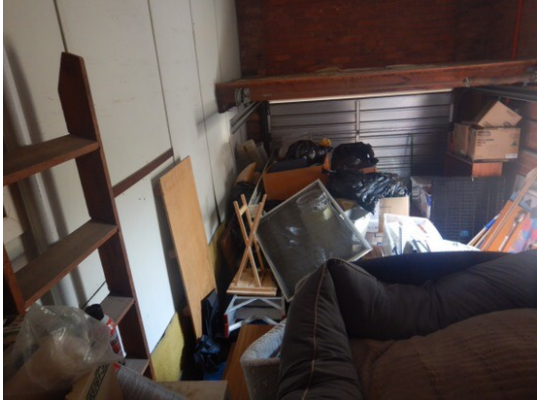
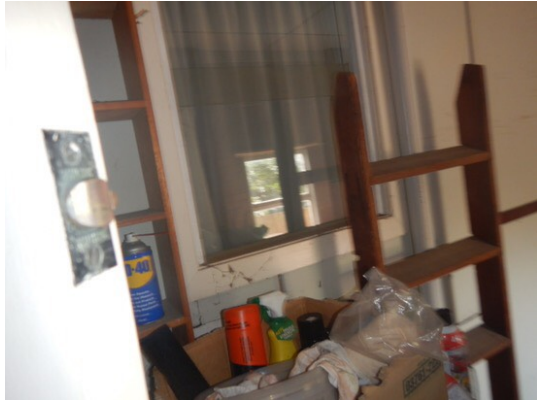
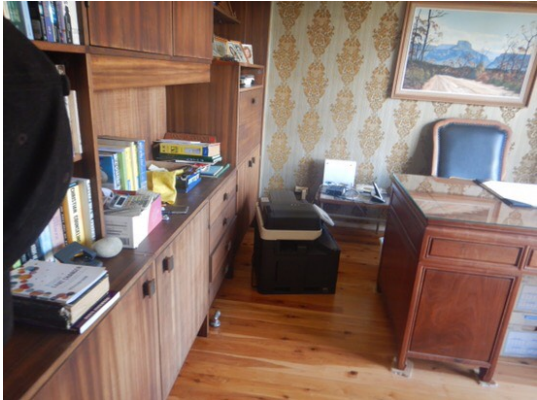
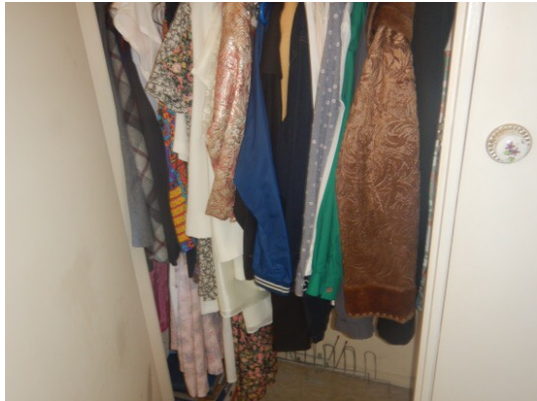
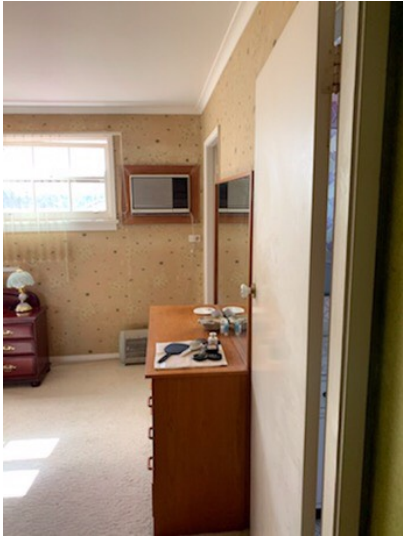
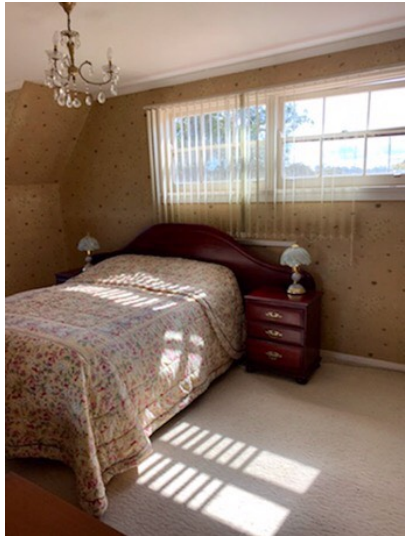
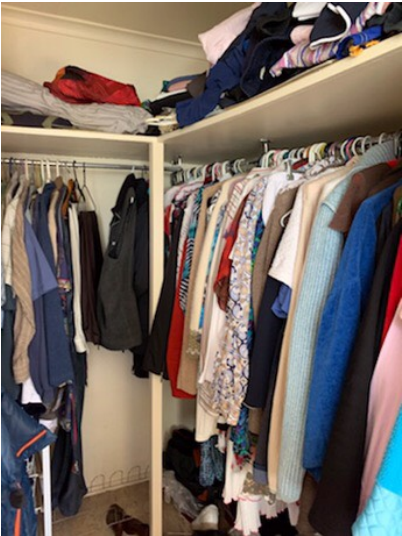
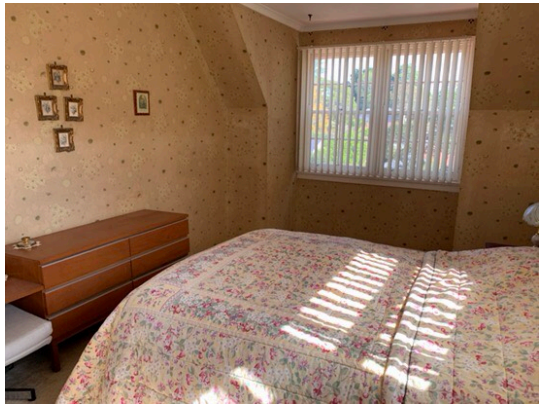
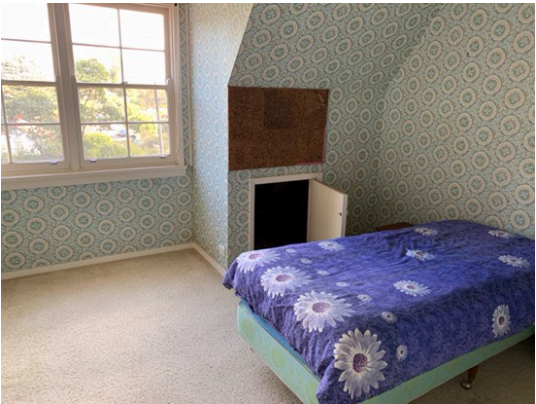
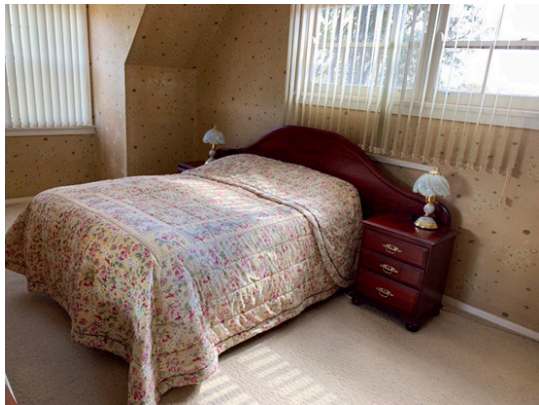
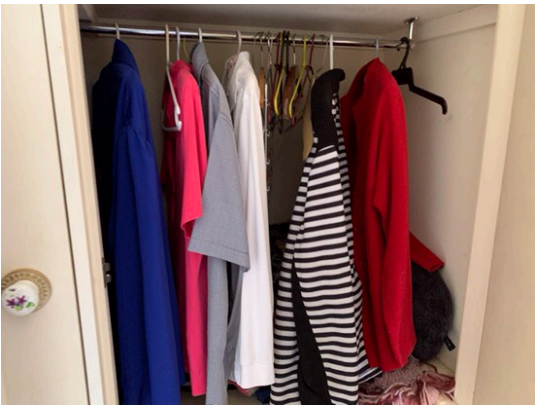
Additional Photos - Obstructions and Limitations

These photographs are an indication of the obstructions and limitations which impeded full inspection of the property at the time of inspection. These obstructions can hide an array of defects and should be removed to allow full inspection to be carried out. A re-inspection is recommended once the areas are made accessible.

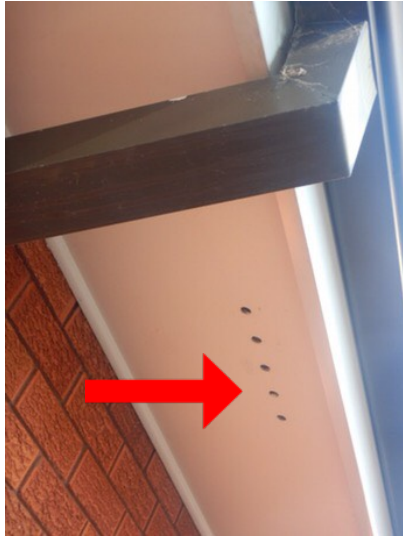
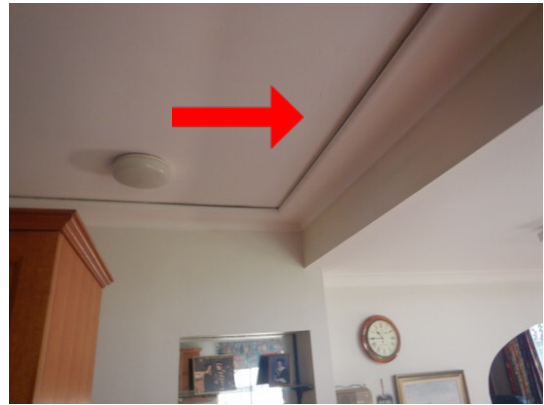
Building: Main Building  
Location: All Areas  
Finding: Asbestos - Suspected ACM Identified on Site  
Information: Reporting on Asbestos is outside the Scope of this Report. This suspected defect is highlighted as a caution only. We suspect, based on our experience in the building industry, that there is a higher risk of the identified building element containing asbestos.

As Asbestos Reporting is outside the scope of this report, we advise that you consider a separate Asbestos Inspection and Condition Audit, which can include the taking of samples for definitive confirmation of the presence of Asbestos.

In the interim, the client is advised to act with caution, especially when considering any damage to building materials general wear and tear renovations extensions demolition and general maintenance activities due to the suspected presence of Asbestos.
