Timber Pest Inspection Report

Inspection Date: Thu, 6 Oct 2022

Property Address: 7 Trigalana Pl, Frenchs Forest NSW 2086,
Australia

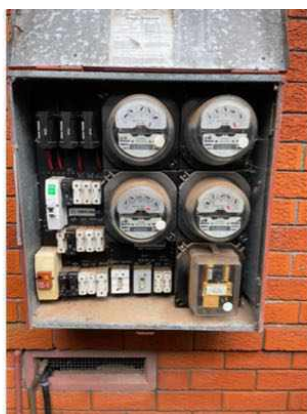
Termite and Timber Pest 1.01

Building:	Building 1
Location:	Yard - Side
Finding:	Termite durable notice not present
Information:	The application of a post-construction chemical termite barrier is highly recommended for all properties. Such barriers are highly effective in preventing termite attack on any timber building elements throughout the property.

A durable notice has been placed in the switchboard unit to indicate current termite barriers. At the time of inspection, it appeared as though there is only a physical termite management system has been installed.

The client may consider gaining further advice from a pest controller as to the costs and procedures involved with this application. It is recommended that obtaining such advice be a short-term priority.

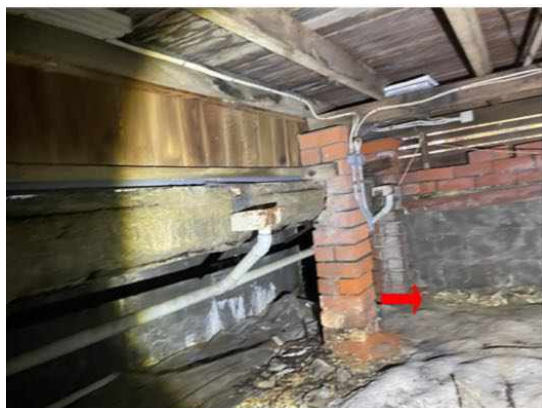
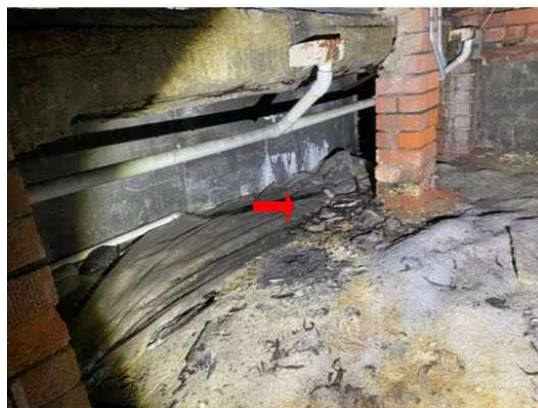
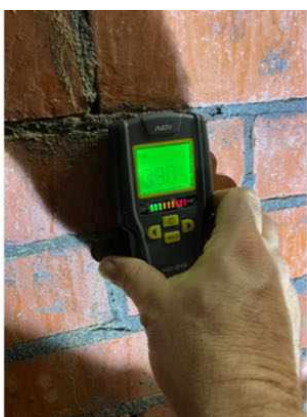
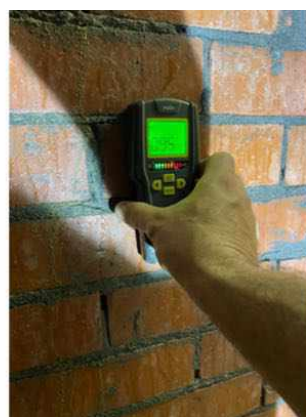
Termite and Timber Pest 1.02

Building:	Building 1
Location:	Subfloor
Finding:	Evidence of excessive moisture was present at the time of inspection
Information:	Excessive moisture can attract termites and produce conditions that promote termite attack fungal growth and wood decay.

Excessive moisture is generally caused by deteriorated inadequate or missing roof drainage leaking plumbing pipes or fixtures poorly plumbed HWS overflows or condenser units and poor site drainage.

It is highly recommended that all plumbing and drainage fixtures and fittings be

maintained regularly in order to prevent excessive moisture being present in the external / internal property.

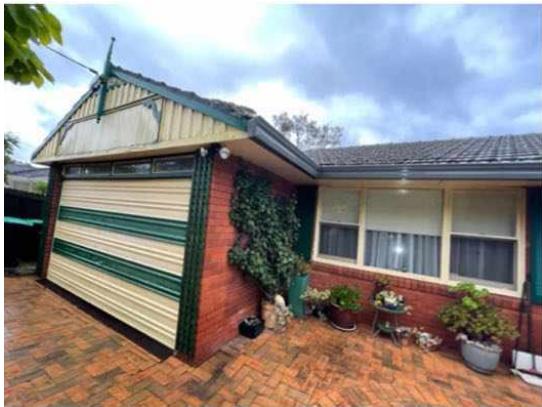
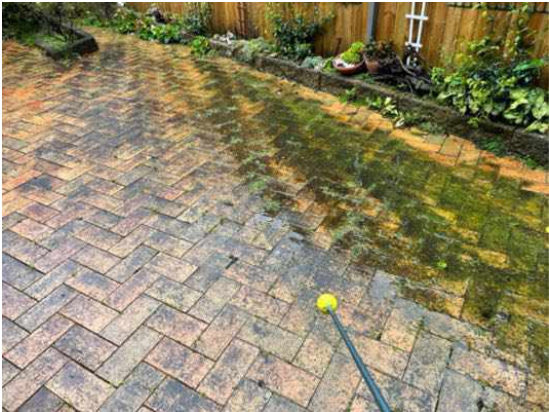
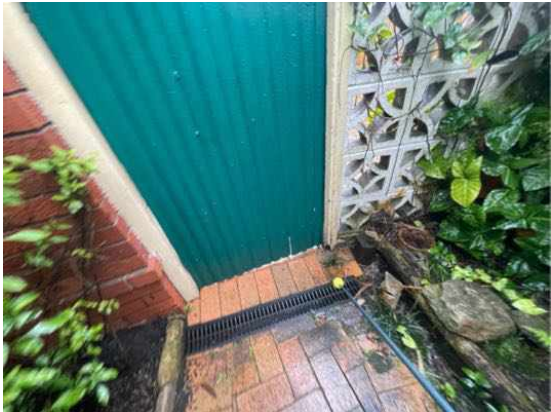
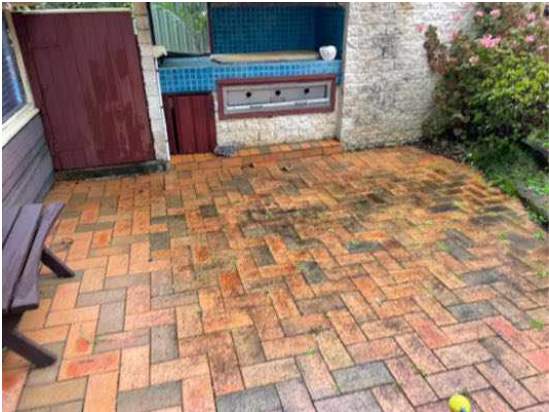
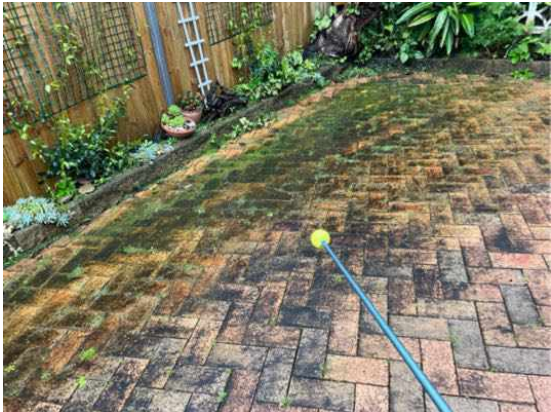
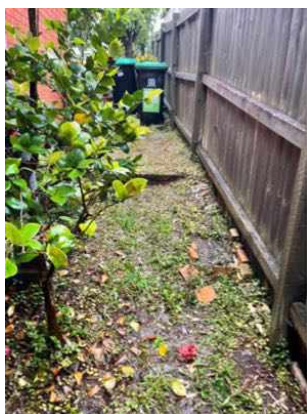
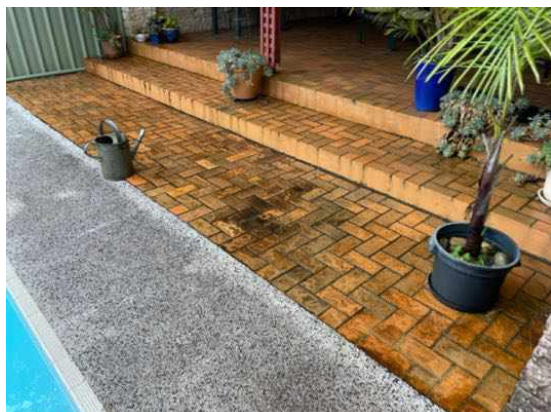
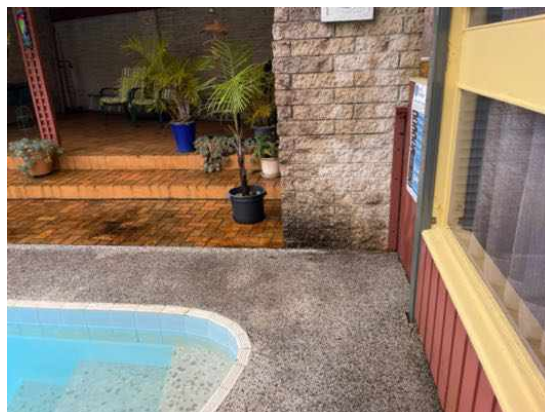
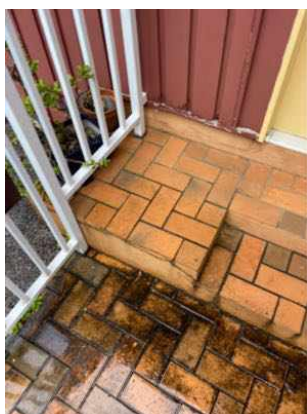
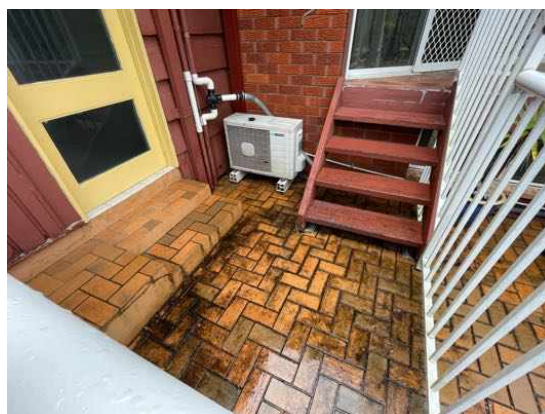
Termite and Timber Pest 1.03

Building:	Building 1
Location:	All External Areas
Finding:	Evidence of excessive moisture was present at the time of inspection
Information:	Excessive moisture can attract termites and produce conditions that promote termite attack fungal growth and wood decay.

Excessive moisture is generally caused by deteriorated inadequate or missing roof drainage leaking plumbing pipes or fixtures poorly plumbed HWS overflows or condenser units and poor site drainage.

It is highly recommended that all plumbing and drainage fixtures and fittings be maintained regularly in order to prevent excessive moisture being present in the external / internal property.

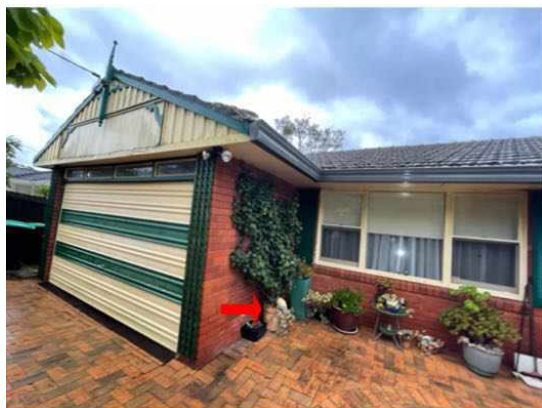
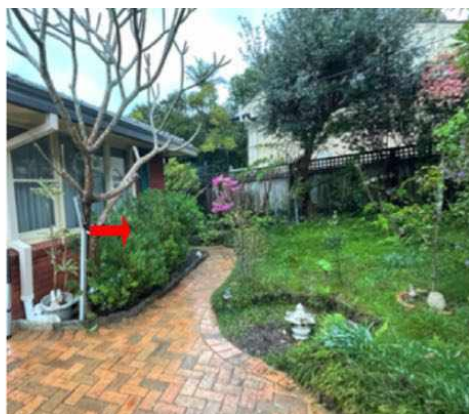
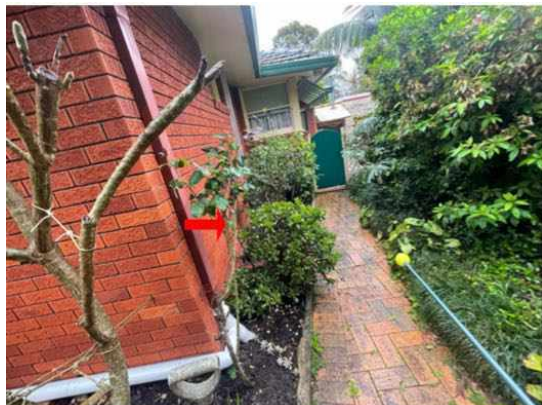
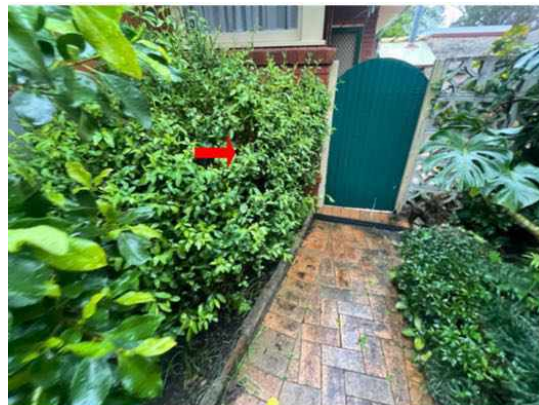
Termite and Timber Pest 1.04

Building:	Building 1
Location:	All External Areas
Finding:	Garden Beds - Conditions Conducive to Termites
Information:	Garden beds were found to be evident in the garden area. These garden beds can include untreated timber, and with a combination of moisture from watering hosing can make conditions conducive to termite activity and termite ingress.

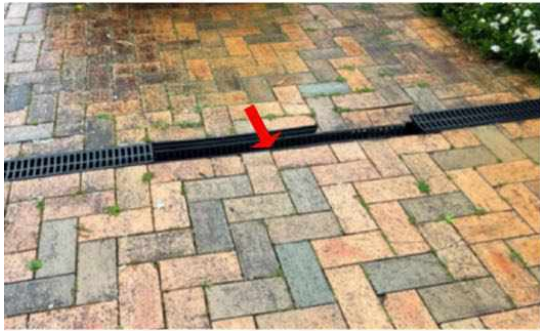
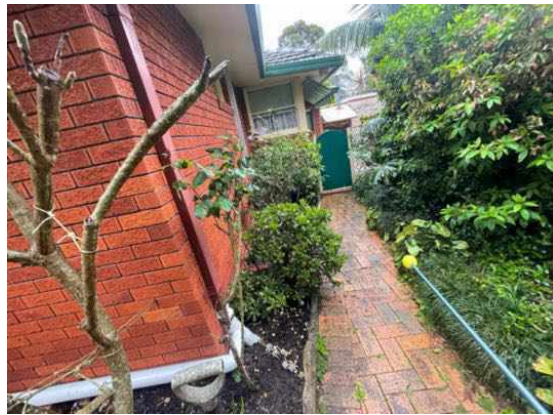
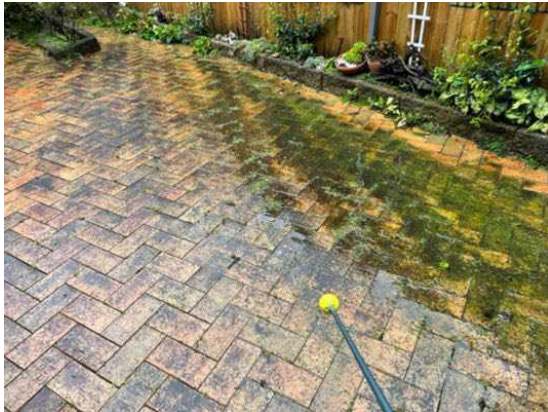
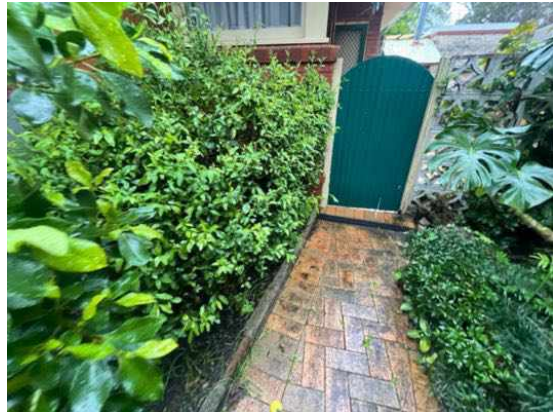
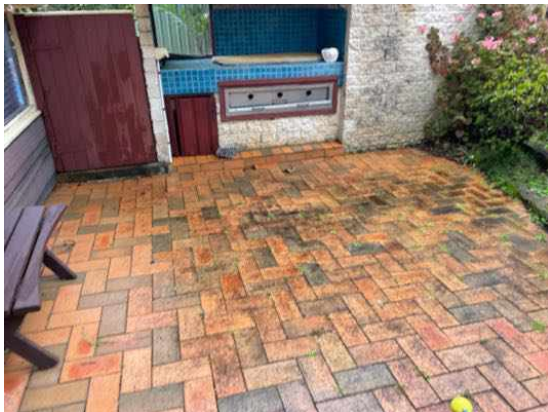
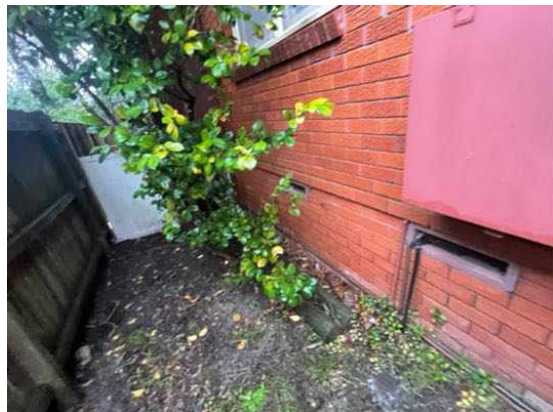
Termite and Timber Pest 1.05

Building:	Building 1
Location:	All External Areas
Finding:	Site drainage - suspected Inadequate
Information:	The site drainage in this area was found to be suspected inadequate at the time of inspection, creating potential for subsequent water damage to associated building elements.

It is important that water does not lie against the base of walls; surrounding paths and ground levels should be sloped to drain water away from walls. Downpipes should not discharge stormwater onto lower walls or plinths. Stormwater should be carried away by large, regularly cleaned drains. Ground levels may need to be lowered to expose a buried DPC.

Where site drainage is inadequate, installation of an Agricultural (Aggie) Drain may be required. A qualified plumber should be appointed to further inspect the property and perform any remedial works as necessary. Water damage and secondary defects are likely to occur if left unmanaged.

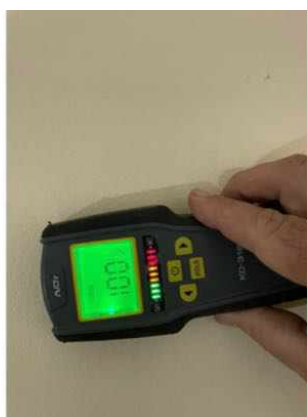
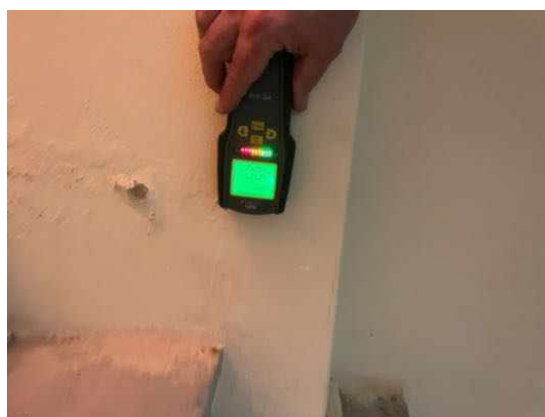
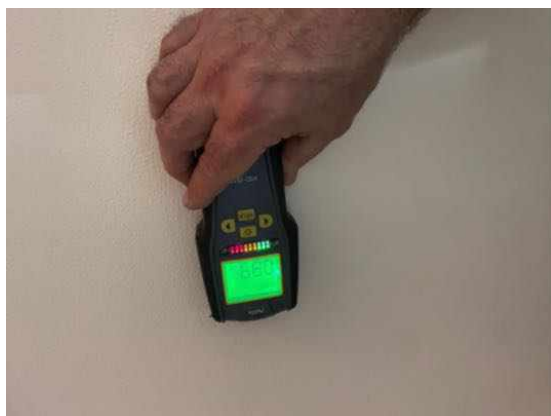
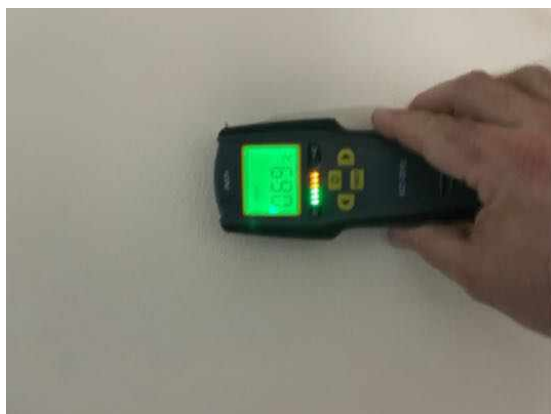
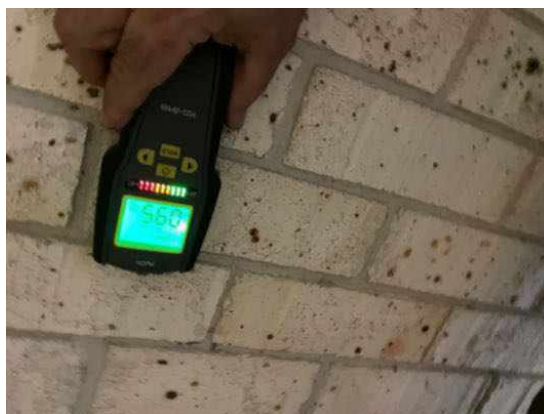
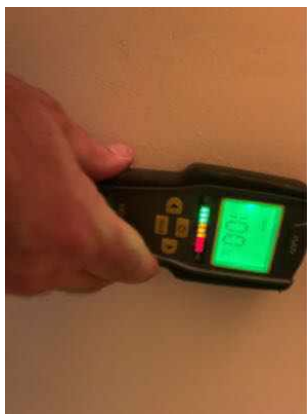
Termite and Timber Pest 1.06

Building: Building 1
Location: Basement
Finding: Evidence of excessive moisture was present at the time of inspection
Information: Excessive moisture can attract termites and produce conditions that promote termite attack fungal growth and wood decay.

Excessive moisture is generally caused by deteriorated inadequate or missing roof drainage leaking plumbing pipes or fixtures poorly plumbed HWS overflows or condenser units and poor site drainage.

It is highly recommended that all plumbing and drainage fixtures and fittings be maintained regularly in order to prevent excessive moisture being present in the external / internal property.

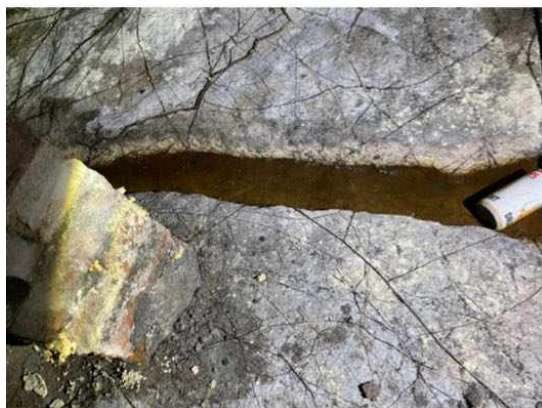
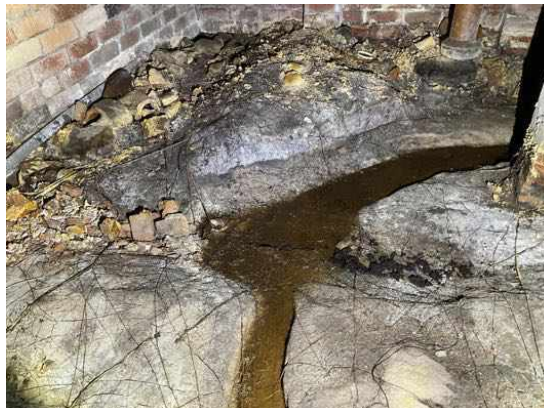
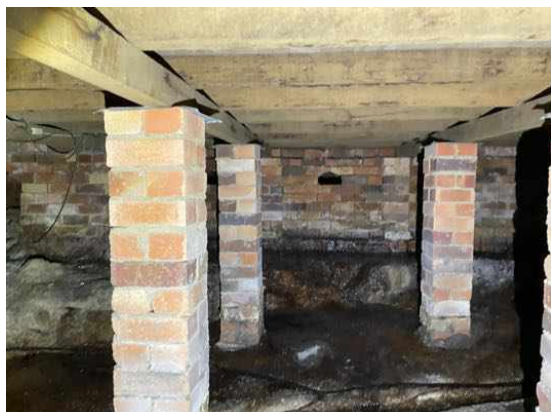
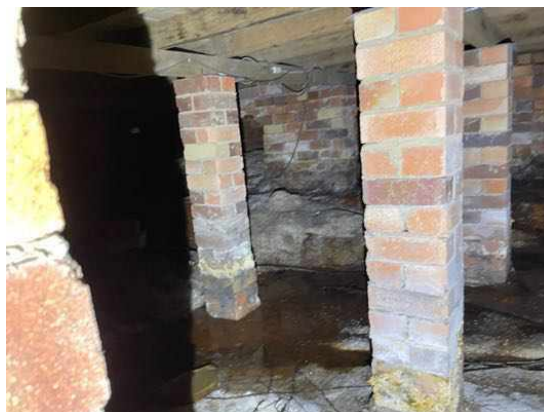
Termite and Timber Pest 1.07

Building:	Building 1
Location:	Subfloor
Finding:	Site drainage - suspected Inadequate
Information:	The site drainage in this area was found to be inadequate at the time of inspection, creating potential for subsequent water damage to associated building elements.

It is important that water does not lie against the base of walls; surrounding paths and ground levels should be sloped to drain water away from walls. Downpipes should not discharge stormwater onto lower walls or plinths. Stormwater should be carried away by large, regularly cleaned drains. Ground levels may need to be lowered to expose a buried DPC.

Where site drainage is inadequate, installation of an Agricultural (Aggie) Drain may be required. A qualified plumber should be appointed to further inspect the property and perform any remedial works as necessary. Water damage and secondary defects are likely to occur if left unmanaged.

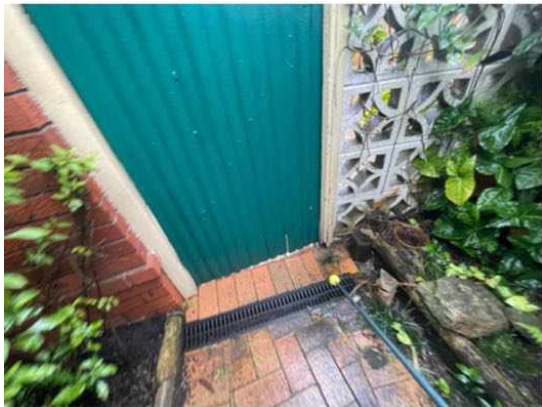
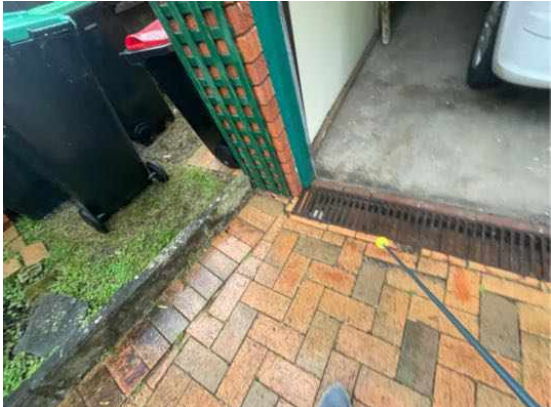
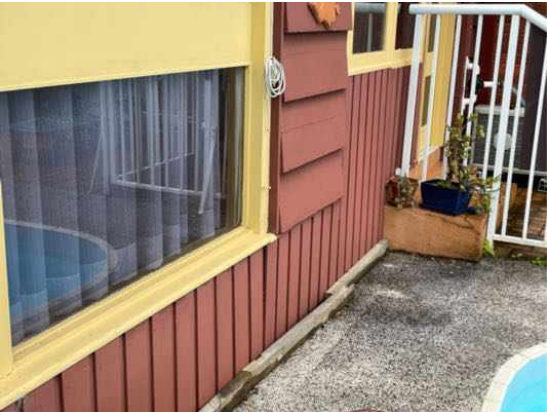
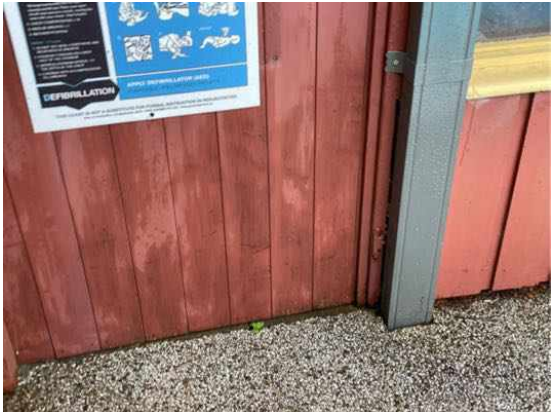
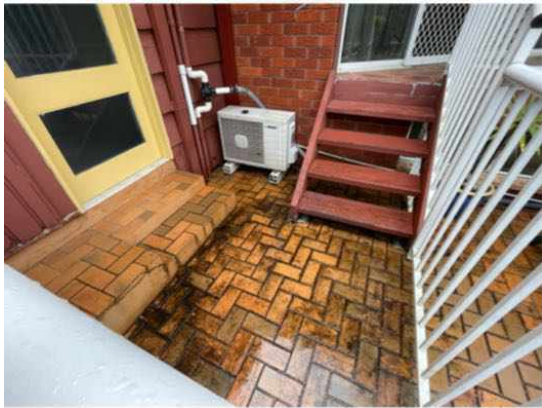
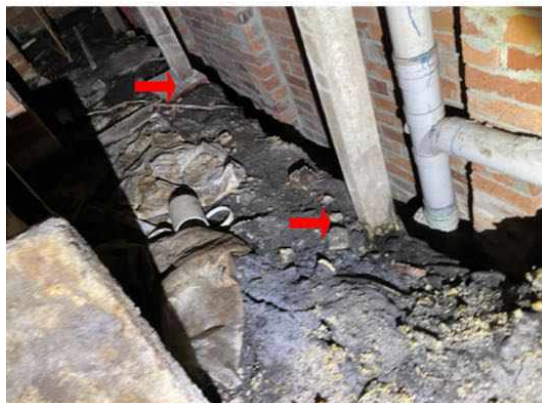
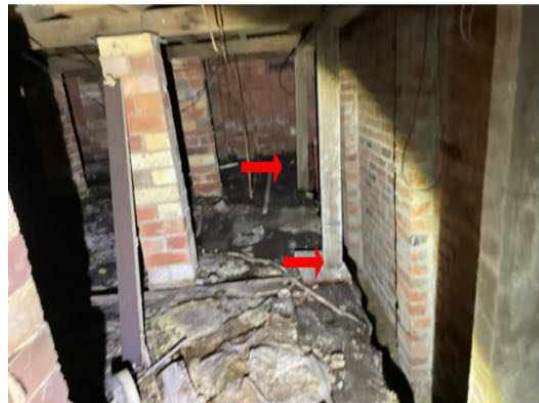
Termite and Timber Pest 1.08

Building:	Building 1
Location:	All Areas
Finding:	Building materials in direct ground contact - conducive to termites
Information:	Where timber elements are in direct contact with the ground and consequently moisture or dampness they become conducive to termite activity.

Whether timber is used as a building element part of a fencing structure or stored as an unused item they can provide an environment that is attractive to termite infestation.

When met with excessive moisture timber begins to decay and develop wood rot. Any timbers that are in direct contact with external grounds especially if left untreated or non- durable also provide ingress for subterranean termites into that particular element.

The removal of any such materials that may be conducive to termite activity should be removed as soon as possible to minimise the risk of termite attack.

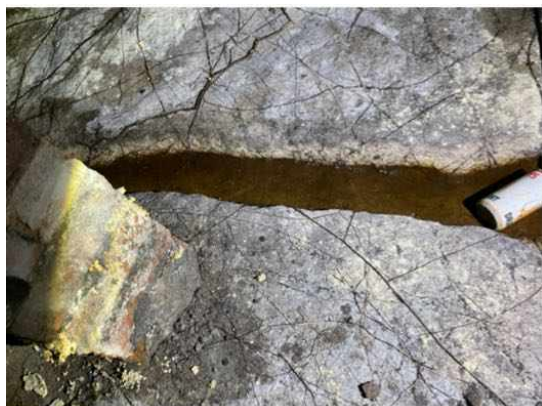
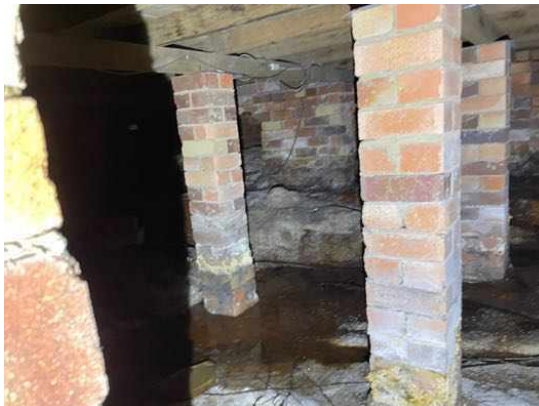
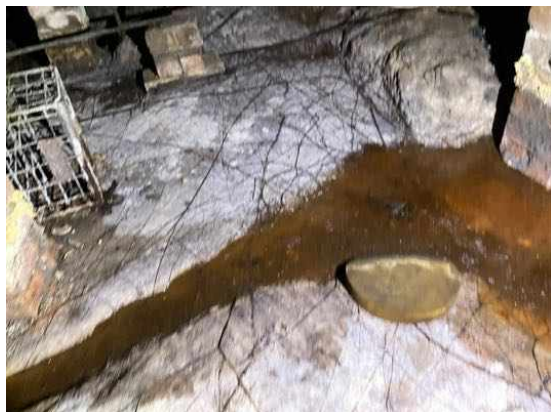
Termite and Timber Pest 1.09

Building: Building 1
 Location: Subfloor
 Finding: Water pooling - subfloor
 Information: Water appears to be pooling in the subfloor. It is suspected that this is a result of poor site drainage but may also be due to excessive moisture from an unidentified source.

Where water is pooling in the subfloor water damage to the external wall cladding is imminent.

Such water pooling also increases the risk of termite activity and the development of fungal decay in the area.

Consult a Plumber regarding the cost of potential site drainage rectification works.

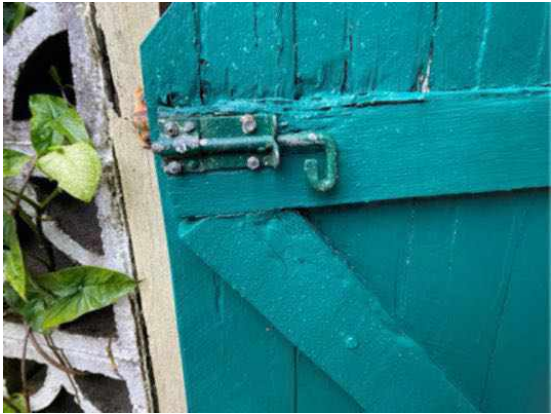
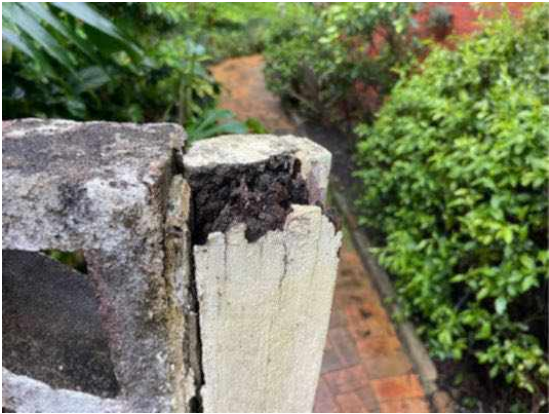
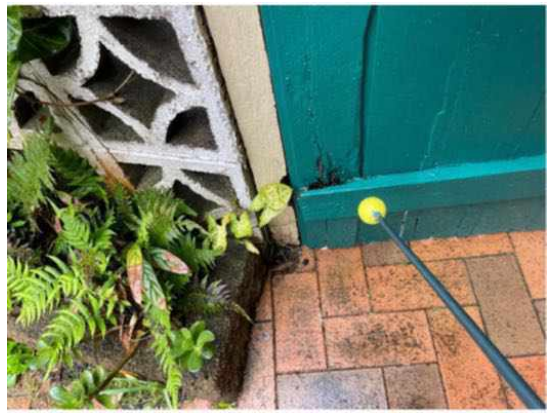
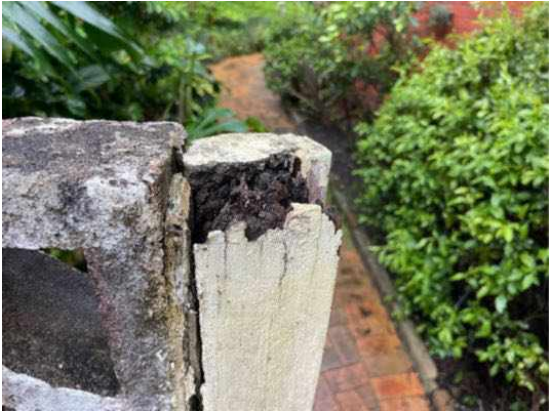
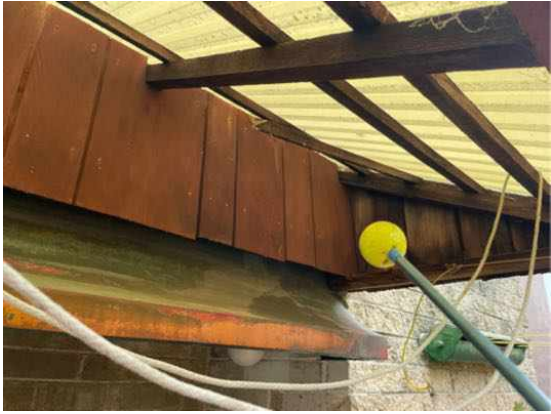
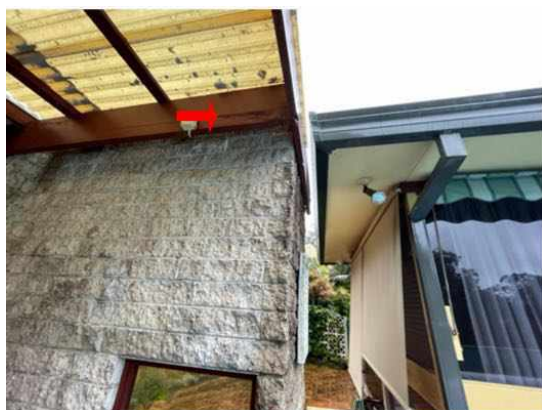
Termite and Timber Pest 7.01

Building:	Building 1
Location:	All External Areas
Finding:	Wood rot
Information:	This building element shows evidence of wood rot. Wood rot, also known as Fungal Decay, occurs when timbers and other cellulose building materials are exposed to damp conditions on an ongoing basis. This could be the result of exposure to weathering over a prolonged period of time, or the attraction of excessive moisture from other abutting building materials. Contributing factors also include poor air ventilation in the area.

Early intervention and regular maintenance, particularly of exterior timbers, will prolong the useful life of these building elements. Prior to any works being performed, the cause of the moisture that has created the visible wood rot should be identified and addressed in a suitable manner.

A carpenter may also be required to replace affected building materials.

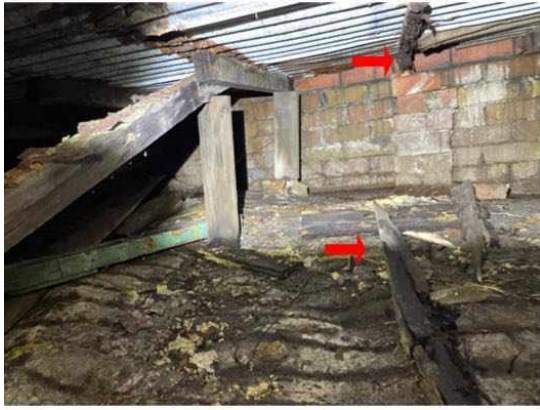
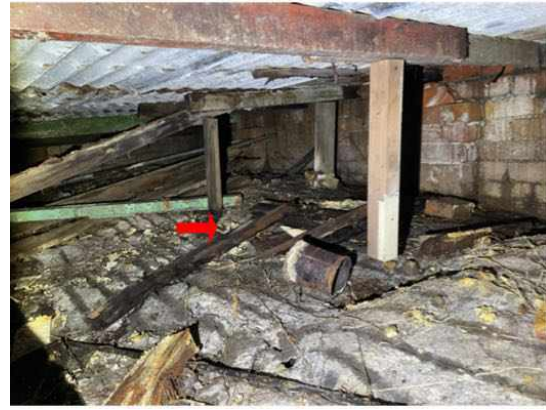
Termite and Timber Pest 7.02

Building: Building 1

Location: Subfloor

Finding: Wood rot

Information: This building element shows evidence of wood rot. Wood rot, also known as Fungal Decay, occurs when timbers and other cellulose building materials are exposed to damp conditions on an ongoing basis. This could be the result of exposure to weathering over a prolonged period of time, or the attraction of excessive moisture from other abutting building materials. Contributing factors also include poor air ventilation in the area.

Wood rot is often associated with general damp problems and is evidenced by a 'musty' smell or mould and mildew occurring on surfaces. If left unmanaged, damp conditions can lead to further health problems and the decay of timbers will continue.

Early intervention and regular maintenance, particularly of exterior timbers, will prolong the useful life of these building elements. Prior to any works being performed, the cause of the moisture that has created the visible wood rot should be identified and addressed in a suitable manner. Replacement of affected timbers may then be a necessary step in protecting surrounding building elements from such deterioration.

A qualified plumber may be appointed to assess the cause of excessive moisture and to provide advice on any remedial works as required. A qualified carpenter or registered builder may also be required to replace affected building materials.

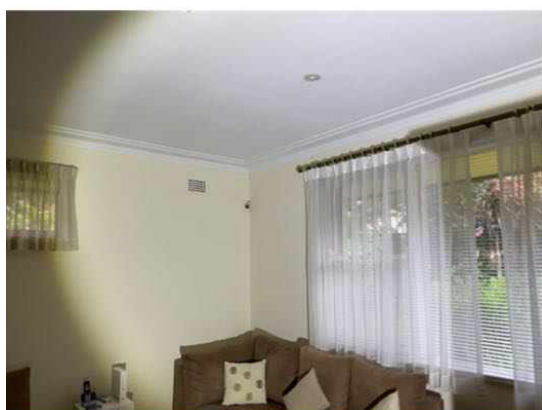
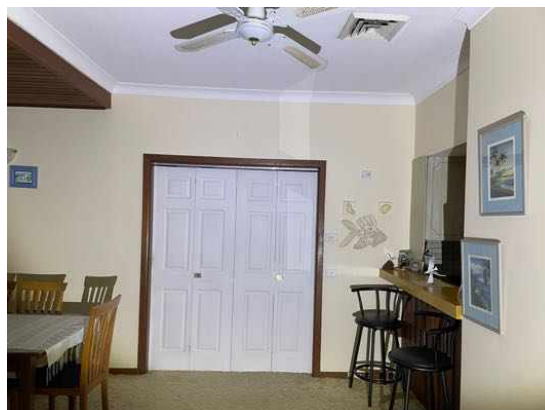
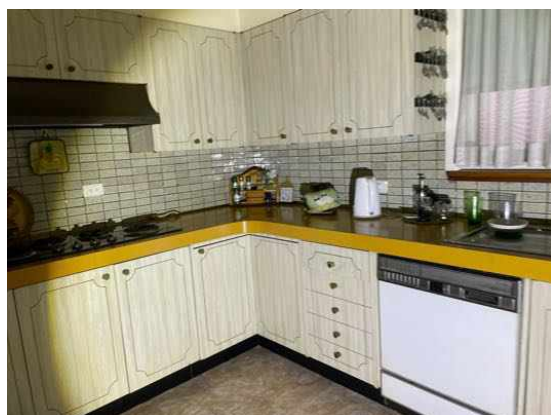
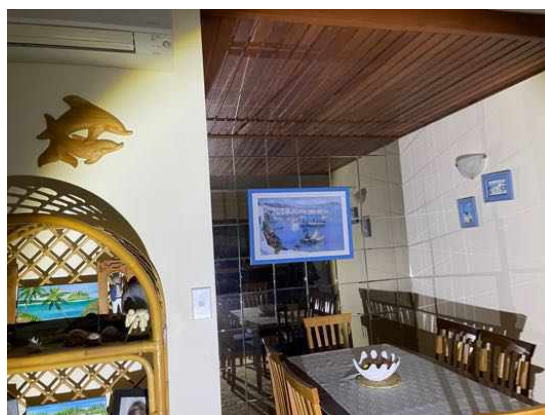
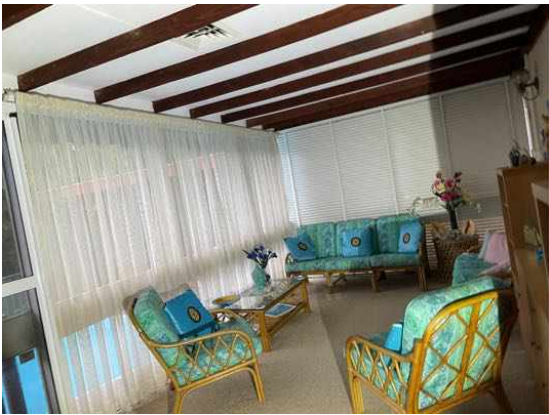
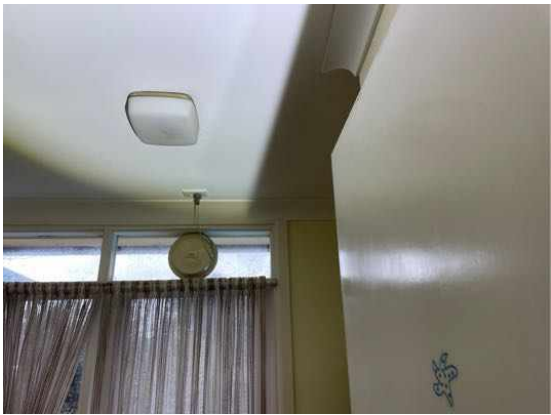
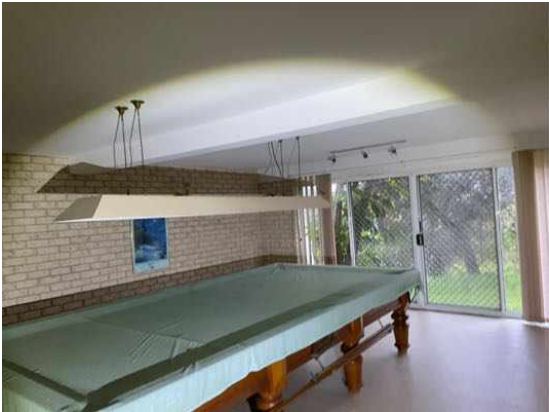
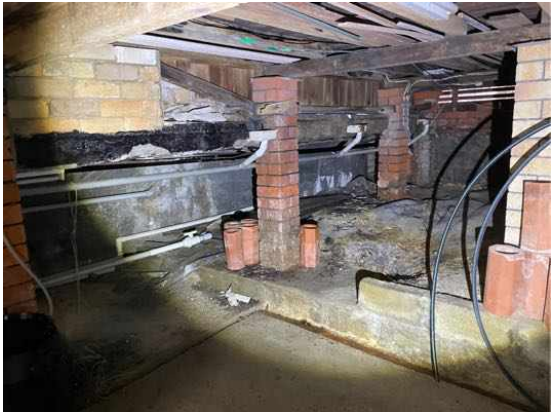
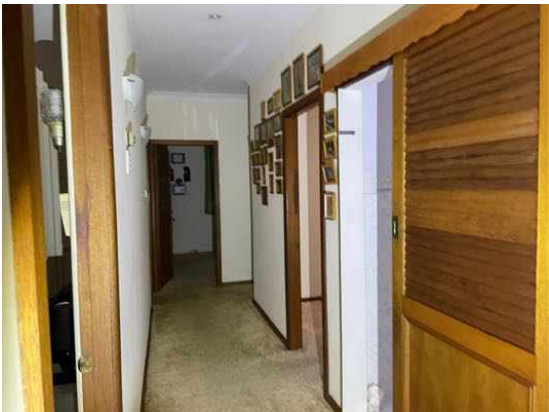
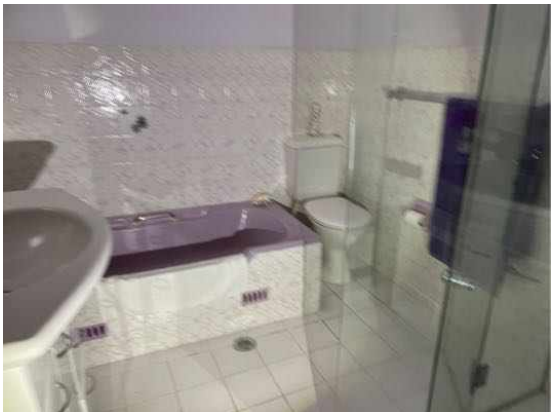
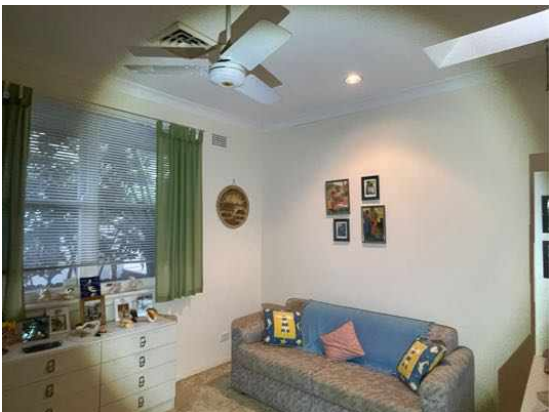
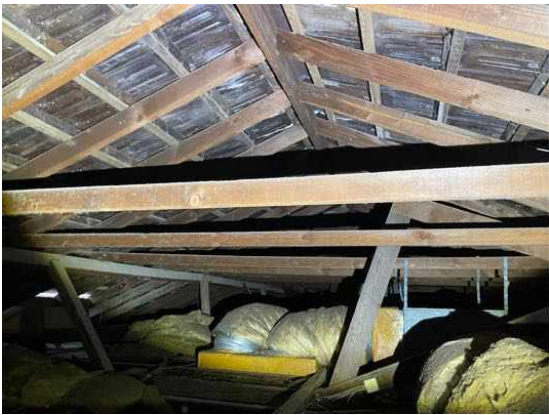
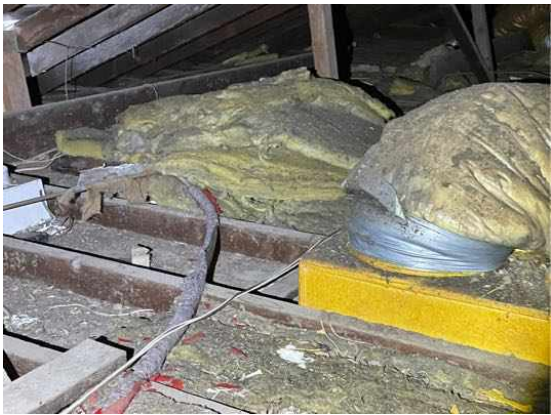
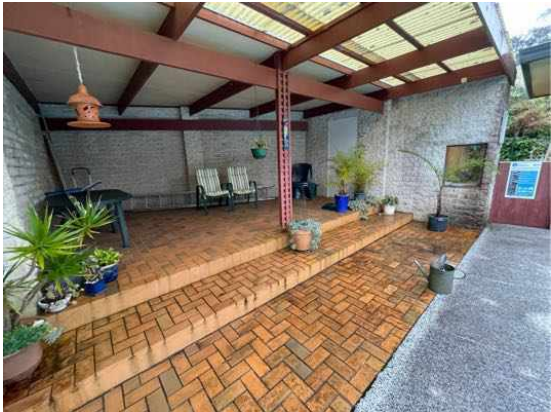
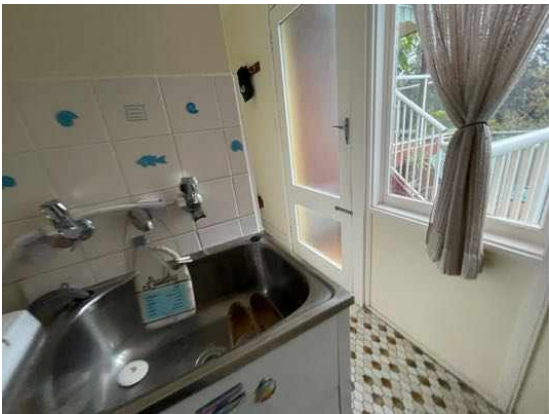
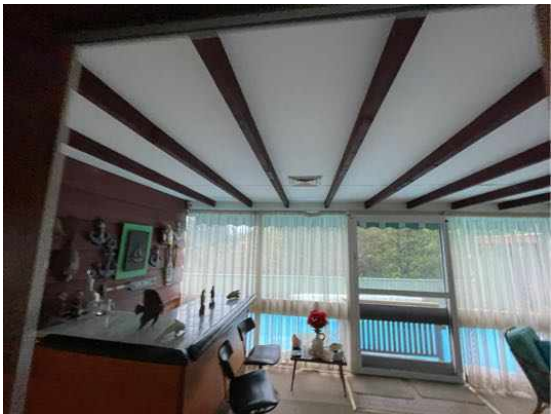
Noted Item

Building: Building 1
 Location: All Areas
 Finding: Additional Photos - Obstructions and Limitations
 Information: These photographs are an indication of the obstructions and limitations which impeded full inspection of the property at the time of inspection. These obstructions can hide an array of defects and should be removed to allow full inspection to be carried out.
