## Building Inspection Report VR

Inspection Date: Thu, 15 Jun 2023

Property Address: 2 Bindo St, The Ponds NSW 2769, Australia

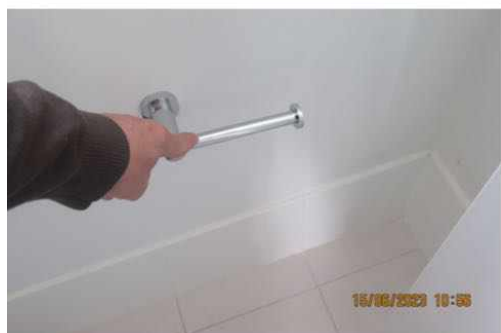
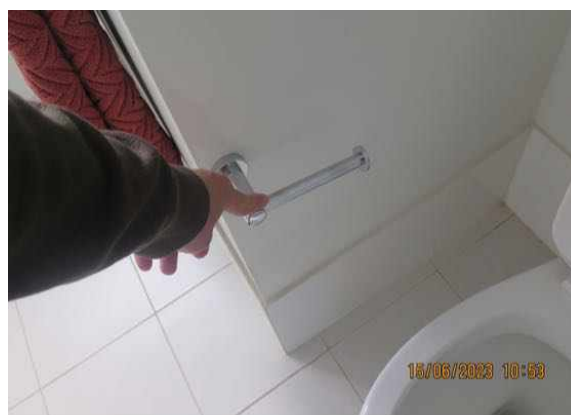
#### Defects 3.01

Building: Main Building  
 Location: All Areas  
 Finding: Fitting or fixture - Loose  
 Information: The fitting in this area is loose and requires adjustment to tighten.

If left unmanaged, the fitting may further deteriorate, causing potential for the development of other minor secondary defects.

A relevant tradesperson should be appointed to perform these rectification works at discretion of the client.

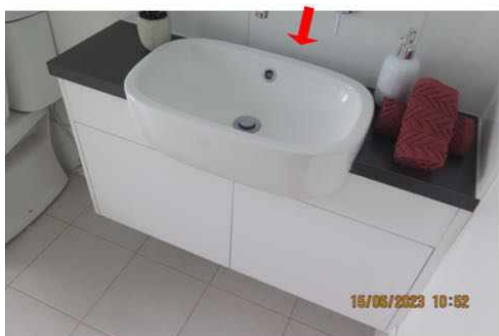
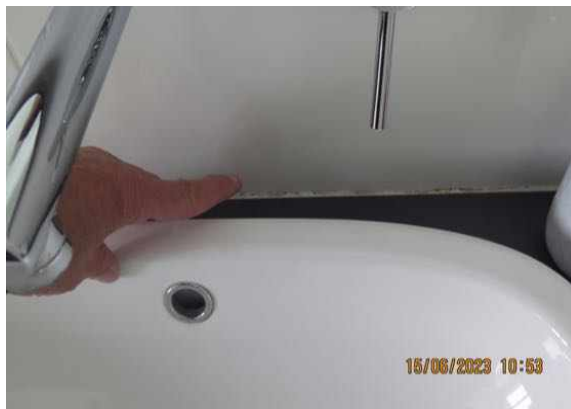
#### Defects 3.02

Building: Main Building  
 Location: Bathroom  
 Finding: Mould - Present  
 Information: Where evidence of mould growth was noted, there may be environmental, biological or health issues associated with the report. A specialist inspection by a suitably qualified environmental health inspector is warranted, where mould is extensive or where any queries regarding air quality spores or other related issues apply.

Generally, the client is advised to ensure that the general environment is free of moisture and humidity to aid in the prevention of mould formation and development. Any mould found during the inspection should be cleaned immediately by a cleaning contractor or the homeowner as applicable.

Please note that severely affected building elements may require replacement by a registered builder or qualified carpenter.

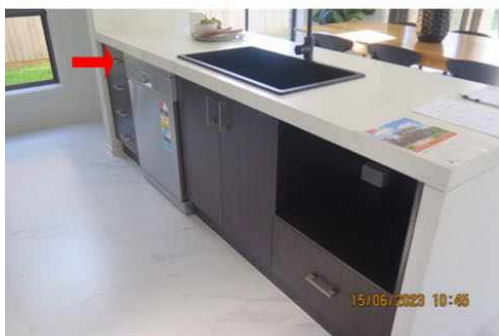
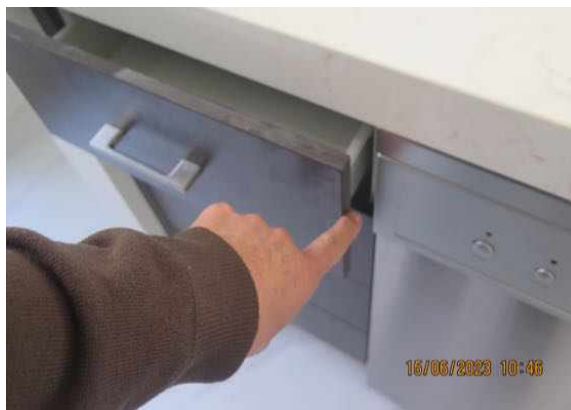
### Defects 3.03

Building: Main Building  
Location: Kitchen  
Finding: Drawer - Stiff to slide  
Information: The drawer in this area was jammed and difficult to slide along the associated tracks at the time of the inspection.

Replacement of hardware or tracks may be required, as well as minor repairs and cleaning. A registered builder or general handy person will be required to repair the affected drawer

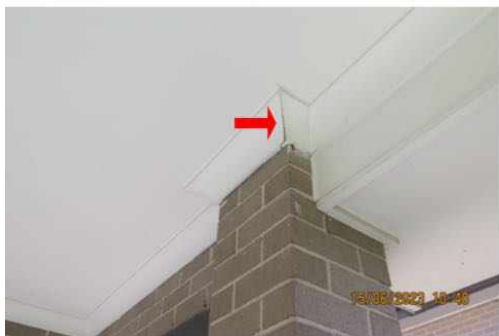
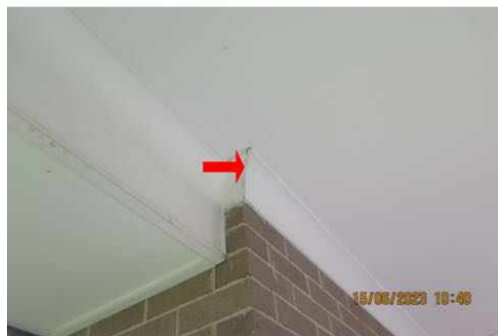
### Defects 3.04

Location: Yard - Back  
Finding: Cracking - Damage Category 2 - Noticeable (up to 5mm)  
Information: Noticeable cracks are a common occurrence as a result of many primary defects. Such causes may include age, general wear and tear, expected building movement, general expansion/contraction of building materials in different weather conditions, and/or minor failings in the installation or application of building materials.

Noticeable cracks may result in minor sticking or jamming of associated doors and windows, which require easement. However, noticeable cracks are easily filled and repaired. A plasterer can be consulted to install an expansion joint at this point to allow for this movement during different weather conditions.

Monitoring of all cracking should be conducted frequently. Always contact a building inspector should cracks widen, lengthen, or become more numerous. Additionally, your building inspector should also be contacted if associated building elements such as doors and windows become more difficult to operate over time.

Relevant tradespeople, such as carpenters, painters and plasterers, should be appointed to perform remedial works, as deemed necessary.
