## **VISUAL BUILDING & PEST INSPECTION REPORT**

Complies with Australian Standard 4349.1 & 4349.6

### Vendor Report

Inspected Property:  
7 Towarri Place Belrose

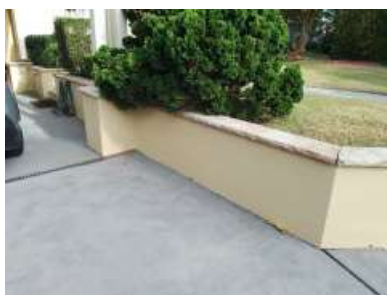
The masonry retaining walls appear in acceptable condition.

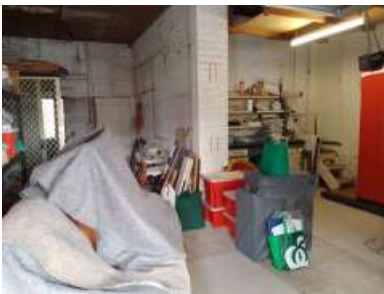
Garage.

The structure is generally in fair condition.

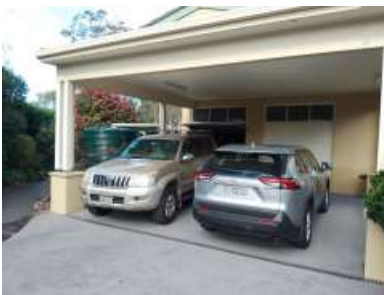
Carport.

The structure is generally in good condition.

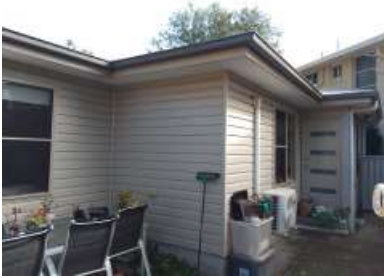
Granny flat.

The structure is generally in good condition.

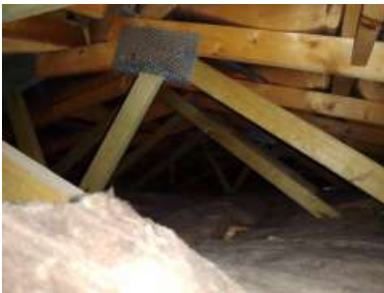
Body access into the roof void was restricted and access was not gained to any areas beyond the roof access hole.

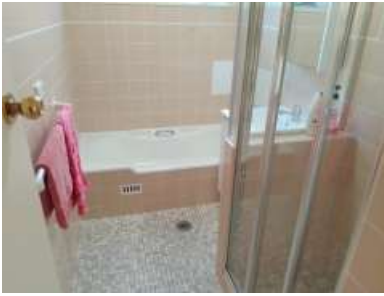
Ground floor.

The shower recess was tested and there was no visible water penetration to surrounding areas. **IMPORTANT NOTE:** This test may not reveal water leaks until the shower is put into constant use and surrounding areas monitored over a period of time.

The condition of the tiles is generally fair.

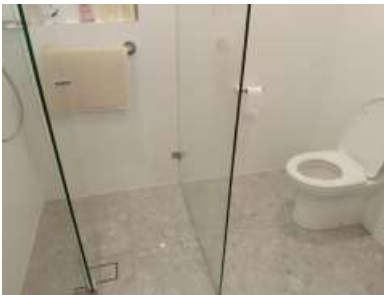
Level one.

The shower recess was tested and there was no visible water penetration to surrounding areas. **IMPORTANT NOTE:** This test may not reveal water leaks until the shower is put into constant use and surrounding areas monitored over a period of time.

The condition of the tiles is generally good.

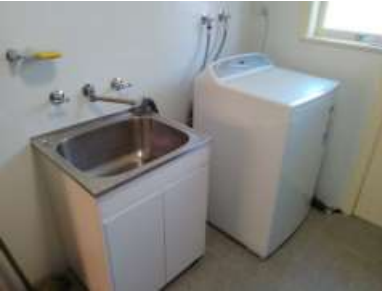
Ground floor.

The tub and taps appear serviceable. Drain appears serviceable.

The condition of the tiles is generally fair.

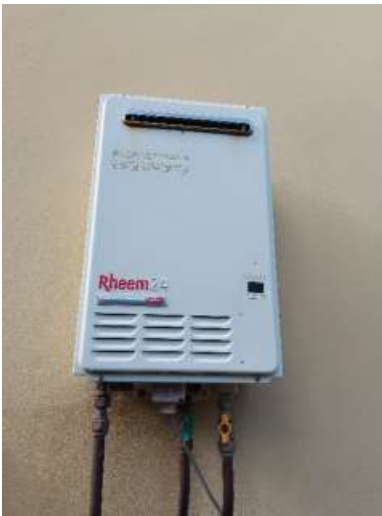
Gas hot water system: Mains pressure: Instantaneous: Located externally: The hot water system appears to be in working condition. No specific tests other than running the hot water tap were carried out. No determination has been made as to the suitability or adequacy of the hot water system in relation to capacity or otherwise.

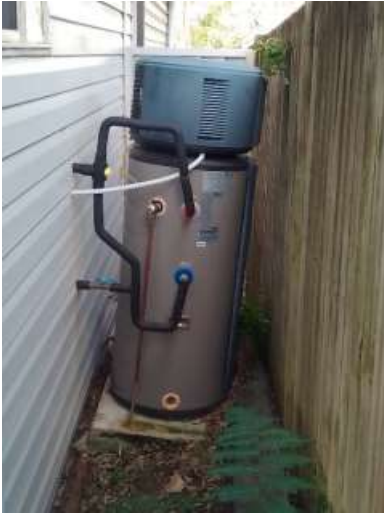
Mains electric hot water system: Mains pressure: Located externally: The hot water system appears to be in working condition. No specific tests other than running the hot water tap were carried out. No determination has been made as to the suitability or adequacy of the hot water system in relation to capacity or otherwise.
