Building and Timber Pest Inspection Report

Inspection Date: Wed, 17 Feb 2021

Property Address: 13 Bluegum Cres, Frenchs Forest NSW 2086, Australia

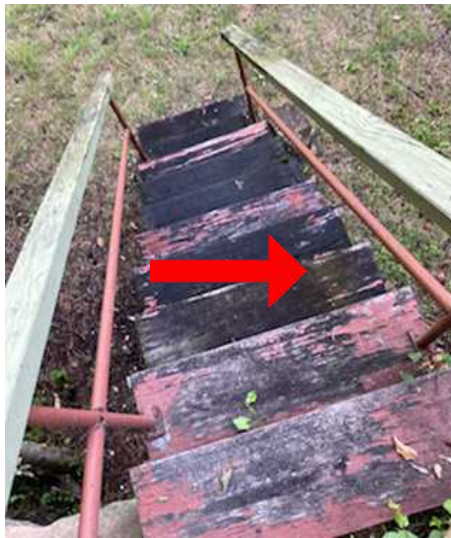
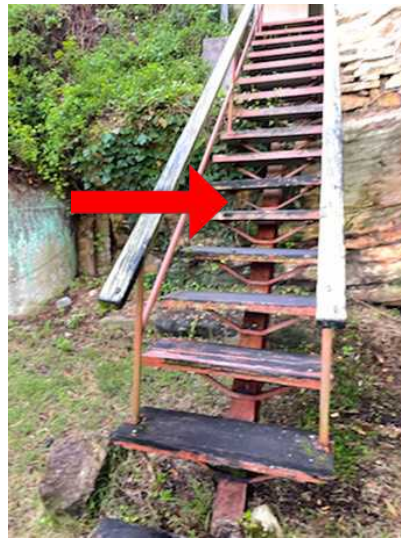
Building: Building 1
Location: Yard - Back
Finding: Stairs - Safety tread not installed
Information: No safety tread has been installed to the external stairs. The installation of anti-slip tread is important on external stairs that are exposed to weather conditions, which may make them slippery when wet.

The absence of anti-slip tread provides a slip hazard and personal injury may ensue. The installation of safety grip on the external stairs is recommended as soon as possible. Works should be completed by a general handyman at the discretion of the client.

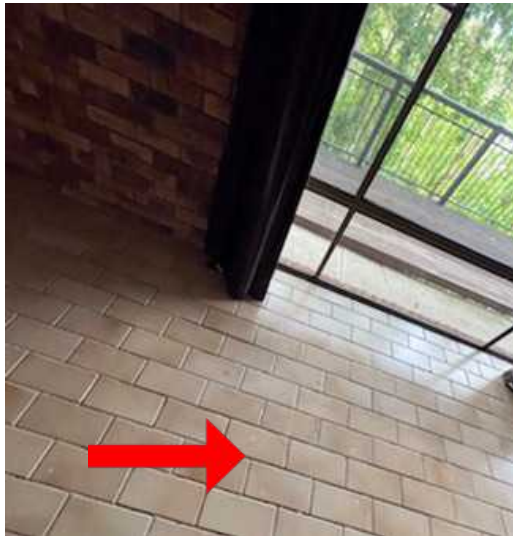
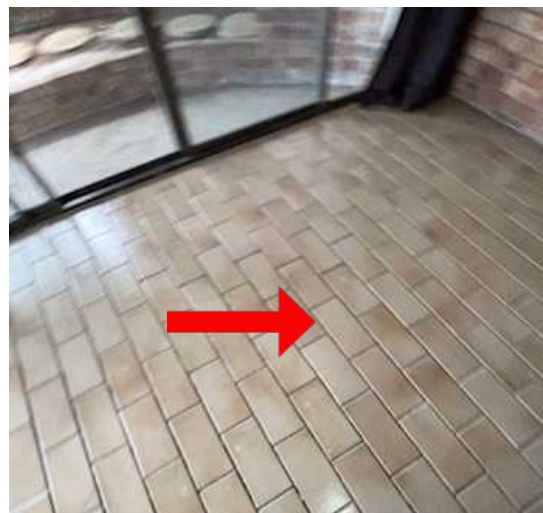
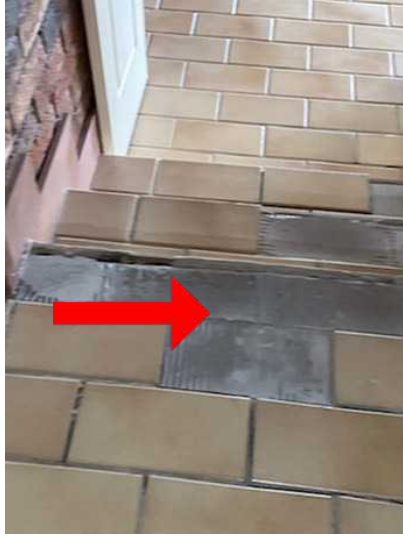
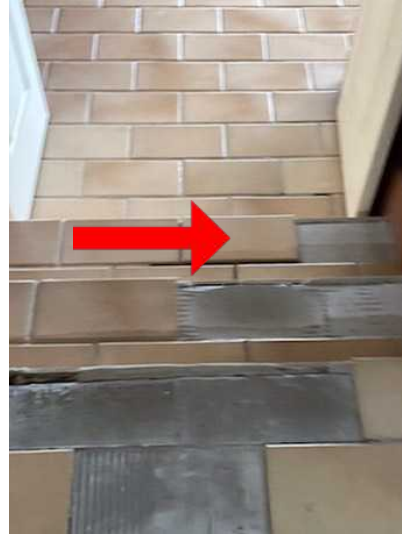
Finding 2.01

Information: Drummy tiled areas were identified at the time of inspection. The term `drummy` refers to tiles that have become detached from their fixing, despite otherwise being in relatively good condition. Such defects are generally caused by physical or moisture damage to the area. Drummy tiled areas may also be a direct result of poor workmanship during the construction process.

Tiled areas may swell and shrink with changes in air humidity if the area has sustained moisture damage. Any exposure to moisture is capable of causing tiled areas to become drummy and/or cracked over a prolonged period of time. Drummy tiled areas generally require removal and replacement of affected tiles, with adequate sealant and grouting.

Specialist trades are available for these types of services. A builder may be required to undertake works if damage is extensive or if secondary building defects have resulted. Otherwise, it is advised that a tiling contractor be appointed to perform works as necessary. Immediate action is recommended to ensure that no further damage is sustained in the affected area.

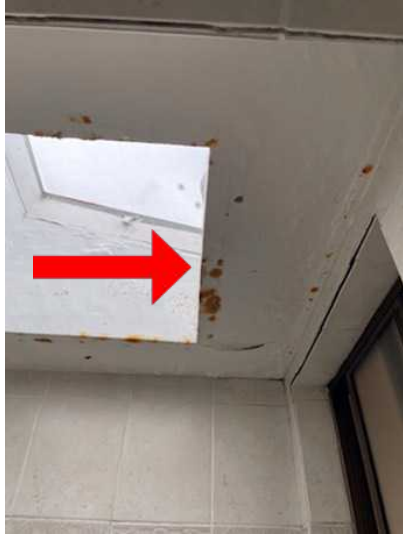
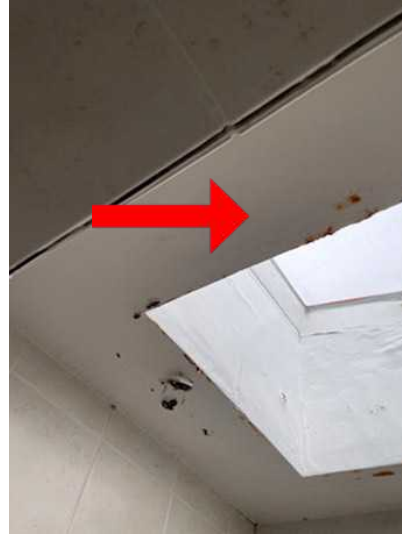
Finding 2.02

Building:	Building 1
Location:	Bathroom
Finding:	Ceiling - Water damaged
Information:	Water damage to the ceiling lining is generally an indication of excessive moisture being present in the roof void, usually via a leak to the roof covering.

Where water damage is evident to the ceiling, the primary requirement is to identify and rectify the source of the leak. A roofing plumber should be appointed as soon as possible to identify the leak and perform rectification works as necessary, ensuring the water damage is restricted.

Once the leak is repaired, consultation with relevant tradespeople, including plasterers and painters, is advised. Rectification works may include replacement of ceiling lining or minor repainting, depending on the extent of the damage.

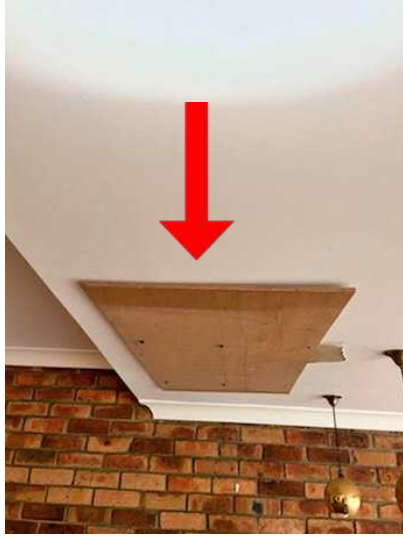
Finding 2.03

Building:	Building 1
Location:	Lounge Room
Finding:	Ceiling - Water damaged
Information:	Water damage to the ceiling lining is generally an indication of excessive moisture being present in the roof void, usually via a leak to the roof covering.

Where water damage is evident to the ceiling, the primary requirement is to identify and rectify the source of the leak. A roofing plumber should be appointed as soon as possible to identify the leak and perform rectification works as necessary, ensuring the water damage is restricted.

Once the leak is repaired, consultation with relevant tradespeople, including plasterers and painters, is advised. Rectification works may include replacement of ceiling lining or minor repainting, depending on the extent of the damage.

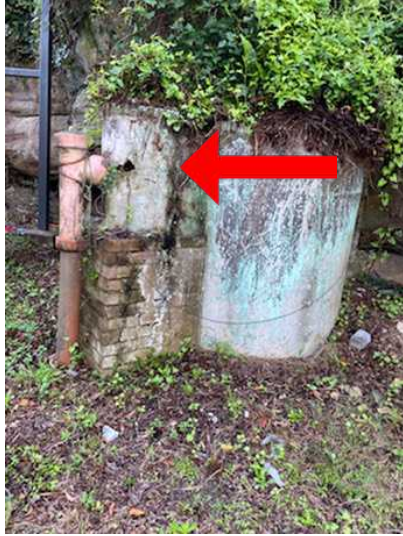
Finding 3.01

Building: Building 1
Location: Yard - Back
Finding: Building element - Damaged tank
Information: Evidence of damage was identified on this tank.

It is highly recommended that a qualified plumber be appointed to repair or remove as soon as possible.

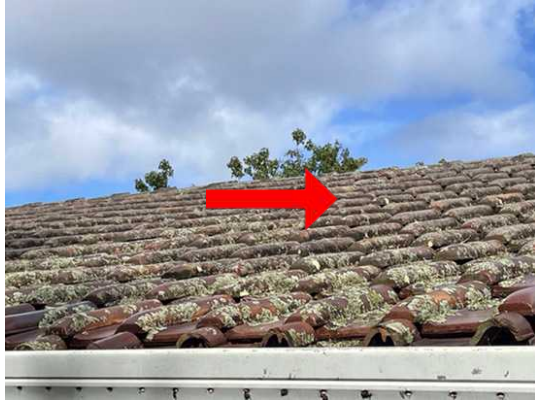
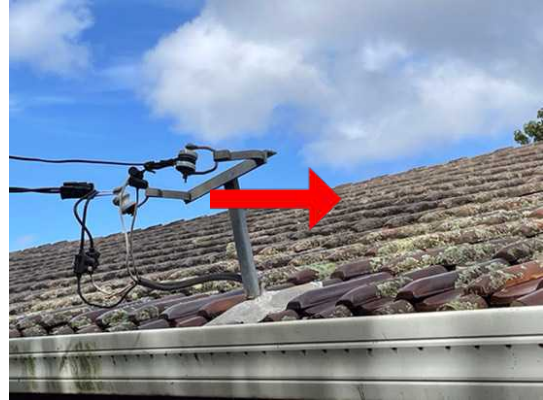
Finding 3.02

Information: Upon inspection of the exterior roofing, the majority of roof tiles were considered to be in a fair condition. While weathering of the tiles is consistent with the age of the property, maintenance works are required.

Consultation with a roofing contractor is highly advised to gain advice on cost of remedial works that may be required in the short to medium term. Remedial works are likely to increase the longevity of the exterior roofing structure.

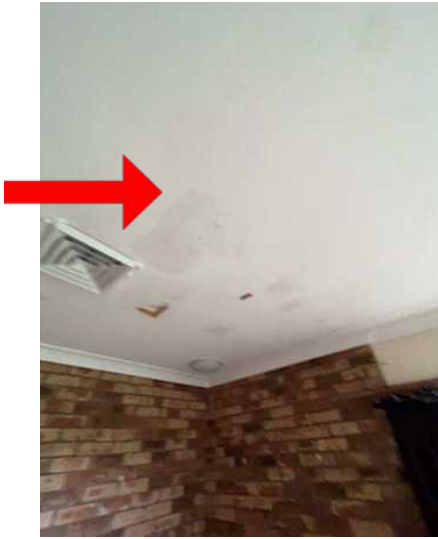
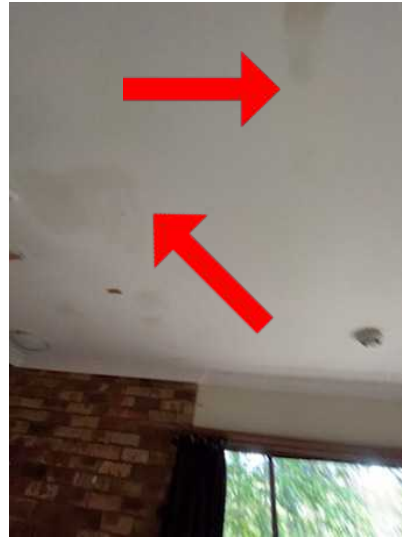
Finding 3.03

Building:	Building 1
Location:	Lounge Room > Ground Level
Finding:	Ceiling - Water stained
Information:	Water staining to ceiling linings in this area was evident at the time of inspection. Water staining indicates that surfaces have been exposed to excessive moisture over time. The minerals and other elements in the water lead to staining, which may graduate to corrosion and deterioration if left unmanaged.

While mostly an appearance defect, water staining can be indicative of more serious defects, which may be currently concealed by interior ceilings.

Where water staining is active, a licensed plumber must be consulted to identify the cause of the staining and to provide advice on any reparation works that may be required. Replacement of any damaged structures is advised.

Conversely, where water staining is old and inactive, affected building materials may be repaired or replaced at client discretion.

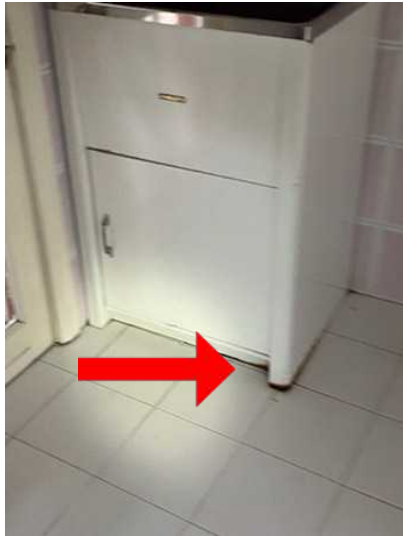
Finding 3.04

Finding: Building element - Rusted or corroded

Information: This building element shows evidence of rusting and corrosion, which is likely to have developed as a result of excessive exposure to moisture and or inadequate coatings..

Rusting and corrosion should be managed by ideally removing or limiting the affected surface from exposure to moisture.

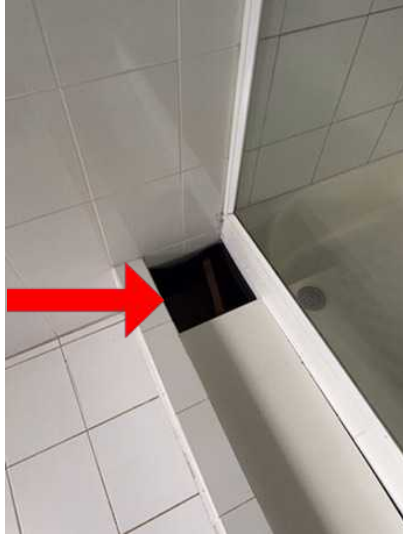
Finding 3.05

Building:	Building 1
Location:	Bathroom
Finding:	Unfinished construction
Information:	The construction in this area appears to be incomplete. The safety of the structure can therefore not be ensured and the creation of secondary defects to surrounding building elements may be likely.

A Builder should be appointed immediately to complete this construction process.

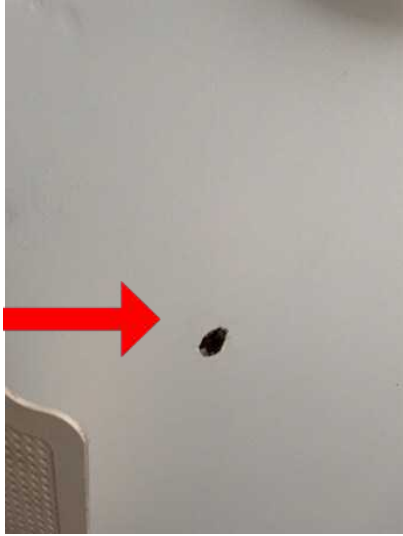
Finding 3.06

Information: Holes in surfaces are generally indicative of impact damage, whether accidental or deliberate, or a failing of the surface material.

Where holes are apparent in the surface of a building material, the surface is no longer sealed against water penetration or further impact damage, which may lead to additional damage to the surrounding surface.

Repair or replacement of the affected building element is recommended to ensure that any secondary defects are minimised. A qualified carpenter or general handyperson should be appointed to perform these works.

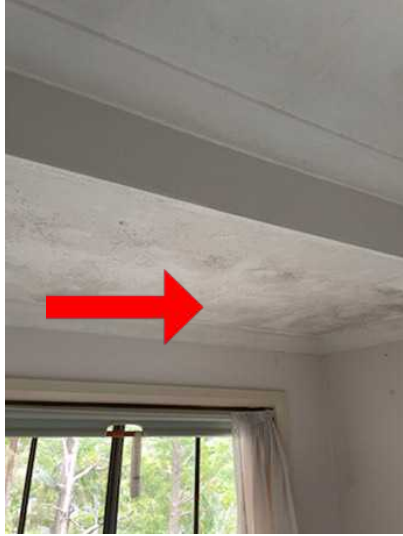
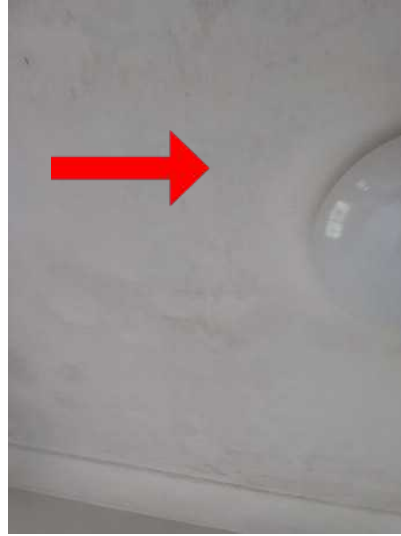
Finding 3.07

Building: Building 1
Location: Bathroom
Finding: Mould - Present
Information:

Where evidence of mould growth was noted, there may be environmental, biological or health issues associated with the report. A specialist inspection by a suitably qualified environmental health inspector is warranted, where mould is extensive or where any queries regarding air quality spores or other related issues apply.

Generally, the client is advised to ensure that the general environment is free of moisture and humidity to aid in the prevention of mould formation and development. Any mould found during the inspection should be cleaned immediately by a cleaning contractor or the homeowner as applicable.

Please note that severely affected building elements may require replacement by a builder or qualified carpenter.

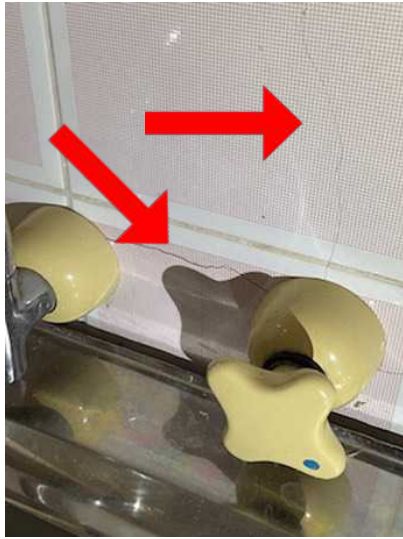
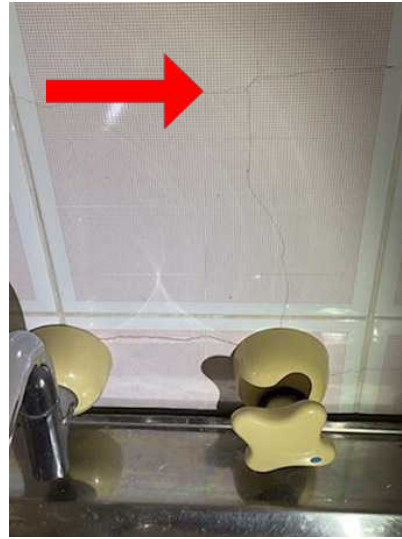
Finding 3.08

Building:	Building 1
Location:	Bathroom
Finding:	Tiles - Cracked or damaged
Information:	Cracking was evident to the tiling in this area at the time of inspection. While the cracking appears to be minor, this area is frequently exposed to water, allowing potential for water penetration into adjoining sections of walls or flooring.

If left unmanaged, water penetration to these areas may lead to subsequent water damage, which is likely necessitate repair work to affected building elements.

A tiling contractor should be appointed to ensure that no further water damage occurs. The re-application of silicone and grouting throughout remaining tile work is also advised, to further protect the area against water penetration.

Where water penetration has led to water damage, appointment of a relevant tradesperson may be required to repair damaged building elements.

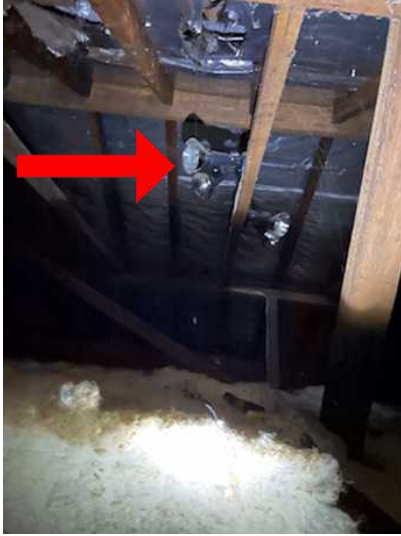
Finding 3.09

Building:	Building 1
Location:	Roof Void
Finding:	Sarking - Damaged
Information:	Sarking, a laminated aluminium foil applied to the interior of the roof covering, assists in insulating the property and acting as a vapour-barrier to the roof void and, subsequently, to the household.

Where sarking is damaged, both insulation and moisture protection of the property are inhibited. This creates a loss of energy and thus negatively impacts the energy efficiency of the property, allowing potential for moisture ingress from condensation or leaking roof tiles.

It is important to repair any holes or damaged sections of sarking to ensure that the building material is fully functional. A builder or qualified carpenter should be consulted to provide further advice on this defect and to perform rectification works at client discretion.

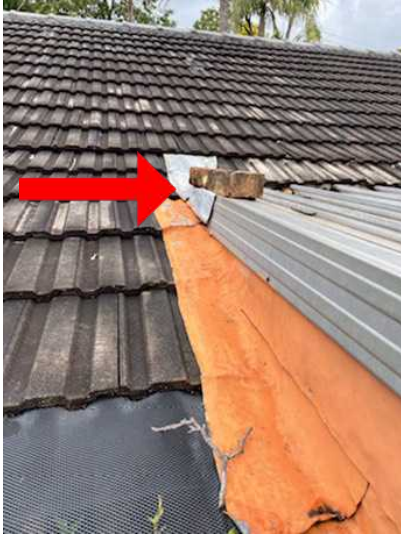
Finding 3.1

Building:	Building 1
Location:	Roof
Finding:	Flashing defective - noncompliant installation
Information:	Instances where it appears the flashing has been installed in a manner that does not comply with the BCA / NCC have occurred.

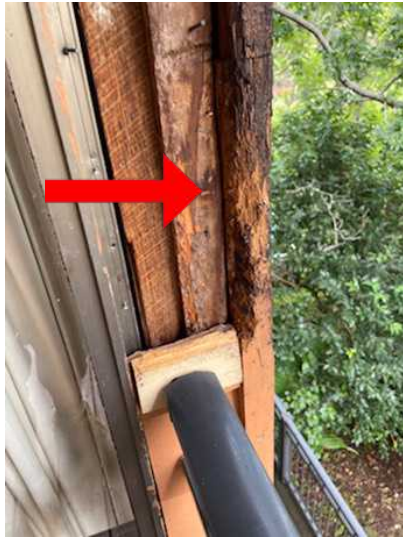
Finding 3.11

Building:	Building 1
Location:	Veranda
Finding:	Evidence of animal damage
Information:	Impact damage was found to be detracting from the appearance and functionality of this building element. It is suspected that this damage has been sustained as result of wear and tear on the building element caused by personal pets. Most damage is superficial.

Depending on the location of the animal damage and the surface area that it has affected, animal damage may generally be repaired by maintenance to surface finishes (i.e. sanding, filling, or painting). Where building elements have sustained major damage, replacement may be required to ensure that no secondary defects occur.

These works can usually be performed by a qualified carpenter or general handyperson and should be completed at the discretion of the client.

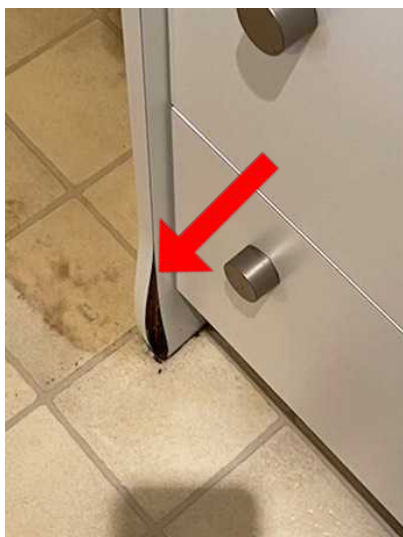
Finding 3.12

Building: Building 1
Location: Kitchen
Finding: Cabinets - Damaged
Information: At the time of inspection the kitchen cabinet were damaged.

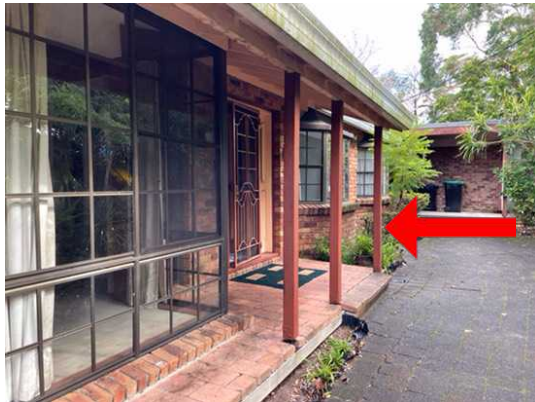
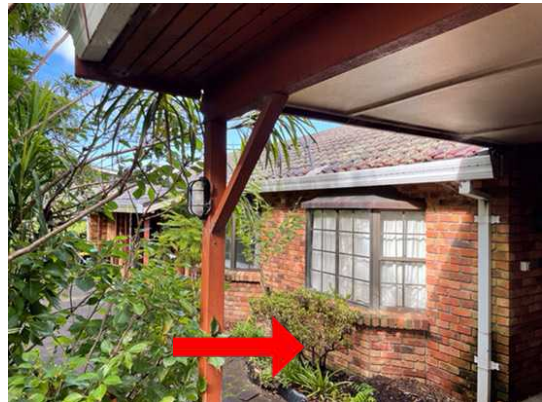
Finding 6.01

Building: Building 1
Location: All Areas
Finding: Garden Beds - Conditions Conducive to Termites
Information: Garden beds were found to be evident in the garden area. These garden beds can include untreated timber, and with a combination of moisture from watering hosing can make conditions conducive to termite activity and termite ingress.

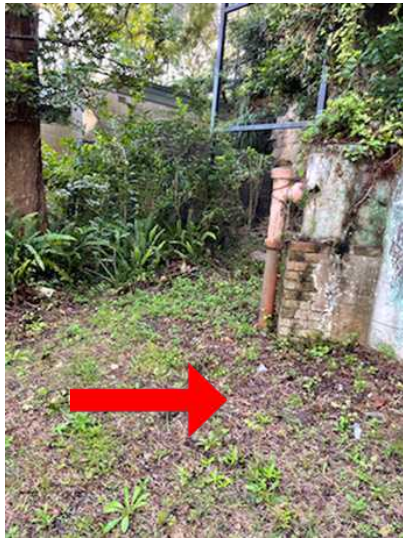
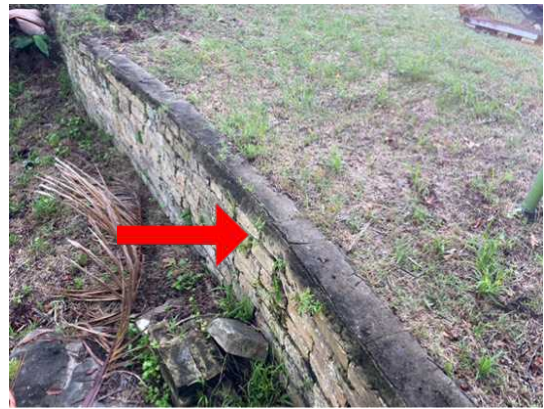
Finding 6.02

Building:	Building 1
Location:	All Areas
Finding:	Excessive moisture - identified
Information:	Excessive moisture can attract termites and produce conditions that promote fungal growth and wood decay.

Excessive moisture is generally caused by deteriorated inadequate or missing roof drainage leaking plumbing pipes or fixtures poorly plumbed HWS overflows or condenser units and poor site drainage.

Prior to any remedial works being performed a qualified plumber should be appointed to further inspect the property and to identify the cause of the excessive moisture. Works to remove affected building elements may then be necessary and should be performed by an appropriate tradesperson.

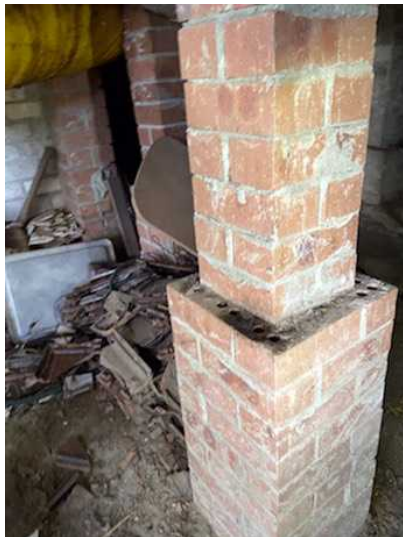
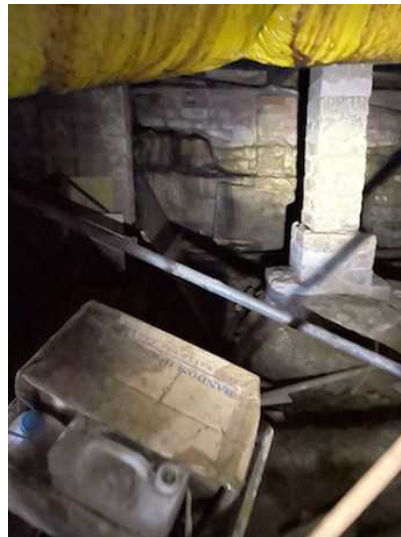
Finding 6.03

Building: Building 1
Location: Subfloor
Finding: Subfloor - Debris
Information:

An array of debris was found in the subfloor area at the time of inspection. Debris in this area restricts subfloor ventilation and creates potential for concealed pest entry. Stored timbers and other materials may also make the area susceptible to termite activity and wood rot.

A clear and empty subfloor will be better ventilated and easier to maintain in a dry condition. The removal of any timber debris is vital in minimising the risk of termite or wood borer activity.

Debris in the subfloor should be removed as soon as possible. Depending on the location and amount of debris and stored items, the homeowner may elect to undertake this task. Alternatively there are a large number of rubbish removal subcontractors that could undertake these works.

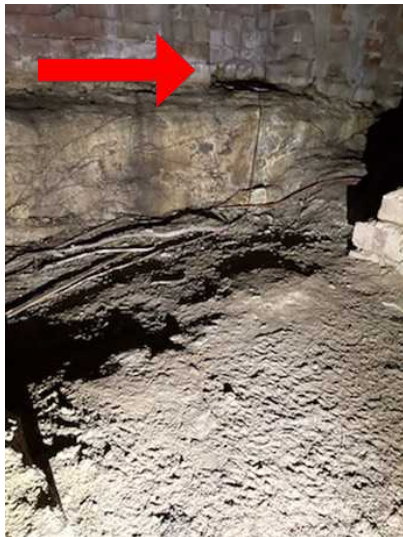
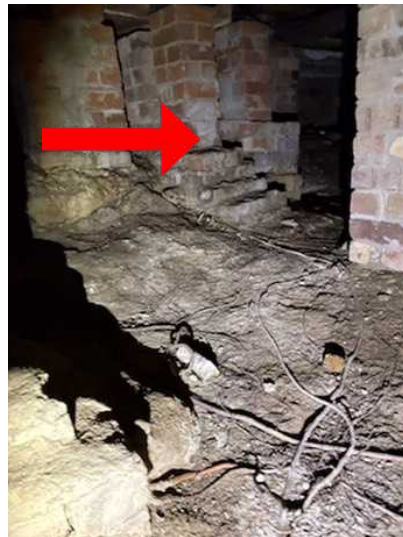
Finding 6.04

Building: Building 1
Location: Subfloor
Finding: Evidence of excessive moisture was present at the time of inspection
Information: Excessive moisture can attract termites and produce conditions that promote termite attack fungal growth and wood decay.

It is recommended that all plumbing and drainage fixtures and fittings be maintained regularly in order to prevent excessive moisture being present in the external / internal property.
