## Building and Timber Pest Inspection Report

Inspection Date: Thu, 22 Apr 2021

Property Address: 60 Romford Rd, Frenchs Forest NSW 2086,  
Australia

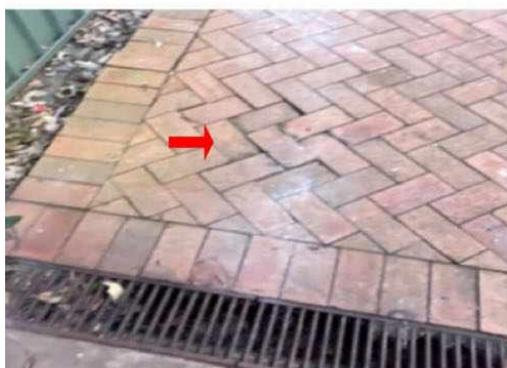
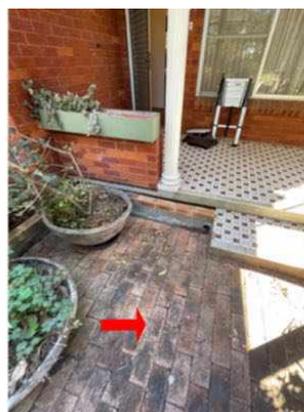
#### Defects 1.01

Building:	Building 1
Location:	Yard - Front
Finding:	Paving - Uneven
Information:	Sections of the external paved area are uneven, creating a potential trip hazard. It appears as though the area has been subject to rough installation, or that paving sections have lifted due to movements in the foundation of the property.

Where paving creates a trip hazard, personal injury may ensue if due caution is not taken by all persons within this area.

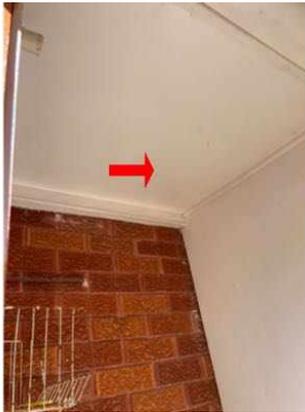
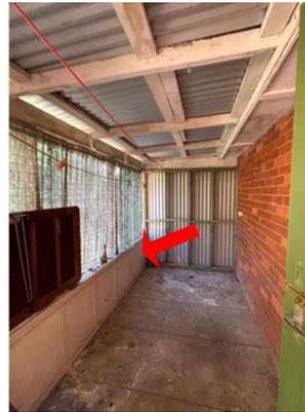
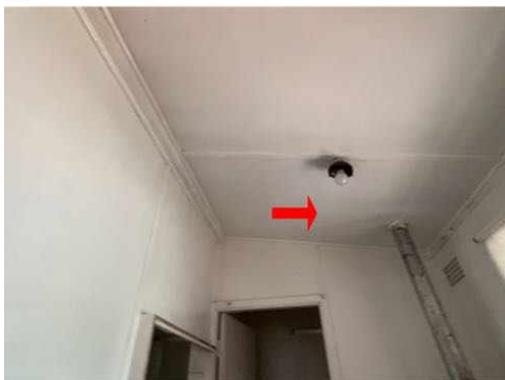
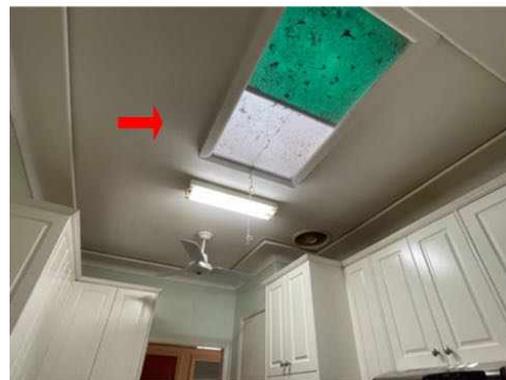
#### Defects 1.02

Building:	Building 1
Location:	All Areas
Finding:	Asbestos - Suspected ACM Identified on Site
Information:	Reporting on Asbestos is outside the Scope of this Report. This suspected defect is highlighted as a caution only. We suspect, based on our experience in the building industry, that there is a higher risk of the identified building element containing asbestos.

As Asbestos Reporting is outside the scope of this report, we advise that you consider a separate Asbestos Inspection and Condition Audit, which can include the taking of samples for definitive confirmation of the presence of Asbestos.

In the interim, the client is advised to act with caution, especially when considering any damage to building materials general wear and tear renovations extensions demolition

and general maintenance activities due to the suspected presence of Asbestos.

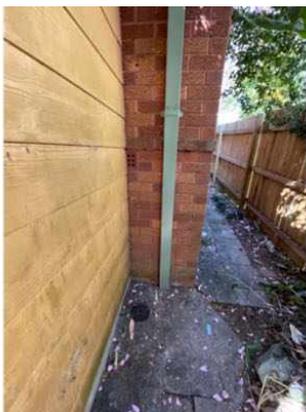
### Defects 3.01

Building:	Building 1
Location:	All Areas
Finding:	Evidence of excessive moisture was present at the time of inspection
Information:	Excessive moisture can attract termites and produce conditions that promote termite attack fungal growth and wood decay.

Excessive moisture is generally caused by deteriorated inadequate or missing roof drainage leaking plumbing pipes or fixtures poorly plumbed HWS overflows or condenser units and poor site drainage.

It is recommended that all plumbing and drainage fixtures and fittings be maintained regularly in order to prevent excessive moisture being present in the external / internal

property.

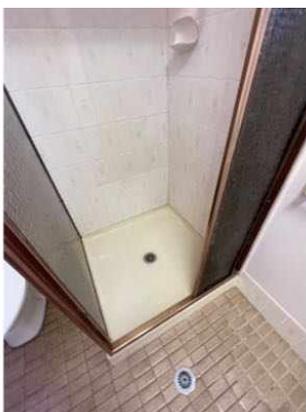
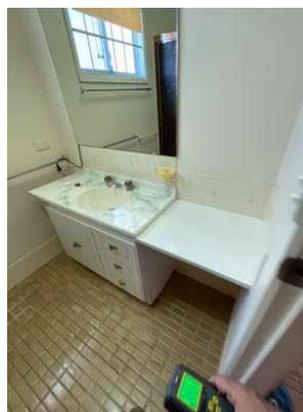
### Defects 3.02

Building:	Building 1
Location:	Bathroom
Finding:	Sealant and grouting - Missing or damaged
Information:	It was noted on inspection that sealant or grout is degraded to the tiled shower alcove and or other areas of the bathroom.

Different materials and floor areas move at different rates, generally causing cracking to grout or sealant at this point. A flexible sealant is required to allow for expected expansion and contraction, while keeping the joint water tight and protective of all associated building materials.

Flexible and mould resistant materials should be applied to affected areas to prevent any subsequent water damage that is likely to occur. Regular maintenance and replacement of damage or missing or damaged sealant and grout is highly recommended to the wet areas, as this is a regular wear and tear defect. Sealant and grouting in areas that come into regular contact with water should be maintained for the long term care of your property.

A sealant specialist or tiling contractor should be appointed to complete these works.

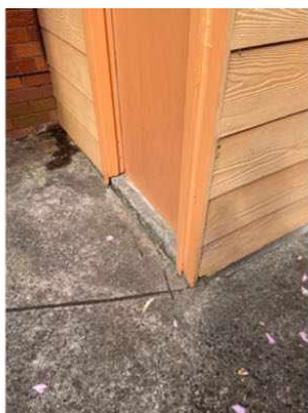
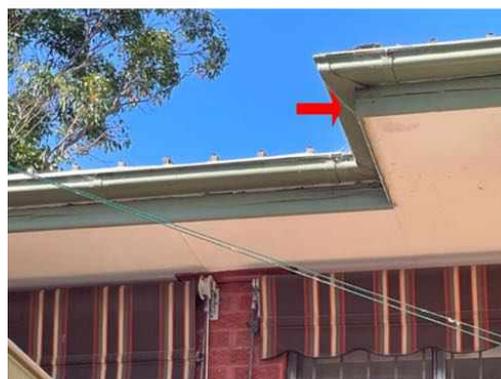
### Defects 3.03

Building:	Building 1
Location:	All External Areas
Finding:	Wood rot
Information:	This building element shows evidence of wood rot. Wood rot, also known as Fungal Decay, occurs when timbers and other cellulose building materials are exposed to damp conditions on an ongoing basis. This could be the result of exposure to weathering over a prolonged period of time, or the attraction of excessive moisture from other abutting building materials. Contributing factors also include poor air ventilation in the area.

Early intervention and regular maintenance, particularly of exterior timbers, will prolong the useful life of these building elements. Prior to any works being performed, the cause of the moisture that has created the visible wood rot should be identified and addressed in a suitable manner. Replacement of affected timbers may then be a necessary step in protecting surrounding building elements from such deterioration.

A qualified carpenter or registered builder may also be required to replace affected building materials.

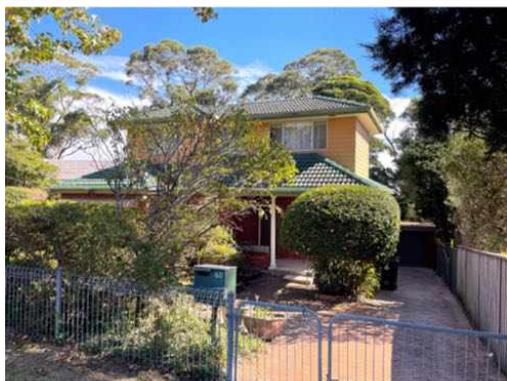
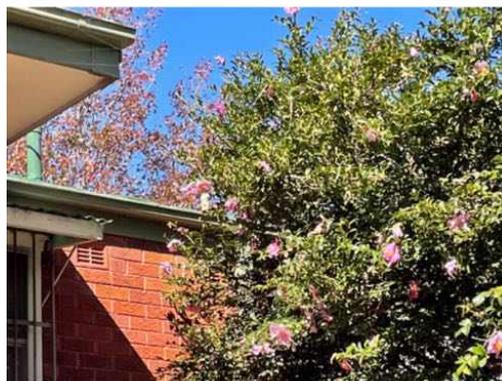
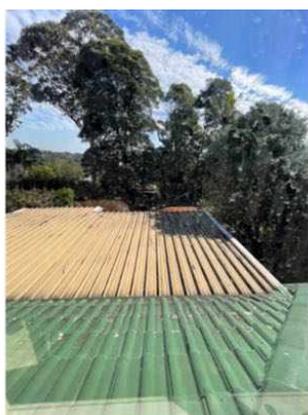
### Defects 3.04

Building:	Building 1
Location:	All External Areas
Finding:	Trees - Overhanging and filling gutters
Information:	Overhanging trees often result in excessive amounts of leaf debris accumulating in gutters.

Gutters are a critical part of the building's management of storm water and rain. It is therefore important that they be kept clear to prevent secondary damage to associated building elements, including exterior and interior walls, ceiling linings and any adjoining building elements. Where gutters are blocked, pooling of rainwater is likely to occur, fast-tracking rust and corrosion of the roof plumbing elements.

It is advised that all overhanging tree branches be removed as soon as possible to prevent any further damage. Repair and/or replacement of sections of damaged guttering may also be required where the extent of the damage necessitates.

Such works should be performed by the homeowner; however, appointment of a landscape contractor or an arborist may be required. Consultation with a licensed roof plumber is required where guttering has been damaged.

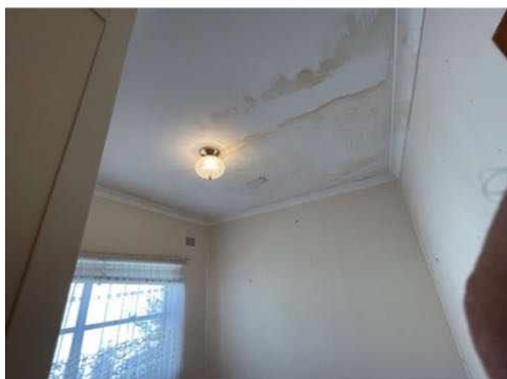
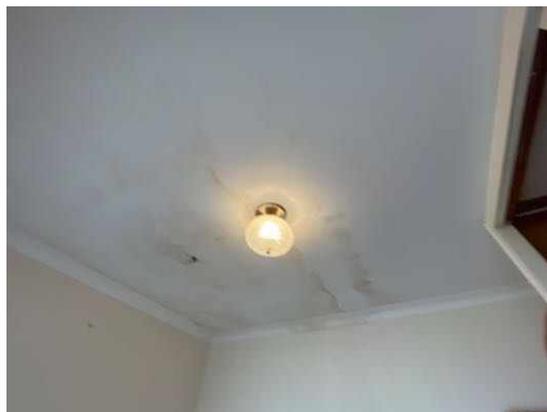
### Defects 3.05

Building:	Building 1
Location:	Bedroom
Finding:	Ceiling - Water damaged
Information:	Water damage to the ceiling lining is generally an indication of excessive moisture being present in the roof void, usually via a leak to the roof covering.

Where water damage is evident to the ceiling, the primary requirement is to identify and rectify the source of the leak. A roofing plumber should be appointed as soon as possible to identify the leak and perform rectification works as necessary, ensuring the water damage is restricted.

Once the leak is repaired, consultation with relevant tradespeople, including plasterers and painters, is advised. Rectification works may include replacement of ceiling lining

or minor repainting, depending on the extent of the damage.

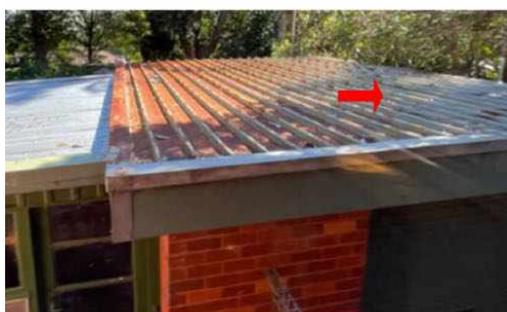
### Defects 3.06

Building:	Building 1
Location:	Garage
Finding:	Roof sheets - Rusted
Information:	Metal roofs generally comprise numerous individual sheets, which join and overlap. These intersections are particularly prone to lift at the edge and consequently rust at these points.

Upon inspection of the exterior roofing structure, evidence of rust to these sections was identified. If left unmanaged, these degrading joints can allow water ingress to the internal roofing structures, potentially leading to secondary damage of building elements. Accelerated deterioration of the roofing sheets and any associated building elements is also likely to occur.

A roofing contractor should be appointed immediately to assess the damage to the roofing sheets and to perform remedial works as necessary. Works may include replacement of severely affected roofing sheets or minor works such as the application of rust-retardant surface protectors.

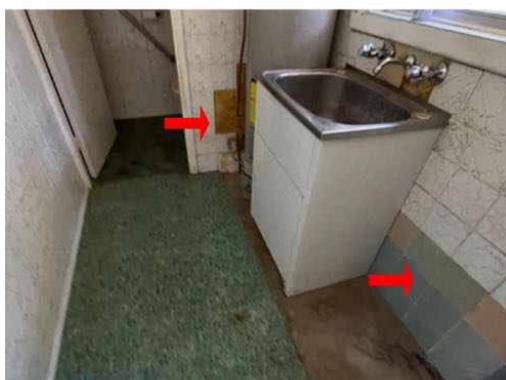
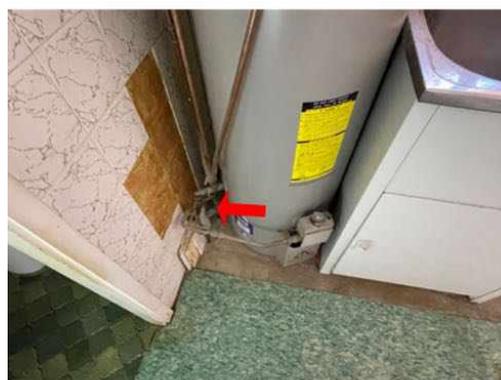
### Defects 3.07

Building: Building 1  
 Location: Laundry  
 Finding: Tiles - Missing  
 Information: Tiles were found to be missing in this tiled area. It appears as though broken tiles have been removed and not replaced, or have come loose from their original fixing through general deterioration.

Where tiles are missing, water penetration is likely to occur to exposed walls and flooring, creating potential for subsequent water damage.

Any tiles that are missing should be replaced immediately by a tiling contractor or general handyman. If left unmanaged over a prolonged period of time, water damage is likely to necessitate repair works to surrounding building elements.

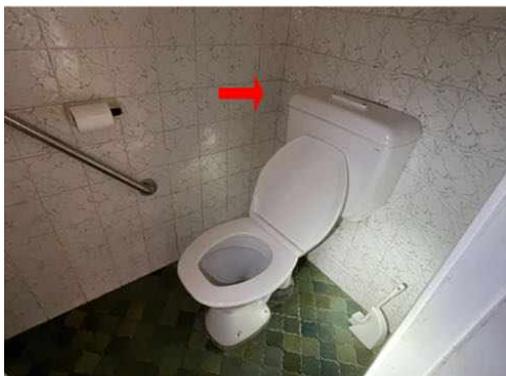
### Defects 3.08

Building: Building 1  
 Location: Bathroom  
 Finding: Sealant and grouting - Missing or damaged  
 Information: Flexible and mould resistant materials should be applied to affected areas to prevent any subsequent water damage that is likely to occur. Regular maintenance and replacement of damage or missing or damaged sealant and grout is highly recommended to the wet areas, as this is a regular wear and tear defect. Sealant and grouting in areas that come into regular contact with water should be maintained for the long term care of your property.

A sealant specialist or tiling contractor should be appointed to complete these works as soon as possible

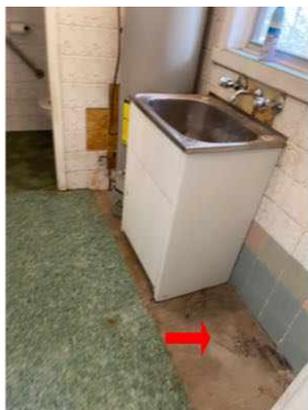
### Defects 3.09

Building:	Building 1
Location:	Laundry
Finding:	Evidence of excessive moisture was present at the time of inspection
Information:	Excessive moisture can attract termites and produce conditions that promote termite attack fungal growth and wood decay.

Excessive moisture is generally caused by deteriorated inadequate or missing roof drainage leaking plumbing pipes or fixtures poorly plumbed HWS overflows or condenser units and poor site drainage.

It is highly recommended that all plumbing and drainage fixtures and fittings be maintained regularly in order to prevent excessive moisture being present in the external / internal property.

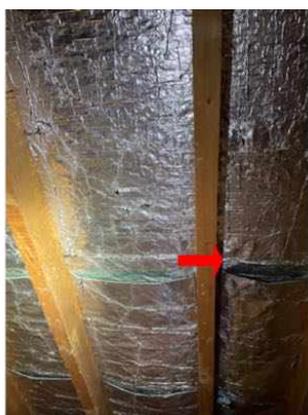
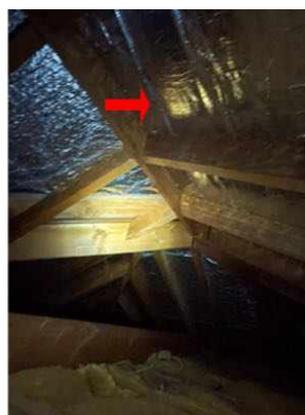
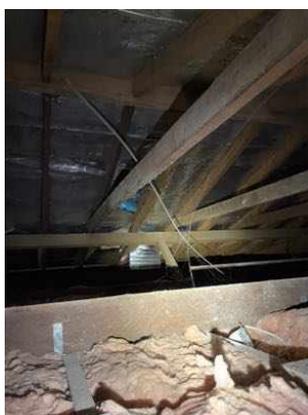
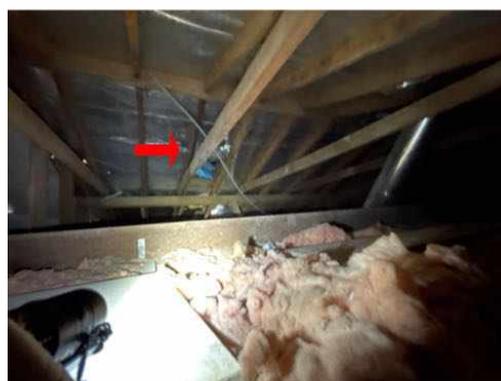
### Defects 3.10

Building:	Building 1
Location:	Roof Void
Finding:	Sarking - Damaged
Information:	Sarking, a laminated aluminium foil applied to the interior of the roof covering, assists in insulating the property and acting as a vapour-barrier to the roof void and,

subsequently, to the household.

Where sarking is damaged, both insulation and moisture protection of the property are inhibited. This creates a loss of energy and thus negatively impacts the energy efficiency of the property, allowing potential for moisture ingress from condensation or leaking roof tiles.

It is important to repair any holes or damaged sections of sarking to ensure that the building material is fully functional. A registered builder or qualified carpenter should be consulted to provide further advice on this defect and to perform rectification works at client discretion.

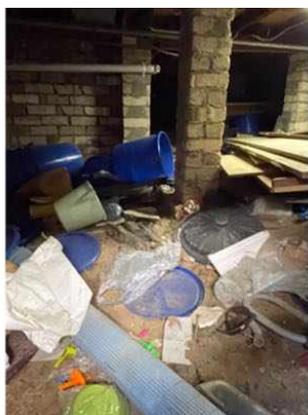
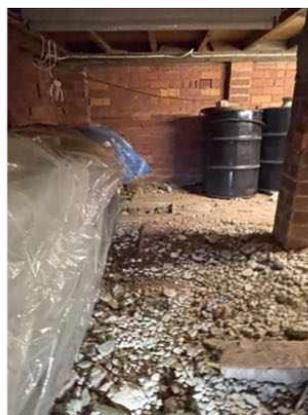
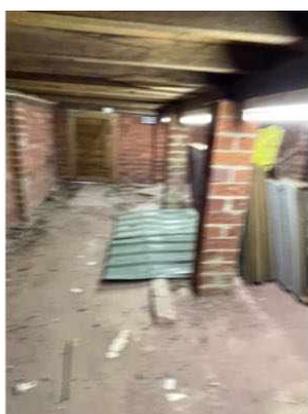
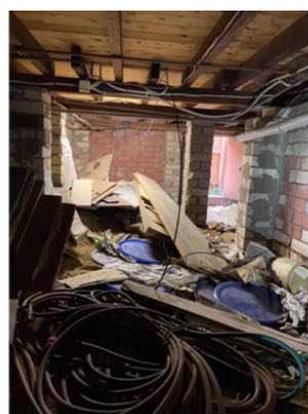
### Defects 3.11

Building:	Building 1
Location:	Subfloor
Finding:	Subfloor - Debris
Information:	An array of debris was found in the subfloor area at the time of inspection. Debris in this area restricts subfloor ventilation and creates potential for concealed pest entry. Stored timbers and other materials may also make the area susceptible to termite activity and wood rot.

A clear and empty subfloor will be better ventilated and easier to maintain in a dry condition. The removal of any timber debris is vital in minimising the risk of termite or

wood borer activity.

Debris in the subfloor should be removed as soon as possible. Depending on the location and amount of debris and stored items, the homeowner may elect to undertake this task. Alternatively there are a large number of rubbish removal subcontractors that could undertake these works.

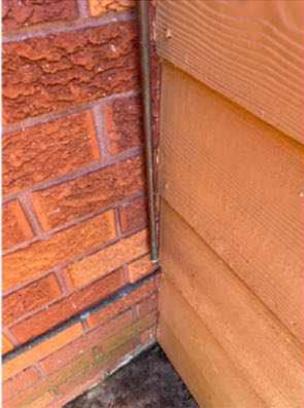
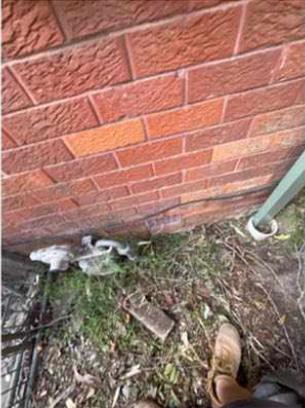
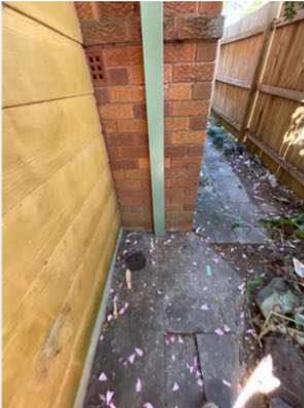
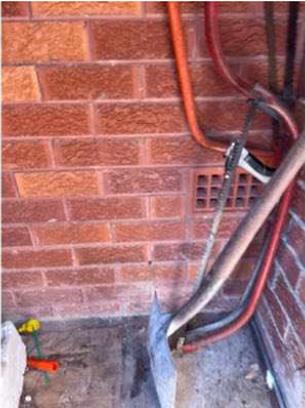
### Defects 3.12

Building:	Building 1
Location:	All Areas
Finding:	Overflow - Not plumbed for drainage
Information:	The overflow is not plumbed or connected to suitable drainage, which has resulted in the surrounding area becoming excessively damp.

These damp conditions can lead to secondary defects such as rot, rust or corrosion of associated building elements, the formation of fungal decay, or even the creation of potential slip hazards. When coupled with poor site drainage, pooling of water may also attract termite activity to this area.

It is highly recommended that a qualified plumber be appointed to install adequate drainage to the overflow. These works will ensure that the area remains dry and free of any secondary defects.

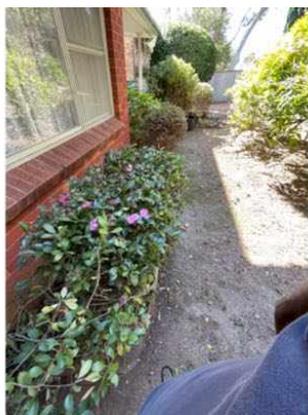
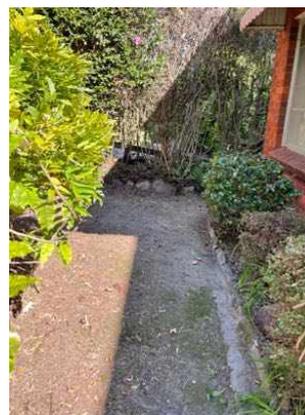
#### Noted Item

Building: Building 1  
 Location: All External Areas  
 Finding: Garden Beds - Conditions Conducive to Termites  
 Information:

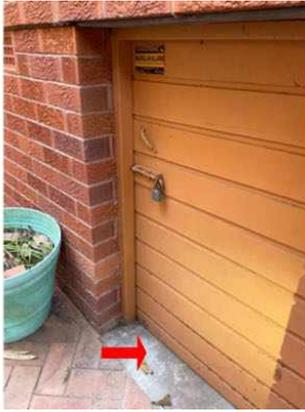
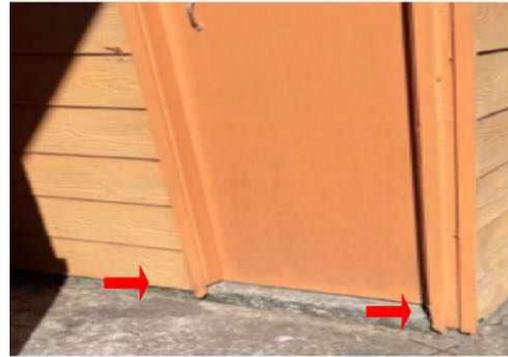
#### Noted Item

Building: Building 1  
 Location: All External Areas  
 Finding: Building materials in direct ground contact - conducive to termites  
 Information: Where timber elements are in direct contact with the ground and consequently moisture or dampness they become conducive to termite activity. Whether timber is used as a building element part of a fencing structure or stored as an unused item they can provide an environment that is attractive to termite infestation. When met with excessive moisture timber begins to decay and develop wood rot. Any timbers that are in direct contact with external grounds especially if left untreated or non-durable also provide ingress for subterranean termites into that particular element. The removal of any such materials that may be conducive to termite activity should be removed as soon as possible to minimise the risk of termite attack.

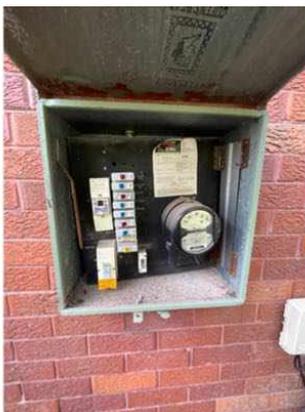
### Noted Item

Building: Building 1  
 Location: Yard - Side  
 Finding: Termite Management System - no evidence of installation  
 Information: The application of a post-construction chemical termite barrier is highly recommended for all properties, particularly if live termite activity has been found on the site previously. Such barriers are highly effective in preventing termite attack on any timber building elements throughout the property.

A durable notice should be placed in the switchboard unit to indicate current termite barriers. At the time of inspection, it appeared as though no termite management system has been installed, with no evidence to suggest preventative works taking place.

The client may consider gaining further advice from a pest controller as to the costs and procedures involved with this application. It is recommended that obtaining such advice be a short-term priority.

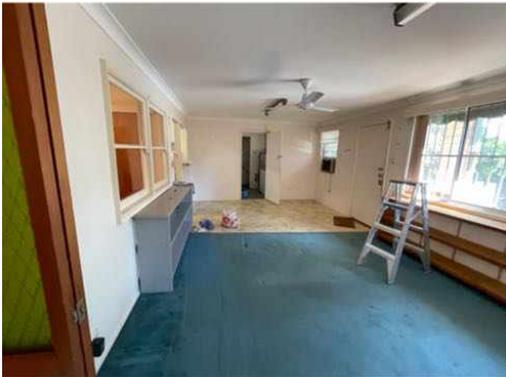
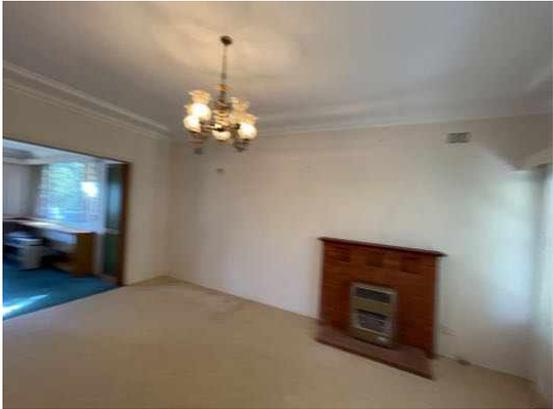
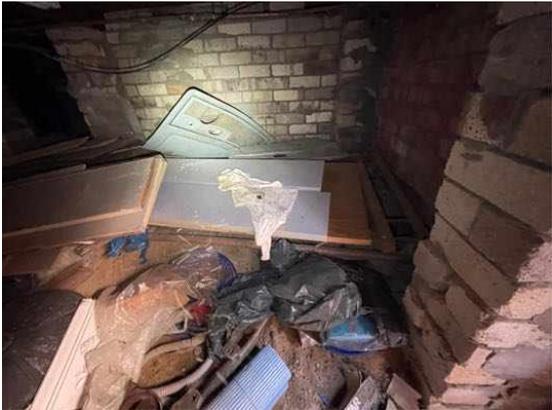
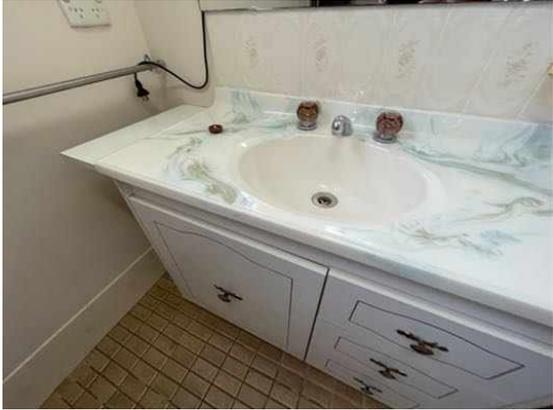
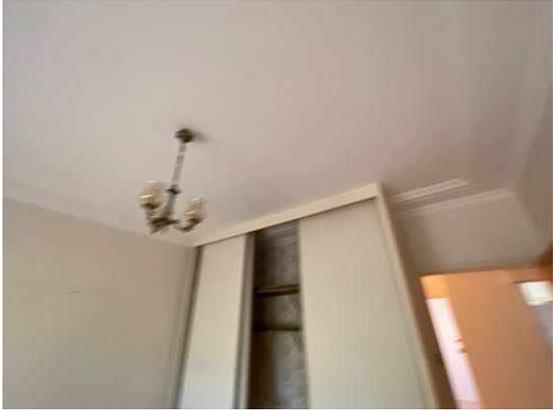
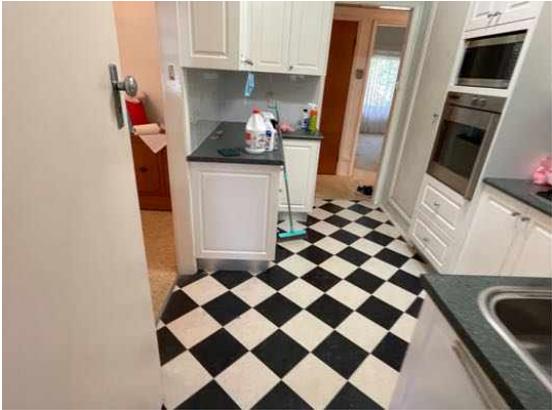
### Noted Item

Building: Building 1  
 Location: All Areas

Finding: Additional Photos - Obstructions and Limitations  
Information: These photographs are an indication of the obstructions and limitations which impeded full inspection of the property at the time of inspection. These obstructions can hide an array of defects and should be removed to allow full inspection to be carried out.
