Building and Timber Pest Inspection Report

Inspection Date: Thu, 4 Nov 2021

Property Address: 44 Grace Ave, Frenchs Forest NSW 2086,
Australia

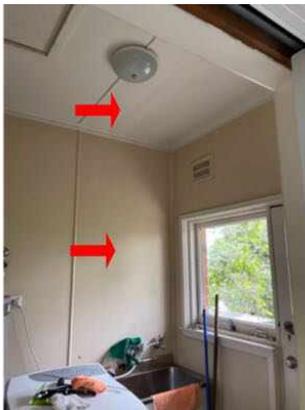
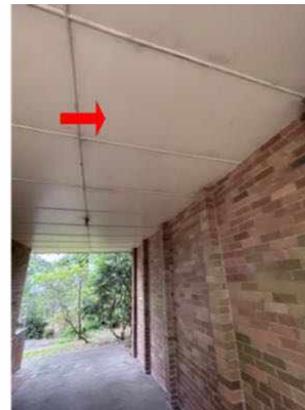
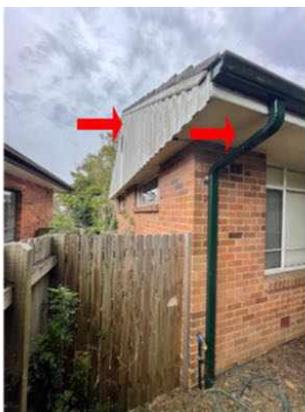
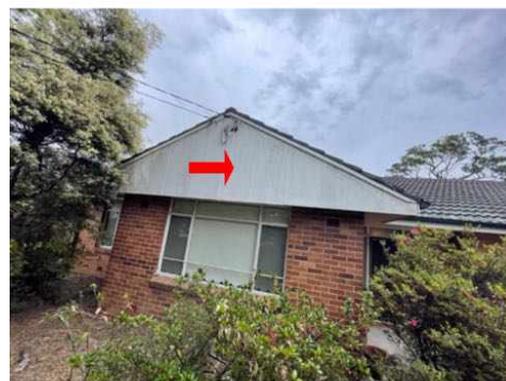
Defects 1.01

Building:	Building 1
Location:	All Areas
Finding:	Asbestos - Suspected ACM Identified on Site
Information:	Reporting on Asbestos is outside the Scope of this Report. This suspected defect is highlighted as a caution only. We suspect, based on our experience in the building industry, that there is a higher risk of the identified building element containing asbestos.

As Asbestos Reporting is outside the scope of this report, we advise that you consider a separate Asbestos Inspection and Condition Audit, which can include the taking of samples for definitive confirmation of the presence of Asbestos.

In the interim, the client is advised to act with caution, especially when considering any damage to building materials general wear and tear renovations extensions demolition and general maintenance activities due to the suspected presence of Asbestos.

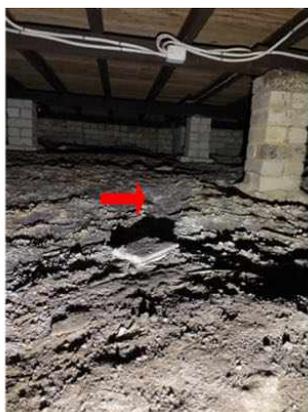
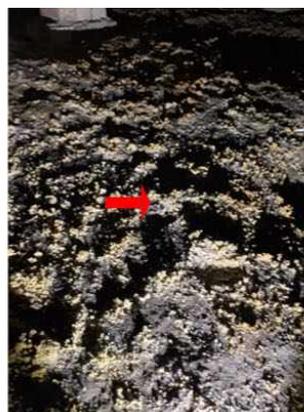
Defects 1.02

Building: Building 1
 Location: Subfloor
 Finding: Mould - Present
 Information: Where evidence of mould growth was noted, there may be environmental, biological or health issues associated with the report. A specialist inspection by a suitably qualified environmental health inspector is warranted, where mould is extensive or where any queries regarding air quality spores or other related issues apply.

Generally, the client is advised to ensure that the general environment is free of moisture and humidity to aid in the prevention of mould formation and development. Any mould found during the inspection should be cleaned immediately by a cleaning contractor or the homeowner as applicable.

Please note that severely affected building elements may require replacement by a registered builder or qualified carpenter.

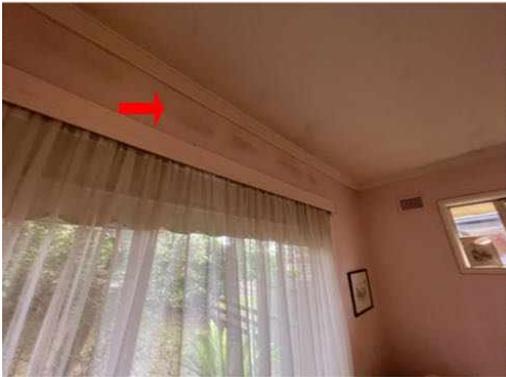
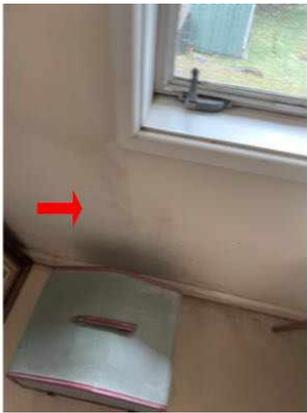
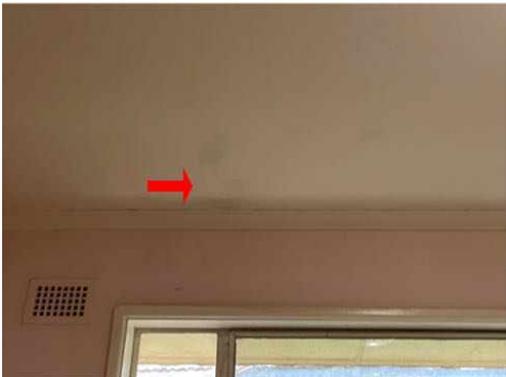
Defects 1.03

Building: Building 1
 Location: All Areas
 Finding: Mould - Present
 Information: Where evidence of mould growth was noted, there may be environmental, biological or health issues associated with the report. A specialist inspection by a suitably qualified environmental health inspector is warranted, where mould is extensive or where any queries regarding air quality spores or other related issues apply.

Generally, the client is advised to ensure that the general environment is free of moisture and humidity to aid in the prevention of mould formation and development. Any mould found during the inspection should be cleaned immediately by a cleaning contractor or the homeowner as applicable.

Please note that severely affected building elements may require replacement by a registered builder or qualified carpenter.

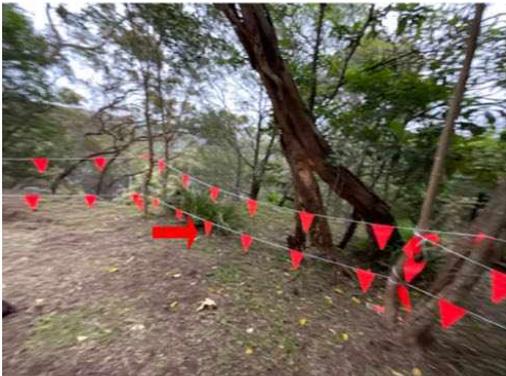
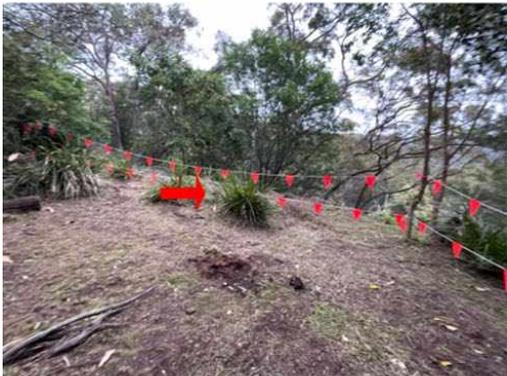
Defects 1.04

Building: Building 1
Location: Yard - Back
Finding: Fencing - missing
Information: This defect creates a potential safety hazard and should be rectified as soon as possible to ensure the safety of the area.

A fencing contractor should be contacted to discuss possible solutions.

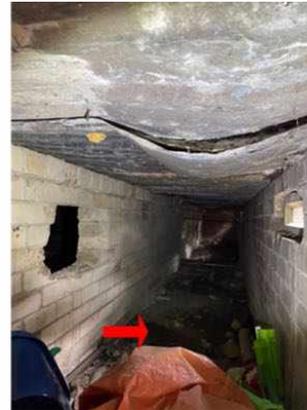
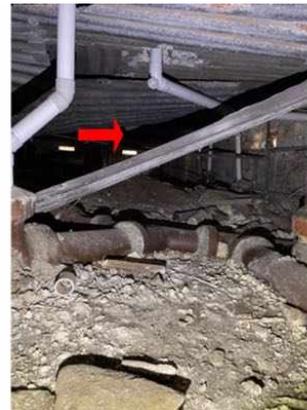
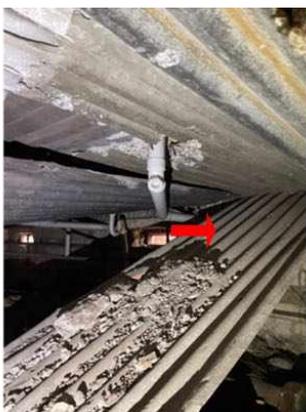
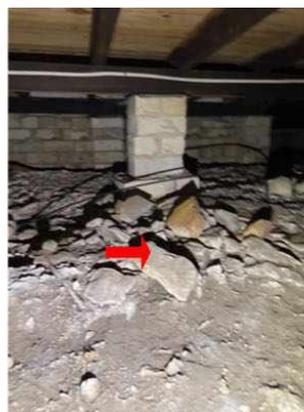
Defects 1.05

Building: Building 1
Location: Subfloor
Finding: Subfloor - Debris
Information:

An array of debris was found in the subfloor area at the time of inspection. Debris in this area restricts subfloor ventilation and creates potential for concealed pest entry. Stored timbers and other materials may also make the area susceptible to termite activity and wood rot.

A clear and empty subfloor will be better ventilated and easier to maintain in a dry condition. The removal of any timber debris is vital in minimising the risk of termite or wood borer activity.

Debris in the subfloor should be removed as soon as possible. Depending on the location and amount of debris and stored items, the homeowner may elect to undertake this task. Alternatively there are a large number of rubbish removal subcontractors that could undertake these works.

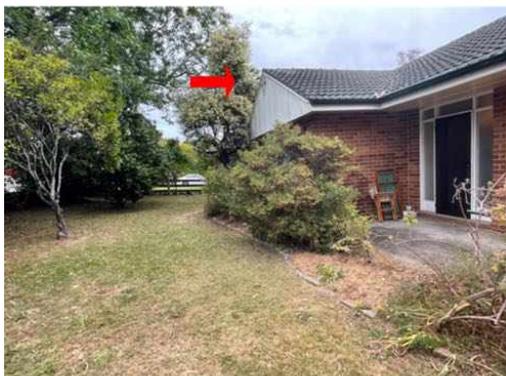
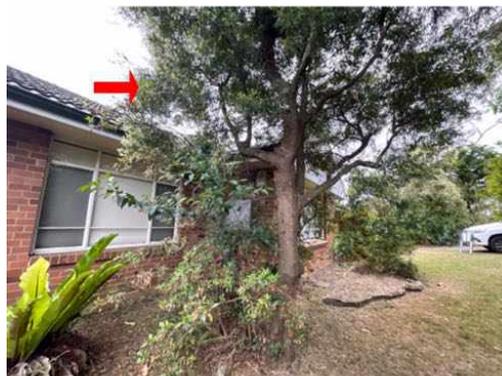
Defects 3.01

Gutters are a critical part of the building's management of storm water and rain. It is therefore important that they be kept clear to prevent secondary damage to associated building elements, including exterior and interior walls, ceiling linings and any adjoining building elements. Where gutters are blocked, pooling of rainwater is likely to occur, fast-tracking rust and corrosion of the roof plumbing elements.

It is highly advised that all overhanging tree branches be removed as soon as possible to prevent any further damage. Repair and/or replacement of sections of damaged guttering may also be required where the extent of the damage necessitates.

Such works should be performed by the homeowner; however, appointment of a landscape contractor or an arborist may be required. Consultation with a licensed roof plumber is required where guttering has been damaged.

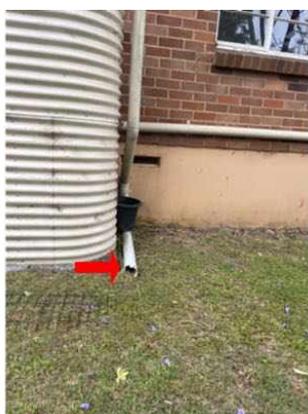
Defects 3.02

Building:	Building 1
Location:	All Areas
Finding:	Overflow - Not plumbed for drainage
Information:	The overflow is not plumbed or connected to suitable drainage, which has resulted in the surrounding area becoming excessively damp. These damp conditions can lead to secondary defects such as rot, rust or corrosion of associated building elements, the formation of fungal decay, or even the creation of potential slip hazards. When coupled with poor site drainage, pooling of water may also attract termite activity to this area. It is highly recommended that a qualified plumber be appointed to install adequate drainage to the overflow. These works will ensure that the area remains dry and free of any secondary defects.

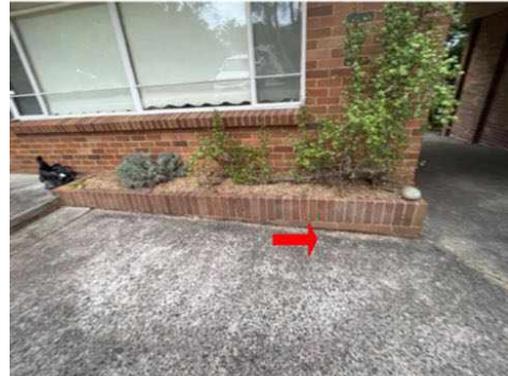
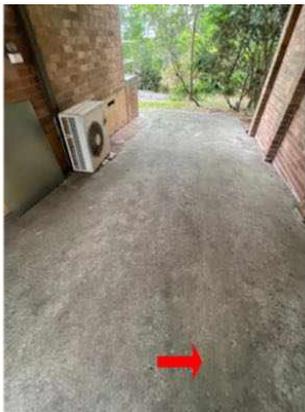
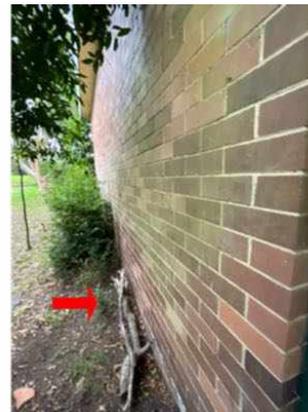
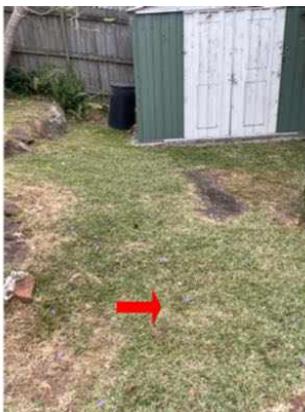
Defects 3.03

Building:	Building 1
Location:	All Areas
Finding:	Site drainage - Inadequate
Information:	The site drainage in this area was found to be inadequate at the time of inspection, creating potential for subsequent water damage to associated building elements.
	It is important that water does not lie against the base of walls; surrounding paths and

ground levels should be sloped to drain water away from walls. Downpipes should not discharge stormwater onto lower walls or plinths. Stormwater should be carried away by large, regularly cleaned drains. Ground levels may need to be lowered to expose a buried DPC.

Where site drainage is inadequate, installation of an Agricultural (Aggie) Drain may be required. A qualified plumber should be appointed to further inspect the property and perform any remedial works as necessary. Water damage and secondary defects are likely to occur if left unmanaged.

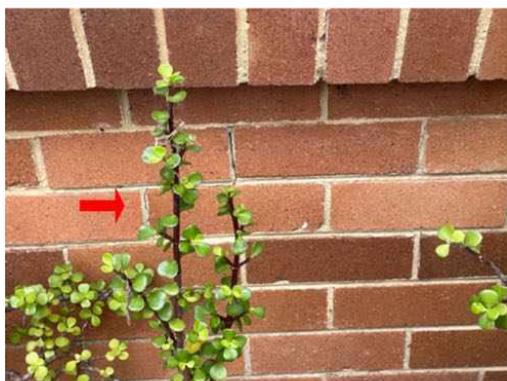
Defects 3.04

Building:	Building 1
Location:	All Areas
Finding:	Brickwork - Step cracking
Information:	Step cracking was identified to the brickwork in this area at the time of inspection. Step cracking, which is similar to other forms of cracking, has a variety of possible causes. However, the most common is the subsidence of adjacent footings.

Step cracking is a relatively common defect, and is most likely to occur adjacent to windows, doors and other openings. Mortar failure in the gaps between affected bricks indicates the stresses and tensions affecting the wall.

Where step cracking is extensive or severe, the client is advised to consult a structural engineer. Minor step cracking can be used as a warning sign to address factors causing stress to the wall, which can include the effect of surrounding trees, water leaks, soil erosion, or even the presence of reactive soils in the surrounding area.

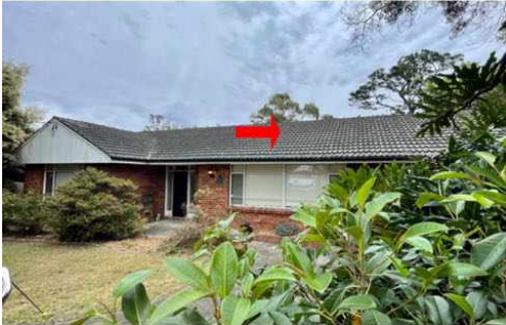
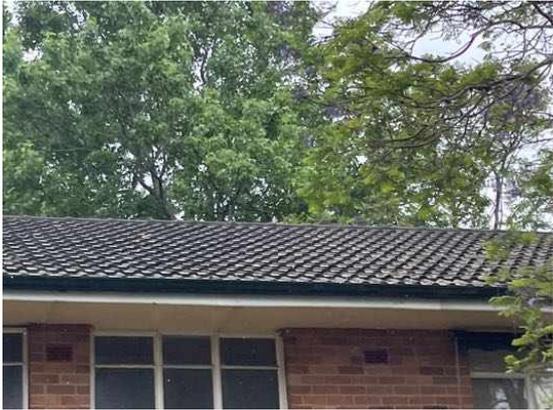
Defects 3.05

Building:	Building 1
Location:	Roof Exterior
Finding:	Roof tiles - Weathered
Information:	Upon inspection of the exterior roofing, the majority of roof tiles were considered to be in a fair condition. While weathering of the tiles is consistent with the age of the property, maintenance works are required.

Where left unmanaged, deteriorating roof tiles are likely to lead to a number of secondary defects, including minor water leaks and weather exposure to internal roofing structures.

Consultation with a roofing contractor is advised to gain advice on cost of remedial works that may be required in the short to medium term. Remedial works are likely to increase the longevity of the exterior roofing structure.

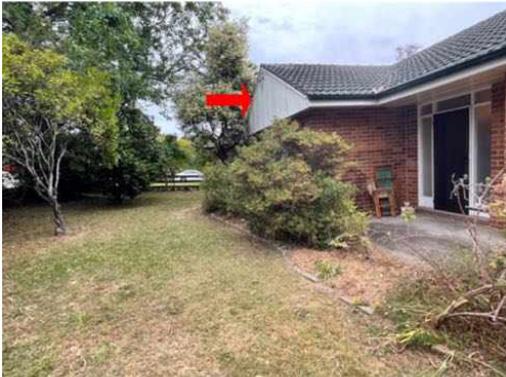
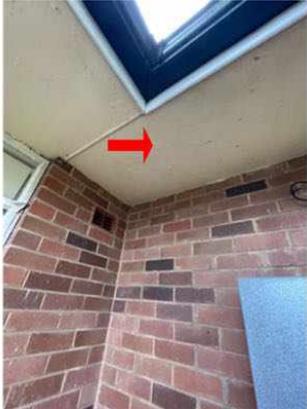
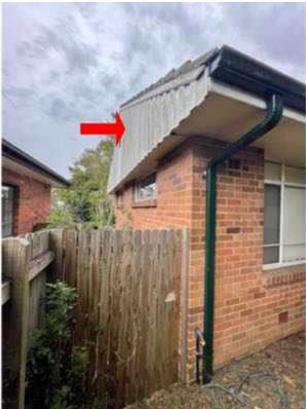
Defects 3.06

Building: Building 1
Location: All Areas
Finding: painting deteriorated
Information: Whilst incomplete or missing paint finish is generally an appearance defect, it can also lead to the development of secondary building defects over time. Incomplete areas of paint finish exposes the area to moisture, potentially accelerating the deterioration of underlying building materials.

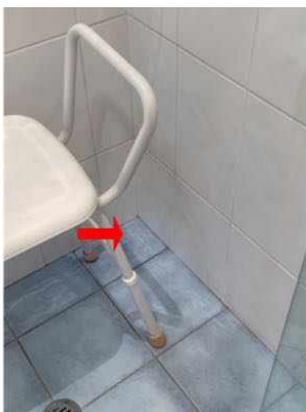
Defects 3.07

Building:	Building 1
Location:	Bathroom
Finding:	Sealant - missing
Information:	Flexible and mould resistant materials should be applied to affected areas to prevent any subsequent water damage that is likely to occur. Regular maintenance and replacement of damage or missing or damaged sealant and grout is highly recommended to the wet areas, as this is a regular wear and tear defect.

Sealant and grouting in areas that come into regular contact with water should be maintained for the long term care of your property. A sealant specialist or tiling contractor should be appointed to complete these works as soon as possible

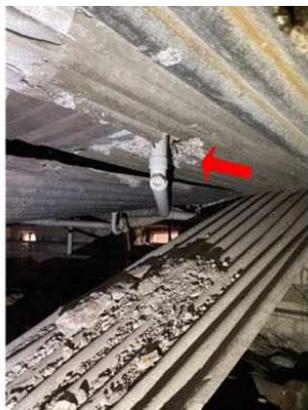
Defects 3.08

Building:	Building 1
Location:	Subfloor
Finding:	Concrete - Cancer
Information:	Concrete cancer is the common term used to describe a number of factors which cause concrete construction to deteriorate. Generally, water penetration causes the concrete reinforcement to rust and expand, creating stresses on the surrounding concrete and in turn causing it to spall (or break away). Alternatively, if the cement component is too alkaline, reactions with the general atmosphere occurs and star-shaped cracks appear which allow rainwater to penetrate. Concrete cancer may also originate from poor original water proofing.

Ultimately, the cause of the concrete cancer (e.g. poor water proofing) must also be addressed, otherwise the problem is likely to recur. Treatment of concrete cancer can be expensive and, left unmanaged, the problem is likely to worsen over time,

potentially leading to the development of major structural defects or safety hazards.

In some instances, repairs are possible; however, repair works will generally involve extensive works, including removal of affected concrete and the treatment or replacement of any exposed steel. Some injection of resins or special mortars may also be possible, however this depends on the size and extent of consequent damage.

The client is advised to exercise caution and to prepare for the potential cost of remedial and / or replacement works. A structural engineer should be appointed to provide estimates on the required works.

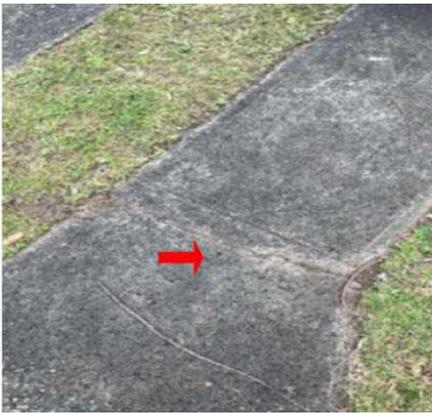
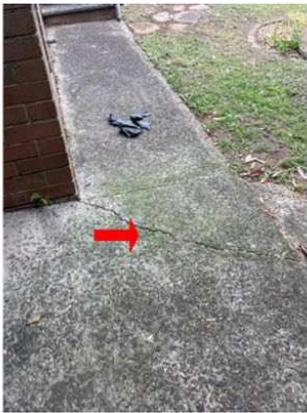
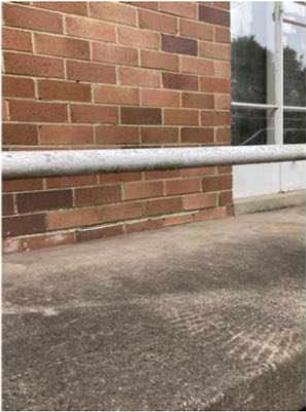
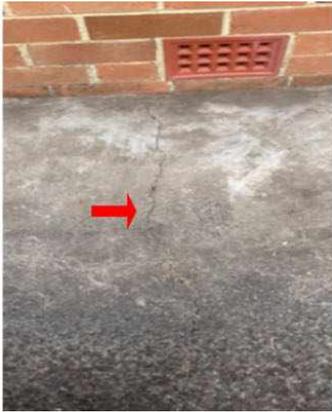
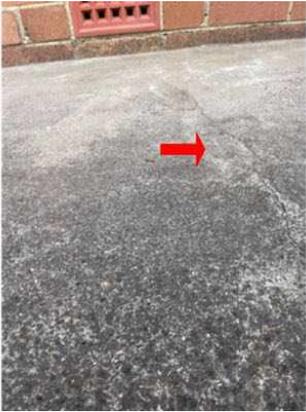
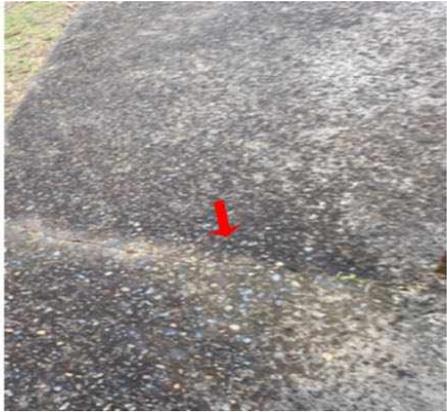
Defects 3.09

Building:	Building 1
Location:	All Areas
Finding:	Cracking - External Concrete Paving Damage Category 1 - Fine (less than 2mm)
Information:	Fine cracks were identified in external concrete paving. Although fine cracks are quite noticeable, they are often only considered to be an appearance defect, and usually do not indicate any structural damage. To be considered a Category 1 or fine crack, the crack is found to be less than 2mm in width.

Generally the cause of a hairline crack in existing concrete paving such as driveways and pathways is indicative of the expansion and contraction of the concrete. Such causes are generally due to environmental factors, such as moisture levels, weather conditions, root systems of nearby trees or the soil types on which they are laid.

Fine cracks may also be due to poor original installation of the concrete. Factors such as poor compaction of the sub surface and/or inadequate reinforcing of the slab may create cracking and other secondary defects.

Monitoring of all cracking should be conducted frequently. Always contact a building inspector should cracks widen, lengthen, or become more numerous.

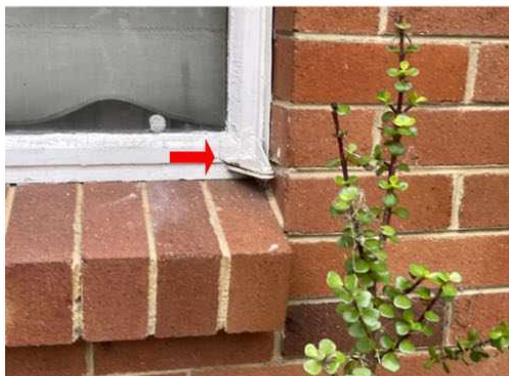
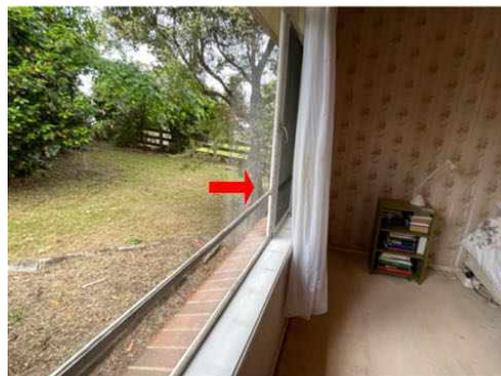
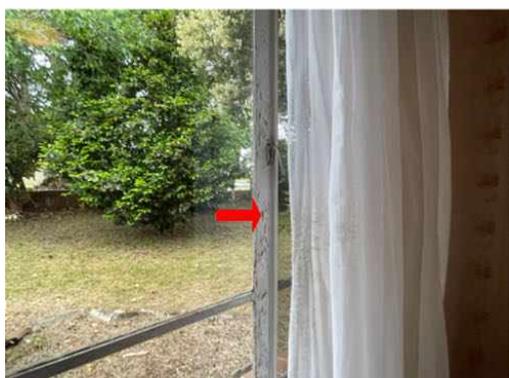
Defects 3.10

Building: Building 1
Location: All Areas
Finding: Windows - Rusted or corroded
Information: This building element shows evidence of rusting and corrosion, which is likely to have developed as a result of excessive exposure to moisture and or inadequate coatings.

Rusting and corrosion should be managed by ideally removing or limiting the affected surface from exposure to moisture. A registered builder may be appointed to replace any building elements that have been severely affected by rust or water damage.

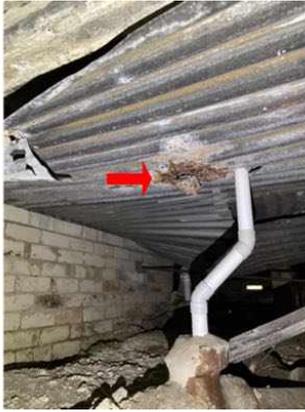
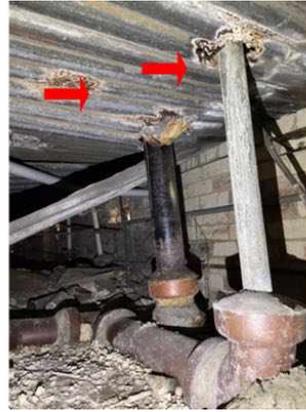
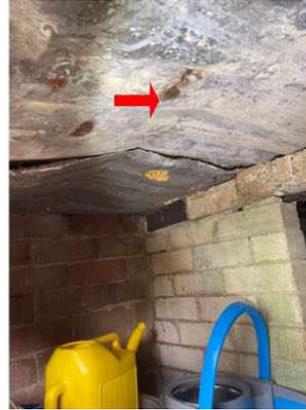
Defects 3.11

Building:	Building 1
Location:	Subfloor
Finding:	Building element - Rusted or corroded
Information:	This building element shows evidence of rusting and corrosion, which is likely to have developed as a result of excessive exposure to moisture and or inadequate coatings.

As surface rust provides no protection to the underlying iron, the deteriorating condition is likely to worsen if not addressed in the short-term future.

Where possible, the use of galvanized (treated) metals or aluminium coated metals aid in rust prevention, as does regular general maintenance. Rust formation can be controlled with coatings, such as paint, that isolate the iron from the environment.

Rusting and corrosion should be managed by ideally removing or limiting the affected surface from exposure to moisture. A registered builder may be appointed to replace any building elements that have been severely affected by rust or water damage.

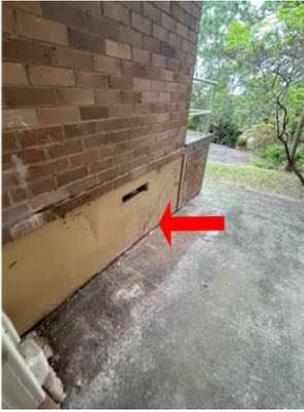
Defects 3.12

Building:	Building 1
Location:	Carport
Finding:	Painted surface - Bubbling
Information:	Sections of paint in this area was found to have bubbled and deteriorated. Paint bubbling is generally an indication of excessive moisture in the area, that is currently hidden by the painted surface.

The presence of excessive moisture can have major implications on associated building elements if left unattended. While only seemingly minor at this stage, the damage cannot be determined due to the paint obstructing any further inspection of the damage.

It is highly advised that the affected paint be cleaned to allow a further, more invasive inspection by a licensed plumber. Failure to act on this defect may necessitate major works in the future.

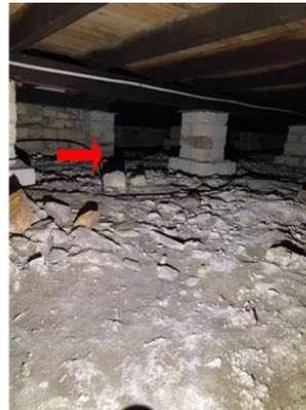
Defects 3.13

Building:	Building 1
Location:	Subfloor
Finding:	Evidence of excessive moisture was present at the time of inspection
Information:	Excessive moisture can attract termites and produce conditions that promote termite attack fungal growth and wood decay.

Excessive moisture is generally caused by deteriorated inadequate or missing roof drainage leaking plumbing pipes or fixtures poorly plumbed HWS overflows or condenser units and poor site drainage.

It is highly recommended that all plumbing and drainage fixtures and fittings be maintained regularly in order to prevent excessive moisture being present in the external / internal property.

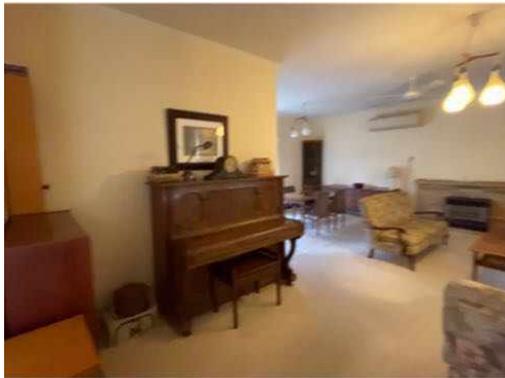
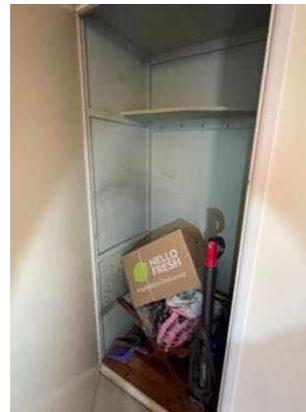
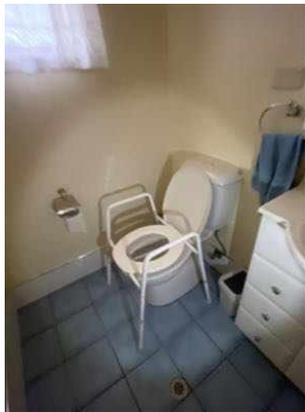
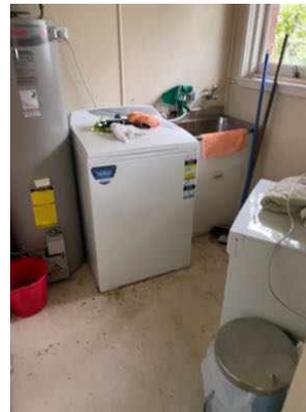
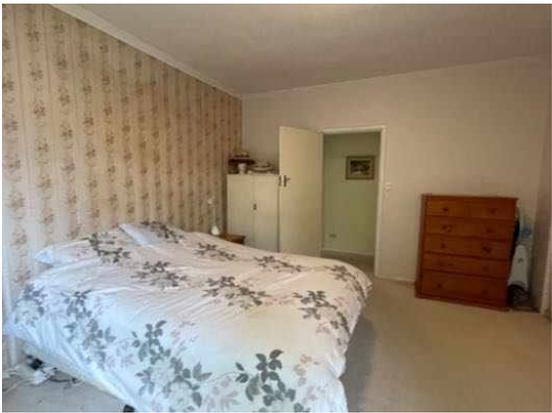
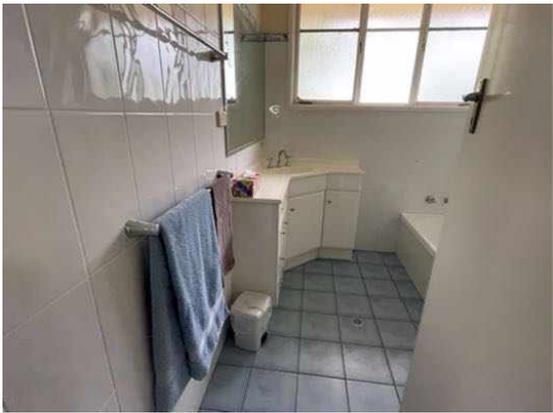
Noted Item

Building: Building 1
Location: All Areas
Finding: Additional Photos - Obstructions and Limitations
Information: These photographs are an indication of the obstructions and limitations which impeded full inspection of the property at the time of inspection. These obstructions can hide an array of defects and should be removed to allow full inspection to be carried out. A re-inspection is recommended once the areas are made accessible.

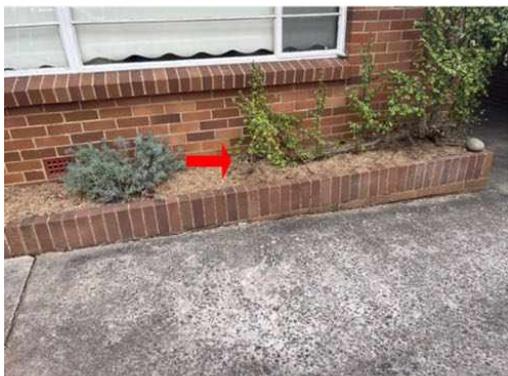
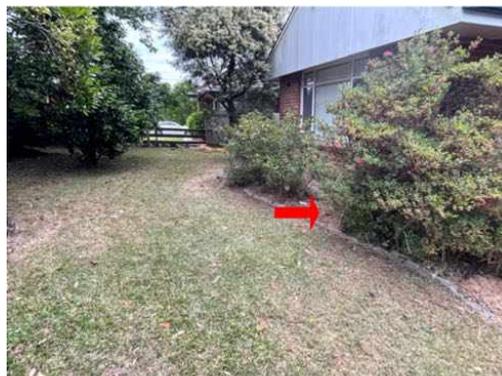
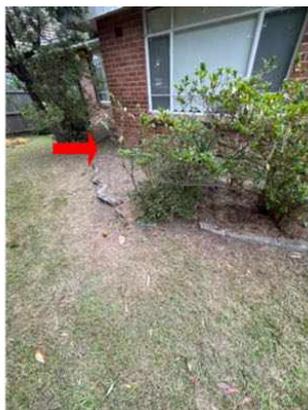
Noted Item

Building: Building 1
 Location: All External Areas
 Finding: Garden Beds - Conditions Conducive to Termites
 Information: Garden beds were found to be evident in the garden area. These garden beds can include untreated timber, and with a combination of moisture from watering hosing can make conditions conducive to termite activity and termite ingress.

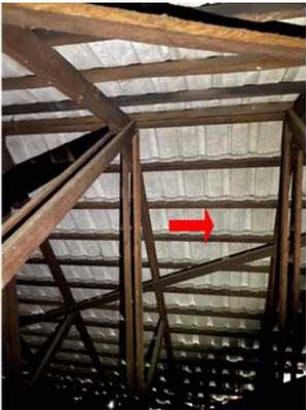
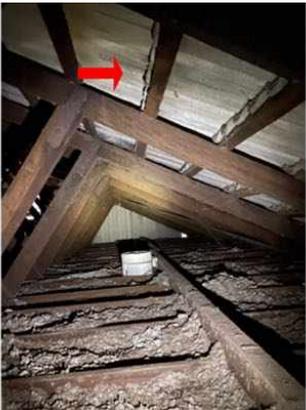
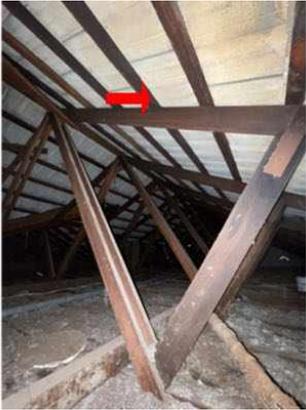
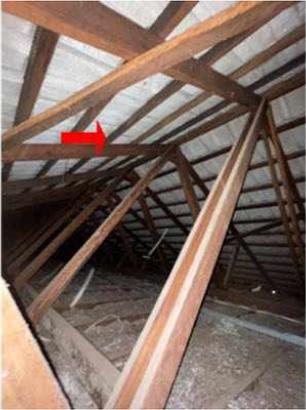
Noted Item

Building: Building 1
Location: Roof Void
Finding: Sarking - Missing
Information: Sarking is missing under the roof sheeting. Sarking acts as an insulator that helps with noise reduction and protects against water penetration. Sarking plays a key role in the operation and function of the overall roofing structure and its performance.

Although not a requirement at the time of construction, replacement of any missing building element is advisable (although this can be quite expensive to do after the time of construction). Where sarking is missing, regular inspections of the roof tiles for cracking and potential moisture penetration is required.

Sarking may be retrospectively fitted by a registered builder at the discretion of the client.
