Building Inspection Report

Inspection Date: Tue, 16 Jan 2024

Property Address: 7 Kurrajong Rd, Frenchs Forest NSW 2086

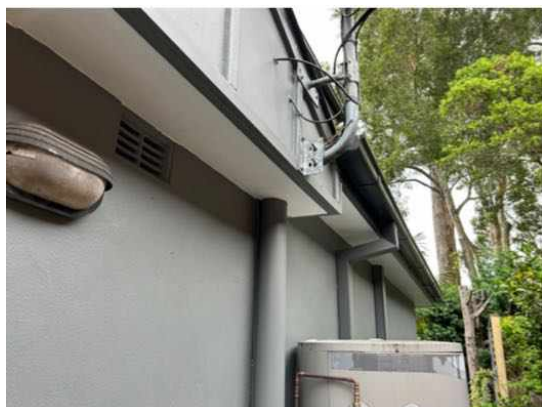
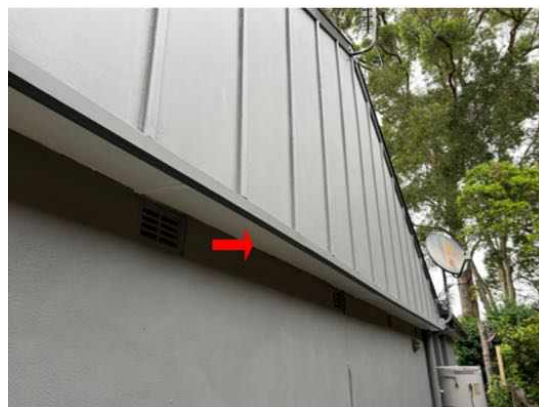
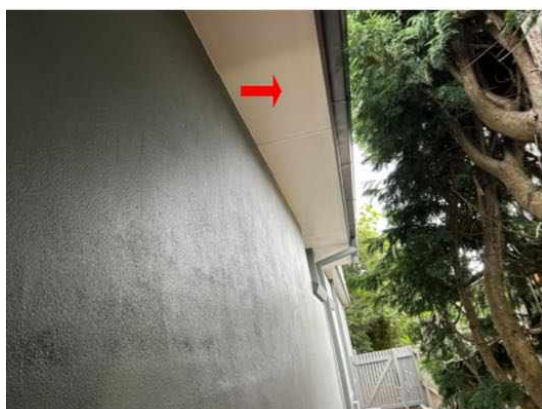
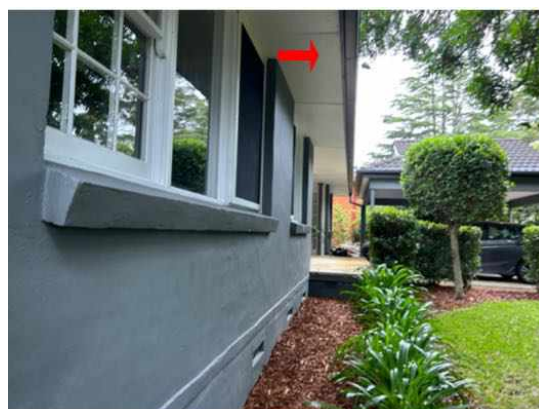
Defects 1.01

Building:	Building 1
Location:	All Areas
Finding:	Asbestos - Suspected ACM Identified on Site
Information:	Reporting on Asbestos is outside the Scope of this Report. This suspected defect is highlighted as a caution only. We suspect, based on our experience in the building industry, that there is a higher risk of the identified building element containing asbestos.

This material has been visually identified as been constructed with the use of asbestos-containing materials (ACM). The material appears to have no obvious signs of damage or deterioration, indicating that the asbestos is currently encapsulated and contained. Damaged and deteriorated ACMs have a

higher probability of releasing airborne asbestos fibres, creating a significant health safety risk.

As Asbestos Reporting is outside the scope of this report, we advise that you consider a separate Asbestos Inspection and Condition Audit, which can include the taking of samples for definitive confirmation of the presence of Asbestos.

In the interim, the client is advised to act with caution, especially when considering any damage to building materials general wear and tear renovations extensions demolition and general maintenance activities due to the suspected presence of Asbestos.

Samples for lab analysis to confirm the presence of asbestos should be taken.

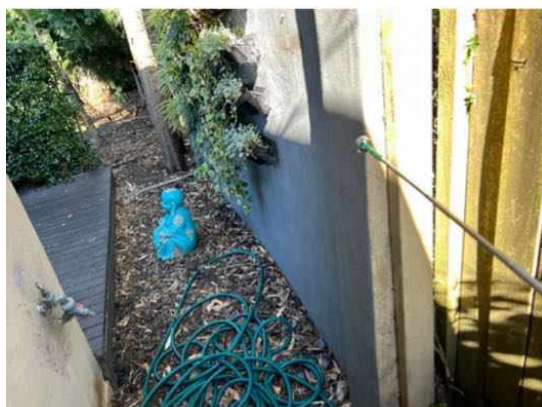
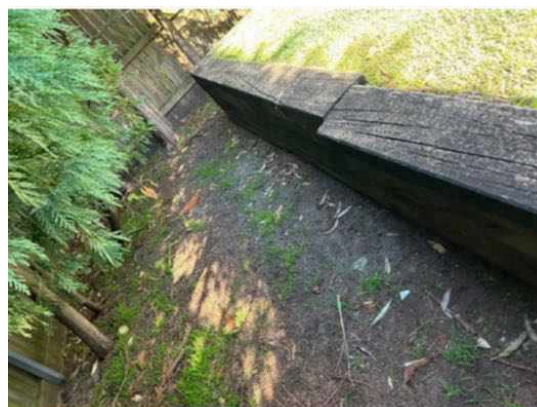
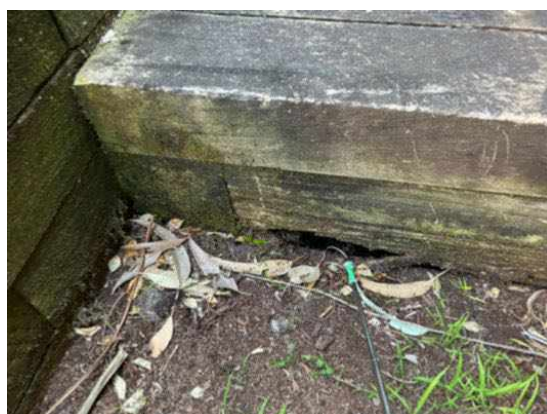
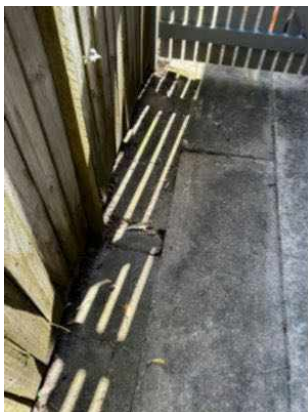
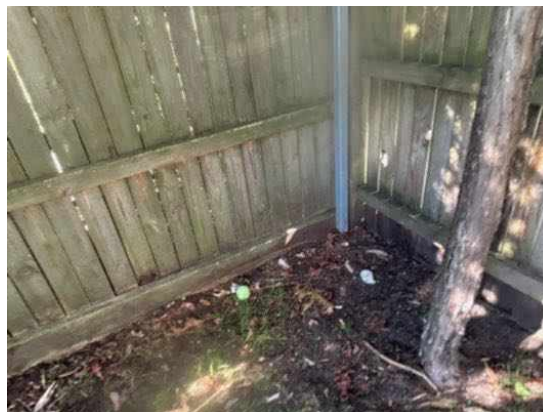
Defects 3.01

Building:	Building 1
Location:	All External Areas/ subfloor
Finding:	Evidence of excessive moisture was present at the time of inspection
Information:	Excessive moisture can attract termites and produce conditions that promote termite attack fungal growth and wood decay.

Excessive moisture is generally caused by deteriorated inadequate or missing roof drainage leaking plumbing pipes or fixtures poorly plumbed HWS overflows or condenser units and poor site drainage.

It is highly recommended that all plumbing and drainage fixtures and fittings be maintained regularly in order to prevent excessive moisture being present in the external / internal property.

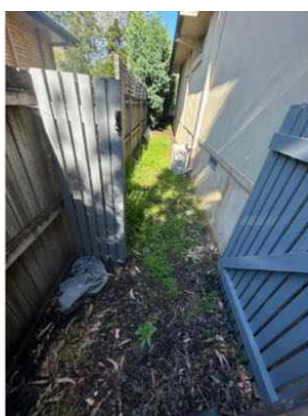
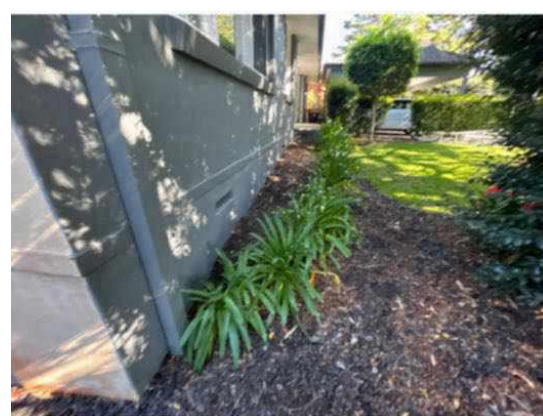
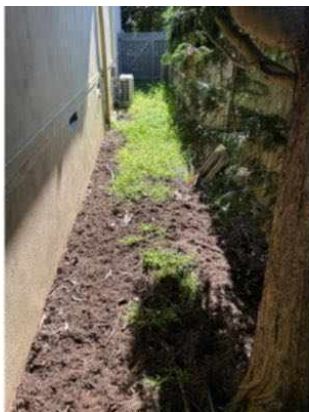
Defects 3.02

Building:	Building 1
Location:	All External Areas
Finding:	Site drainage - suspected Inadequate
Information:	The site drainage in this area was found to be inadequate at the time of inspection, creating potential for subsequent water damage to associated building elements.

It is important that water does not lie against the base of walls; surrounding paths and ground levels should be sloped to drain water away from walls. Downpipes should not discharge stormwater onto lower walls or plinths. Stormwater should be carried away by large, regularly cleaned drains. Ground levels may need to be lowered to expose a buried DPC.

Where site drainage is inadequate, installation of an Agricultural (Aggie) Drain may be required. A qualified plumber should be appointed to further inspect the property and perform any remedial works as necessary. Water damage and secondary defects are likely to occur if left unmanaged.

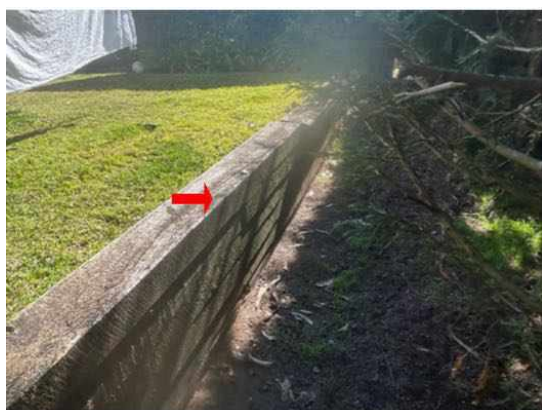
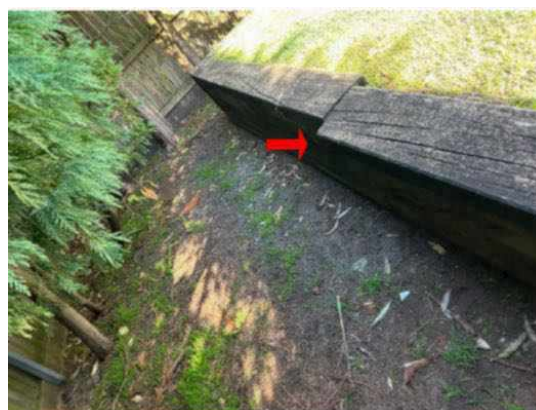
Defects 3.03

Building:	Building 1
Location:	All External Areas
Finding:	Retaining wall - Defective
Information:	The retaining wall in this area was found to be defective at the time of inspection. Generally, defective retaining walls are caused by poor original design or material use. However, deteriorated retaining walls may also be a result of substandard construction, poor site drainage or unmanaged stormwater flows.

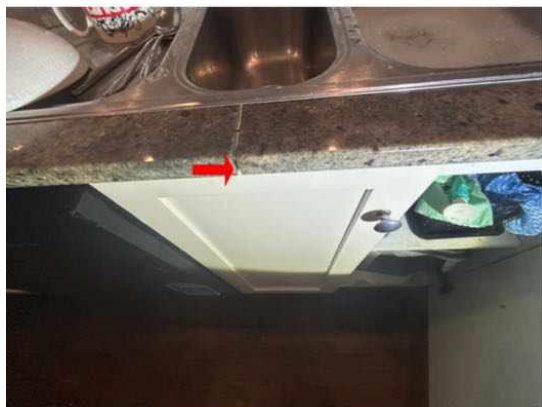
Defects 3.04

Building:	Building 1
Location:	Kitchen
Finding:	Sealant - missing/ deteriorated/ maintenance
Information:	Flexible and mould resistant materials should be applied to affected areas to prevent any subsequent water damage that is likely to occur. Regular maintenance and replacement of damage or missing or damaged sealant and grout is highly recommended to the wet areas, as this is a regular wear and tear defect.

Sealant and grouting in areas that come into regular contact with water should be maintained for the long term care of your property. A sealant specialist or tiling contractor should be appointed to complete these works.

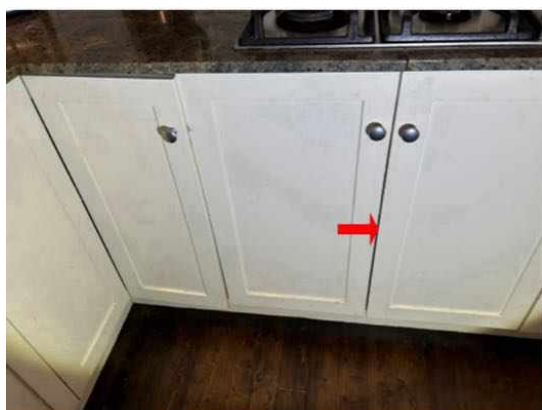
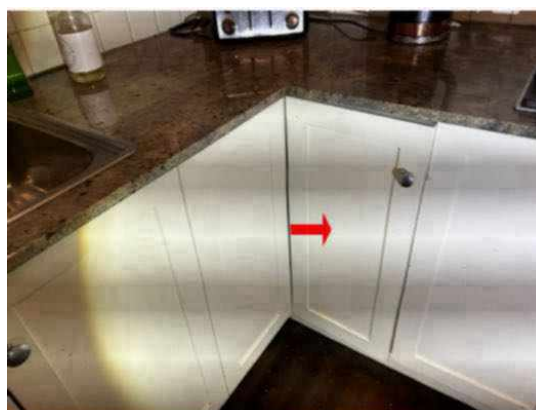
Defects 3.05

Building:	Building 1
Location:	Kitchen
Finding:	Cabinetry- Evidence of damaged
Information:	Rectification works may include replacement of cabinetry depending on the extent of the damage.

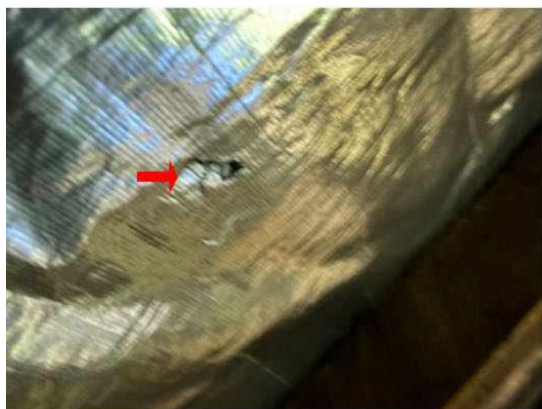
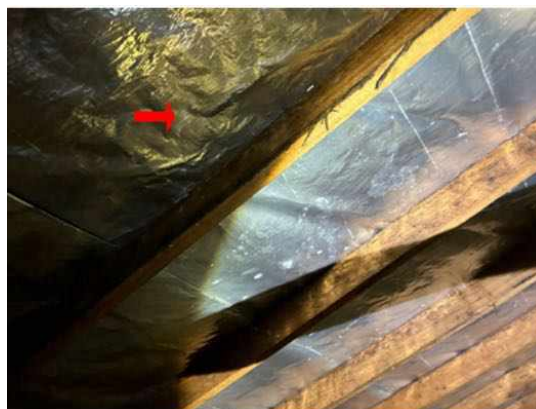
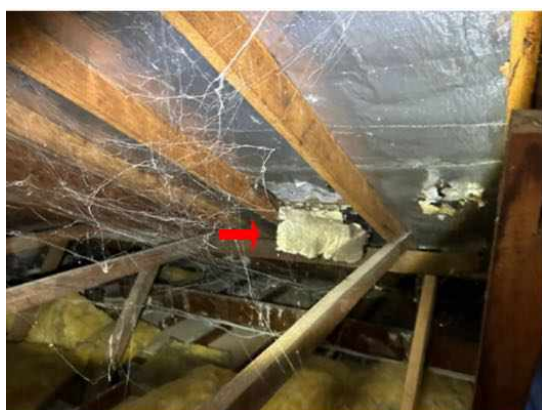
Defects 3.06

Building:	Building 1
Location:	Roof Void
Finding:	Sarking - Damaged
Information:	Sarking, a laminated aluminium foil applied to the interior of the roof covering, assists in insulating the property and acting as a vapour-barrier to the roof void and, subsequently, to the household.

Where sarking is damaged, both insulation and moisture protection of the property are inhibited. This creates a loss of energy and thus negatively impacts the energy efficiency of the property, allowing potential for moisture ingress from condensation or leaking roof tiles.

It is important to repair any holes or damaged sections of sarking to ensure that the building material is fully functional. A registered builder or qualified carpenter should be consulted to provide further advice on this defect and to perform rectification works at client discretion.

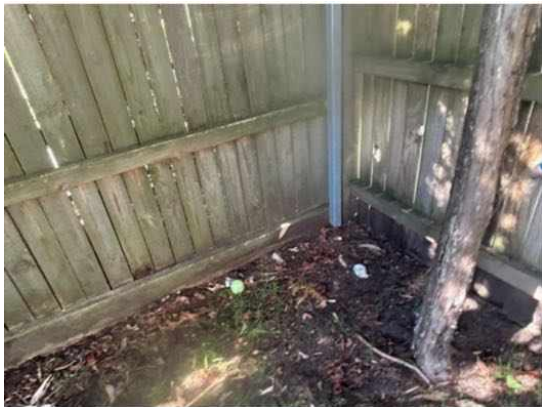
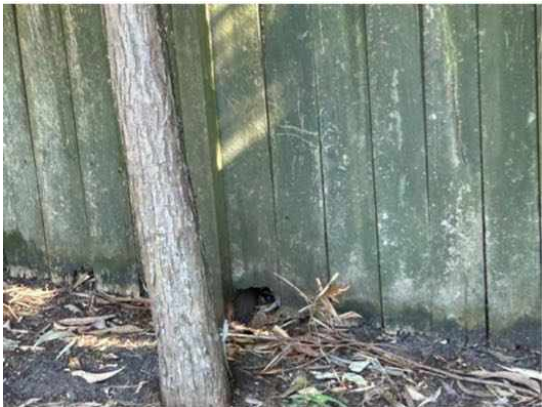
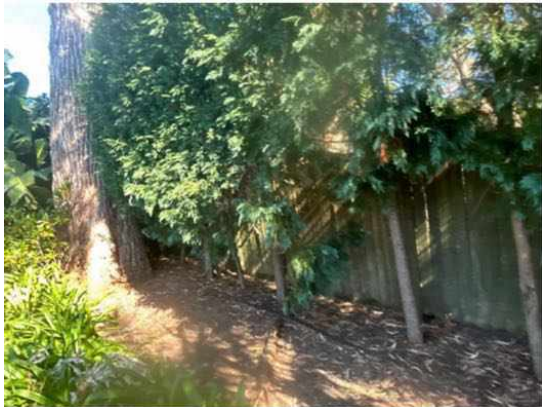
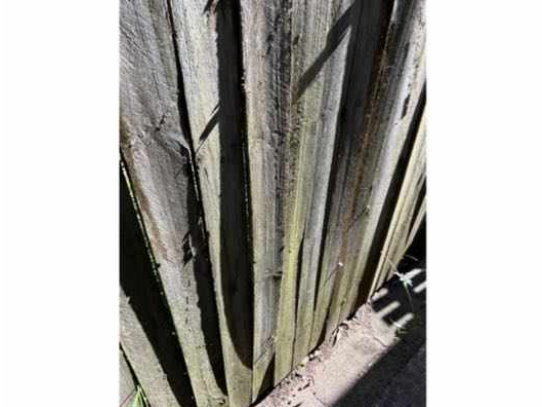
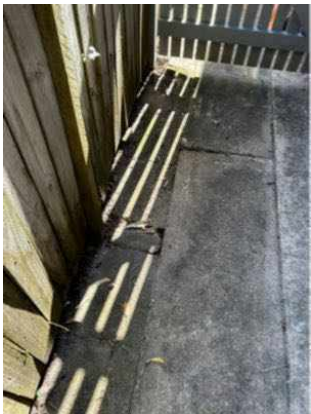
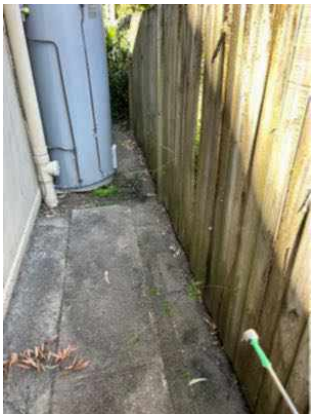
Defects 3.07

Building:	Building 1
Location:	All Areas
Finding:	Fencing - Deteriorated
Information:	It was noted at the time of inspection that sections of the fencing throughout the property have deteriorated. Typically fencing deteriorates due to age and or wear, rot and or rust which is generally expected for a structure of this age, due to prolonged exposure to weather conditions. Sometimes inadequate installation or maintenance can be to blame.

If left unattended, it is likely that further damage will occur. It is suspected that repair of several elements of the fencing may be required however replacement may be a consideration of the client also.

A licensed fencing contractor should be appointed to provide further advice and perform rectification works as necessary.

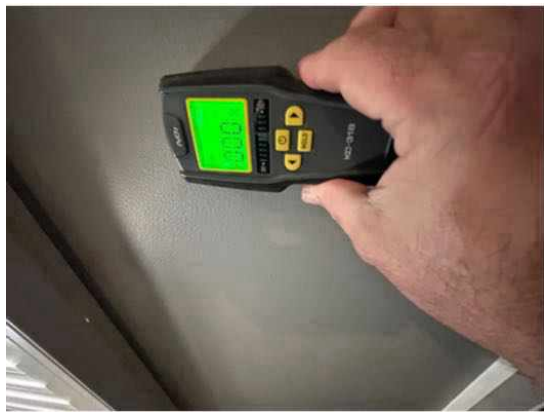
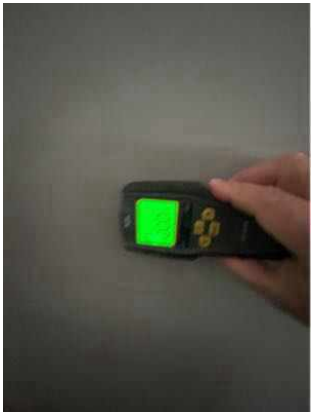
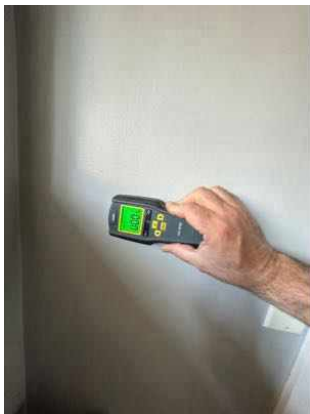
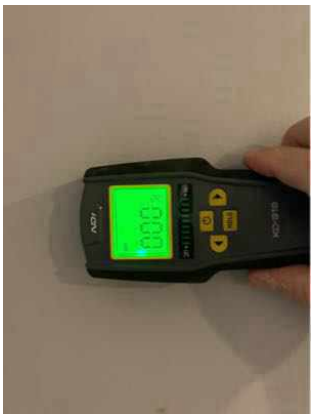
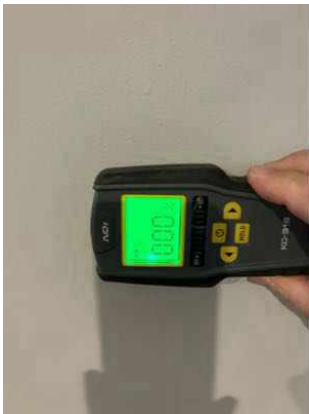
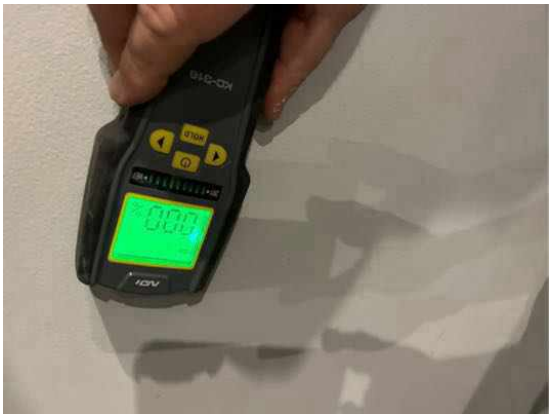
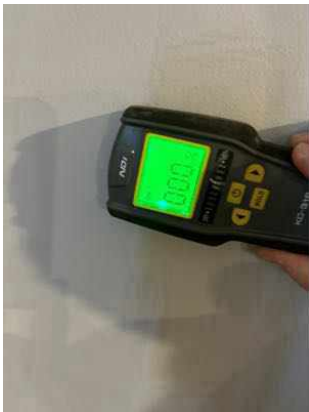
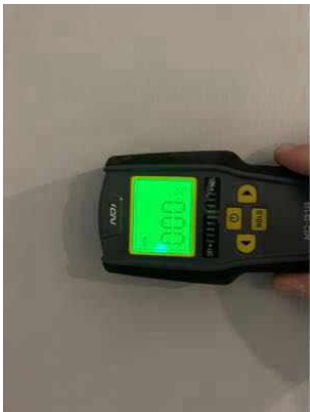
Building: Building 1
Location: All Areas
Finding: Moisture meter readings - low
Information: The moisture meter result for the areas inspected.

The moisture reading of 0-15% is quite normal and gives no cause for concern.
However, moisture readings in excess of 15% indicate the need for further inspection.

Levels between 25-30% indicate that there may be water ingress, meaning that remedial work could be required.

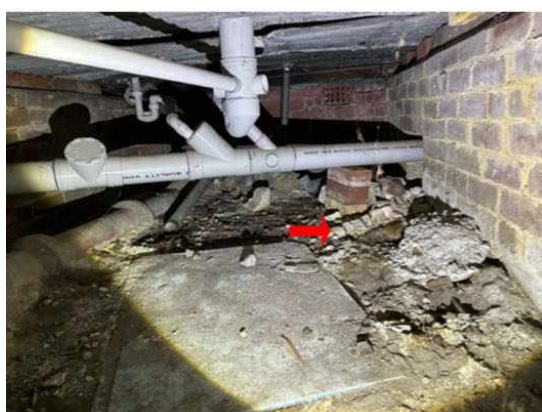
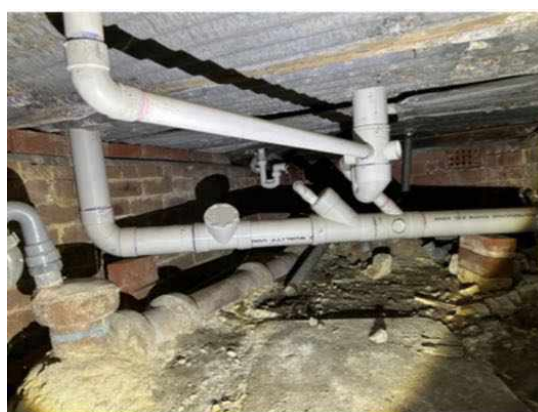
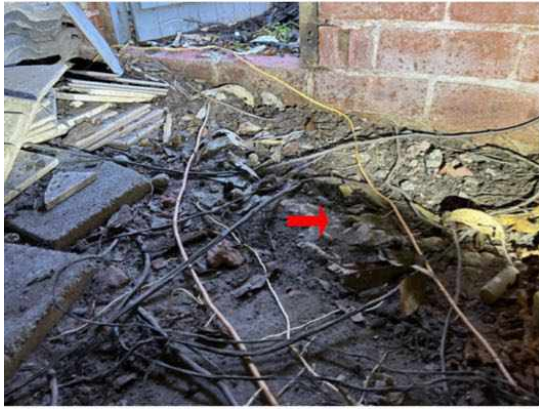
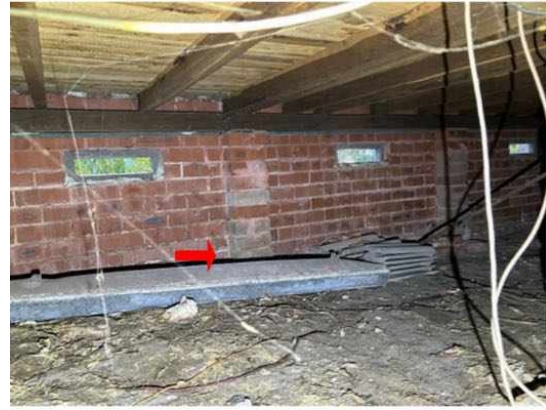
Finding: Subfloor - Debris

Information: An array of debris was found in the subfloor area at the time of inspection. Debris in this area restricts subfloor ventilation and creates potential for concealed pest entry. Stored timbers and other materials may also make the area susceptible to termite activity and wood rot.

A clear and empty subfloor will be better ventilated and easier to maintain in a dry condition. The removal of any timber debris is vital in minimising the risk of termite or wood borer activity.

Debris in the subfloor should be removed as soon as possible. Depending on the location and amount of debris and stored items, the homeowner may elect to undertake this task. Alternatively there are a large number of rubbish removal subcontractors that could undertake these works.

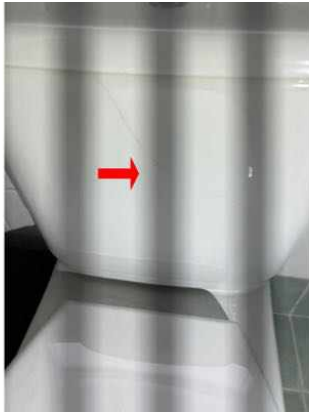
Finding: Toilet system - Damage Category 0 - Hairline (less than 1mm)

Information: Hairline cracks are very minor in nature and generally are only ever an appearance defect. While such cracking may be noticeable in some cases, it is quite common and does not indicate any structural damage.

Monitoring of all cracking should be conducted frequently. Always contact a builder should cracks widen, lengthen, or become more numerous.
