## **VISUAL BUILDING AND PEST INSPECTION REPORT**

Complies with Australian Standard 4349.1 & 4349.3

21 Nicholas Avenue Forestville

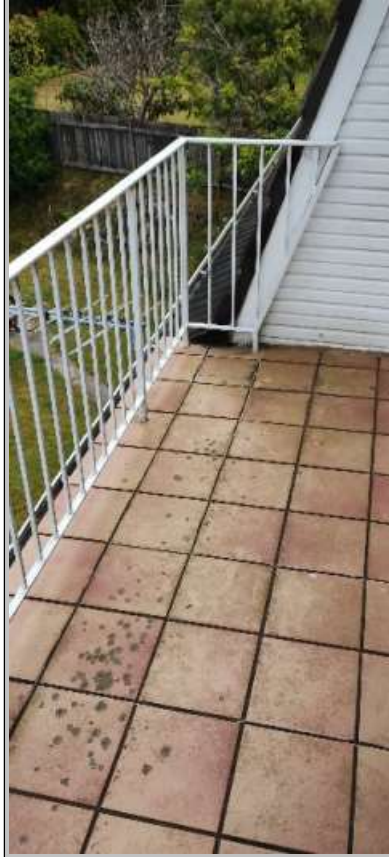
Rear elevation.

The general condition of this structure is fair.

Some evidence of water damage to lounge ceiling below. No moisture detected at time of inspection. Flashing to sills or waterproofing / sealing to area may be required.

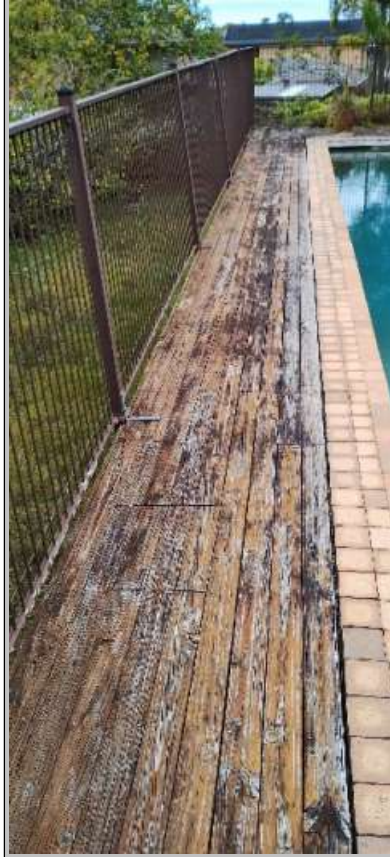
Adjacent pool.

Moderate wood decay is present to the structure and decayed timbers should be replaced.

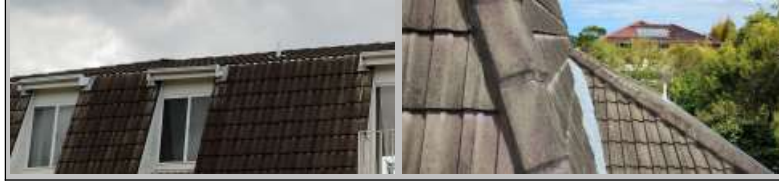
The overall condition of the roof coverings is fair. Surface of the concrete tiles is deteriorating and the area requires sealing.

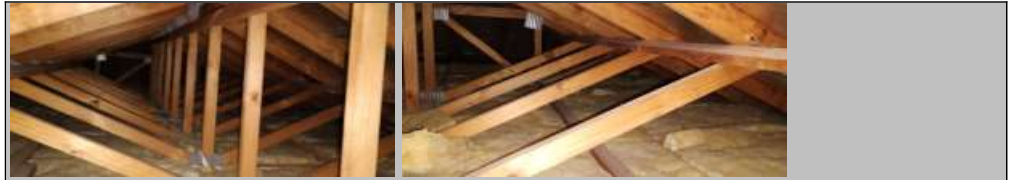
Body access into the roof void was restricted and access was not gained to any areas beyond the roof access hole.

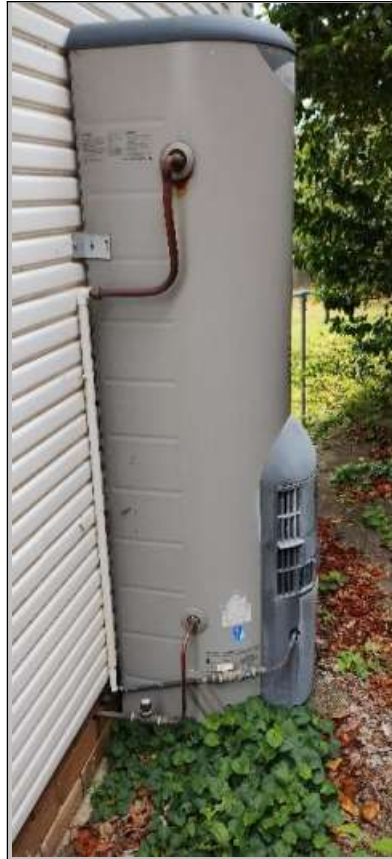
Gas hot water system: Mains pressure: Located externally: The hot water system appears to be in working condition. No specific tests other than running the hot water tap were carried out. No determination has been made as to the suitability or adequacy of the hot water system in relation to capacity or otherwise.

The unit was manufactured in 2007.

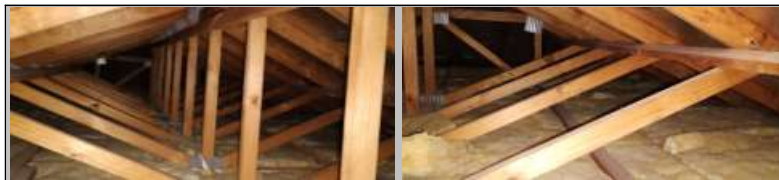
Body access into the roof void was restricted and access was not gained to any areas beyond the roof access hole.
