Affordable Inspections

1,2 & 3/25 Palmer Street Georgetown

1st September 2021

Building Report

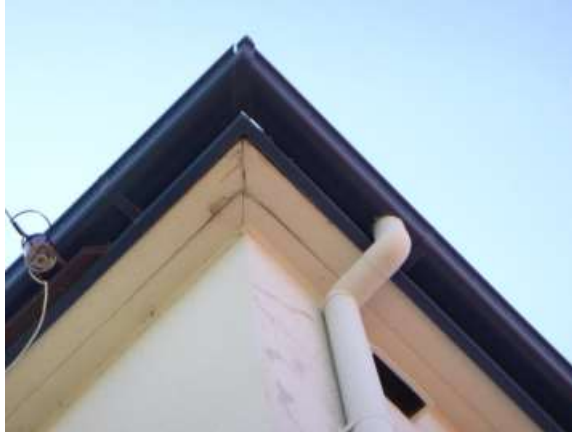
The eaves are lined with timber lining boards. The overall condition of the eaves lining is good. The paint work to the eaves is deteriorating and maintenance is required.

**The following action is
recommended:**

A Licensed painter should be called to make a further evaluation and repairs or rectification as needed.

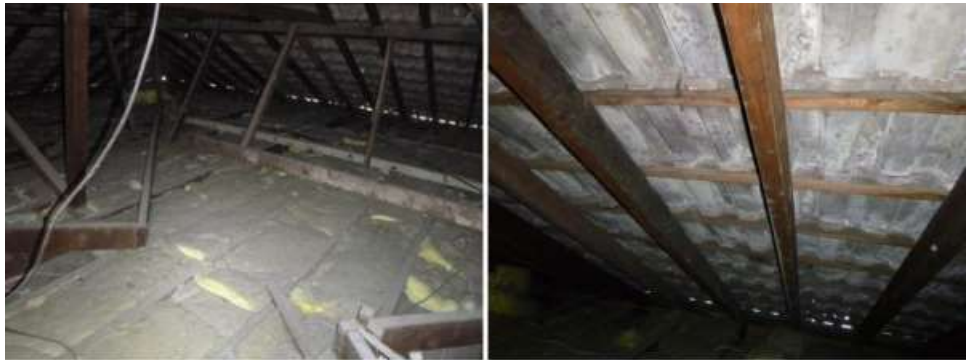
Roof Supports - Type and Condition: The cut and pitched roof timbers appear to provide adequate support.

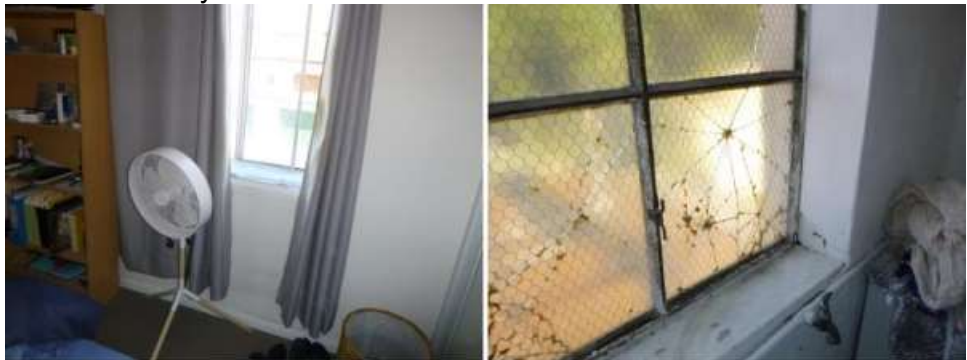
Windows Condition: The condition of the windows is generally good. Adjustment is required to some windows to ensure smooth operation. Cracked glass was evident and will require replacement. Sill height to the window(s) is below BCA Standards and may be a hazard. Recommend the sill be raised or a safety rail be installed, seek advice for current Rules & Regulations on window requirements.

Location/area To all 3 units. Low windows were noted upstairs unit 3. Cracked glass was noted in laundry.

The following action is recommended: A licensed builder should be called to make a further evaluation and repairs or rectification as needed. A glazier should be called to make a further evaluation and repairs or rectification as needed.

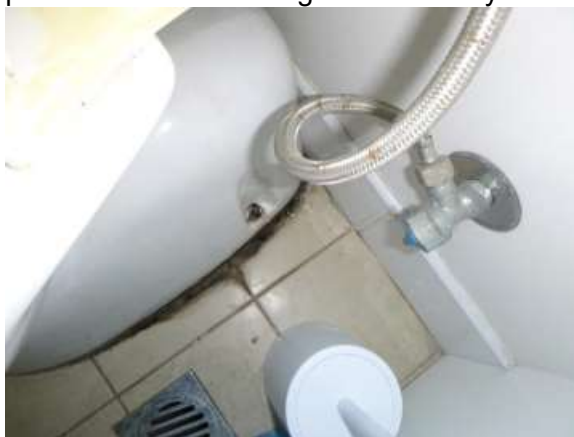
Toilet Condition: The toilet appears to be in working order. A leak is present at the rear of the toilet pan and appears to be caused from a leaking pan seal or cistern leak. A plumber should investigate and rectify the leak.

The following action is recommended: A Licensed plumber should be called to make a further evaluation and repairs or rectification as needed.

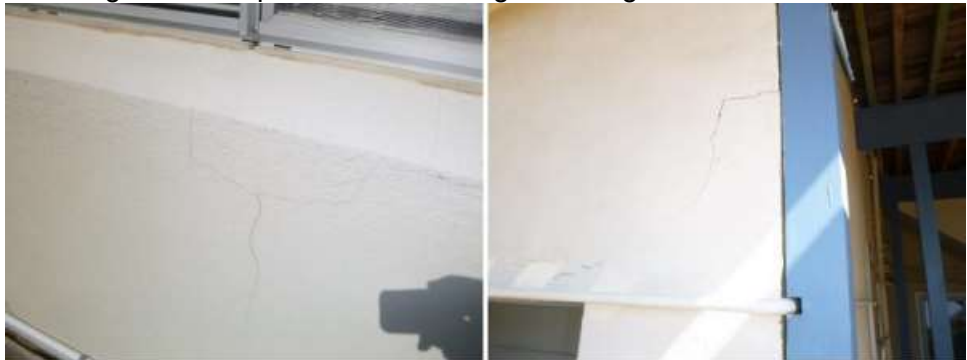
Position/Location: All elevations.

Cracking to Masonry or Concrete Elements: Cracks are evident. Visible cracking has been categorized as a serviceability defect. Cracking of a building element is a serviceability defect where in the opinion of the inspector the function of the building element is impaired however, the expected consequence of this cracking is unknown until further information is obtained.

Cracking can be expected in a building of this age and construction.

The following action is recommended: A licensed builder should be called to make a further evaluation and repairs or rectification as needed.

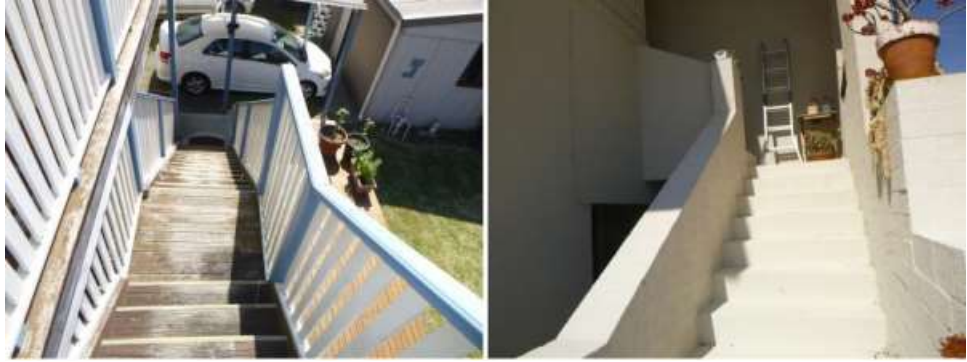
Type & Condition: Timber stair structure needs to be checked by a qualified builder and/or engineer on a regular basis for structural adequacy. The stairs are constructed primarily from timber, Paint deterioration was noted to framework. Handrail requires repairs.

. The front stairs are constructed primarily from concrete the overall condition of the stairs is fair. The handrails and balustrades do not appear to comply with the current BCA Standards for height and spacing. Although this report does not generally comment on items of compliance, this issue may become a safety issue and therefore was included in this report. Recommend a builder or engineer to provide a scope of works to make safe as this is a fall hazard especially for children.

The following action is recommended: A licensed builder should be called to make a further evaluation and repairs or rectification as needed. A Licensed painter should be called to make a further evaluation and repairs or rectification as needed.

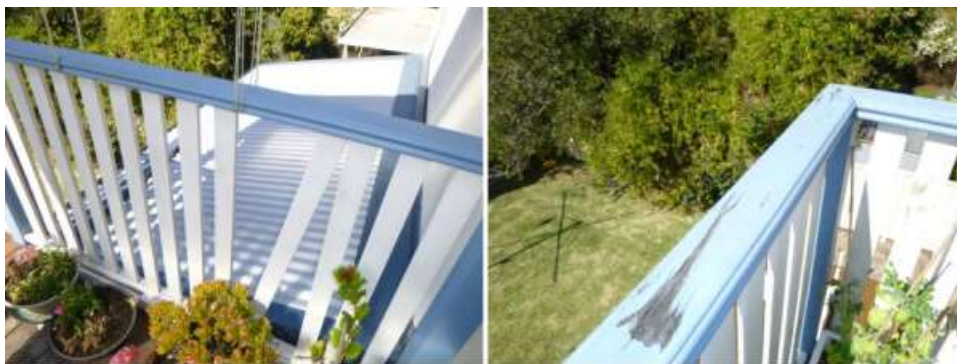
Position/Location:	Rear elevation.
Construction & Condition:	Constructed from timber. Constructed from metal.
Roof Construction:	The roof is of skillion construction.
Roof is covered with:	Corrugated steel: Polycarbonate:
Roof Covering Condition Detail:	The overall condition of the roof coverings is fair.
Defects or Maintenance Items:	Timber structure needs to be checked by a qualified builder and/or engineer on a regular basis for structural adequacy. Handrail requires repairs. Paint deterioration was noted to framework.

The following action is recommended: A licensed builder should be called to make a further evaluation and repairs or rectification as needed. A Licensed painter should be called to make a further evaluation and repairs or rectification as needed.

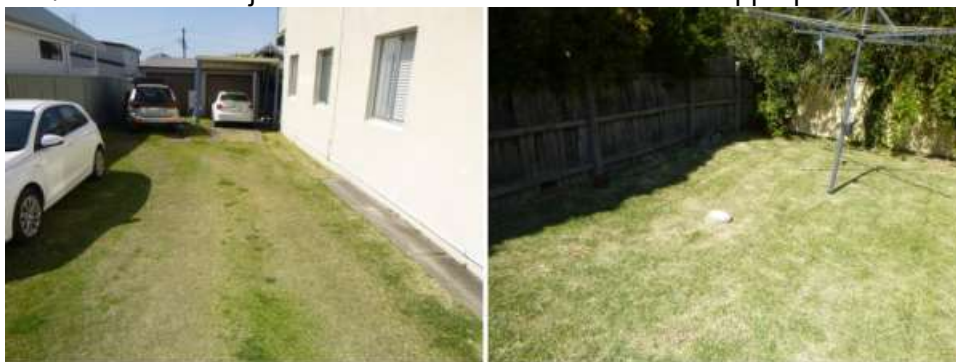
Description: Low areas on property (paths, pavers, grass areas etc) require adjustment and/or soil level adjustment to divert stormwater to the appropriate drains.

The following action is recommended: A licensed builder should be called to make a further evaluation and repairs or rectification as needed. A Licensed plumber should be called to make a further evaluation and repairs or rectification as needed.

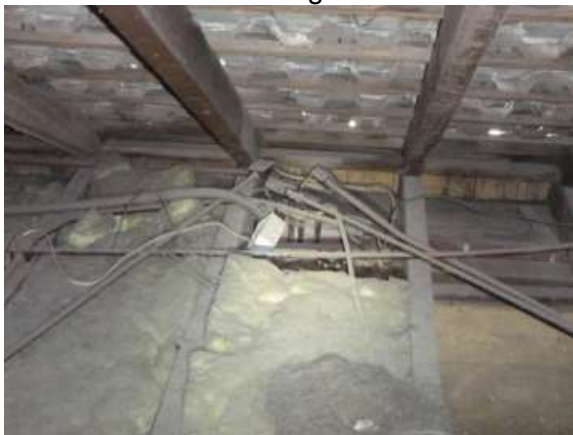
Gas is connected to the premises but has not been inspected. Downlights are required to be installed with clearance around the insulation, do not cover installed down lights as overheating of the units may occur. An electrician is required to check and adjust batten clearance to comply with the safety requirements, The downlights require further checking to ensure they are not located within 200mm of a structural ceiling/roof timbers, where timber is located within 200mm of the downlight then a heat dissipating shroud is required to be installed. Alternate light globes maybe an option seek a qualified electrician for advice. The cold water was operational but the adequacy was not tested and is not commented on. Smoke detectors are fitted however, the positioning, operation or adequacy was not tested and is not commented on. Some old conduct wiring was noted in roof void.

**The following action is recommended:**

An electrician should be called to make a further evaluation and repairs or rectification as needed.
