## **VISUAL BUILDING & PEST INSPECTION REPORT**

### **Vendor Report**

**79 Lonsdale Avenue, Berowra Heights**

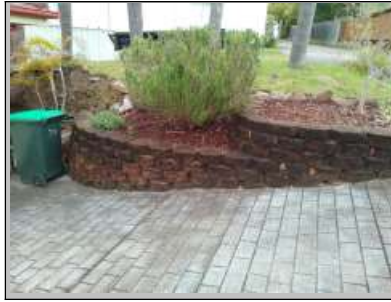
The masonry retaining walls appear in acceptable condition.

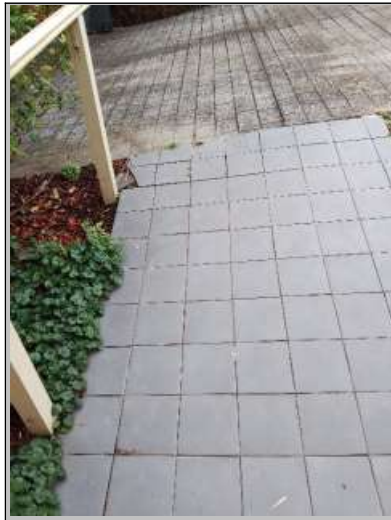
The paths/paved areas are in fair condition. Some cracked tiles at front requires replacing.

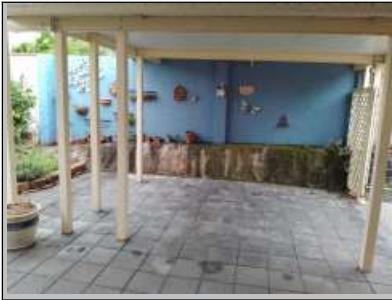
Position/Location: Rear elevation.

Construction & Condition: Constructed from concrete or masonry. The condition of the structure is generally acceptable.

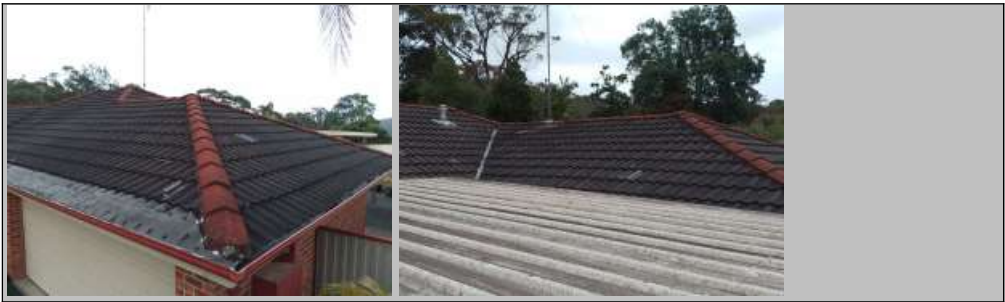
The roof is of pitched construction.

The overall condition of the roof coverings is fair.

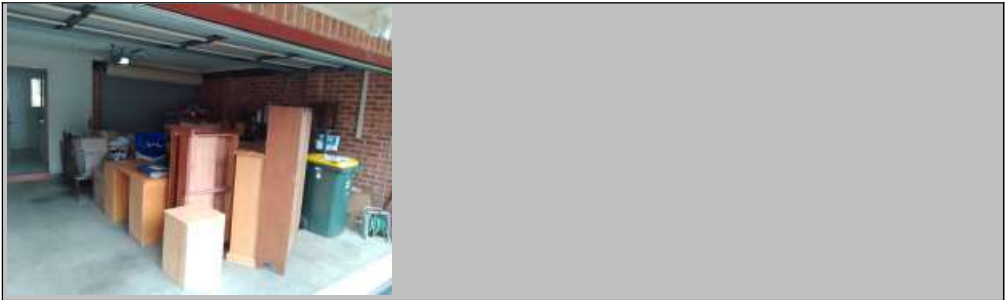
Garage.

Under the main roof.

The structure is generally in good condition.

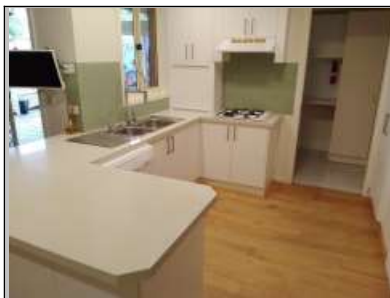
The condition of the fixtures is generally good, A glass splashback is located over the benchtop area. Glass appears to be in serviceable condition.

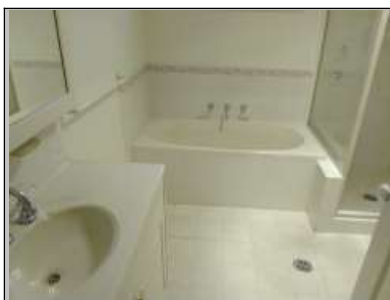
Adjacent to hall.

The shower recess was tested and there was no visible water penetration to surrounding areas. **IMPORTANT NOTE:** This test may not reveal water leaks until the shower is put into constant use and surrounding areas monitored over a period of time.

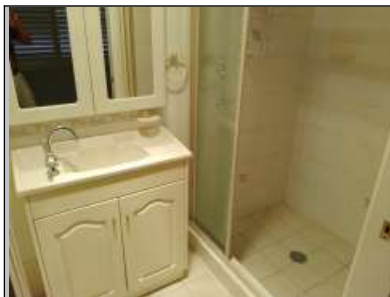
Front.

The shower recess was tested and there was no visible water penetration to surrounding areas. IMPORTANT NOTE: This test may not reveal water leaks until the shower is put into constant use and surrounding areas monitored over a period of time.

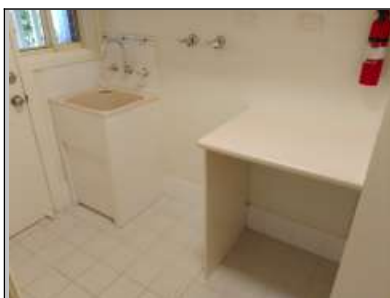
Level three. Adjacent to the kitchen.

The tub and taps appear serviceable. Drain appears serviceable.

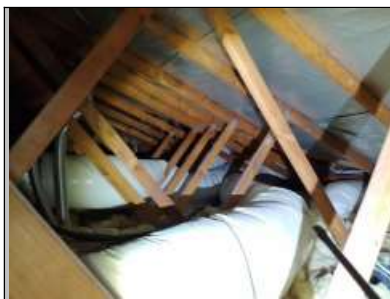
Ducting associated with air-conditioning or heating restricted inspection. Inspection was restricted above the following locations and or areas: bedrooms and lounge.

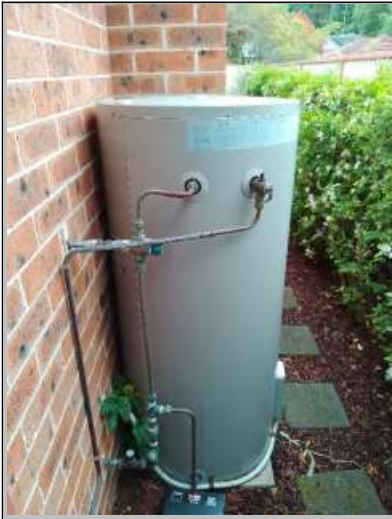
| Type/Condition: | Mains electric hot water system: Mains pressure: Located externally: The hot water system appears to be in working condition. No specific tests other than running the hot water tap were carried out. No determination has been made as to the suitability or adequacy of the hot water system in relation to capacity or otherwise. |

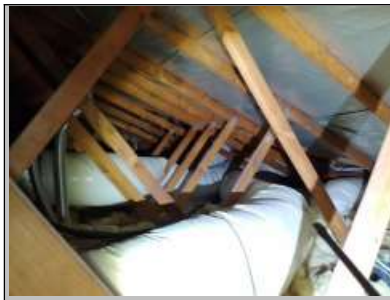
Ducting associated with air-conditioning or heating restricted inspection. Inspection was restricted above the following locations and or areas: bedrooms and lounge.

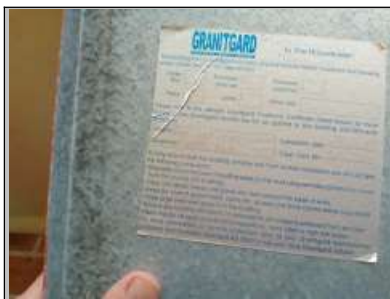
A notice indicates that the property may have been treated during construction in respect to protection against subterranean termite attack. We strongly recommend any prospective purchaser attempt to verify this information and obtain copies of all relevant documentation.
