Building Inspection Report

Inspection Date: Mon, 19 Aug 2019

Property Address: 11 Lee Road, Beacon Hill NSW, Australia

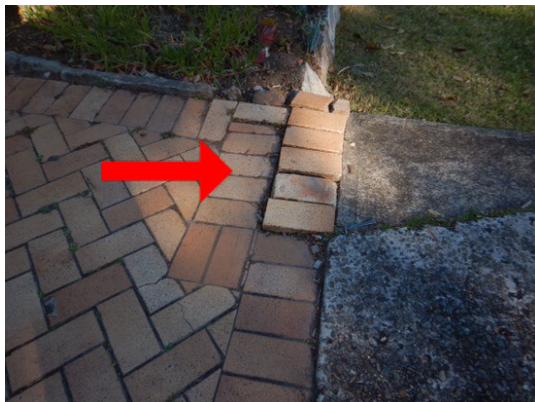
Defects 3.01

Building:	Main Building
Location:	Yard - Front
Finding:	Paving - Uneven
Information:	This paved area are uneven, creating a potential trip hazard. It appears as though the area has been subject to rough installation, or that paving sections have lifted due to movements in the foundation of the property.

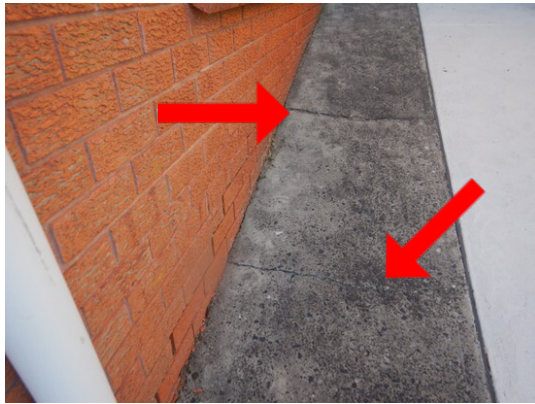
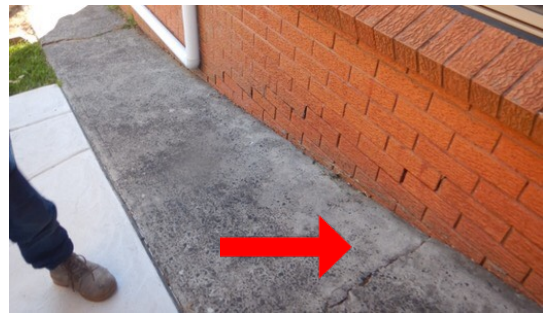
Defects 3.02

Finding: Cracking - External Concrete Paving

Information: Cracks were identified in external concrete paving. Cracks are generally found in older concrete paving, and may also present as a trip hazard as consequence of an uneven or curved surface.

General age and expected deterioration of the paved areas is a common cause of this type of cracking.

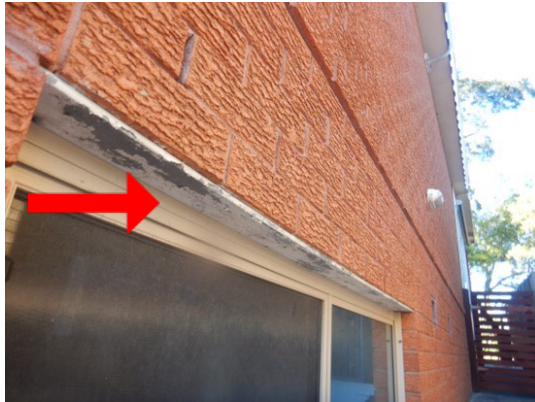
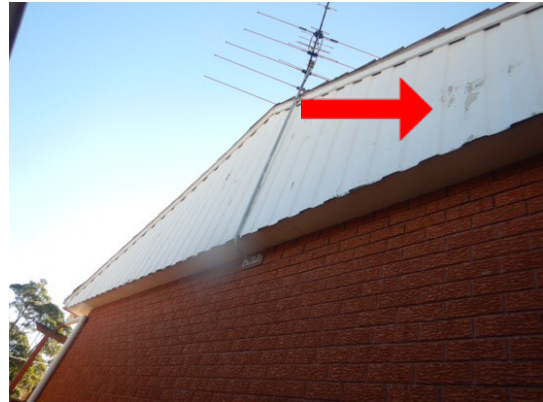
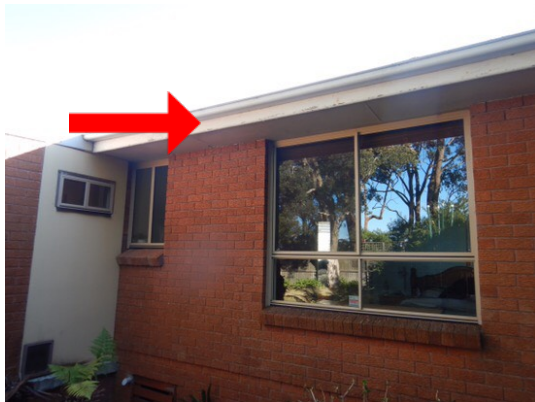
Defects 3.03

Building:	Main Building
Location:	All Areas
Finding:	External painting deteriorated
Information:	a few areas of the external paint work have been neglected and require attention to prepare and re paint.

Whilst deteriorated paint finish is generally an appearance defect, it can also lead to the development of secondary building defects over time. Incomplete areas of paint finish exposes the area to moisture, potentially accelerating the deterioration of underlying building materials.

Deteriorated paint finishes should be sanded back, filled, leveled and painted, as applicable. Where inadequate or missing paint protection has led to the deterioration of the associated building element, repair and/or replacement of this building element may be required.

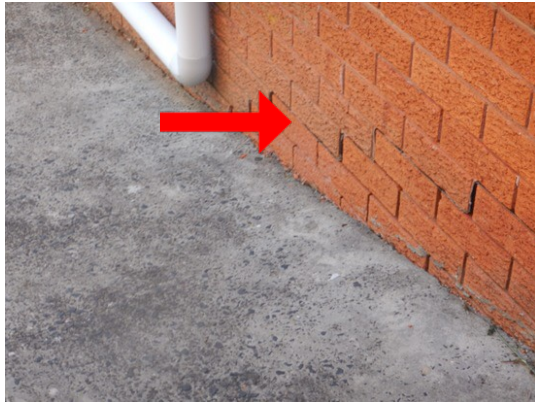
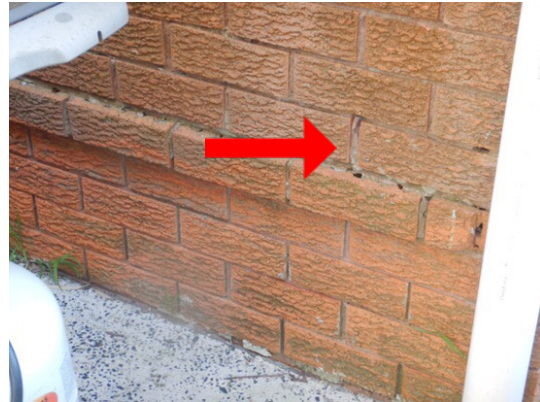
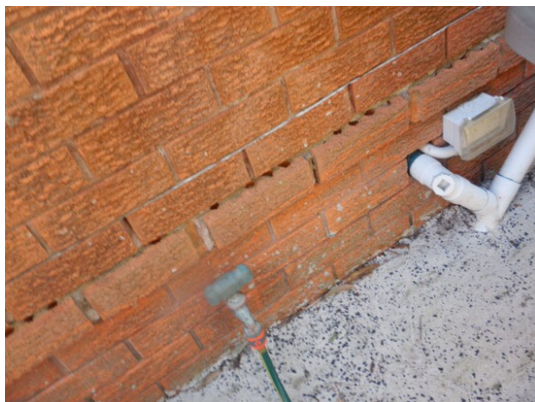
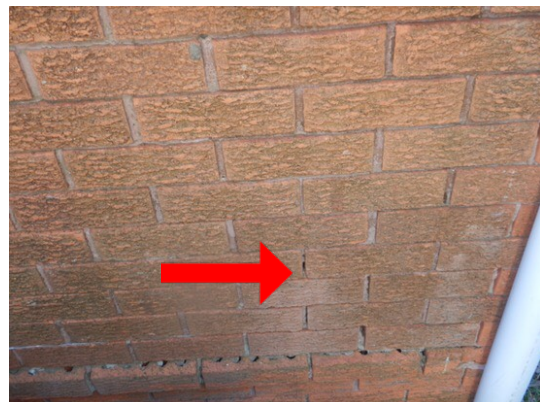
Defects 3.04

Finding: Brickwork - Deteriorated mortar

Information: Mortar, or 'bedding', is the material which fills joins and intersections between bricks in masonry walls and structures. Sections of mortar in this brickwork were identified as having deteriorated, which is generally expected for a property of this age and condition.

Mortar may deteriorate as a result of age of building materials, minor movement of bricks, or frequent exposure to weathering. Mortar should be replaced to ensure that bricks remain in their intended location and to prevent gaps, which would allow water or moisture ingress and secondary damage as a result.

Mortar deterioration can be addressed by a bricklayer where areas of deterioration are localised and easily accessible.

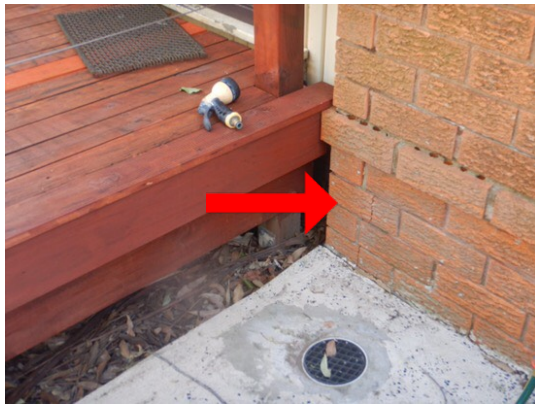
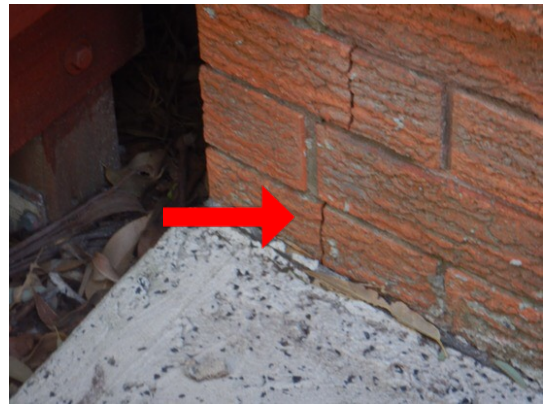
Defects 3.05

Building:	Main Building
Location:	All Areas
Finding:	Brickwork - Cracking [Fine]
Information:	Although fine cracks are quite noticeable, they are often only considered to be an appearance defect and usually do not indicate any structural damage. Generally, the cause of a fine crack is indicative of a separation between brickwork and mortar throughout the structure, but single bricks may also show cracks of this nature.

Cracking of this nature can generally be repaired with minor filling and should be conducted by a qualified bricklayer.

Always contact a builder should cracks widen lengthen or become more numerous.

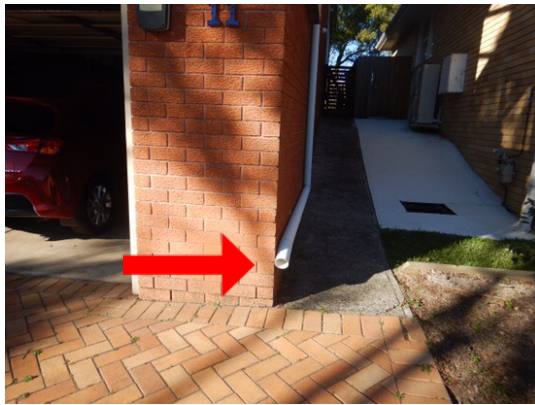
Defects 3.06

Building:	Main Building
Location:	Yard - Side
Finding:	Stormwater drain - Not connected
Information:	The roof plumbing is not adequately connected to stormwater drainage on the site. This disconnection negatively impacts the functional capacity of the roof plumbing.

Where roof plumbing doesn't drain adequately, the area at the base perimeter can become excessively damp, potentially creating an environment that is susceptible to rust and corrosion of surrounding building elements, as well as attracting termites and other pests.

It is recommended that a plumber be appointed to further inspect the area and to install adequate drainage equipment where necessary.

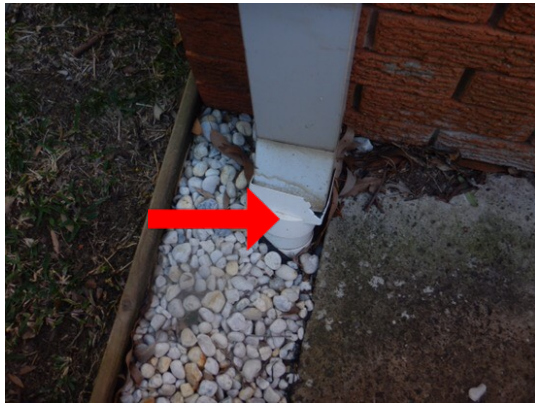
Defects 3.07

Building:	Main Building
Location:	Yard - Side
Finding:	Plumbing fitting - Broken
Information:	Breakage occurs generally when the plumbing fittings have either aged and decayed, or as a result of damage (accidental or deliberate).

Repair and/or replacement of broken elements is advised to ensure that additional secondary defects do not arise as a consequence. Such works are necessary, as all building elements play a key role in the operation and function of the overall structure and its performance.

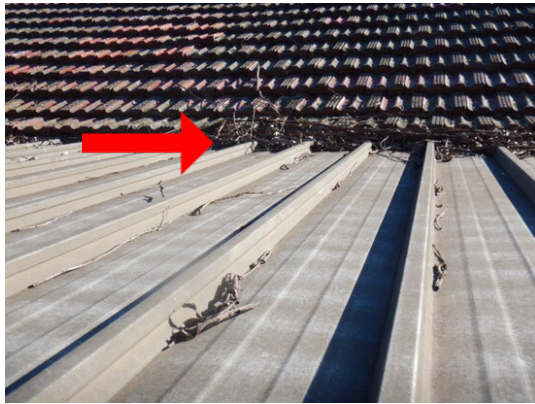
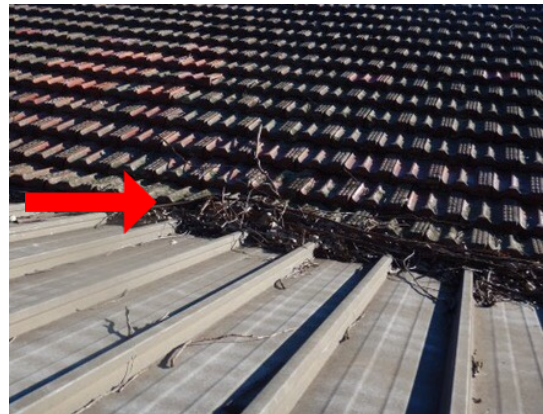
Defects 3.08

Building:	Main Building
Location:	Roof
Finding:	Debris - on roof
Information:	Roofs and gutters are a critical part of the building's management of storm water and rain. It is therefore important that they be kept clear to prevent secondary damage to associated building elements, including exterior and interior walls, ceiling linings and any adjoining building elements.

Such works should be performed by the homeowner; however, appointment of a landscape contractor or an arborist may be required.

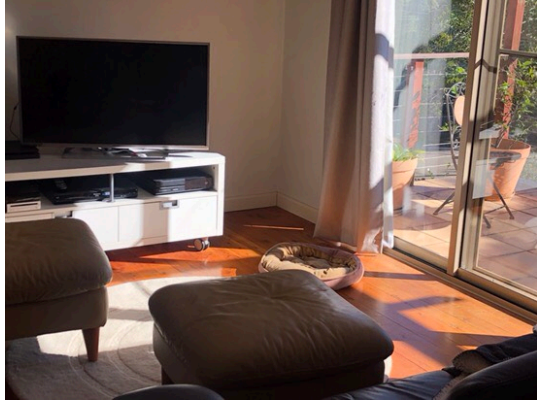
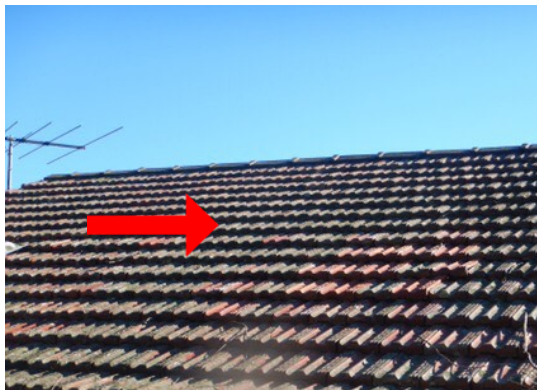
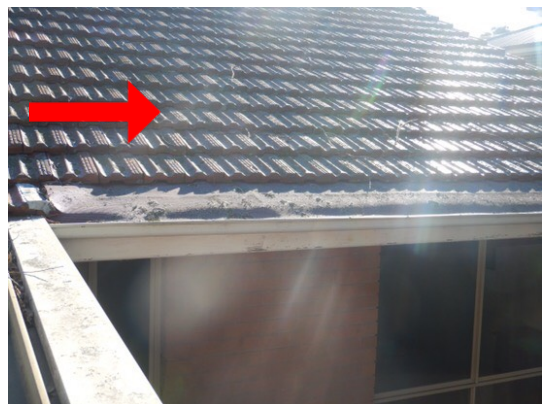
Building:	Main Building
Location:	Roof
Finding:	Roof tiles - Weathered
Information:	Upon inspection of the exterior roofing, the majority of roof tiles were considered to be in a good condition. While weathering of the tiles is consistent with the age of the property, maintenance works maybe required in the future.

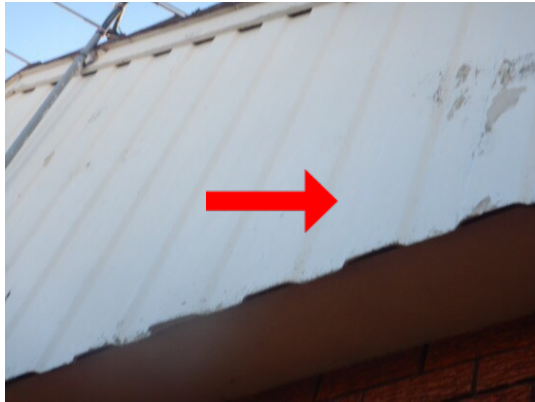
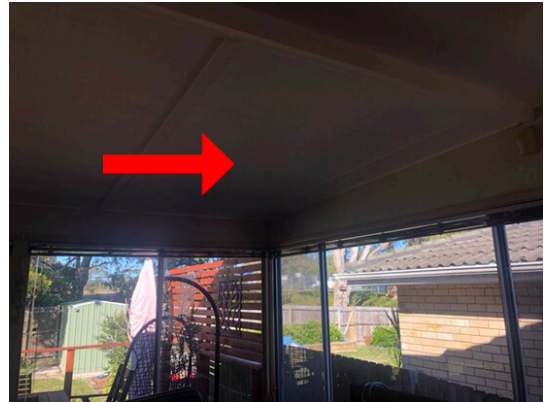
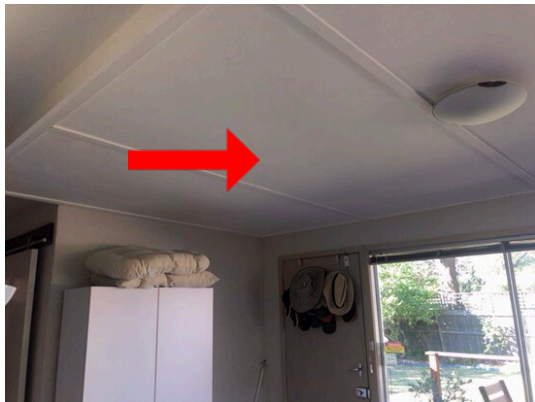
Building: Main Building
Location: All Areas
Finding: Asbestos - Suspected ACM Identified on Site
Information: Reporting on Asbestos is outside the Scope of this Report. This suspected defect is highlighted as a caution only. We suspect, based on our experience in the building industry, that there is a higher risk of the identified building element containing asbestos.

As Asbestos Reporting is outside the scope of this report, we advise that you consider a separate Asbestos Inspection and Condition Audit, which can include the taking of samples for definitive confirmation of the presence of Asbestos.

In the interim, the client is advised to act with caution, especially when considering any damage to building materials general wear and tear renovations extensions demolition and general maintenance activities due to the suspected presence of Asbestos.

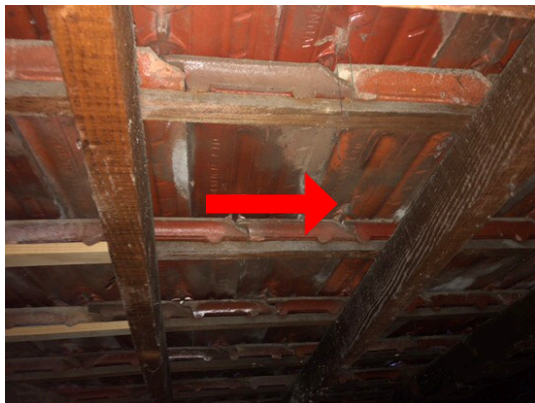
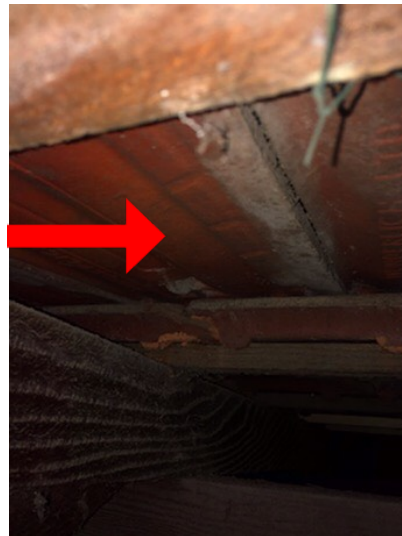
Building:	Main Building
Location:	Roof Void
Finding:	Sarking - Missing
Information:	Sarking is missing under the roof sheeting. Sarking acts as an insulator that helps with noise reduction and protects against water penetration. Sarking plays a key role in the operation and function of the overall roofing structure and its performance.

Although not a requirement at the time of construction, replacement of any missing building element is advisable (although this can be quite expensive to do after the time of construction). Where sarking is missing, regular inspections of the roof tiles for cracking and potential moisture penetration is required.

Sarking may be retrospectively fitted by a registered builder at the discretion of the client.
