## Building and Timber Pest Inspection Report

Inspection Date: Tue, 13 Jul 2021

Property Address: 5A Gladys Ave, Frenchs Forest NSW 2086,  
Australia

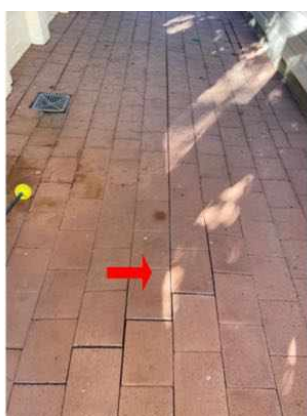
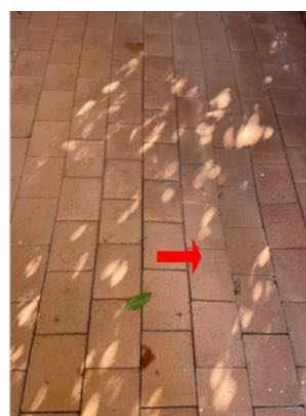
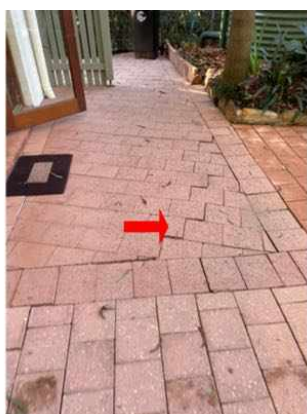
#### Defects 1.01

| Location: | Yard - Back |
| Finding: | Paving - Uneven |
| Information: | Sections of the external paved area are uneven, creating a potential trip hazard. It appears as though the area has been subject to rough installation, or that paving sections have lifted due to movements in the foundation of the property. |

Where paving creates a trip hazard, personal injury may ensue if due caution is not taken by all persons within this area.

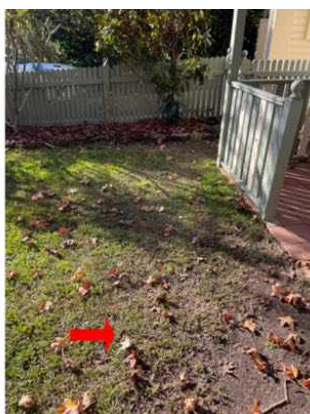
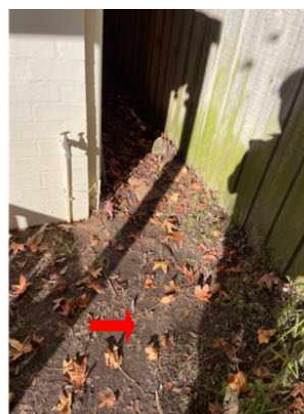
### Defects 3.01

| Location: | All Areas |
| Finding: | Evidence of excessive moisture was present at the time of inspection |
| Information: | Excessive moisture can attract termites and produce conditions that promote termite attack fungal growth and wood decay. |

Excessive moisture is generally caused by deteriorated inadequate or missing roof drainage leaking plumbing pipes or fixtures poorly plumbed HWS overflows or condenser units and poor site drainage.

It is recommended that all plumbing and drainage fixtures and fittings be maintained regularly in order to prevent excessive moisture being present in the external / internal property.

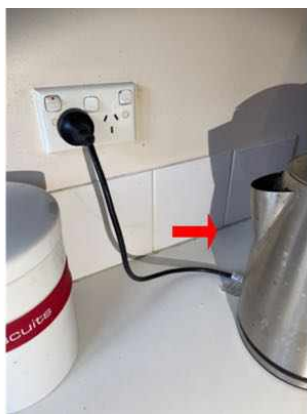
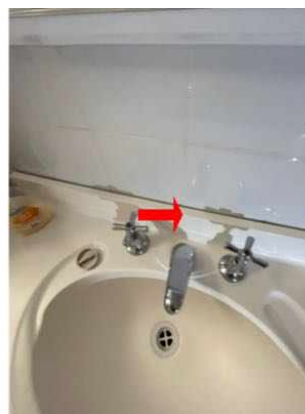
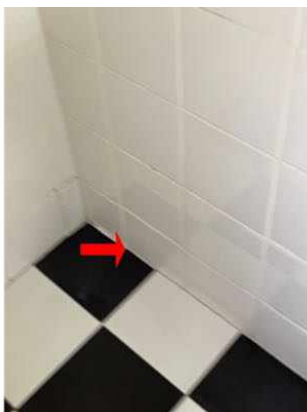
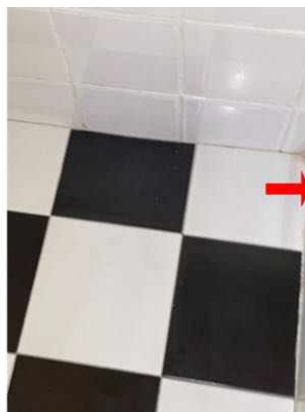
### Defects 3.02

| Location: | Bathroom |
| Finding: | Sealant and grouting - Missing or damaged |

| Information: | Flexible and mould resistant materials should be applied to affected areas to prevent any subsequent water damage that is likely to occur. Regular maintenance and replacement of damage or missing or damaged sealant and grout is highly recommended to the wet areas, as this is a regular wear and tear defect. Sealant and grouting in areas that come into regular contact with water should be maintained for the long term care of your property. |

A sealant specialist or tiling contractor should be appointed to complete these works.

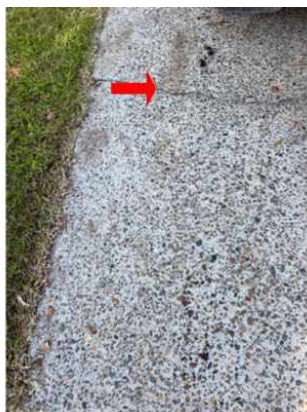
### Defects 3.03

| Location: | All Areas |
| Finding: | Cracking - External Concrete Paving Damage Category 2 - Distinct (less than 3mm) |
| Information: | Distinct cracks were identified in external concrete paving. Distinct cracks are generally found in older concrete paving, and may also present as a trip hazard as consequence of an uneven or curved surface. |

General age and expected deterioration of the paved areas is a common cause of this type of cracking. However, expansion and contraction of the slab may also have occurred due to environmental factors. Such factors include variable moisture and weather conditions, the presence of trees and their roots having a settling or lifting affect on the soil, or the effect of load bearing, e.g. heavy vehicles over a sustained period of time.

Cracking to this degree may also be due to poor original installation of the concrete. Factors such as poor compaction of the sub surface and/or inadequate reinforcing of the slab may create cracking and other secondary defects.

Repairs are likely to be required to prevent further cracking and to reduce hazards associated with cracking, such as tripping. Monitoring of all cracking should be conducted frequently. Always contact a building inspector should cracks widen, lengthen, or become more numerous.

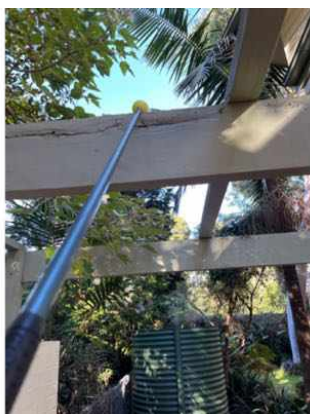
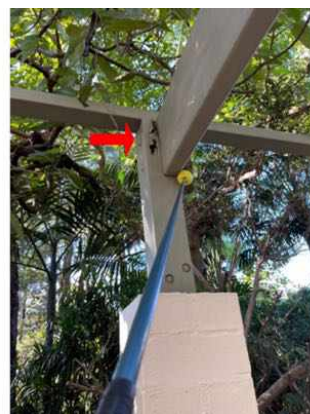
### Defects 3.04

| Location: | All External Areas |
| Finding: | Wood rot |
| Information: | This building element shows evidence of wood rot. Wood rot, also known as Fungal Decay, occurs when timbers and other cellulose building materials are exposed to damp conditions on an ongoing basis. This could be the result of exposure to weathering over a prolonged period of time, or the attraction of excessive moisture from other abutting building materials. Contributing factors also include poor air ventilation in the area. |

Early intervention and regular maintenance, particularly of exterior timbers, will prolong the useful life of these building elements. Prior to any works being performed, the cause of the moisture that has created the visible wood rot should be identified and addressed in a suitable manner. Replacement of affected timbers may then be a necessary step in protecting surrounding building elements from such deterioration.

A qualified carpenter or registered builder may also be required to replace affected building materials.

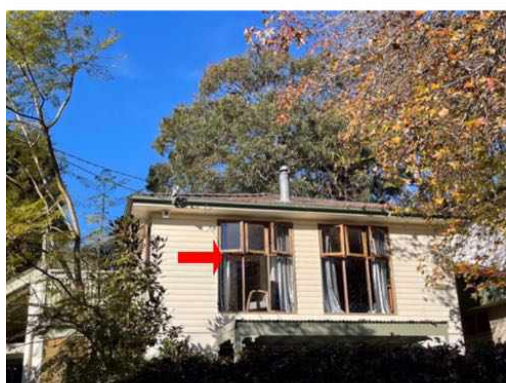
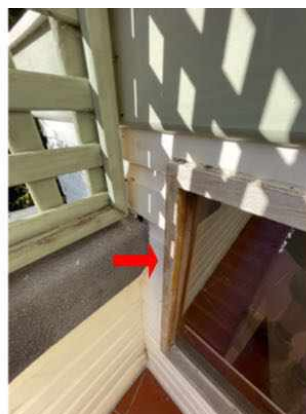
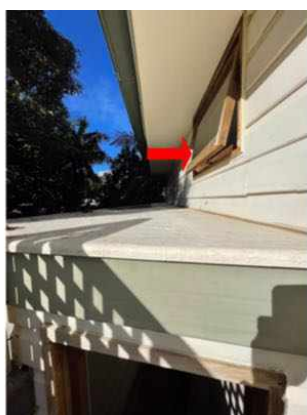
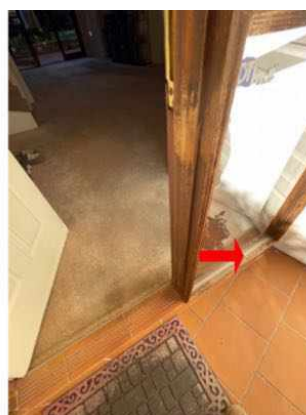
### Defects 3.05

| Location: | All External Areas |
| Finding: | Timber - exposed to weather |
| Information: | External timbers that are frequently exposed to harsh weather conditions require adequate protection in order to maintain their condition. Where timbers have not been painted or treated adequately, general deterioration is likely to occur at an accelerated rate. |

If left unattended, replacement of these timbers is likely to be necessary in the short-term future. Adequate treatment of these timbers is required as soon as possible by a painting contractor or general handyman.

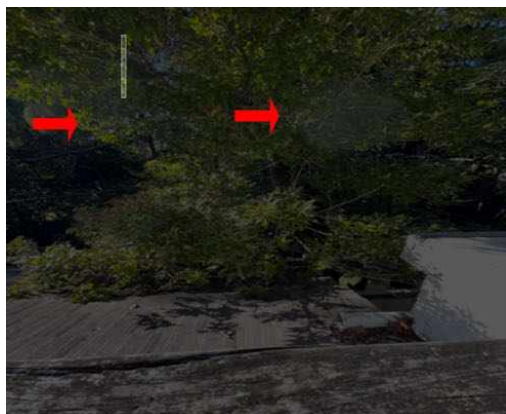
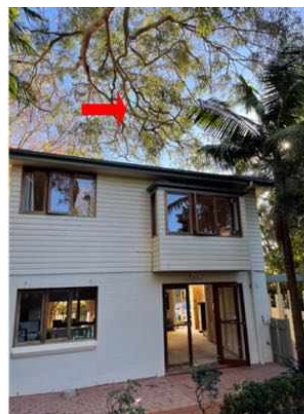
### Defects 3.06

| Location: | All External Areas |
| Finding: | Trees - Overhanging and filling gutters |
| Information: | Overhanging trees often result in excessive amounts of leaf debris accumulating in gutters. |

Gutters are a critical part of the building's management of storm water and rain. It is therefore important that they be kept clear to prevent secondary damage to associated building elements, including exterior and interior walls, ceiling linings and

any adjoining building elements. Where gutters are blocked, pooling of rainwater is likely to occur, fast-tracking rust and corrosion of the roof plumbing elements.

It is advised that all overhanging tree branches be removed as soon as possible to prevent any further damage. Repair and/or replacement of sections of damaged guttering may also be required where the extent of the damage necessitates.

Such works should be performed by the homeowner; however, appointment of a landscape contractor or an arborist may be required. Consultation with a licensed roof plumber is required where guttering has been damaged.

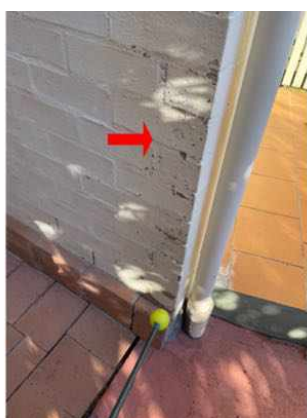
### Defects 3.07

| Location: | Carport |
| Finding: | painting deteriorated |
| Information: | Whilst incomplete or missing paint finish is generally an appearance defect, it can also lead to the development of secondary building defects over time. Incomplete areas of paint finish exposes the area to moisture, potentially accelerating the deterioration of underlying building materials. |

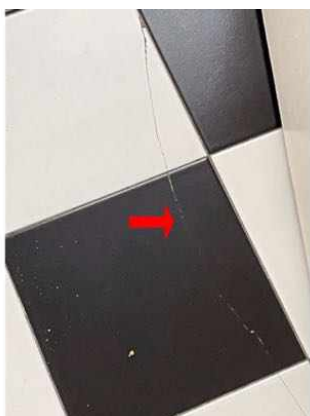
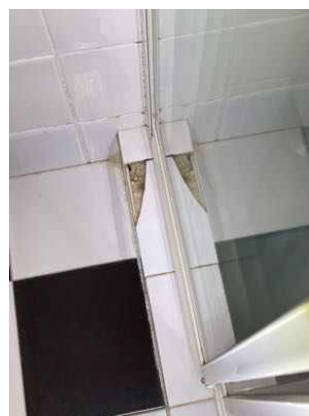
### Defects 3.08

| Location: | Bathroom |
| Finding: | Tiles - Cracked or damaged |
| Information: | Cracking was evident to the tiling in this area at the time of inspection. While the cracking appears to be minor, this area is frequently exposed to water, allowing potential for water penetration into adjoining sections of walls or flooring. |

If left unmanaged, water penetration to these areas may lead to subsequent water damage, which is likely necessitate repair work to affected building elements.

A tiling contractor should be appointed to ensure that no further water damage occurs. The re-application of silicone and grouting throughout remaining tile work is also advised, to further protect the area against water penetration.

Where water penetration has led to water damage, appointment of a relevant tradesperson may be required to repair damaged building elements.

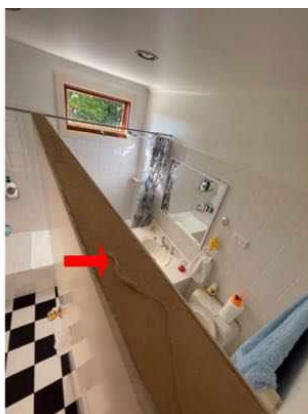
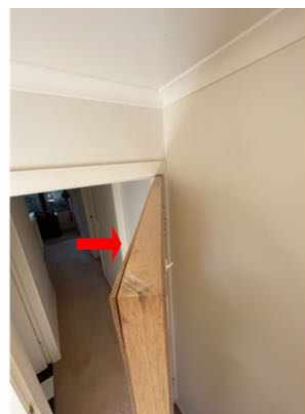
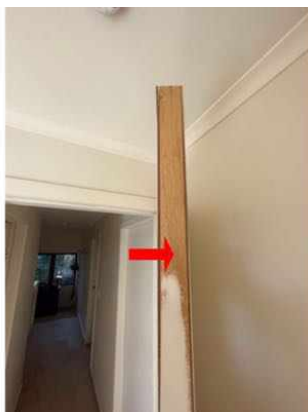
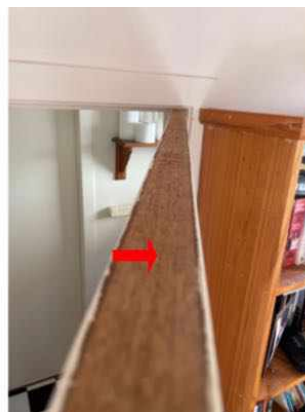
### Defects 3.09

| Location: | All Areas |
| Finding: | Door finish - incomplete on top and bottom of door |
| Information: | The paint finish in this area was identified as being incomplete at the time of inspection. Whilst incomplete or missing paint finish is generally an appearance defect, it can also lead to the development of secondary building defects over time. Incomplete areas of paint finish exposes the area to moisture, potentially accelerating the deterioration of underlying building materials. A painting contractor should be appointed to perform necessary works to aid the appearance of the affected area and to ensure the area is protected against further deterioration. Alternatively, the homeowner following manufacturer instructions may perform these works. |

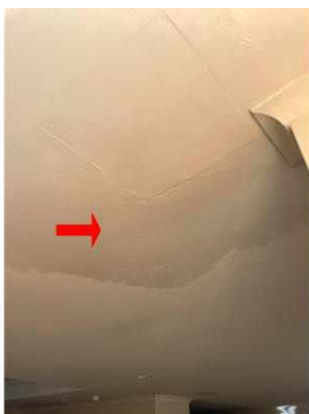
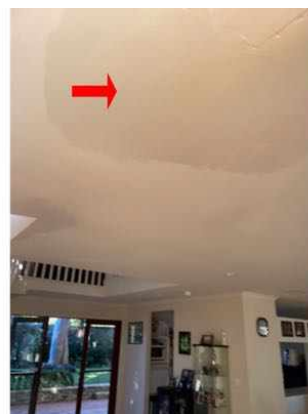
### Defects 3.10

| Location: | Lounge Room |
| Finding: | Paint finish - Incomplete |
| Information: | The paint finish in this area was identified as being incomplete at the time of inspection. |

Whilst incomplete or missing paint finish is generally an appearance defect, it can also lead to the development of secondary building defects over time. Incomplete areas of paint finish expose the area to moisture, potentially accelerating the deterioration of underlying building materials.

Incomplete paint finishes should be sanded back, filled, leveled and painted, as applicable. Where inadequate or missing paint protection has led to the deterioration of the associated building element, repair and/or replacement of this building element may be required.

A painting contractor should be appointed as soon as possible to perform necessary works to aid the appearance of the affected area and to ensure the area is protected against further deterioration. Alternatively, the homeowner following manufacturer instructions may perform these works.

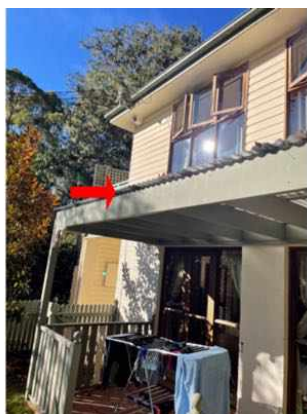
### Defects 3.11

| Location: | Yard - Front |
| Finding: | painting deteriorated |
| Information: | Whilst incomplete or missing paint finish is generally an appearance defect, it can also lead to the development of secondary building defects over time. Incomplete areas of paint finish exposes the area to moisture, potentially accelerating the deterioration of underlying building materials. |

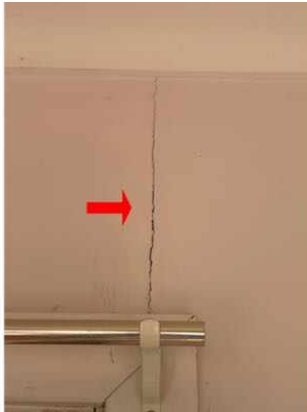
### Defects 3.12

| Finding: | Cracking - Damage Category 2 - Noticeable (up to 5mm) |
| Information: | <p>Noticeable cracks are a common occurrence as a result of many primary defects. Such causes may include age, general wear and tear, expected building movement, general expansion/contraction of building materials in different weather conditions, and/or minor failings in the installation or application of building materials.</p> <p>Noticeable cracks may result in minor sticking or jamming of associated doors and windows, which require easement. However, noticeable cracks are easily filled and</p> |

repaired. A plasterer can be consulted to install an expansion joint at this point to allow for this movement during different weather conditions.

Monitoring of all cracking should be conducted frequently. Always contact a building inspector should cracks widen, lengthen, or become more numerous. Additionally, your building inspector should also be contacted if associated building elements such as doors and windows become more difficult to operate over time.

Relevant tradespeople, such as carpenters, painters and plasterers, should be appointed to perform remedial works, as deemed necessary.

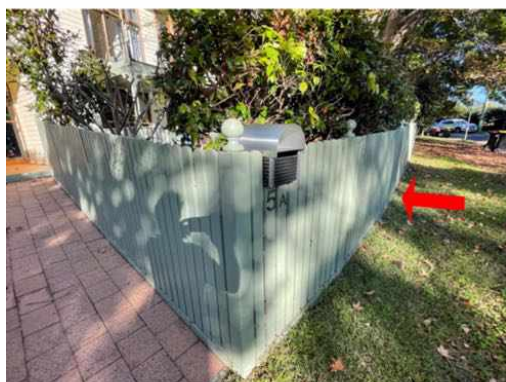
Building: Building 1  
 Location: Driveway  
 Finding: Subsidence - Local trees and vegetation  
 Information: Trees and other vegetation can have a significant local effect on drying of soils. Over a number of years, especially during drought conditions, adjacent trees and vegetation may draw excessive moisture from the soils. The opposite may also occur, where swelling of the soil results when the trees decline or are removed.

As the cumulative moisture deficient is reversed, the surface level around the tree (and adjoining subfloor) will rise and expand laterally. This is often damaging to buildings unless the foundations have been strengthened or designed to cope with the effect.

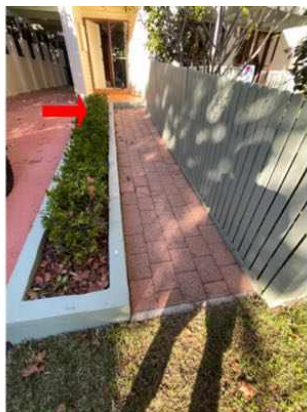
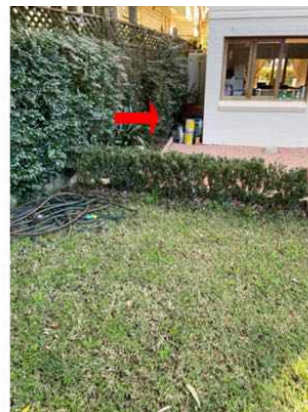
Building: Building 1  
 Location: All External Areas  
 Finding: Garden Beds - Conditions Conducive to Termites  
 Information:

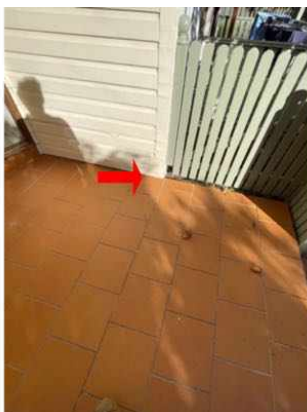
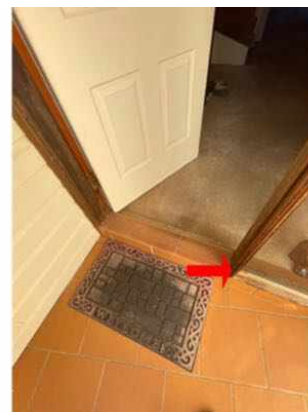
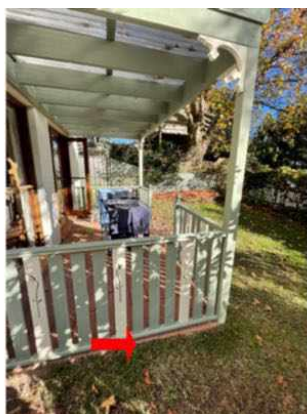
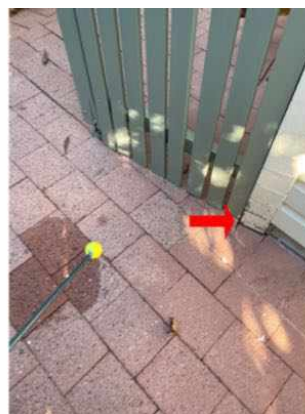
| Finding: | Building materials in direct ground contact - conducive to termites |
| Information: | Where timber elements are in direct contact with the ground and consequently moisture or dampness they become conducive to termite activity. Whether timber is used as a building element part of a fencing structure or stored as an unused item they can provide an environment that is attractive to termite infestation. When met with excessive moisture timber begins to decay and develop wood rot. Any timbers that are in direct contact with external grounds especially if left untreated or non- durable also provide ingress for subterranean termites into that particular element. The removal of any such materials that may be conducive to termite activity should be removed as soon as possible to minimise the risk of termite attack. |

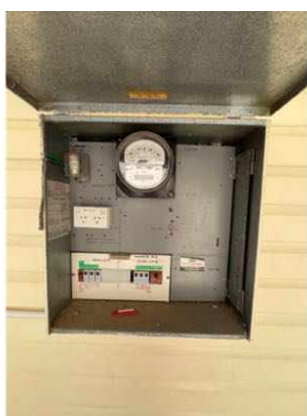
Building: Building 1  
 Location: Yard - Side  
 Finding: Termite Management System - no evidence of installation  
 Information: The application of a post-construction chemical termite barrier is highly recommended for all properties, particularly if live termite activity has been found on the site previously. Such barriers are highly effective in preventing termite attack on any timber building elements throughout the property.

A durable notice should be placed in the switchboard unit to indicate current termite barriers. At the time of inspection, it appeared as though no termite management system has been installed, with no evidence to suggest preventative works taking place.

The client may consider gaining further advice from a pest controller as to the costs and procedures involved with this application. It is recommended that obtaining such advice be a short-term priority.

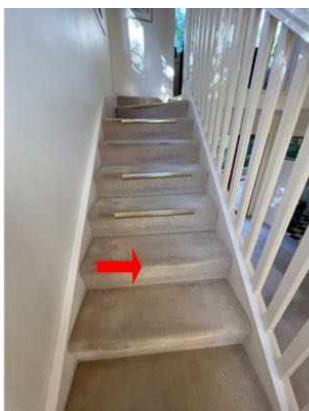
Building: Building 2  
 Location: All Areas

Finding: Carpet - Deteriorated  
 Information: Sections of the carpet floor covering in this area appeared to be deteriorated from general wear and tear.
