71 Bolwarra Avenue, West Pymble, New South Wales, 2073 Australia

Pre-Purchase Standard Property & Timber Pest Report

30th Apr, 2024

Report number:	9550778
Inspection Date:	30th Apr, 2024
Property Address	71 Bolwarra Avenue, West Pymble, New South Wales, 2073 Australia

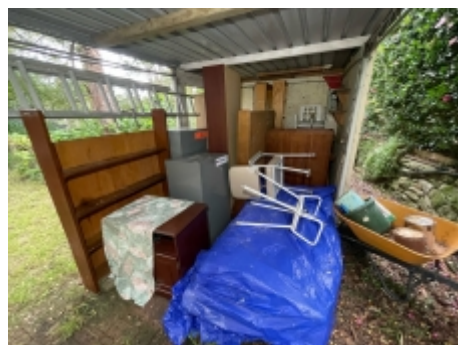
Carport - Obstructions

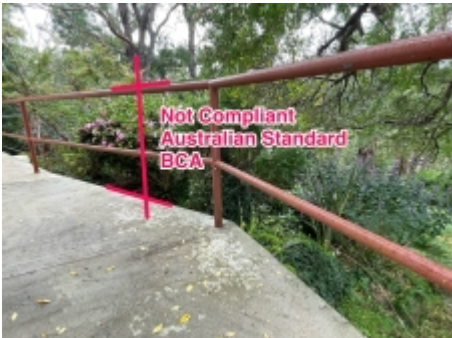
Fall Hazard - Note Only
Railing Balustrade Gaps and Top Rail Height is not consistent with Current Australian Standards for Handrail Safety.
- Top Rail must be minimum 1.000mm
- Maximum Balustrade gaps 0.125mm

Not Compliant - BCA

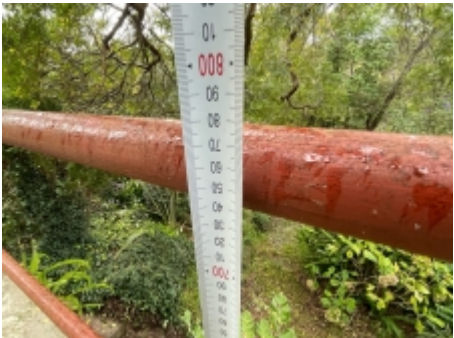
Not Compliant - BCA

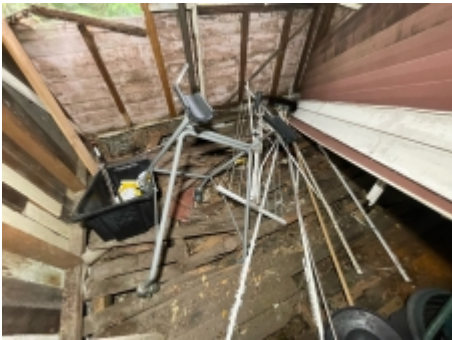
Flooring and Wall Deterioration - (See Pest Section E)

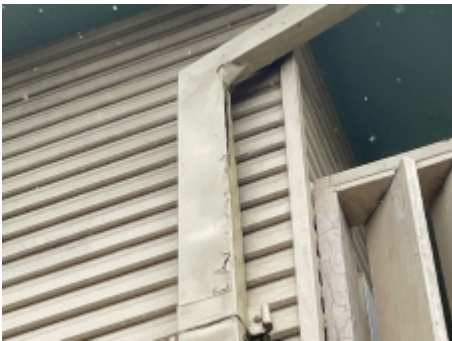
Down pipes

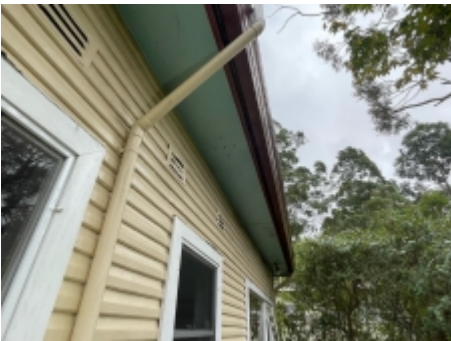
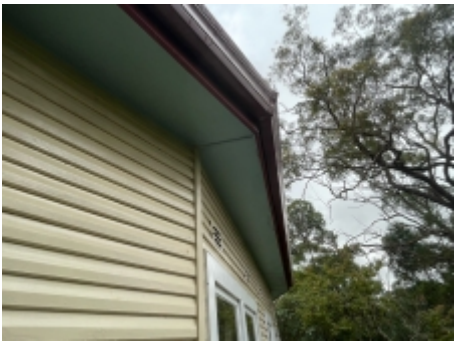
Asbestos Linings - Sample / Test

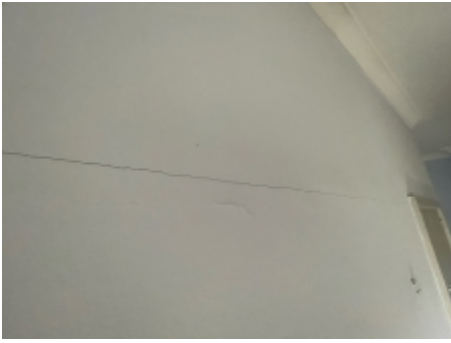
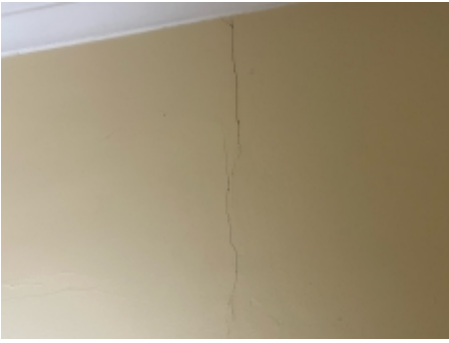
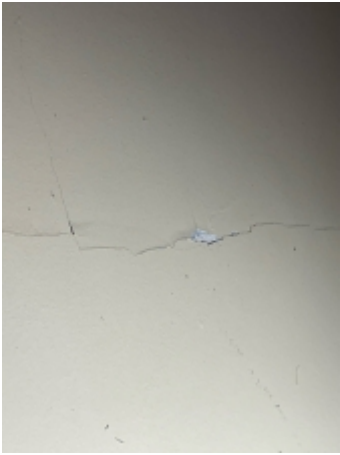
Hairline cracking - Plasterboard / generally

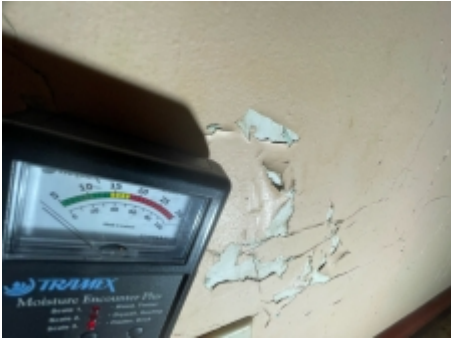
Poor Finishes / Linings - General

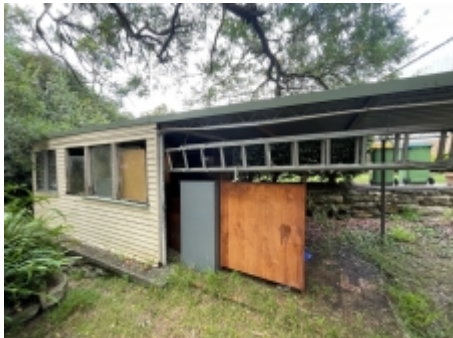
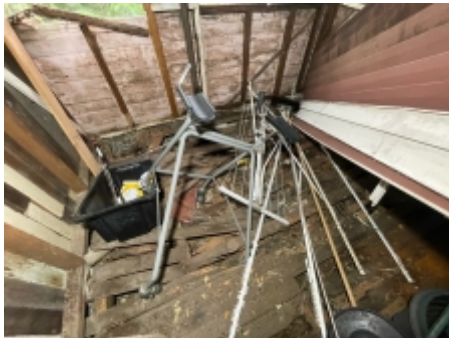
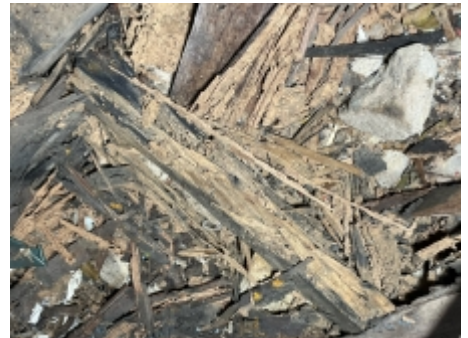
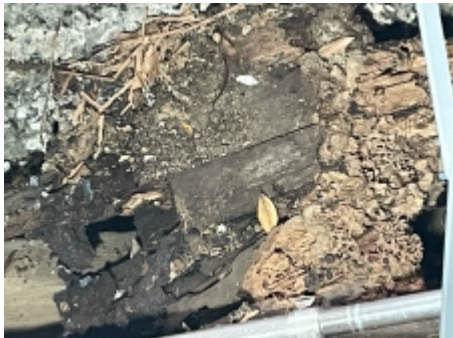
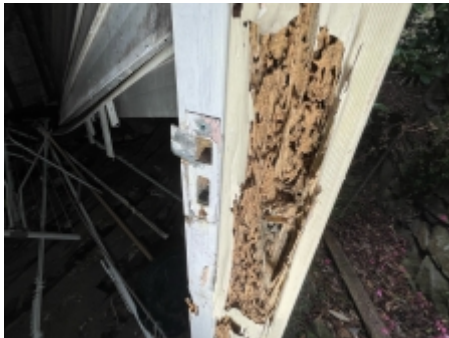
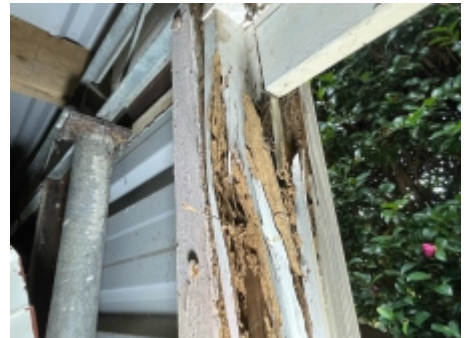
Additional Comments	Significant previous Termite Damage noted to the carport floor / Walls / Frames. No Active Termites found at time of non destructive inspection. Recommend complete Removal of Structure and Immediate chemical Treatment of Property.
E3 Termite workings and/or damage	The following evidence was found
The extent of any visible damage appears:	Undetermined
Location	Garage - Carport Area
Additional Comments	Significant Termite Damage to the Substructure of the Garage / Frames / Sills / Windows / Doors. We Recommend Immediate Removal of the Garage Structure and Chemical Treatment of Property.

Termite Evidence / Damage

Treatment of Timber Pest Attack is required.	Yes, as detailed in Section E
In addition to this Report a Subterranean Termite Management Proposal to help manage the risk of future subterranean termite access to buildings and structures is	Recommended - see Item E2
Removal of Conditions Conducive to Timber Pest Attack is necessary.	Yes, as detailed in Section E
Due to the susceptibility of the property to sustaining Timber Pest Attack the next inspection is recommended	immediately
Additional Notes:	<p>We Recommend the Removal of Carport and Structure.</p> <p>No Evidence of Termites or Termite Activity found in Main Property.</p> <p>However - Risk is extremely High due to proximity of Previous activity.</p> <p>Recommend the immediate chemical treatment of the property by a licensed pest technician.</p>

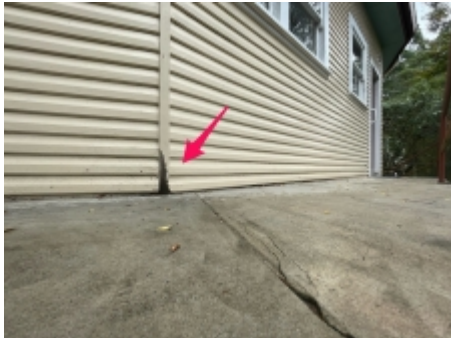
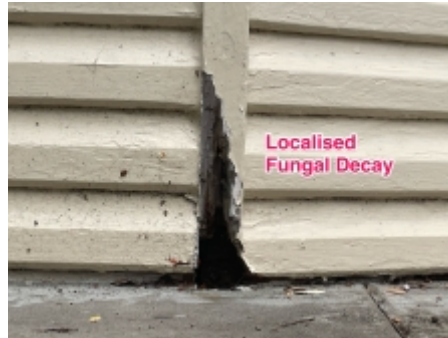
The extent of any visible damage appears:	Localised
Additional Comments	Some Minor Fungal Decay noted in external Cladding - Appears Localised

Timber Fungal Decay

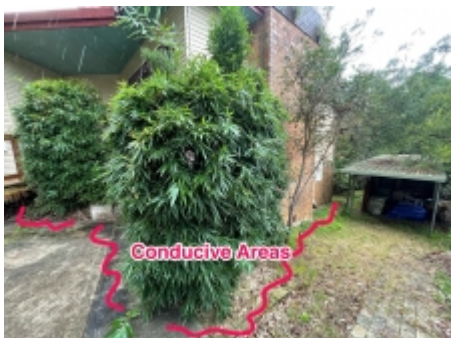
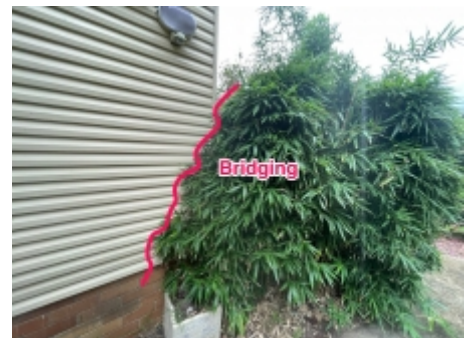
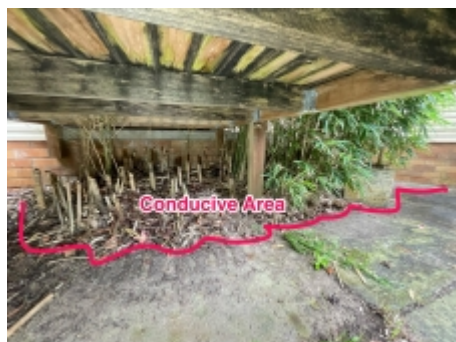
E9 Lack of adequate subfloor ventilation	No evidence was found
E10 The presence of excessive moisture	No evidence was found
E11 Bridging or breaching of termite barriers and inspection zones	The following evidence was found
Location	Garden / Trees
Additional Comments	General Bridging of the External Walls in Multiple areas. Timber Ramp in Contact with ground / External Walls

Conductive Areas

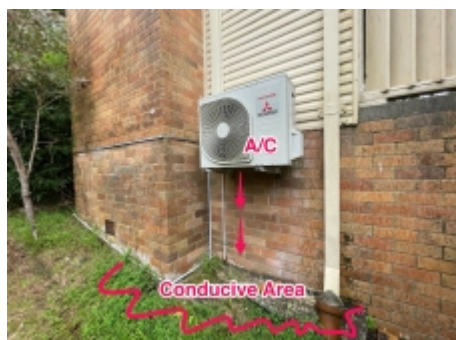
A/C - Overflow / Conducive

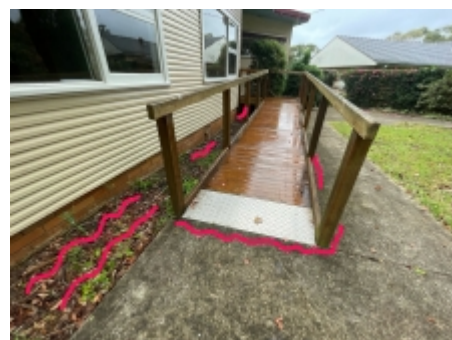
E12 Untreated or non-durable timber used in a hazardous environment	No evidence was found
E13 Other conditions conducive to timber pest attack	The following evidence was found
Location	A/C Condenser
Additional Comments	A/C - Condensate overflow is not connected to a waste - Moisture Conducive Poor Drainage areas at North elevation of Property.

Poor Drainage / Bridging

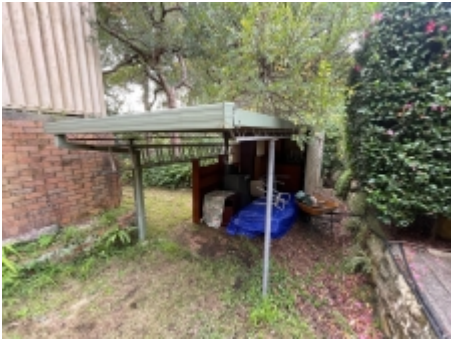
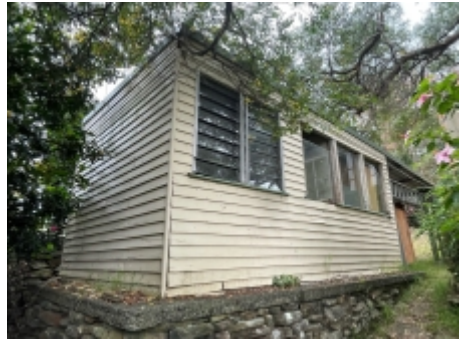
E14 Major safety hazards	The following evidence was found
Location	Carport
Details of Evidence	As noted in Section E - Termite Damage and destruction of Floor / Wall / Door & Window sections.
Additional Comments	As Noted in Section E - Pest - We recommend the immediate removal of the carport structure.
