## Building Inspection Report

Inspection Date: Tue, 08 Oct 2019

Property Address: 5 Riverhill Ave, Forresterville

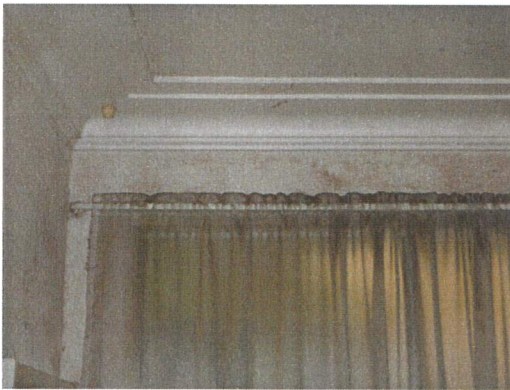
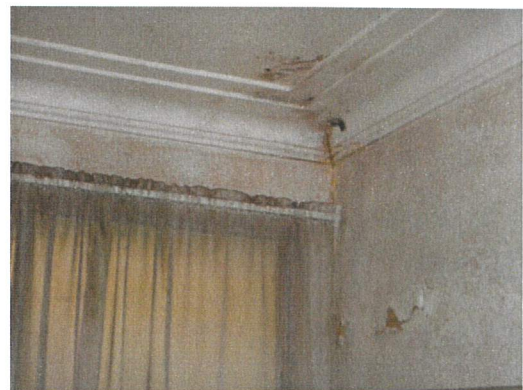
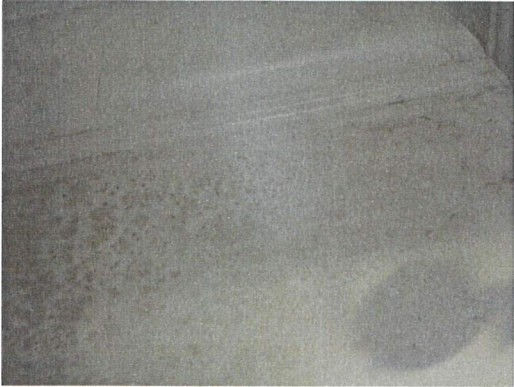
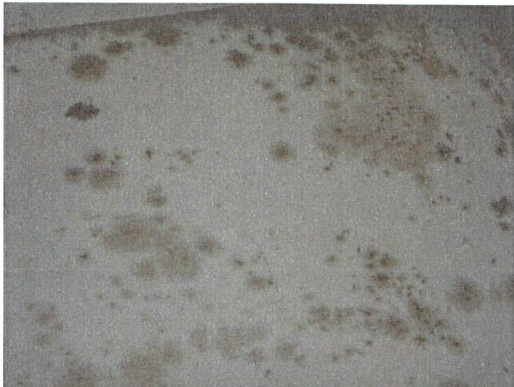
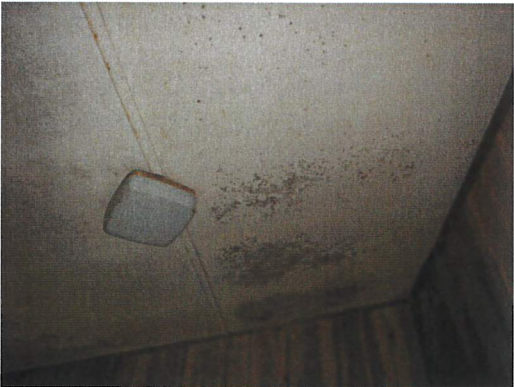
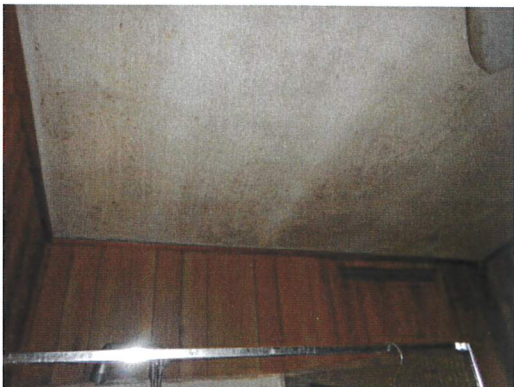
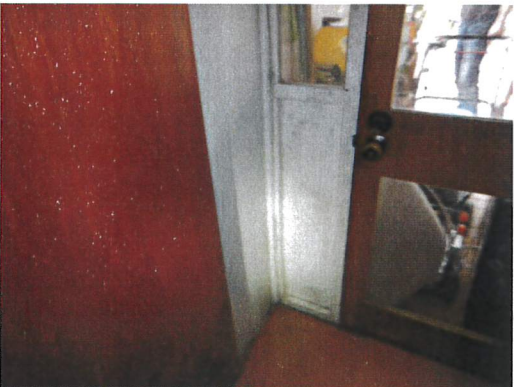
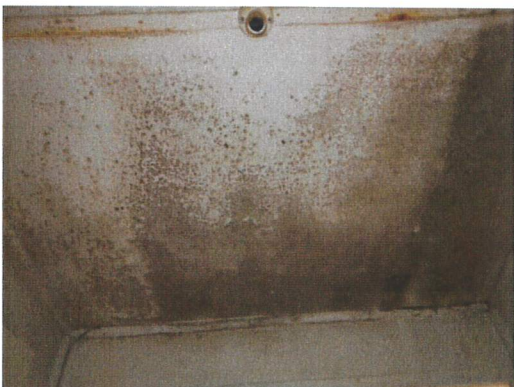
#### Defects 1.01

Building: Main Building  
Location: All Areas  
Finding: Mould - Present  
Information:

Where evidence of mould growth was noted, there may be environmental, biological or health issues associated with the report. A specialist inspection by a suitably qualified environmental health inspector is warranted, where mould is extensive or where any queries regarding air quality spores or other related issues apply.

Generally, the client is advised to ensure that the general environment is free of moisture and humidity to aid in the prevention of mould formation and development. Any mould found during the inspection should be cleaned immediately by a cleaning contractor or the homeowner as applicable.

Please note that severely affected building elements may require replacement by a registered builder or qualified carpenter.

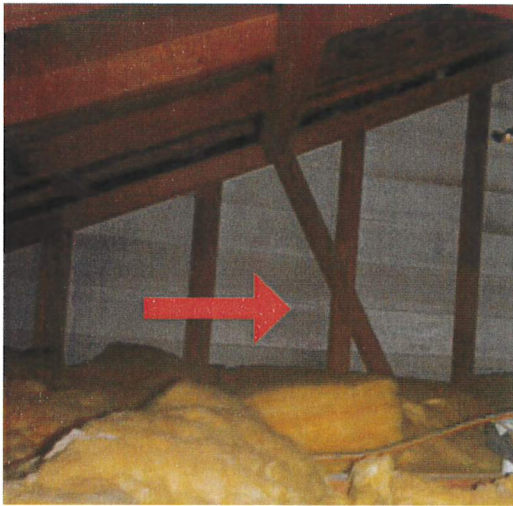
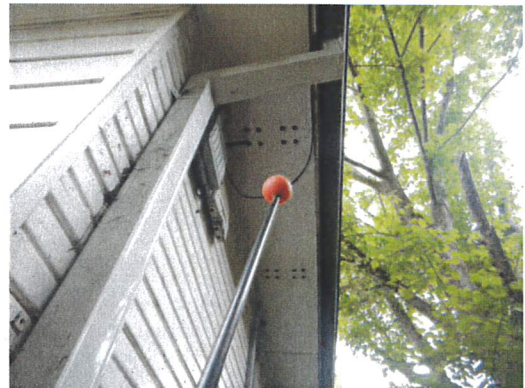
### Defects 1.02

Building: Main Building  
Location: All Areas  
Finding: Asbestos - Suspected ACM Identified on Site  
Information: Reporting on Asbestos is outside the Scope of this Report. This suspected defect is highlighted as a caution only. We suspect, based on our experience in the building industry, that there is a higher risk of the identified building element containing asbestos.

In the interim, the client is advised to act with caution, especially when considering any damage to building materials general wear and tear renovations extensions demolition and general maintenance activities due to the suspected presence of Asbestos.

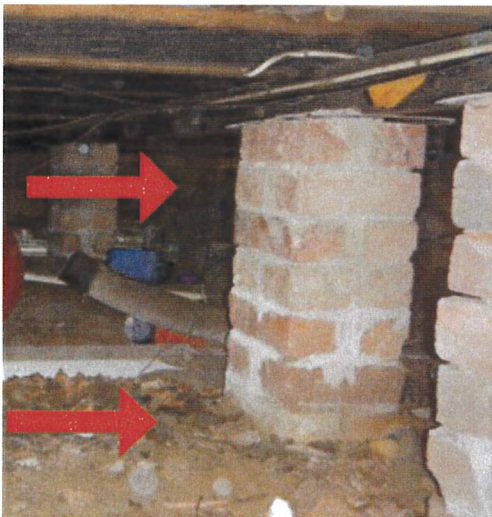
### Defects 3.01

Finding: Subfloor - Lack of ventilation

Information: It was noted at the time of inspection that the subfloor area lacks adequate ventilation. Ventilation can be restricted by a variety of minor defects, including obstructions in the subfloor space, a lack of vents or a low clearance.

A well ventilated subfloor aids in maintaining dry conditions, preventing secondary damage such as wood rot and pest activity, as well as preventing the development of mould and mildew (which can lead to respiratory safety hazards for occupants).

The initial step in improving ventilation is to ensure that the subfloor area is free of any debris or stored items. Where ventilation is still inadequate, it is advised to ensure that all vents are clear of blockages, and additional vents may be installed.

The client may also consider mechanical ventilation (powered fans) to improve subfloor airflow. Remedial works should be conducted as a matter of urgency to protect against the development of potentially harmful subfloor conditions.

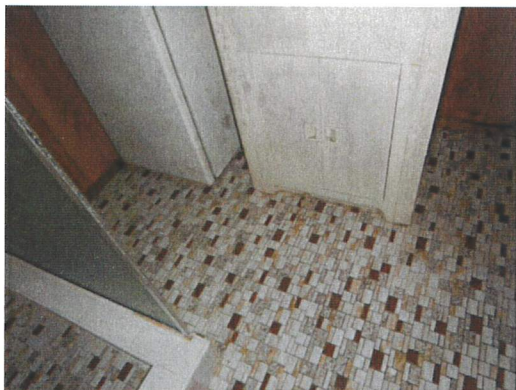
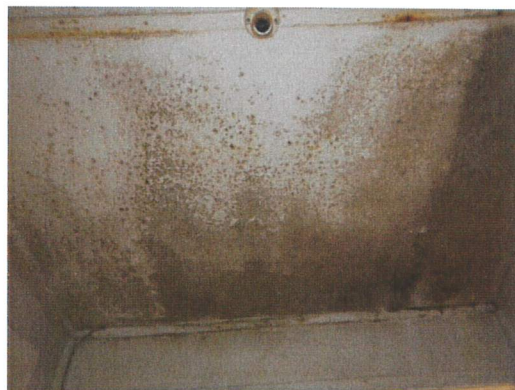
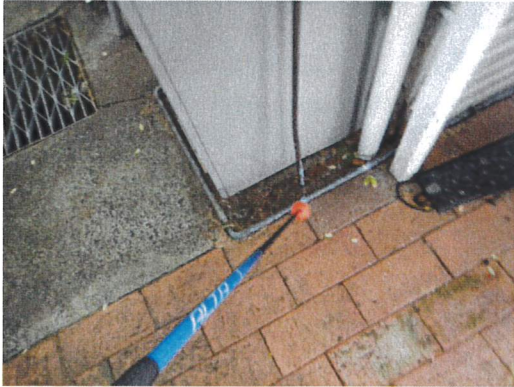
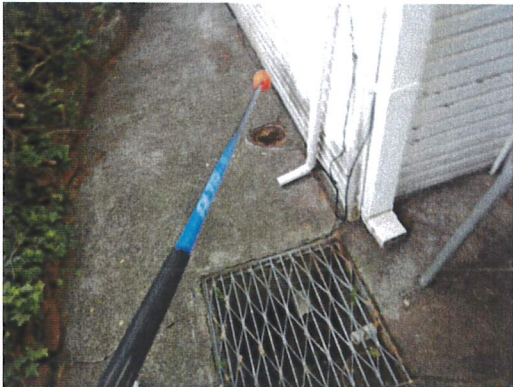
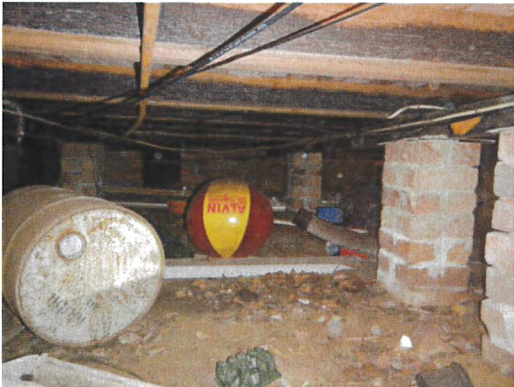
### Defects 3.02

Building: Main Building  
Location: Subfloor  
Finding: Excessive moisture - identified  
Information: Excessive moisture can attract termites and produce conditions that promote fungal growth and wood decay.

Excessive moisture is generally caused by deteriorated inadequate or missing roof drainage leaking plumbing pipes or fixtures poorly plumbed HWS overflows or condenser units and poor site drainage.

Prior to any remedial works being performed a qualified plumber should be appointed to further inspect the property and to identify the cause of the excessive moisture. Works to remove affected building elements may then be necessary and should be performed by an appropriate tradesperson.

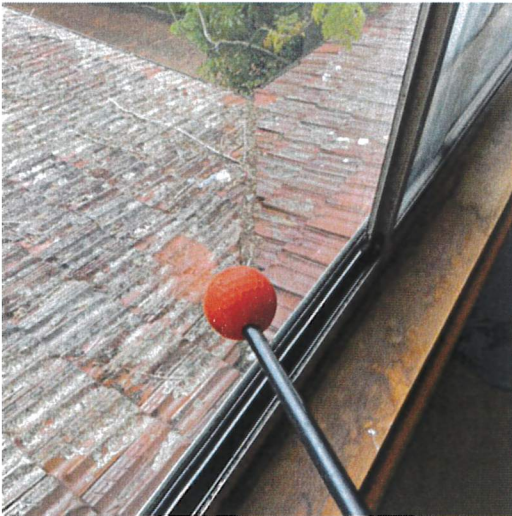
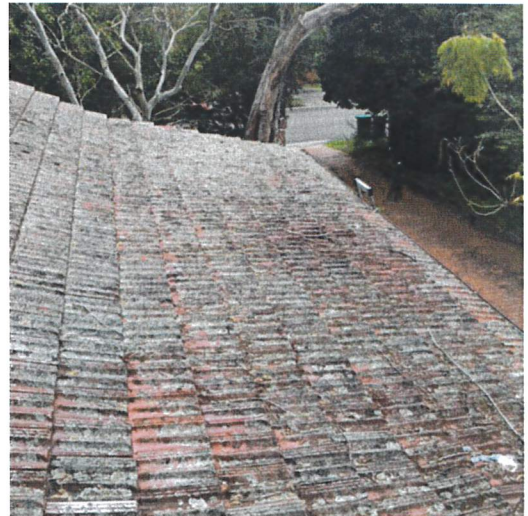
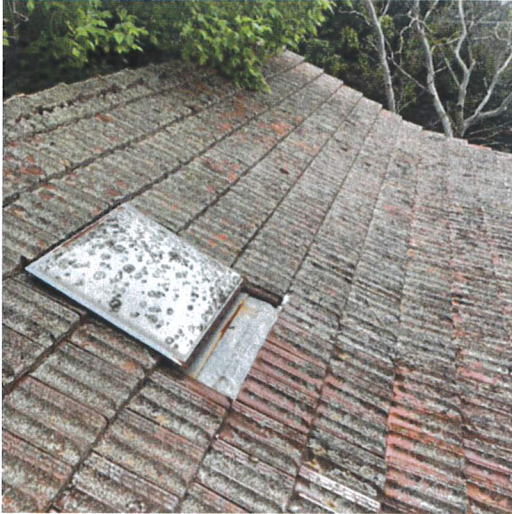
## Defects 3.03

Building:	Main Building
Location:	Roof Exterior
Finding:	Roof tiles - Weathered
Information:	Upon inspection of the exterior roofing, the majority of roof tiles were considered to be in a poor condition. While weathering of the tiles is consistent with the age of the property, maintenance works are required.

Isolated areas of mortar have come loose in the valleys and minor cracking is also present. Re-pointing and re-sealing the may be considered as an interim solution by the client to help preserve and extend the life span of the tiles.

Where left unmanaged, deteriorating roof tiles are likely to lead to a number of secondary defects, including minor water leaks and weather exposure to internal roofing structures.

Consultation with a roofing contractor is highly advised to gain advice on cost of remedial works that may be required in the short to medium term. Remedial works are likely to increase the longevity of the exterior roofing structure.

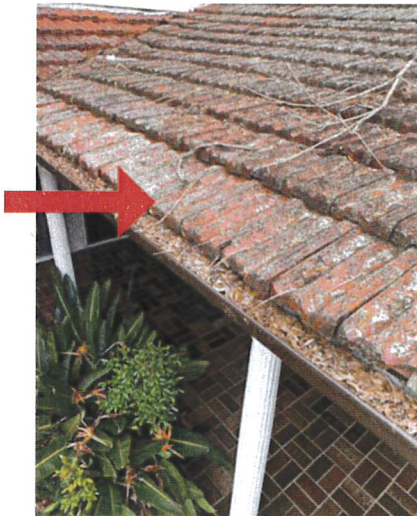
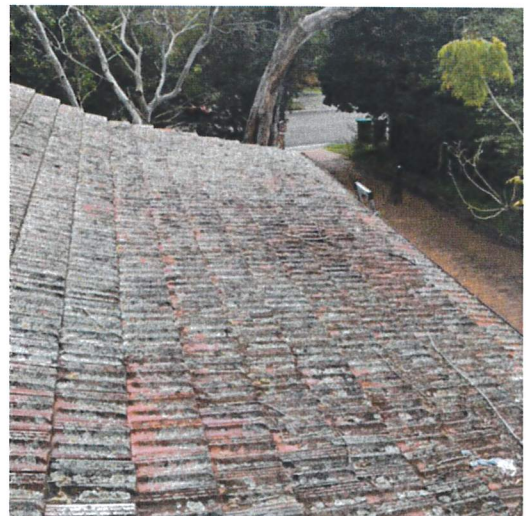
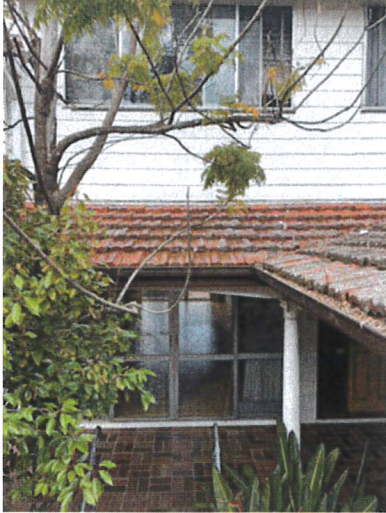
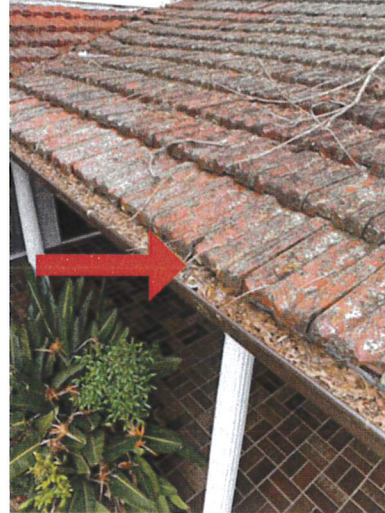
## Defects 3.04

Building:	Main Building
Location:	Roof Exterior
Finding:	Trees - Overhanging and filling gutters
Information:	Overhanging trees often result in excessive amounts of leaf debris accumulating in gutters.

Gutters are a critical part of the building's management of storm water and rain. It is therefore important that they be kept clear to prevent secondary damage to associated building elements, including exterior and interior walls, ceiling linings and any adjoining building elements. Where gutters are blocked, pooling of rainwater is likely to occur, fast-tracking rust and corrosion of the roof plumbing elements.

It is highly that all overhanging tree branches be removed as soon as possible to prevent any further damage. Repair and/or replacement of sections of damaged guttering may also be required where the extent of the damage necessitates.

Such works should be performed by the homeowner; however, appointment of a landscape contractor or an arborist may be required. Consultation with a licensed roof plumber is required where guttering has been damaged.

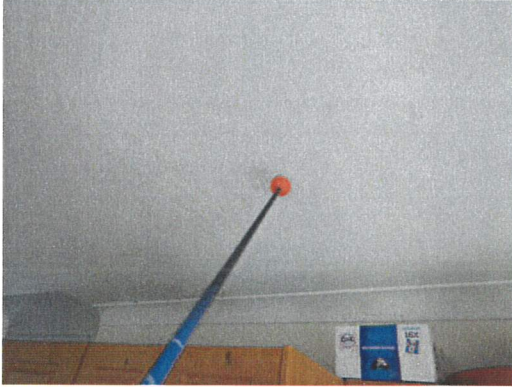
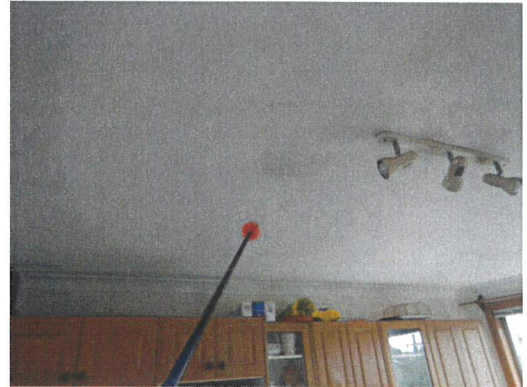
### Defects 3.05

Finding: Ceiling - Water stained

Information: Water staining to ceiling linings in this area was evident at the time of inspection. Water staining indicates that surfaces have been exposed to excessive moisture over time. The minerals and other elements in the water lead to staining, which may graduate to corrosion and deterioration if left unmanaged.

While mostly an appearance defect, water staining can be indicative of more serious defects, which may be currently concealed by interior ceilings.

Where water staining is active, a licensed plumber must be consulted to identify the cause of the staining and to provide advice on any repair works that may be required. Replacement of any damaged structures is advised.

Conversely, where water staining is old and inactive, affected building materials may be repaired or replaced at client discretion.

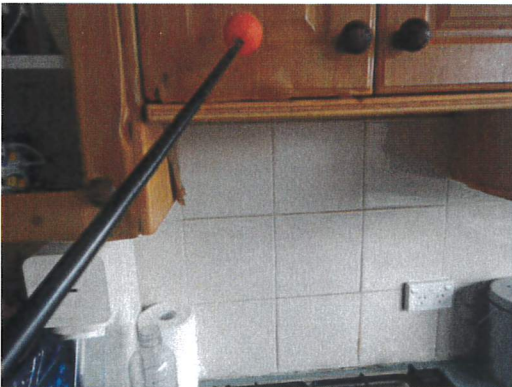
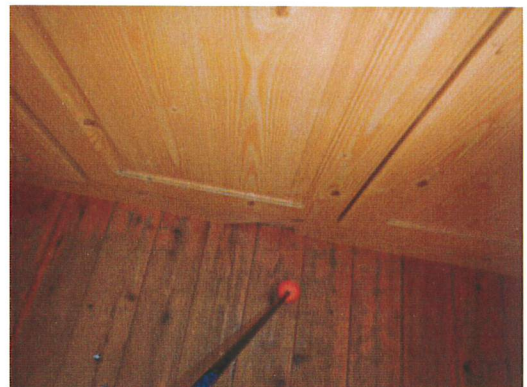
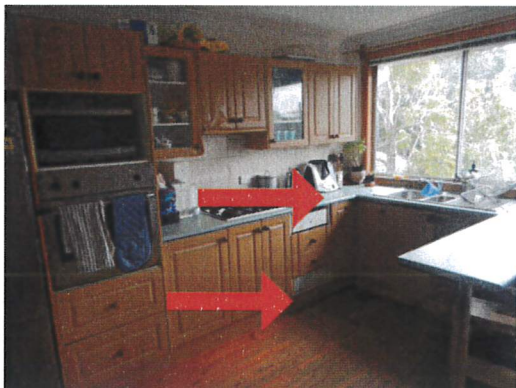
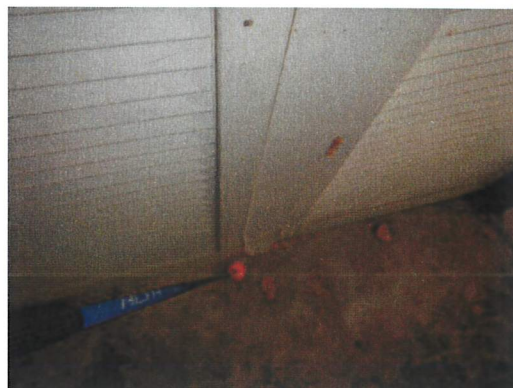
### Defects 3.06

Building: Main Building  
Location: Kitchen  
Finding: kitchen Cabinetry - Damaged  
Information: Evidence of damage was identified to Kitchen Cabinetry, potential implications if left unmanaged and suggest trade responsible for rectification.

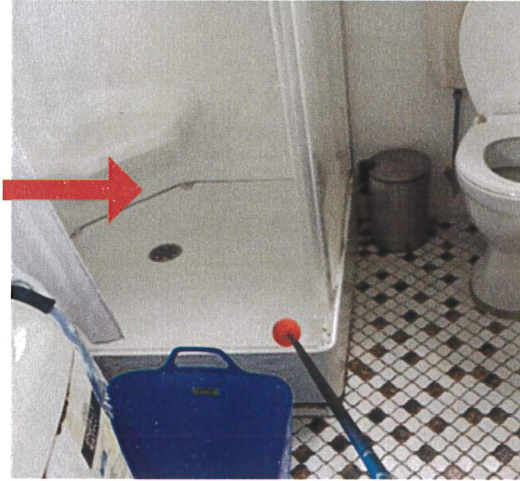
### Defects 3.07

Finding: Sealant

Information: Flexible and mould resistant materials should be applied to affected areas to prevent any subsequent water damage that is likely to occur. Regular maintenance and replacement of damage or missing or damaged sealant and grout is recommended to the wet areas, as this is a regular wear and tear defect.

Sealant and grouting in areas that come into regular contact with water should be maintained for the long term care of your property.

A sealant specialist or tiling contractor should be appointed to complete these works.

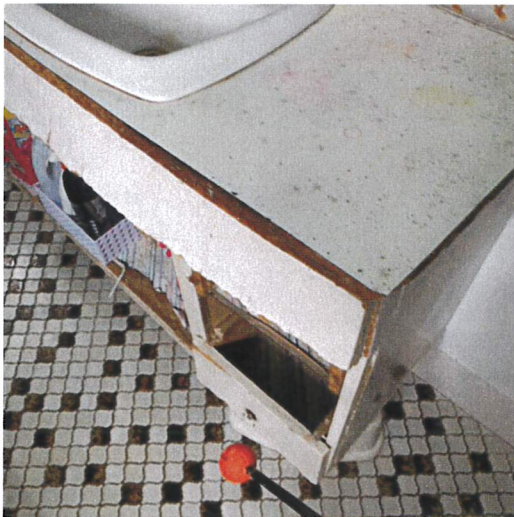
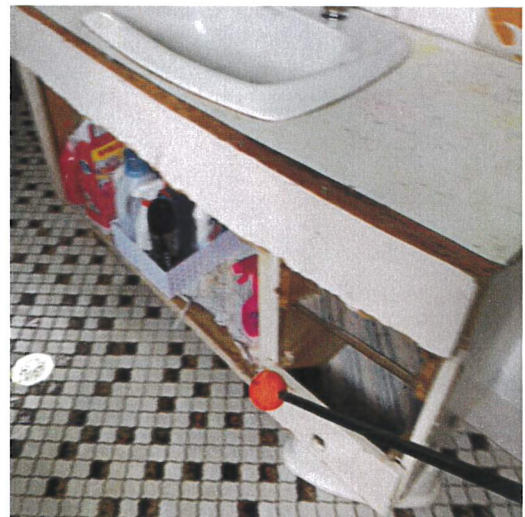
### Defects 3.08

Building: Main Building  
Location: Bathroom 2  
Finding: Bathroom Cabinetry - Damaged  
Information: Evidence of damage was identified to Kitchen Cabinetry, potential implications if left unmanaged and suggest trade responsible for rectification.

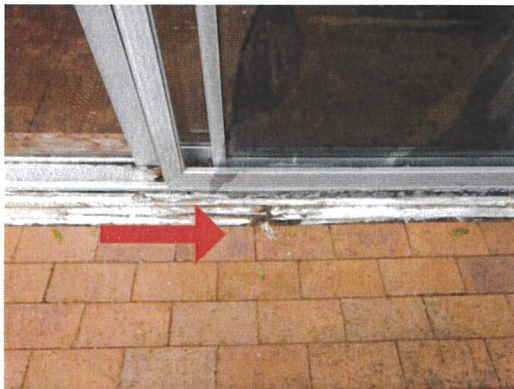
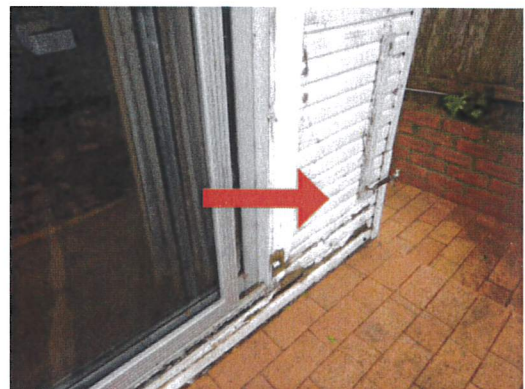
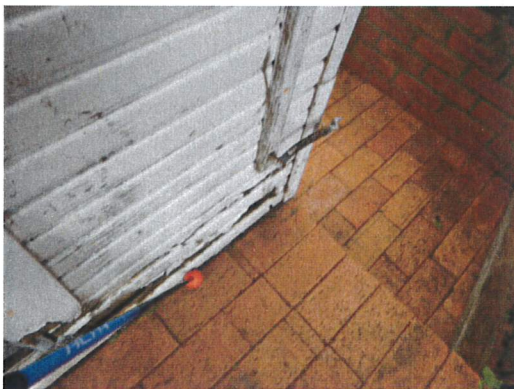
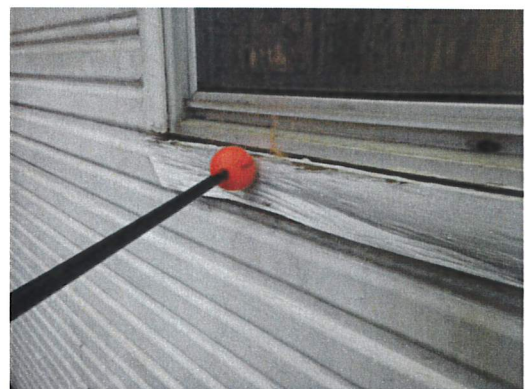
### Defects 3.09

Finding: Wood rot

Information: Wood rot is often associated with general damp problems and is evidenced by a 'musty' smell or mould and mildew occurring on surfaces. If left unmanaged, damp conditions can lead to further health problems and the decay of timbers will continue.

Early intervention and regular maintenance, particularly of exterior timbers, will prolong the useful life of these building elements. Prior to any works being performed, the cause of the moisture that has created the visible wood rot should be identified and addressed in a suitable manner. Replacement of affected timbers may then be a necessary step in protecting surrounding building elements from such deterioration.
