# ACCURATE PROPERTY INSPECTIONS

## PRE-PURCHASE BUILDING INSPECTION REPORT

2 Barnes Road

Frenchs Forest

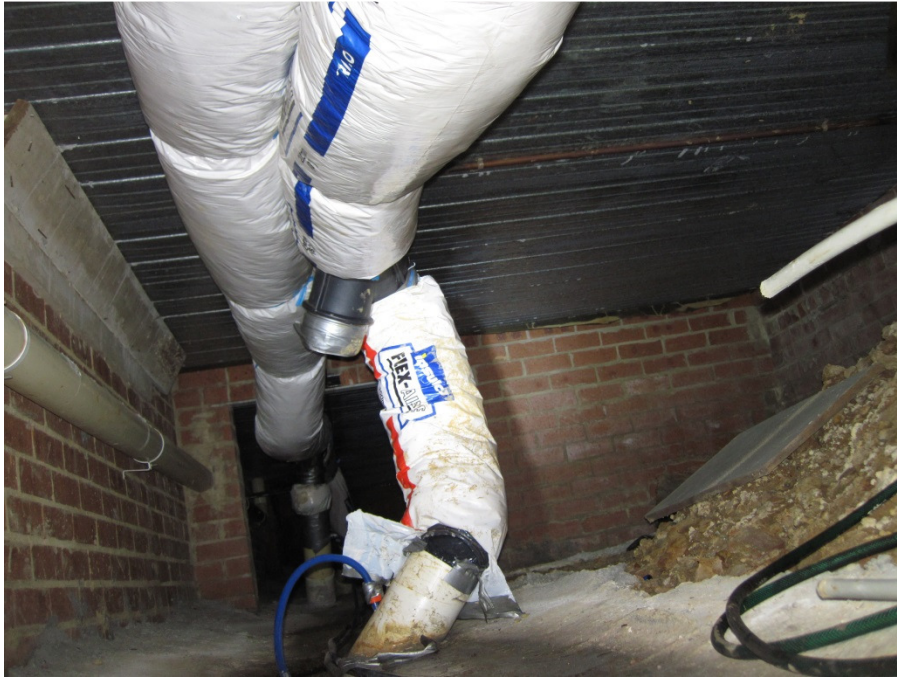
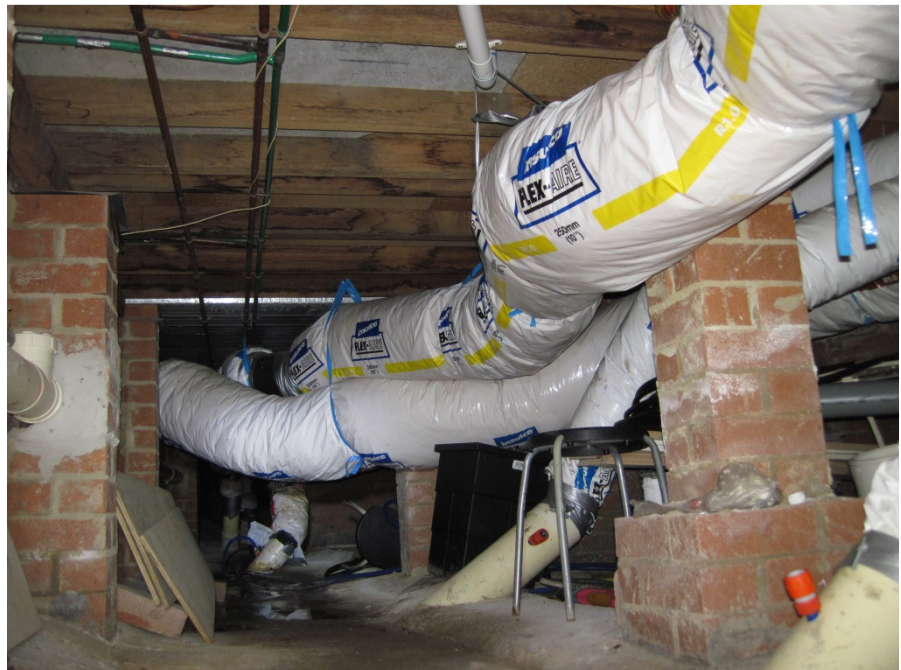
Floor Structure

Ventilation is important in minimising infestations by timber pests and preventing damp problems. The ventilation will need to be assessed by a ventilation expert and upgraded if required by fitting open mesh access doors wherever possible and by fitting the correct cross flow ventilation.
