Timber Pest Inspection Report

Inspection Date: Tue, 27 Aug 2019

Property Address: 3 Tisane Avenue, Frenchs Forest NSW, Australia

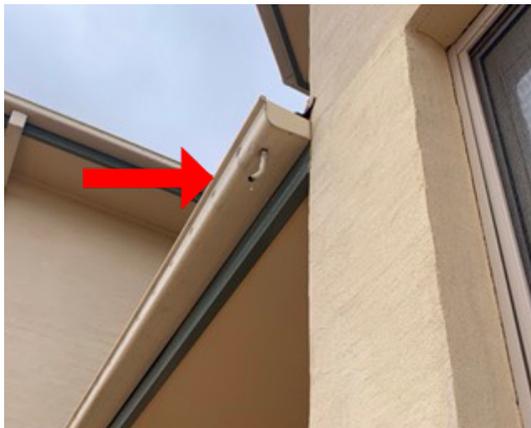
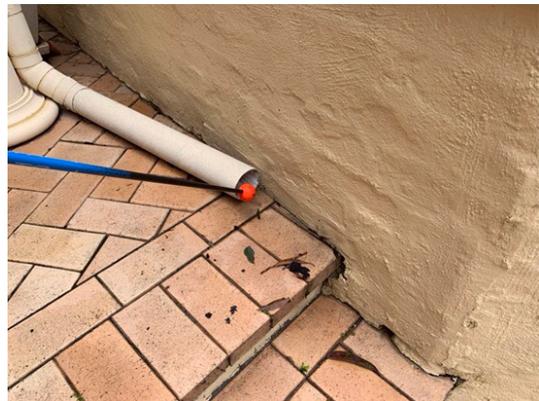
Building:	Main Building
Location:	All Areas
Finding:	Overflow - Not plumbed for drainage
Information:	The overflow is not plumbed or connected to suitable drainage, which has resulted in the surrounding area becoming excessively damp.

These damp conditions can lead to secondary defects such as rot, rust or corrosion of associated building elements, the formation of fungal decay, or even the creation of potential slip hazards. When coupled with poor site drainage, pooling of water may also attract termite activity to this area.

It is highly recommended that a qualified plumber be appointed to install adequate drainage to the overflow. These works will ensure that the area remains dry and free of any secondary defects.

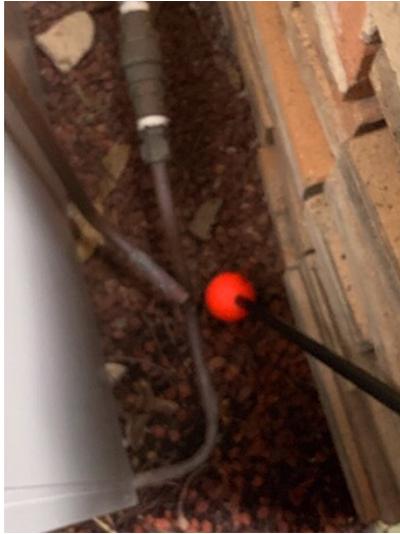
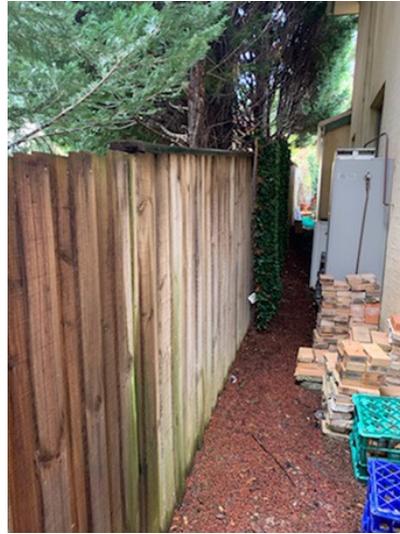
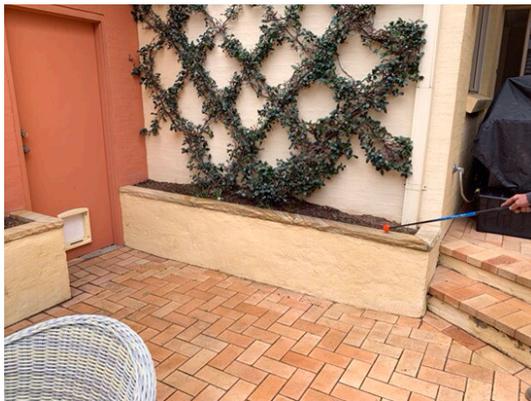
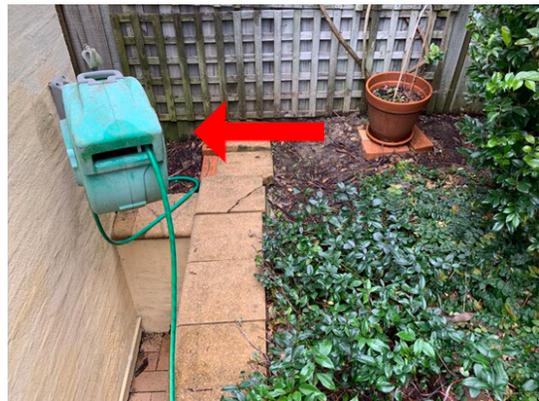
Finding: Garden Beds - Conditions Conducive to Termites

Information: Garden beds were found to be evident in the garden area. These garden beds can include untreated timber, and with a combination of moisture from watering hosing can make conditions conducive to termite activity and termite ingress.

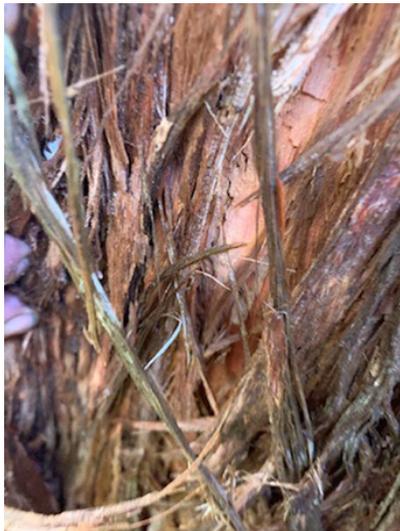
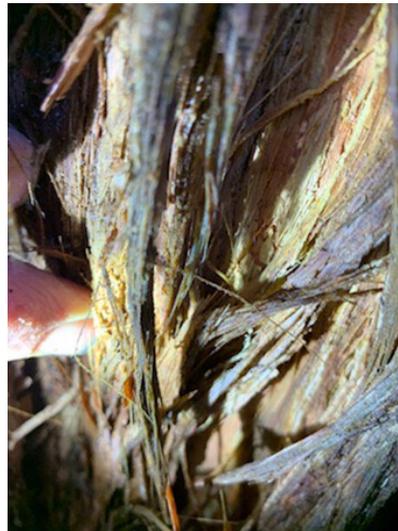
Building: Main Building
Location: All Areas
Finding: Evidence of termite workings / damage was absent at the time of inspection
Information: No evidence was found at the time of inspection to suggest that termite activity is present on the property including past workings and damage.

The homeowner should comply with instructions and recommendations as per the warranty provided by the pest company and continue to monitor areas which have conditions conducive to termite activity.

Annual pest inspections are also advised in order to identify such workings.

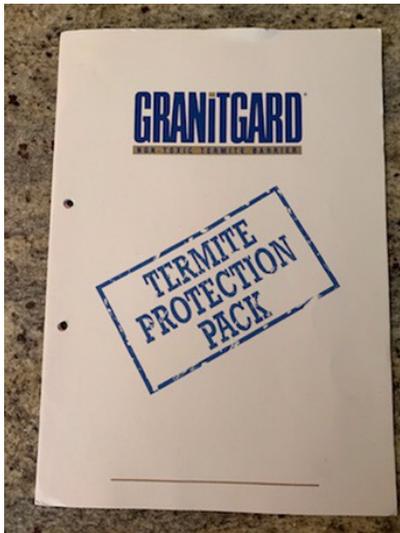
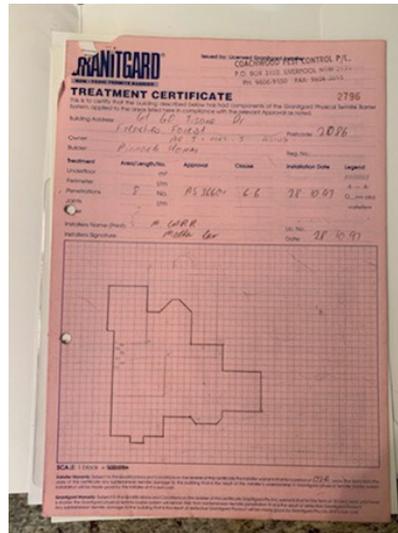
Building: Main Building
 Location: All Areas
 Finding: Evidence of a previous termite management system was identified
 Information: There are a number of factors which indicate the presence of a previously installed or applied termite barrier. The most common are a durable notice (to the inside of your meter box) observable physical barriers installed to building perimeter and in ground reticulation systems.

Where a Termite Management System has been identified you should refer to the type of barrier date of installation warranty conditions and any documentation provided by a builder or past owner. Consult the company who installed the barrier to confirm whether the system is still under warranty.

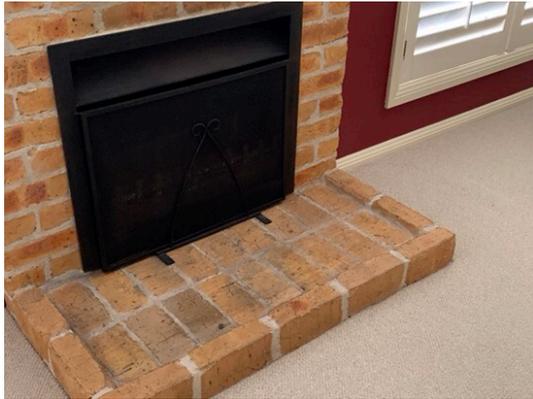
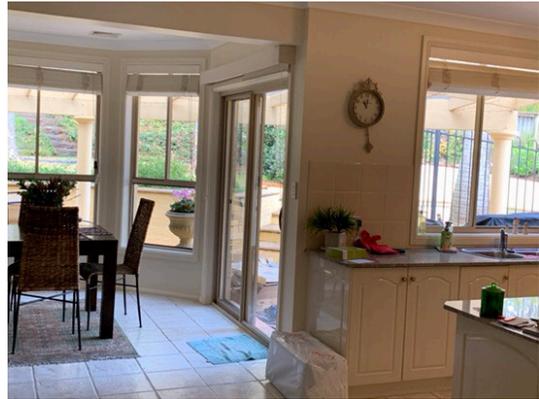
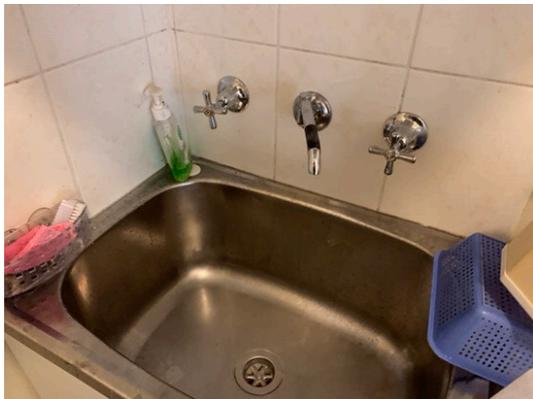
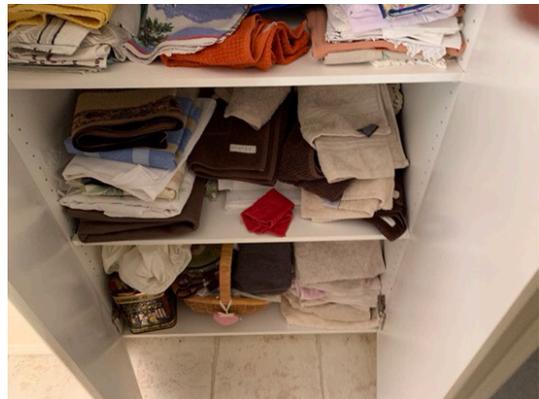
Finding: Additional Photos - Obstructions and Limitations

Information: These photographs are an indication of the obstructions and limitations which impeded full inspection of the property at the time of inspection.
