## NOTICE OF SWIMMING POOL NON-COMPLIANCE

(Clause 22E, Swimming Pools Act 1992)

**Premises to which this notice relates:** 11 Holland Crescent Frenchs Forest.

**Pool Installation Description:** In-ground concrete swimming pool

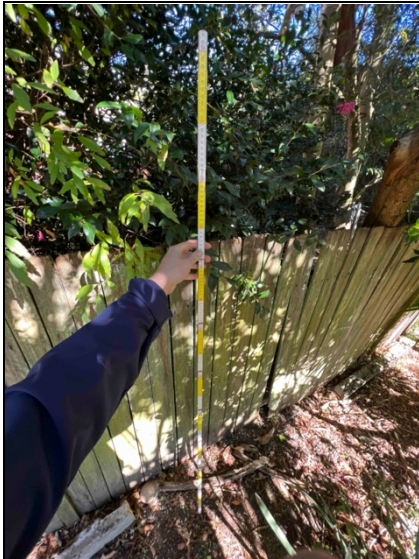
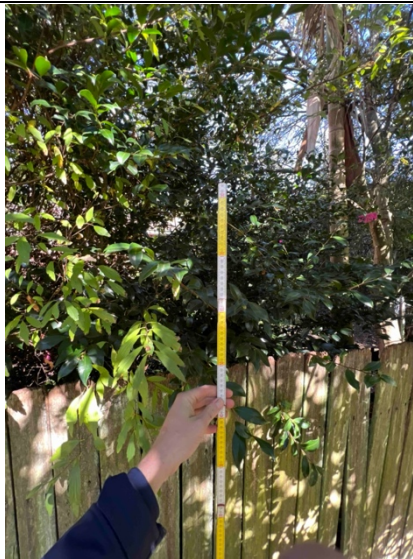
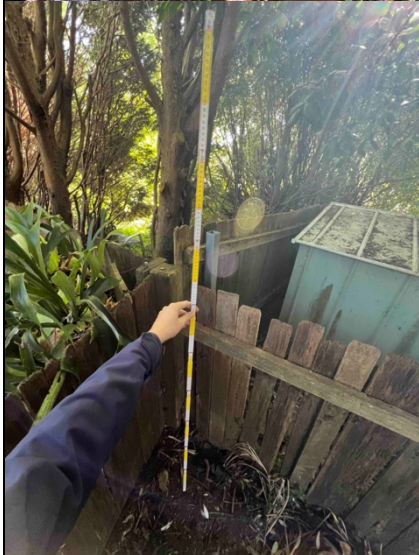
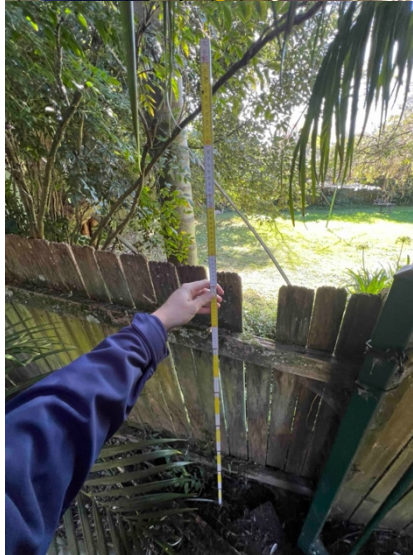
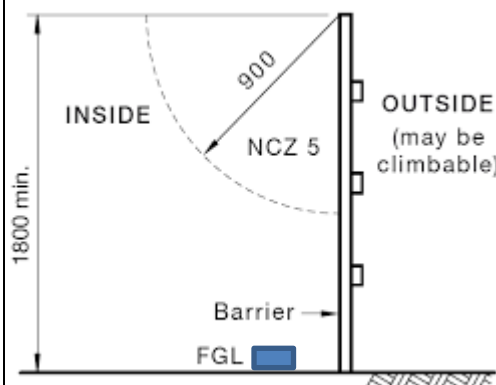
The effective height of the boundary fences was not 1800 mm or more. The height of the fences was measured from the top of the fence to the ground level on the pool side of the fence.

Steps, retaining wall or change of level within 500mm of base of fence

Above is a diagram showing the NCZ5 requirements for an 1800mm boundary fence.

Raise the boundary fences so they are 1800 mm or more in height (measured on the pool side of the fence). The height of a boundary fence is measured from the top of the fence to the ground level on the pool side of the fence. Where there is an object such as pavers, raised garden bed or decking etc within 500 mm of the boundary fence, the 1800 mm in height is measured to that object and not the ground. Alternatively, any ground or surface object on the pool side of the fence could be lowered or removed (500 mm or more away from the fence) so that the 1800 mm effective height of the fence is achieved. If the fence height is increased, the required 900 mm NCZ 5 is required to be measured from the top of the fence so that any fence extension construction provided on top of the existing fence must not have footholds greater than 10 mm wide within 900 mm of the top of the extended fence. The new 1800mm boundary fence height must run for 900mm past each intersection with the internal barrier.

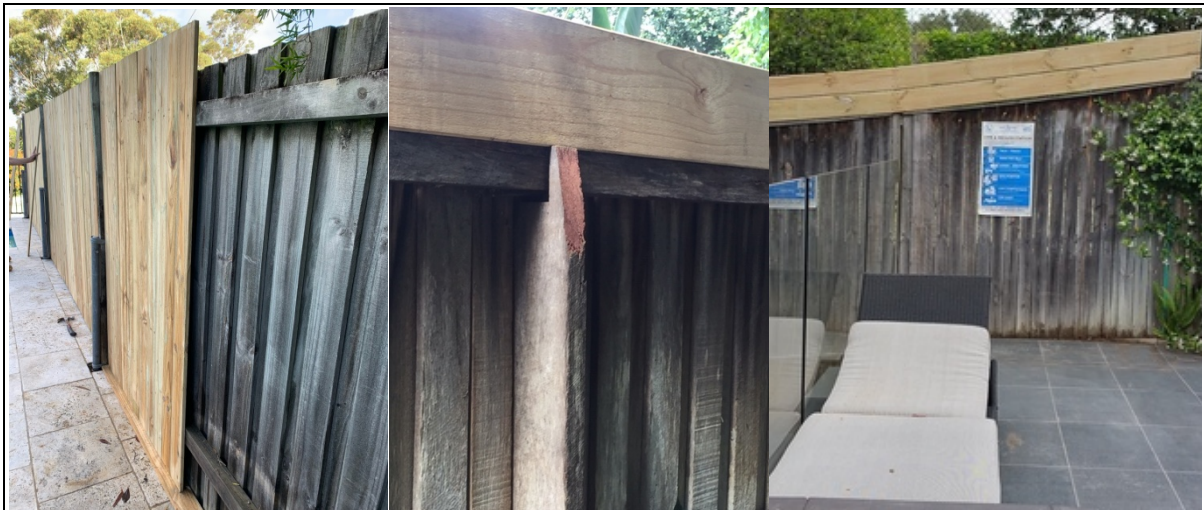
Below are some examples of ways to extend boundary fences.

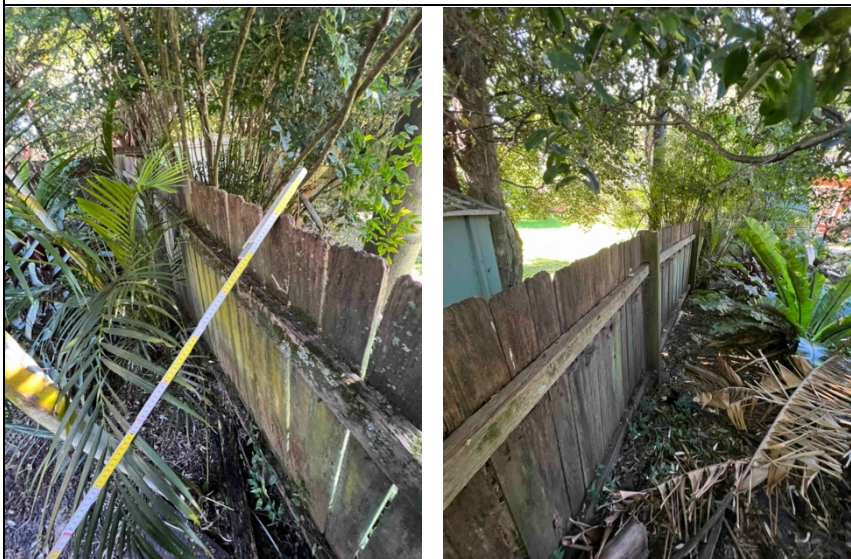
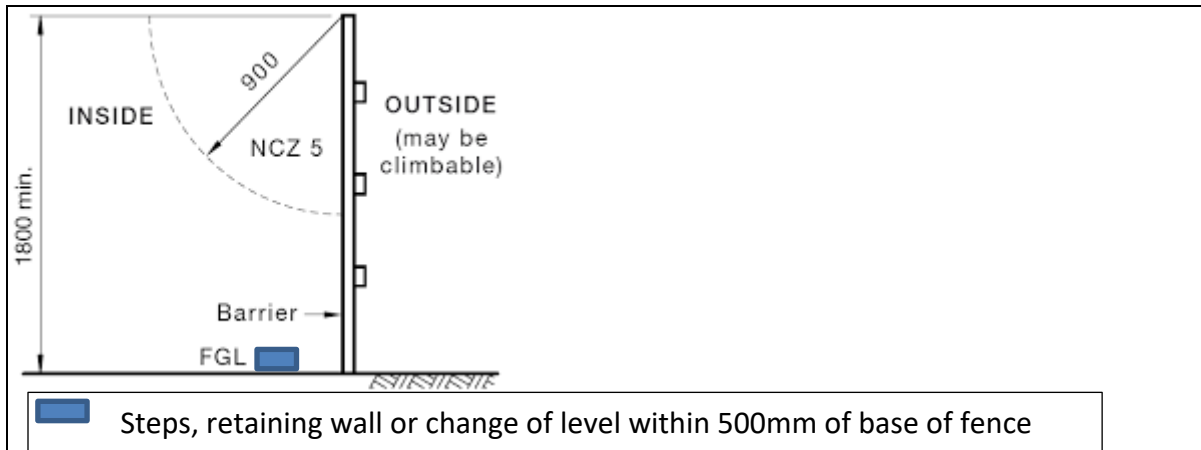
A rail was located on the inside of the boundary fence that could be used as a foothold for children to climb down into the pool enclosure.

Above is a diagram showing the NCZ5 requirements for an 1800mm boundary fence.

Shield the rail from within the 900 mm Non-Climb Zone (NCZ 5). The NCZ 5 is a 900 mm arc measured from the top of the fence and is quarter-circle in shape. If the rails are to be shielded, the minimum angle or splay of the shielding is 60 degrees. There is specifically designed 60-degree sections of timber that can be attached to the top surface of the rail.

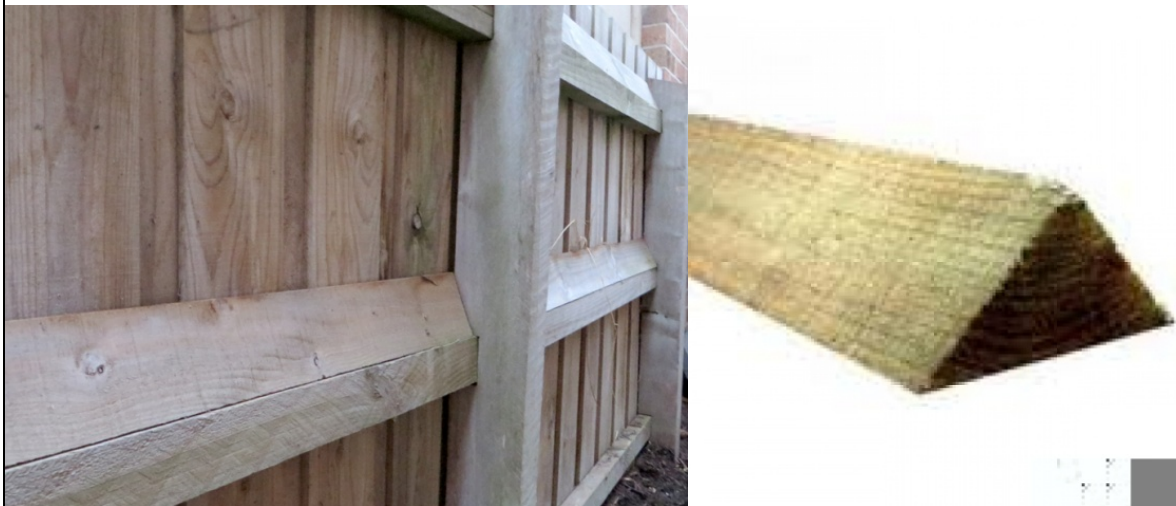
Below are some examples of 60-degree sections of shielding that can be attached to exposed rails.

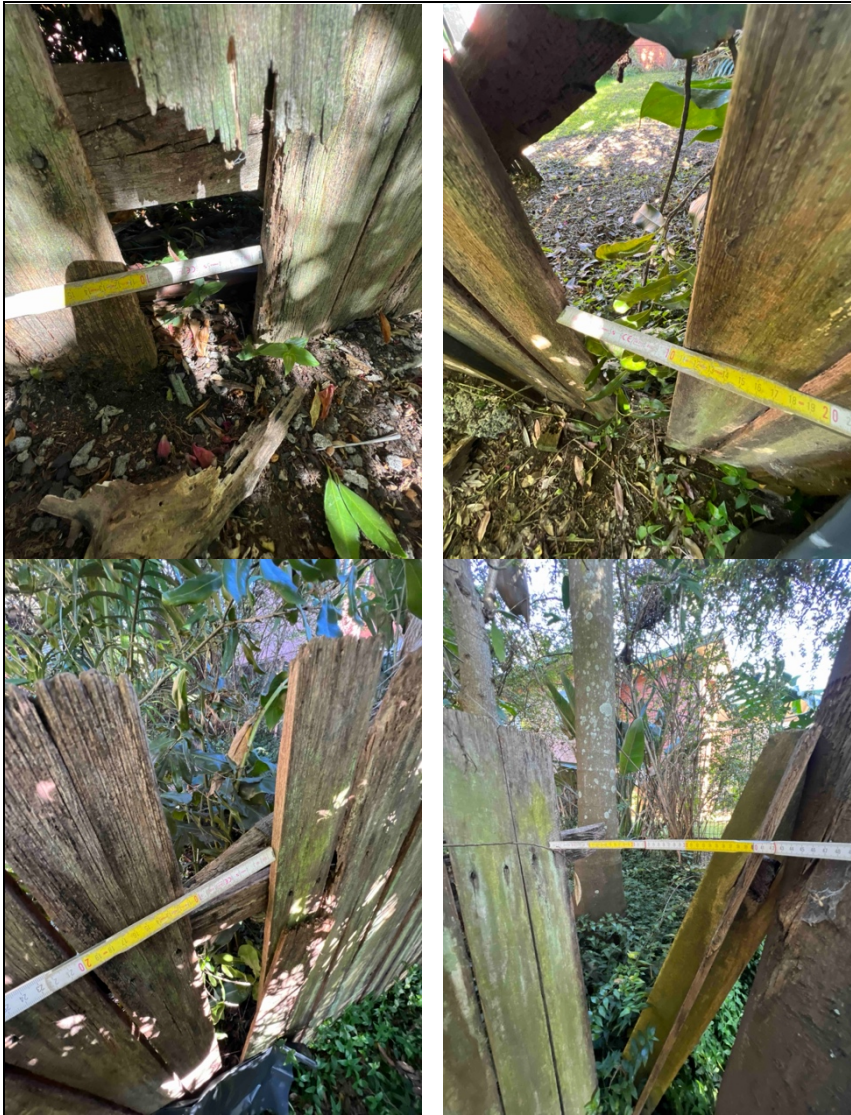
There were gaps in the boundary fence greater than 100 mm. Gaps greater than 100 mm are not permitted in or under the pool fence. Sections of the boundary fence were missing palings. There was also a section of the boundary fence that was leaning over and had broken away from the neighbouring section of fence, creating a larger gap.

Reduce all gaps to less than 100 mm using permanent and structurally adequate construction. Repair or replace the sections of damaged fence so the structural integrity of the fence is maintained.

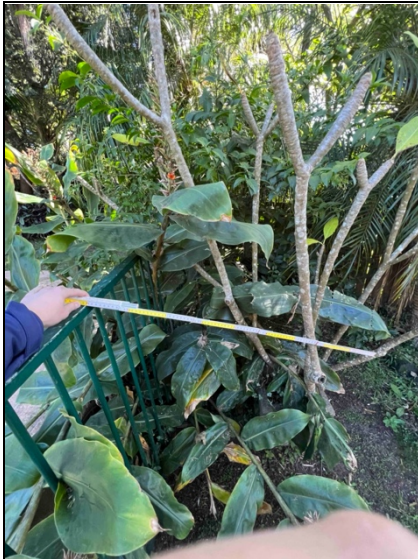
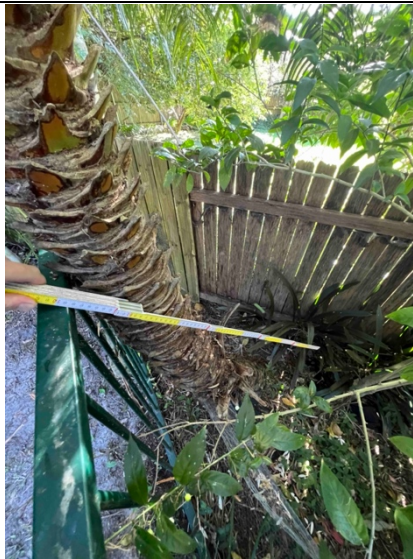
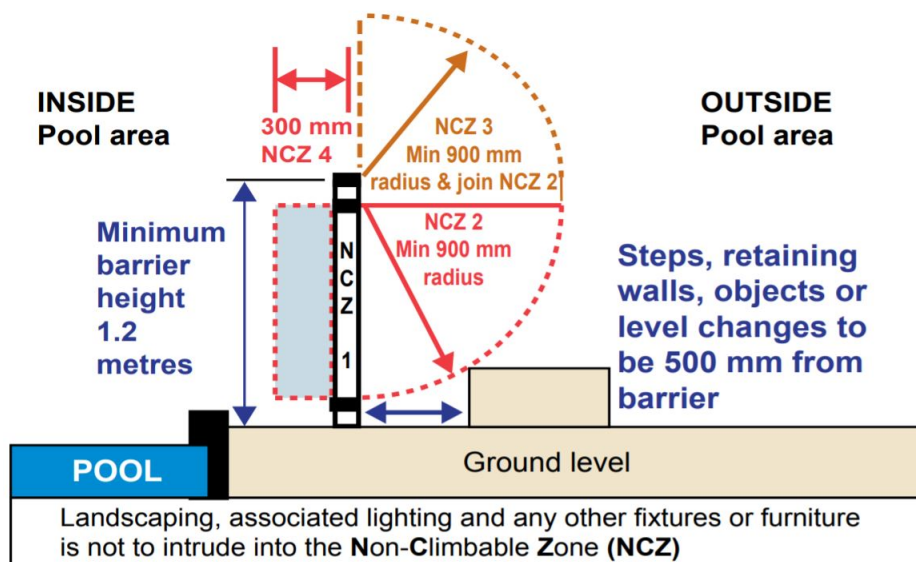
Vegetation was within the 900 mm Non-Climb Zone (NCZ) on the outside of the pool fence. The 900 mm NCZ is required to be kept clear so that children cannot use any object close to the fence to assist them to climb into the pool enclosure.

Above is a diagram showing the NCZ requirements for an internal barrier less than 1800mm high.

Prune or remove the vegetation so that no branches or fork sections are within the 900 mm NCZ. The NCZ is a 900 mm arc measured from the top of the fence and extends upward above the fence (ie the 900 mm NCZ is semi-circular in shape).

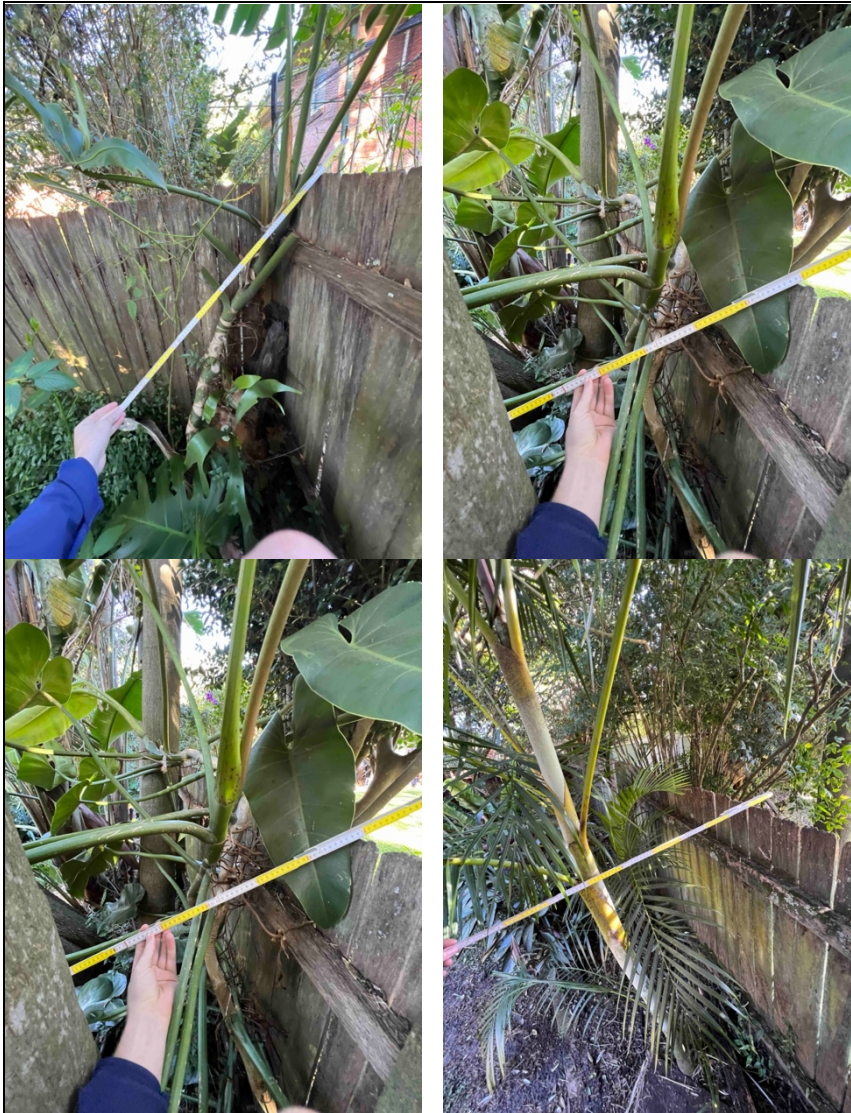
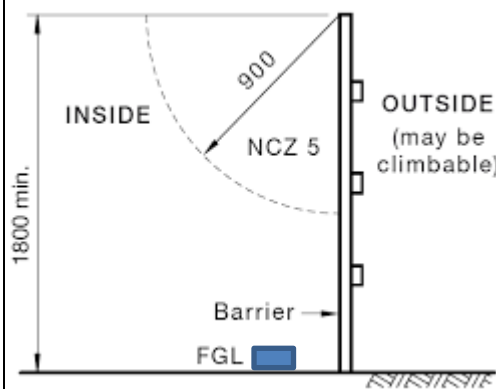
Vegetation was located on the inside of the boundary fence that could be used as a foothold for children to climb down into the pool enclosure.

Steps, retaining wall or change of level within 500mm of base of fence

Above is a diagram showing the NCZ5 requirements for an 1800mm boundary fence.

Remove or prune the vegetation so that no climbable branches or fork sections are within the 900 mm NCZ 5.

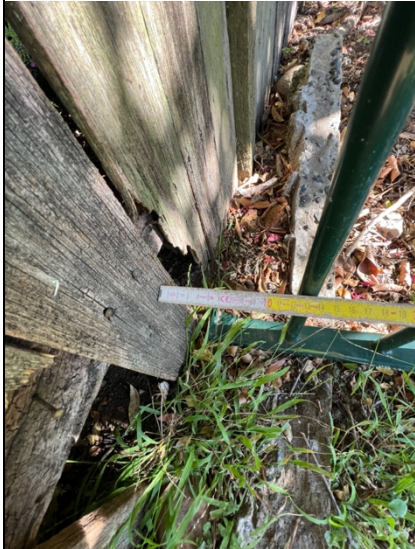
There was a gap greater than 100 mm between the boundary fence and the internal pool fence where the two fences intersected.

Reduce the gap to less than 100 mm using permanent and secure construction. Eg a timber paling.

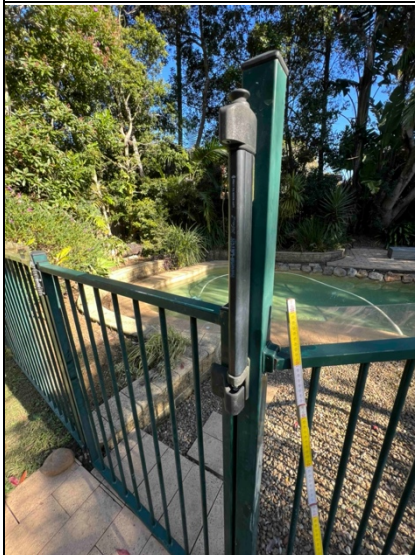
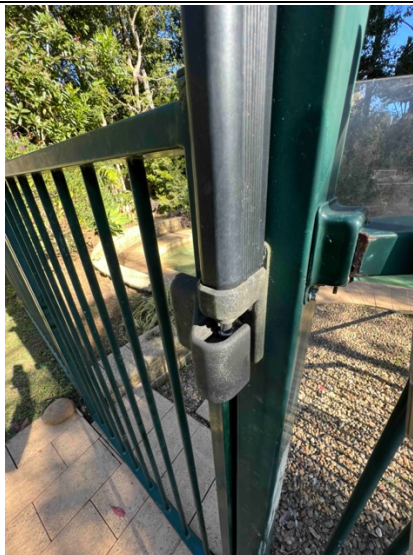
The pool gate did not self-close and self-latch because the gate strike was not correctly aligned with the post latch.

Adjust the latch mechanism so the gate self-closes and self-latches from any open position, including when the gate is resting on the latch.

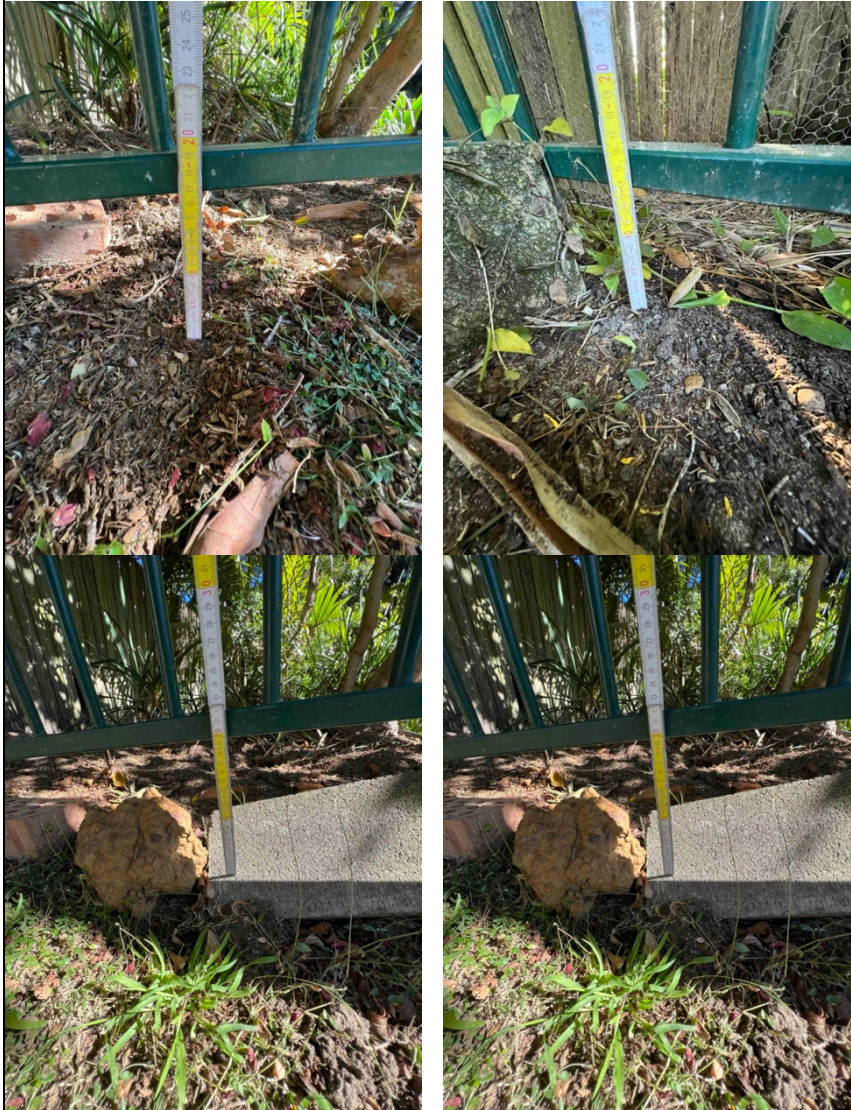
There were gaps under the internal pool fence greater than 100 mm. Gaps greater than 100 mm are not permitted in or under the pool fence.

Reduce all gaps under the pool fence to less than 100 mm using permanent and structurally adequate construction.
