## NOTICE OF SWIMMING POOL NON-COMPLIANCE

**Notice Date:** 17 November 2023

**Premises to which this notice relates:** 102 Bantry Bay Road Frenchs Forest.

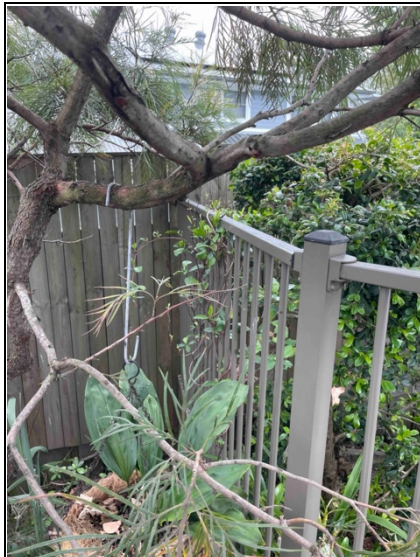
<p><b>1. Defect/non-compliance identified</b></p> <p>A Shrub was within the 900 mm Non-Climb Zone (NCZ 2 &amp; 3) on the outside of the pool fence. The 900 mm NCZ is required to be kept clear so that children cannot use any object close to the fence to assist them to climb into the pool enclosure.</p> <p><b>Suggested solution for rectification</b></p> <p>Prune or remove the Shrub so that no climbable branches are within the 900 mm NCZ. The NCZ is a 900 mm arc measured from the top of the fence and extends upward above the fence (ie the 900 mm NCZ is semi-circular in shape).</p> <p>Alternatively, if the section of barrier opposite the climbable vegetation is replaced or extended so the barrier is 1800mm or more in height the climbable vegetation could remain as it is. AS 1926.1 – 2012 (the Australian Standard used to assess your barrier) has a section (2.2.3) that allows internal barriers greater than 1800mm high to NOT require any Non Climb Zones (NCZ's).</p>

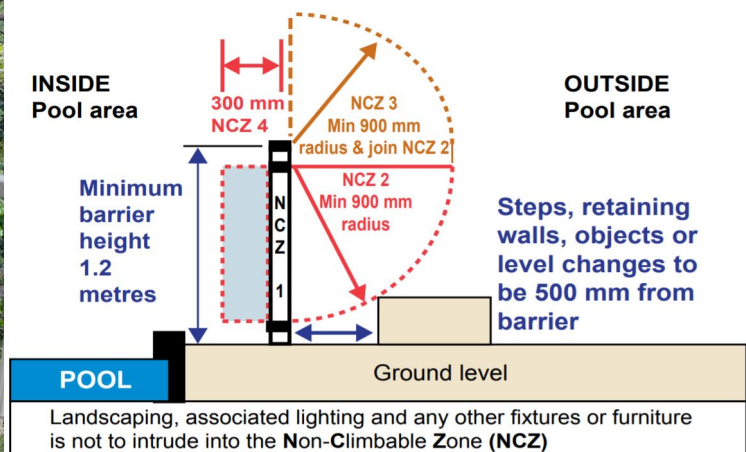
Above is a diagram showing internal barriers less than 1800mm high non climb zones.

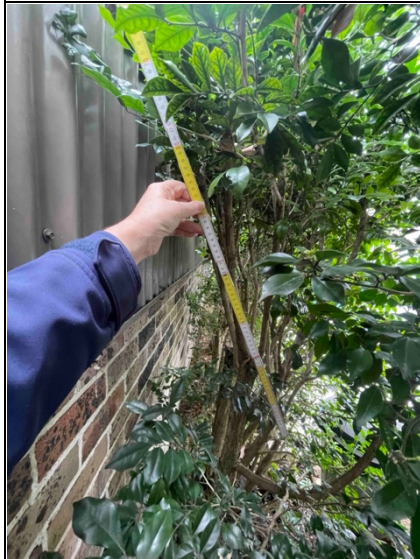
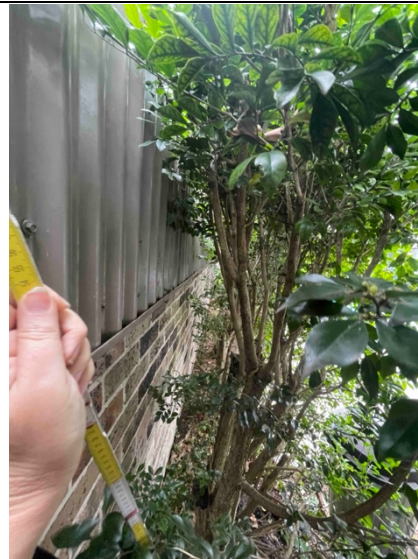
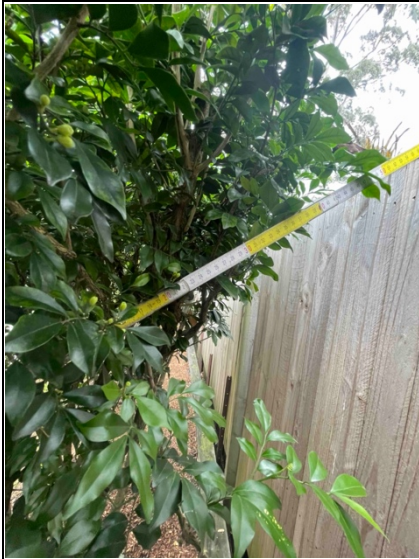
A hedge was located on the inside of the boundary fence that could be used as a foothold for children to climb down into the pool enclosure.

Remove or prune the hedge so that no branch is within the 900 mm NCZ 5.

Alternatively, if a new 1800mm high internal barrier is installed between the vegetation and the swimming pool the climbable vegetation could remain as it is. AS 1926.1 – 2012 (the Australian Standard used to assess your barrier) has a section (2.2.3) that allows internal barriers greater than 1800mm high to NOT require any Non Climb Zones (NCZ's). See example photographs below.

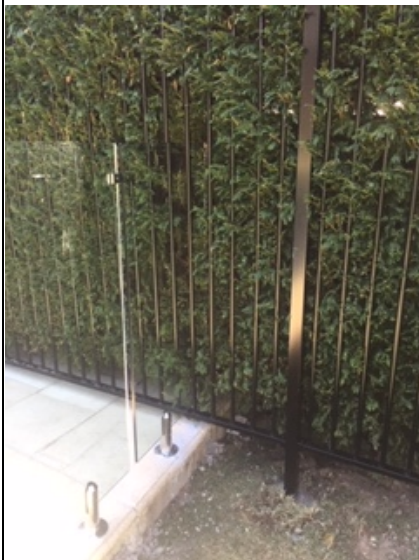
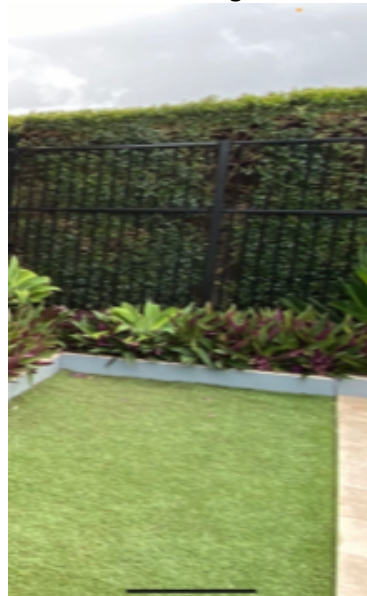
Below are some examples of newly installed 1800mm high internal barrier for vegetation

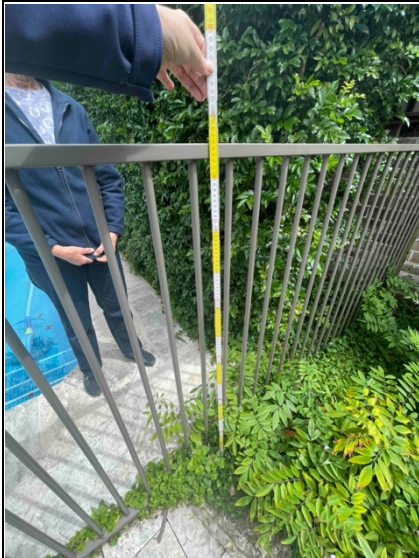
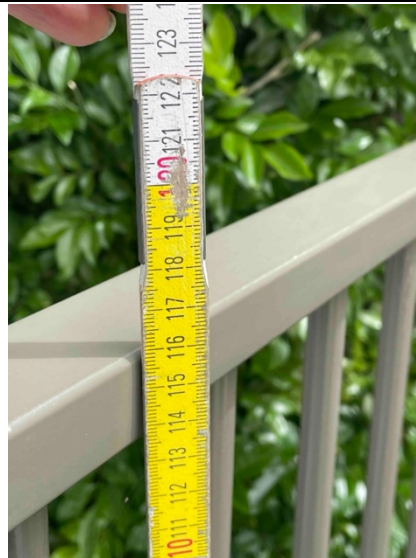
A section of the internal pool fence was not 1200 mm or more in height as the garden bed/ rockery at the base of the fence has reduced the effective height of the fence.

Increase the height of the fence so that the effective height is 1200 mm or more measured on the outside of the fence. Alternatively, the garden bed on the outside of the fence can be removed or

lowered so the 1200 mm can be measured to the ground or base of the fence. The height of the fence is measured from the top of the fence to the ground level on the outside of the fence. Where there is an object within 500 mm of the pool fence such as garden beds etc, the 1200 mm height is measured to the surface of the garden and/or garden bed edging boards etc and not the base of the fence. If raising the fence is the option used, the gap under the fence must not exceed 100 mm. In most cases, the fence will need to be raised to a height that will create a gap greater than 100 mm under the fence. In such cases, it is more effective to raise the fence and then close the gap (that is created) by using permanent and secure construction under the pool fence panels rather than replacing the entire fence with higher fence panel.

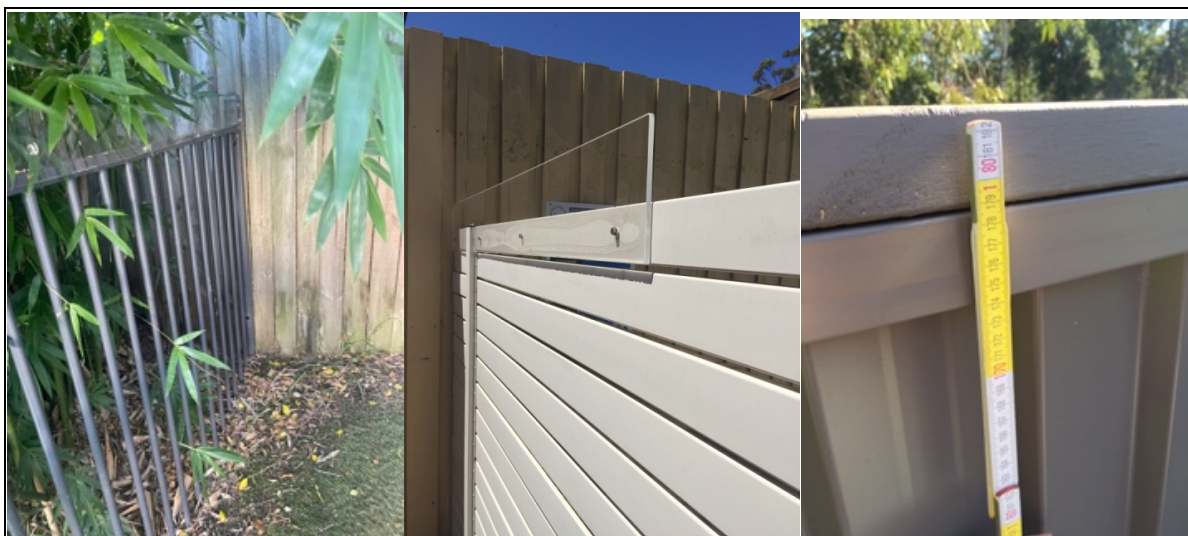
Below are some examples of increasing fence height

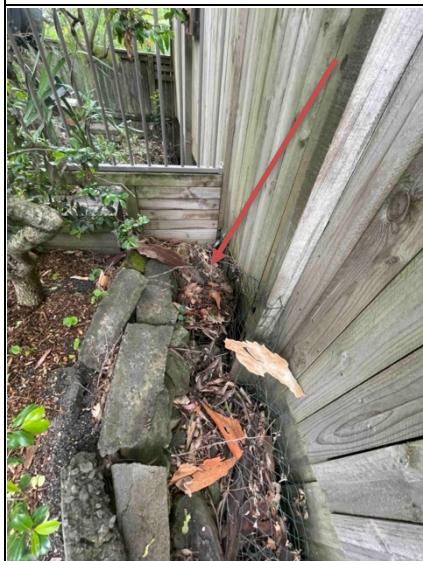
There was a gap under the internal pool fence greater than 100 mm. Gaps greater than 100 mm are not permitted in or under the pool fence.

Reduce all gaps under the pool fence to less than 100 mm using permanent and structurally adequate construction.
