## NOTICE OF SWIMMING POOL NON-COMPLIANCE

(Clause 22E, Swimming Pools Act 1992)

**Premises to which this notice relates:** 122 Forest Way Belrose.

**Pool Installation Description:** In-ground fibreglass swimming pool

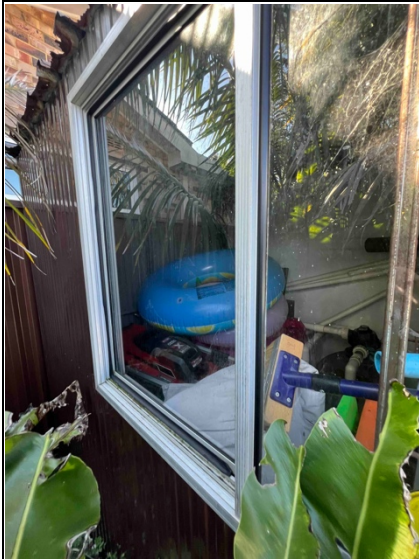
<p><b>1. Defect/non-compliance identified</b></p> <p>There was a garden shed within the pool enclosure that was not solely being used to store pool toys, chemicals and other items associated with the pool. Garden sheds are not permitted to be located wholly within a pool enclosure unless the sole purpose is to store equipment directly related to the swimming pool.</p> <p><b>Suggested solution for rectification</b></p> <p>Remove the garden shed from within the pool enclosure or install a new pool fence to separate the garden shed from the pool. Alternatively, all non-related pool equipment could be removed from the garden shed and the shed be used solely to store pool toys and equipment.</p>
---

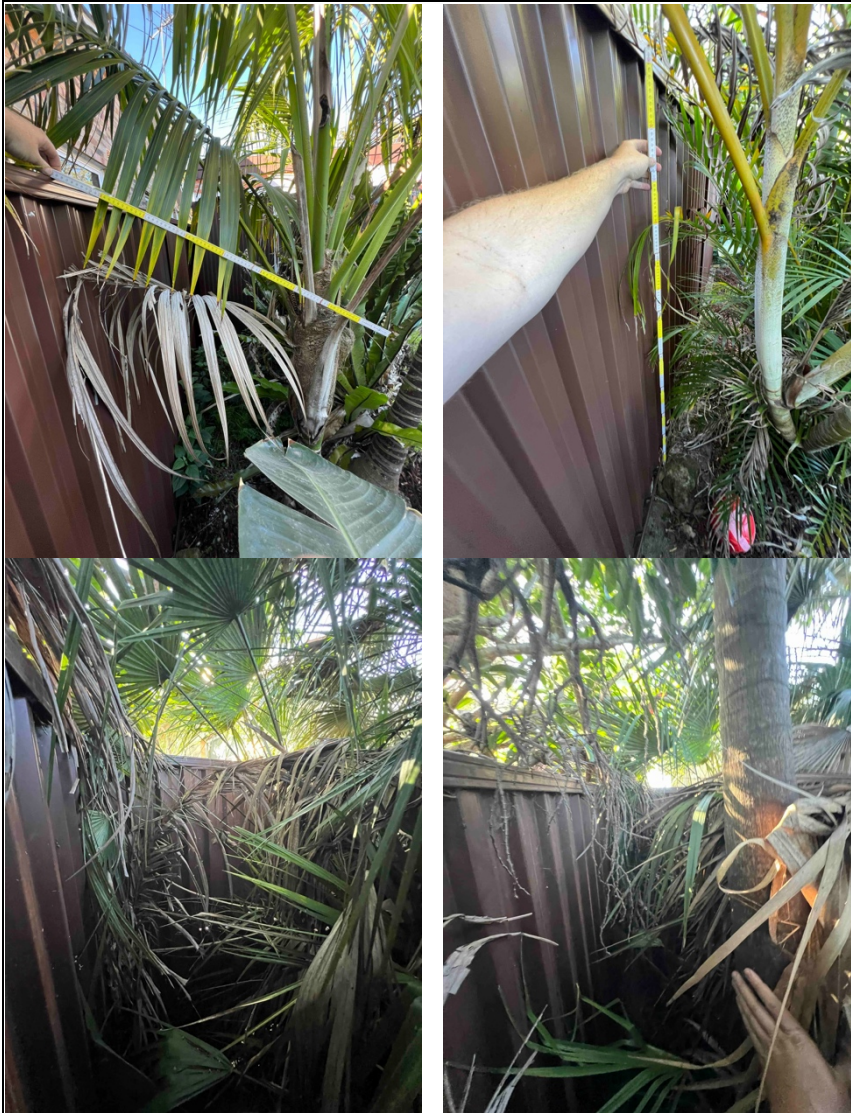
Palm fronds were located on the inside of the boundary fence that could be used as a foothold for children to climb down into the pool enclosure.

There was a section of dense vegetation in the rear corner of the property. The area needs to be cleared out so access can be obtained. All areas of the swimming pool barrier must be documented and ensure compliance.

Remove or prune the palm fronds so that no climbable branches/fronds are within the 900 mm NCZ 5. When the fronds are cut they must be cut flush with the trunk so no indentations or projections greater than 10mm are remaining.

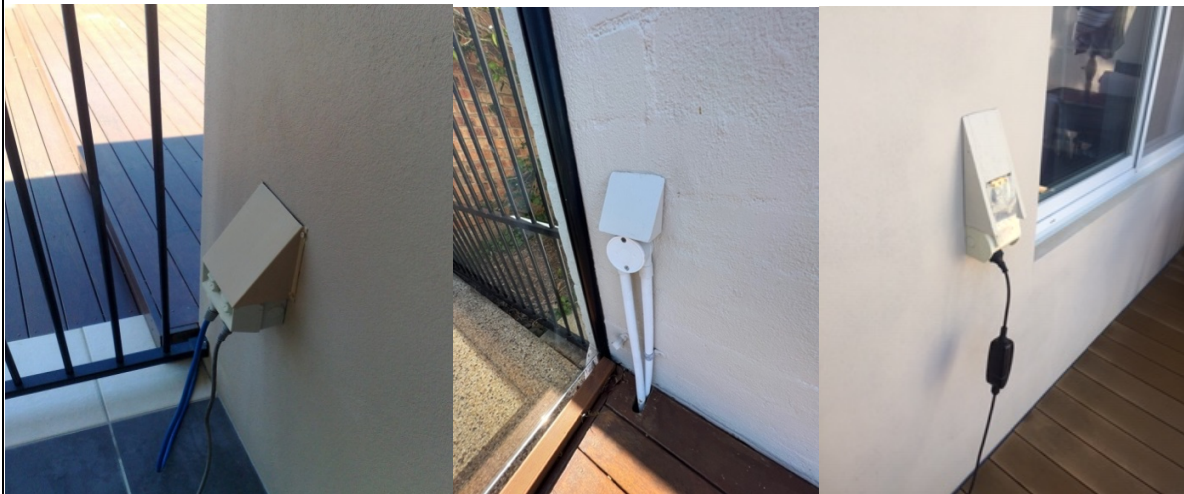
See below examples of 60-degree angled sections of timber that could be attached to shield the top surface of the PowerPoint.

**Alternatively** attach a sharp 60-degree angled section of timber to cover the top surface of the Power point. Once an object or surface has a 60-degree angle attached it is no longer classed as a climbing point.

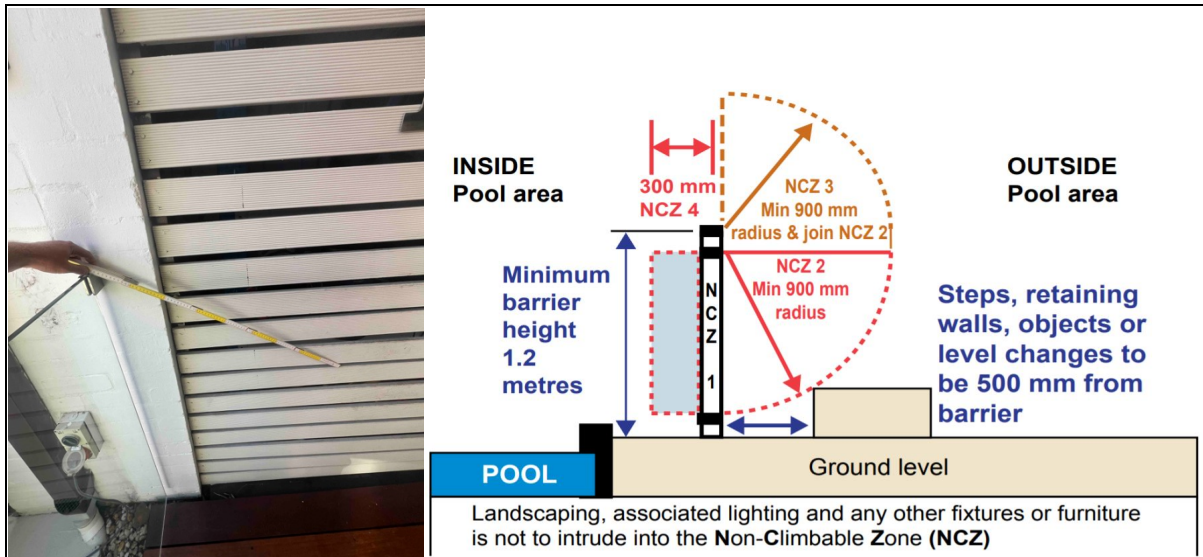
A climbable screen was within the 900 mm Non-Climb Zone (NCZ) on the outside of the pool fence. The 900 mm NCZ is required to be kept clear so that children cannot use any object close to the fence to assist them to climb into the pool enclosure.

Above is a diagram showing the NCZ requirements for an internal barrier less than 1800mm high.

Shield the sections of the climbable screen that are located within the 900 mm NCZ so they cannot be used to assist children to climb over the fence and into the pool enclosure. This can be done by attaching a section of perspex or similar. The NCZ is a 900 mm arc measured outward from the top most rail on the fence (if there is an upper rail) or the top of the fence and also extends upward above the top of the fence. The NCZ is semi-circular in shape.

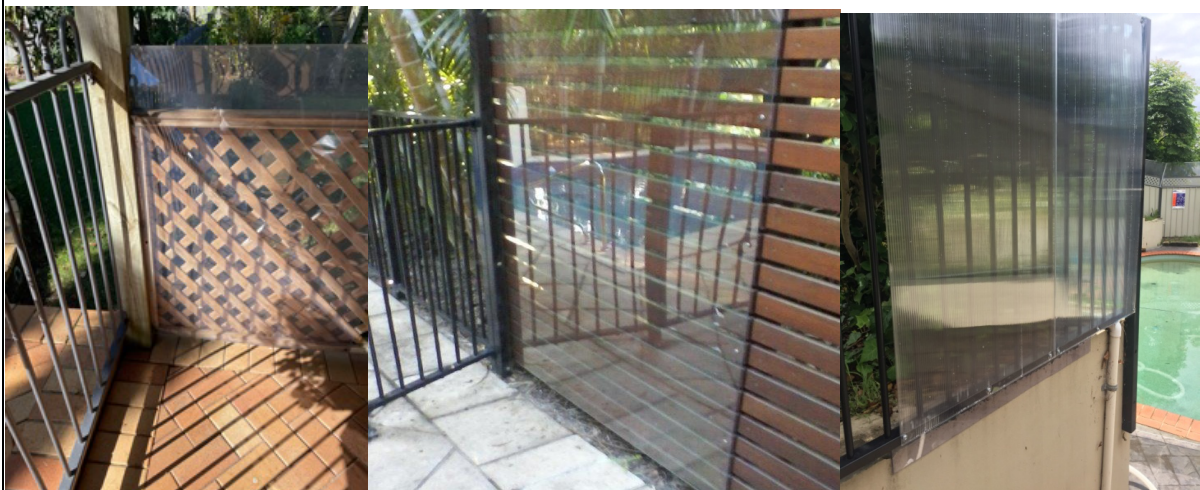
See below some examples of shielding climbable screens adjoining the barrier.

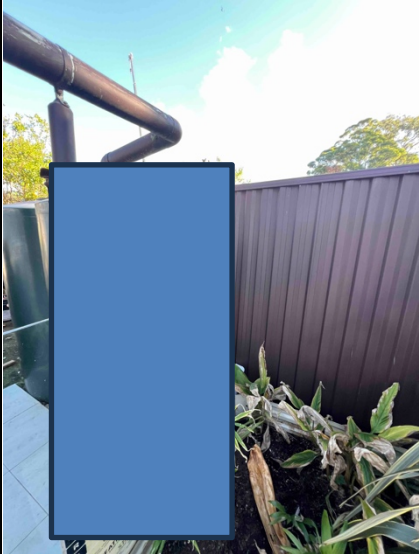
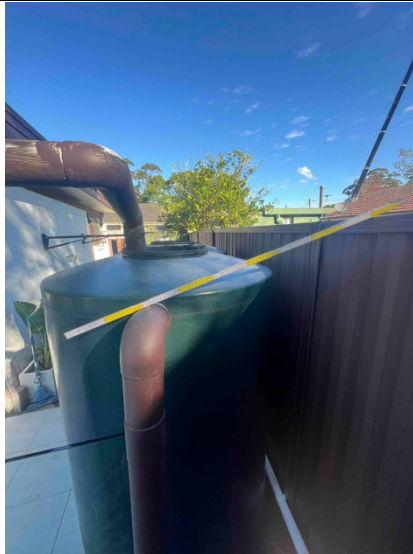
The internal pool fence (water tank) was greater than 50 mm wide where it intersects with the boundary fence and could be used as a foothold for neighbouring children to climb down into the pool enclosure. The boundary fence has a 900 mm Non Climbable Zone (called the NCZ5 zone) that is measured in an arc from the top of the boundary fence and is located on the pool side of the boundary fence. Internal fences are permitted to intersect with the boundary fence and be within NCZ5 as long as the internal pool fence has no horizontal surfaces greater than 50 mm wide. The internal fence top rail and posts are greater than 50mm wide and are not permitted to be within NCZ5.

See above diagram where a section of 1800mm screen can be attached.

Attach a section of 1800mm screen (against the water tank pool side) that will increase the fall from the top of the water tank to the pool level. The fall must be at least 1800mm and needs to continue for 900mm out past the edge of the tank. **The adjoining screen/panel**

must be attached Infront of the pipe and ensure the gap between the glass and new screen is less than 100mm so it acts as one continuous barrier.

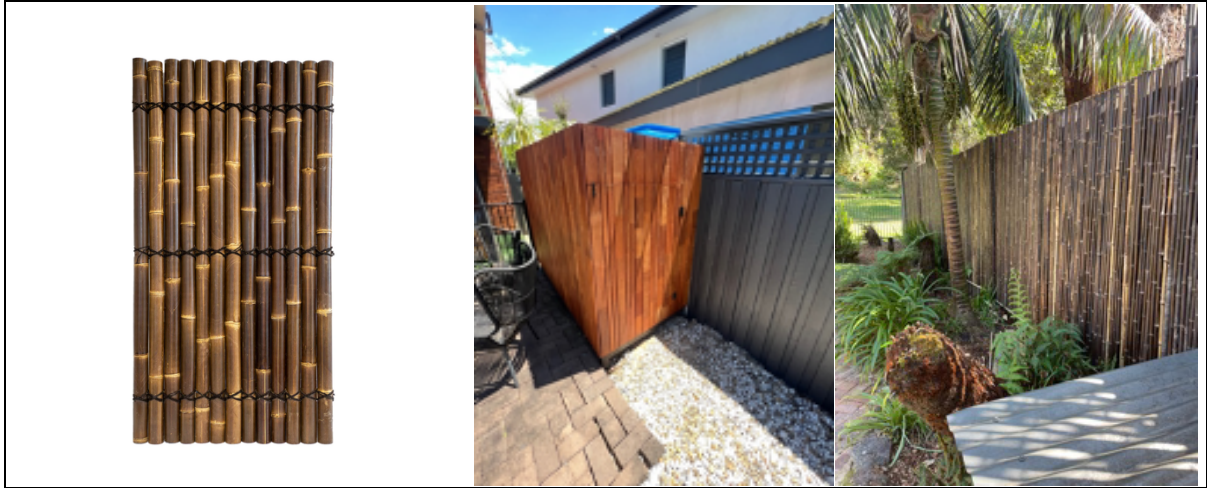
See below some examples of 1800mm solid bamboo screening that could be attached against the tank to increase the fall to 1800mm poolside. The screening must be rigid and solid.
