## **NOTICE OF SWIMMING POOL NON-COMPLIANCE**

(Clause 22E, Swimming Pools Act 1992)

**Premises to which this notice relates:** 2 Berrinda Place Frenchs Forest.

**Pool Installation Description:** In-ground concrete swimming pool

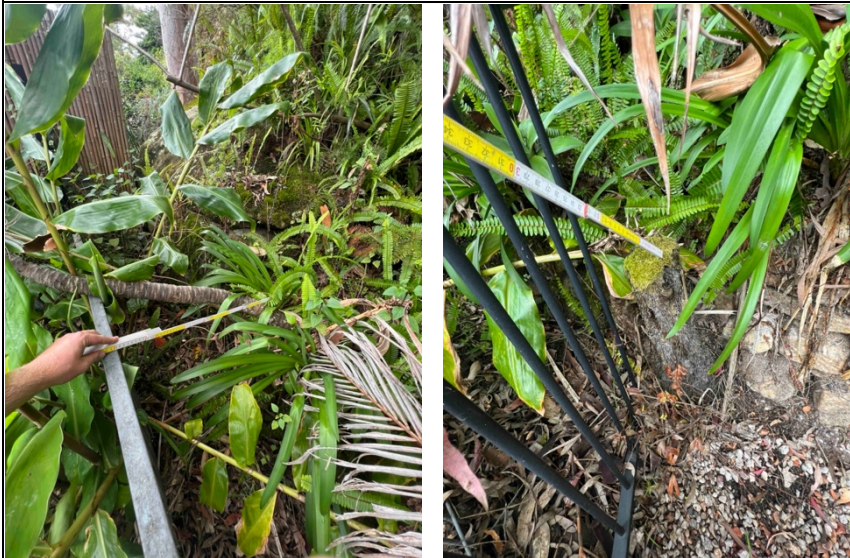
**2. Defect/non-compliance identified**

Vegetation was within the 900 mm Non-Climb Zone (NCZ) on the outside of the pool fence. The 900 mm NCZ is required to be kept clear so that children cannot use any object close to the fence to assist them to climb into the pool enclosure.

Above is a diagram showing the NCZ requirements for an internal barrier less than 1800mm high.

Prune or remove the vegetation so that no branch, stumps or fork sections are within the 900 mm NCZ. The NCZ is a 900 mm arc measured from the top of the fence and extends upward above the fence (ie the 900 mm NCZ is semi-circular in shape).

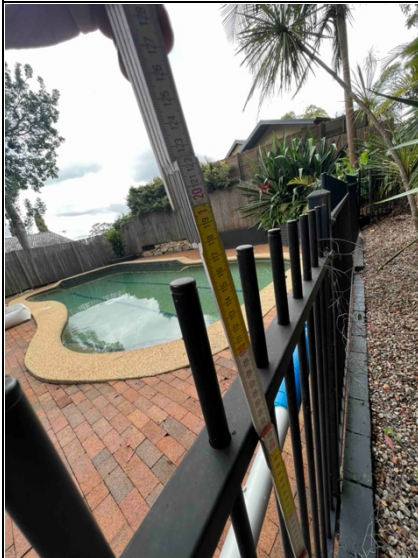
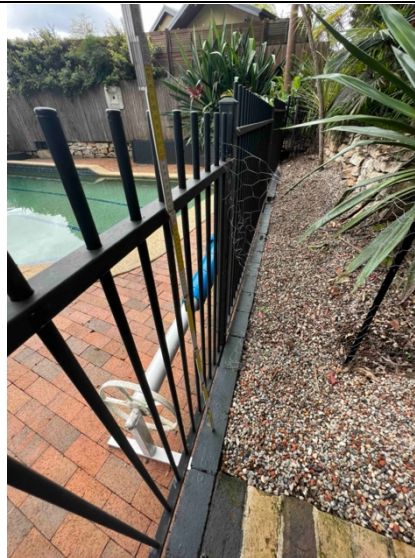
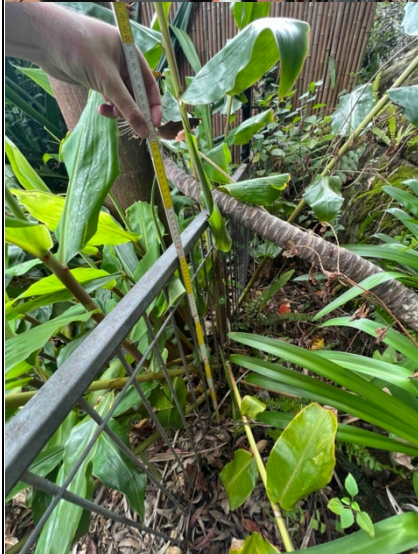
**3. Defect/non-compliance identified**

Sections of the internal pool fence were not 1200 mm or more in height.

Above is a diagram showing the NCZ requirements for an internal barrier less than 1800mm high.

Increase the height of the fence so that the effective height is 1200 mm or more measured on the outside of the fence. The height of the fence is measured from the top of the fence

to the ground level on the outside of the fence. Where there is an object within 500 mm of the pool fence, the 1200 mm height is measured to that object and not the ground. Alternatively, any object on the outside of the fence that is within 500 mm of the fence can be lowered or removed so the 1200 mm can be measured to the ground. If raising the fence is the option used, the gap under the fence must not exceed 100 mm. In most cases, the fence will need to be raised to a height that will create a gap greater than 100 mm under the fence. In such cases, it is more effective to raise the fence and then close the gap (that is created) by using permanent and secure construction under the pool fence panels rather than replacing the entire fence with higher fence panel.

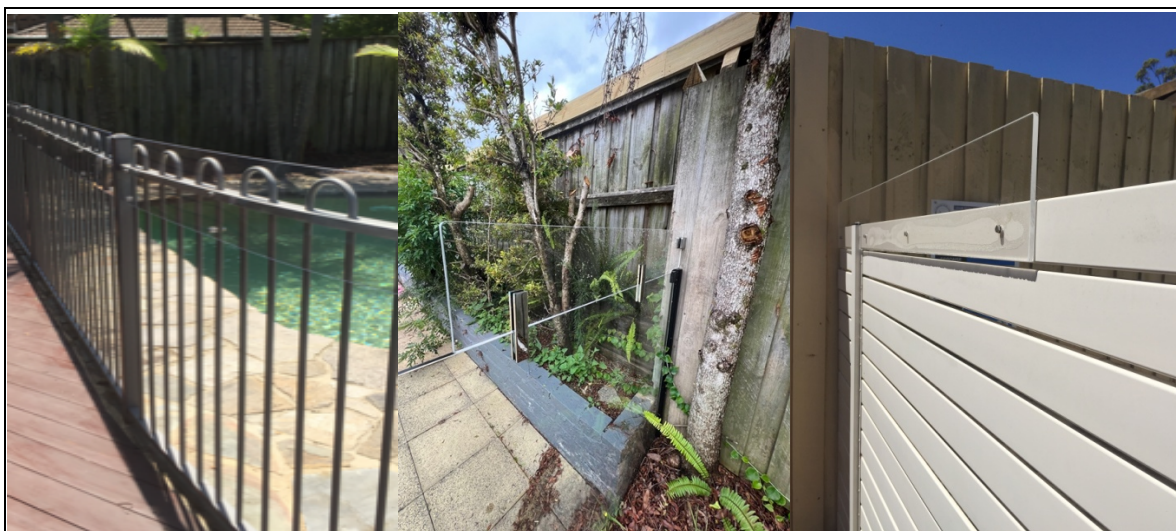
Below are some examples of extending the height of internal barriers to 1200mm.

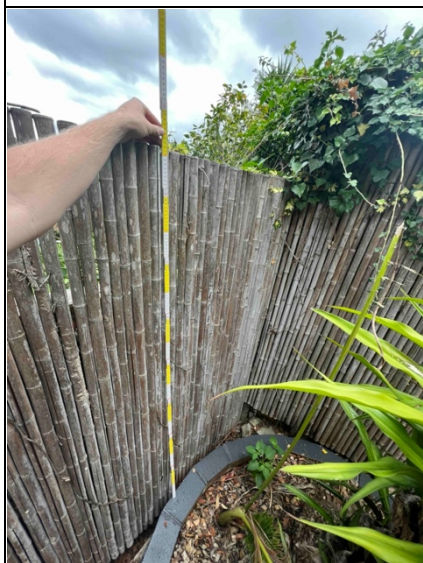
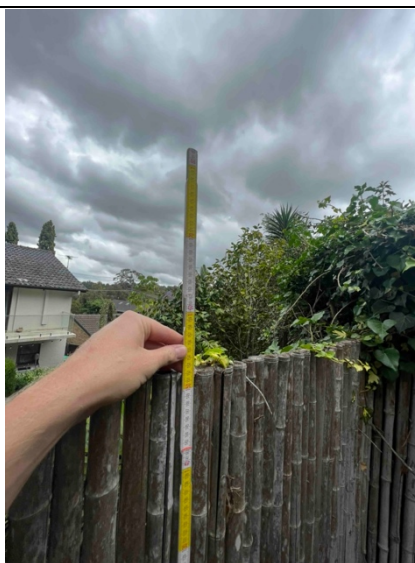
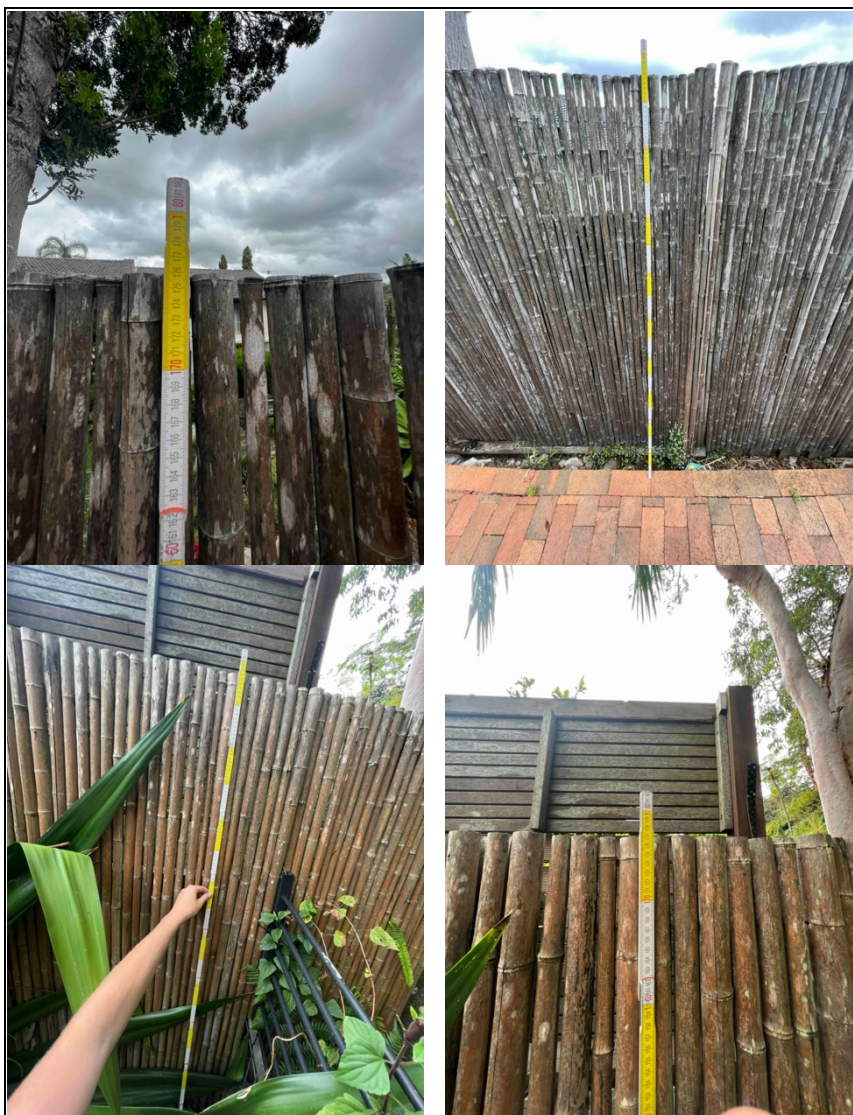
#### 4. **Defect/non-compliance identified**

The effective height of the boundary fences was not 1800 mm or more. The height of the fences was measured from the top of the fence to the ground level on the pool side of the fence.

Steps, retaining wall or change of level within 500mm of base of fence

Above is a diagram showing the NCZ5 requirements for an 1800mm boundary fence.

Raise the boundary fences so they are 1800 mm or more in height (measured on the pool side of the fence). The height of a boundary fence is measured from the top of the fence to the ground level on the pool side of the fence. Where there is an object such as pavers, raised garden bed or decking etc within 500 mm of the boundary fence, the 1800 mm in height is measured to that object and not the ground. Alternatively, any ground or surface object on the pool side of the fence could be lowered or removed (500 mm or more away from the fence) so that the 1800 mm effective height of the fence is achieved. If the fence height is increased, the required 900 mm NCZ 5 is required to be measured from the top of the fence so that any fence extension construction provided on top of the existing fence must not have footholds greater than 10 mm wide within 900 mm of the top of the extended fence.

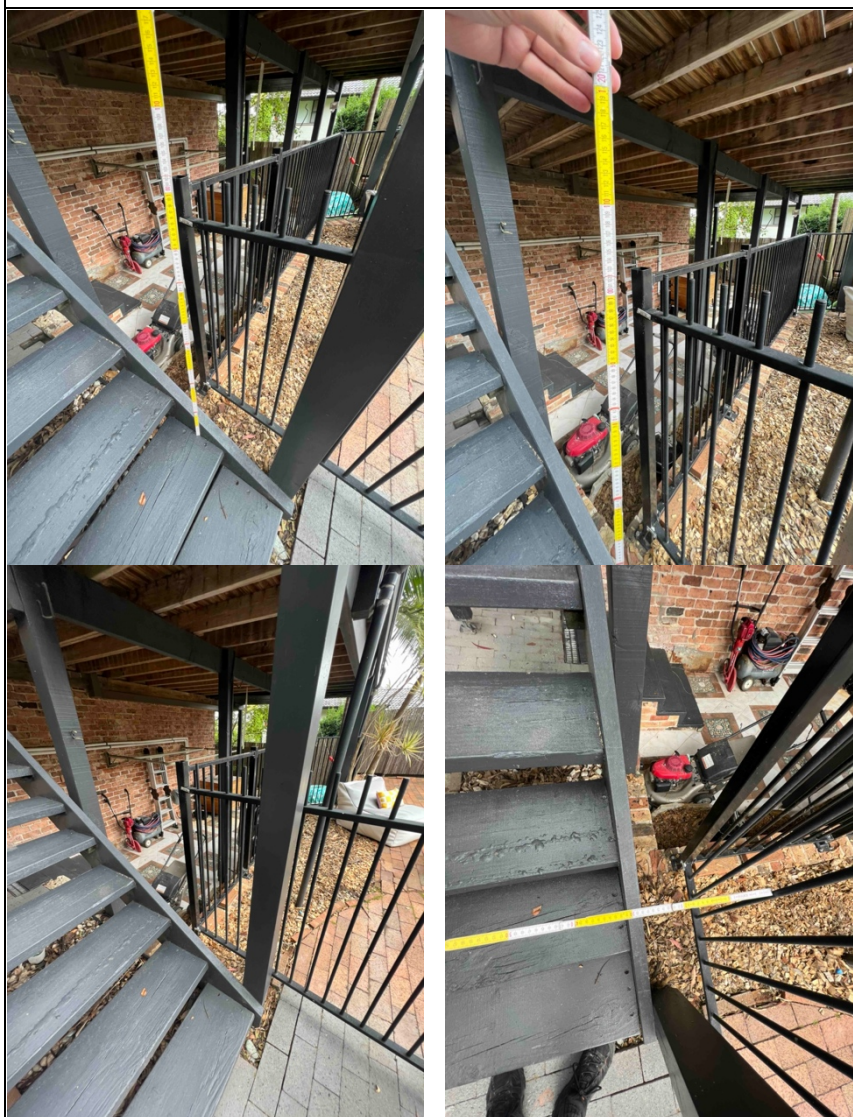
##### 5. **Defect/non-compliance identified**

The internal pool fence was not 1200 mm or more in height as the stairs at the base of the fence has reduced the effective height of the fence.

Above is a diagram showing the NCZ requirements for an internal barrier less than 1800mm high.

Increase the height of the fence so that the effective height is 1200 mm or more measured

on the outside of the fence. The height of the fence is measured from the top of the fence to the ground level on the outside of the fence. Where there is an object within 500 mm of the pool fence such as garden beds etc, the 1200 mm height is measured to the surface of the garden and/or garden bed edging boards etc and not the base of the fence. If raising the fence is the option used, the gap under the fence must not exceed 100 mm. In most cases, the fence will need to be raised to a height that will create a gap greater than 100 mm under the fence. In such cases, it is more effective to raise the fence and then close the gap (that is created) by using permanent and secure construction under the pool fence panels rather than replacing the entire fence with higher fence panel. Alternatively the internal barrier can be re positioned so the stairs are no longer within the 500mm exclusion zone.

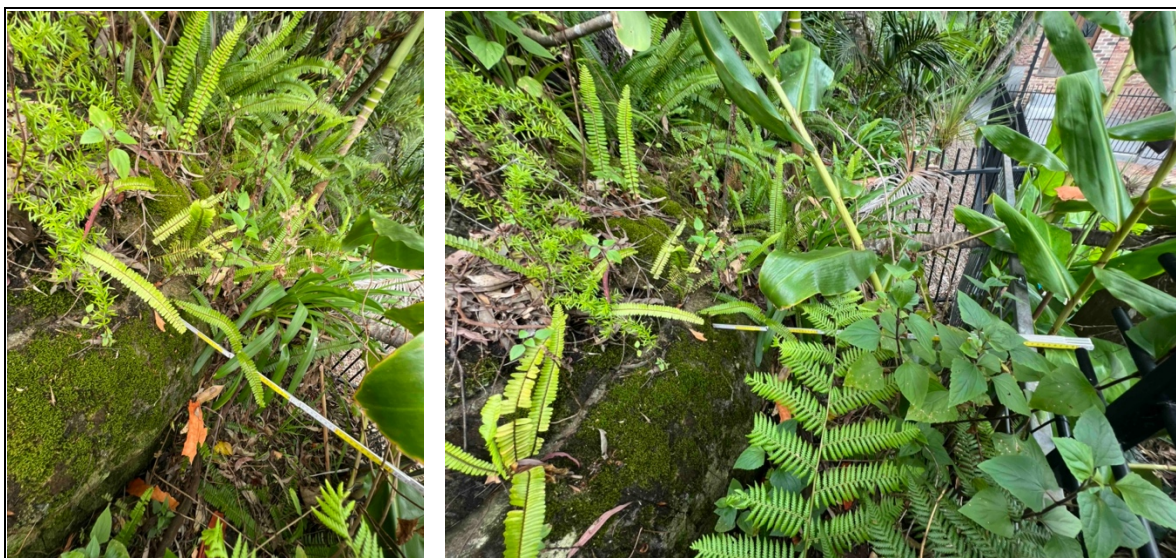
#### 7. Defect/non-compliance identified

A Rock was within the 900 mm Non-Climb Zone (NCZ) on the outside of the pool fence. The 900 mm NCZ is required to be kept clear so that children cannot use any object close to the fence to assist them to climb into the pool enclosure.

Above is a diagram showing the NCZ requirements for an internal barrier less than 1800mm high.

Remove or relocate the rock outside the 900 mm NCZ so it cannot be used to assist children to climb over the fence and into the pool enclosure. The NCZ is a 900 mm arc measured outward from the top most rail on the fence (if there is an upper rail) or the top of the fence and also extends upward above the top of the fence. The NCZ is semi-circular in shape. Alternatively, the internal barrier can be raised so the rock is no longer within the 900mm NCZ.

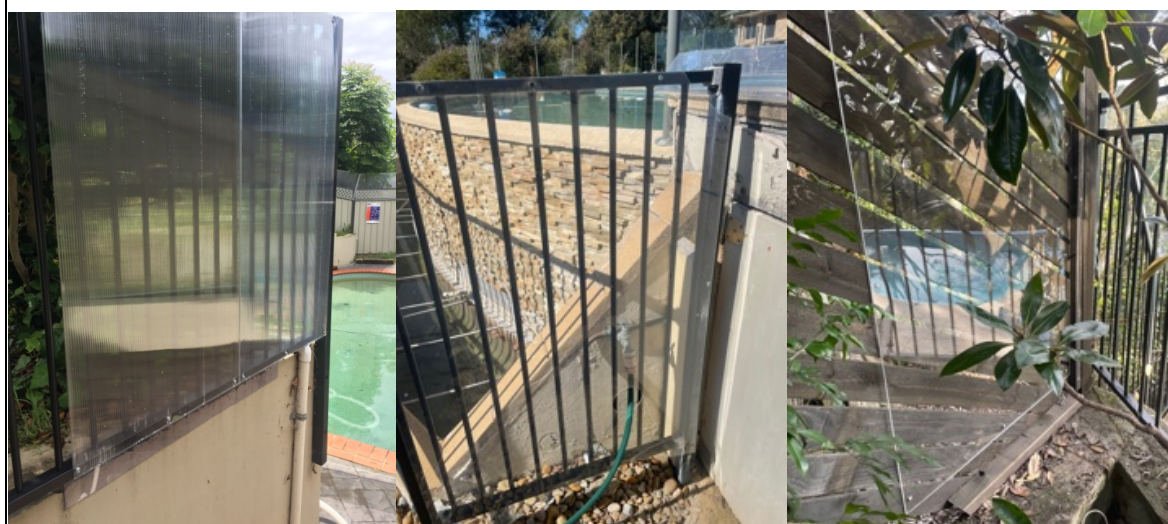
Below are some examples of perspex shielding attached to the outside of barriers.

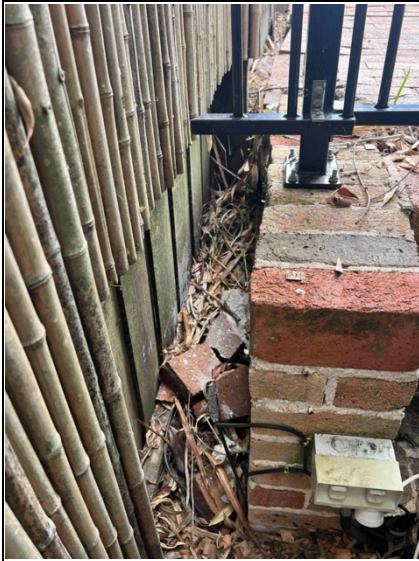
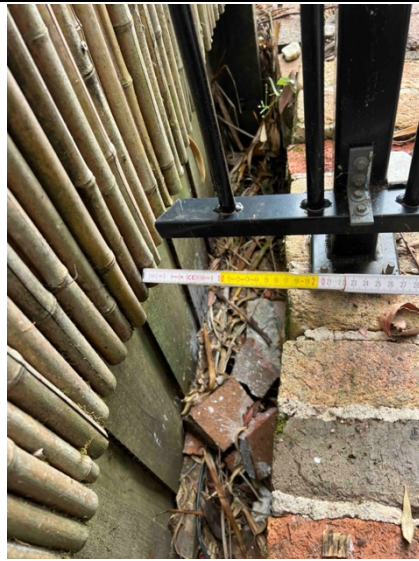
#### 9. **Defect/non-compliance identified**

There were gaps in the internal pool fence greater than 100 mm. Gaps greater than 100 mm are not permitted in or under the pool fence.

Reduce all gaps to less than 100 mm using permanent and structurally adequate construction. Eg timber or perspex.

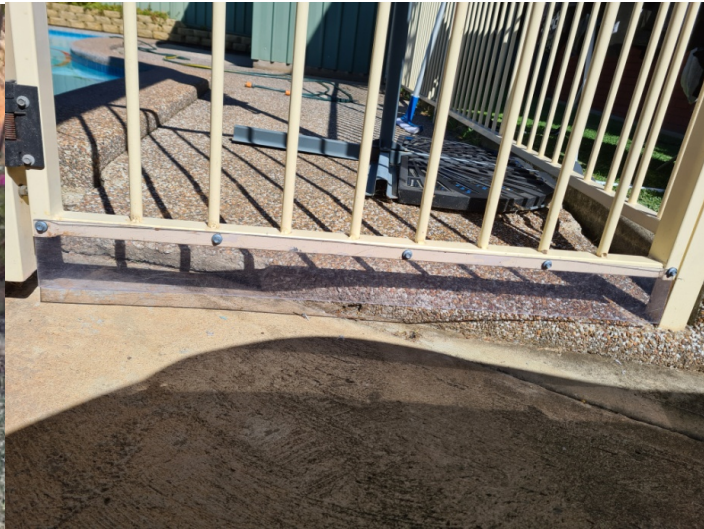
Below are some examples of ways to reduce gaps to less than 100mm.

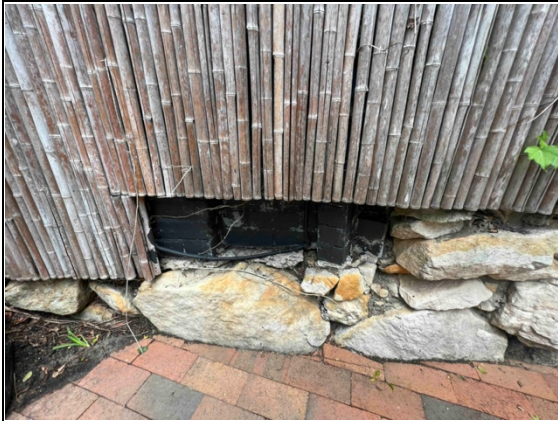
**10. Defect/non-compliance identified**

There was a gap under the boundary fence greater than 100 mm. Gaps greater than 100 mm are not permitted in or under the pool fence.

Reduce all gaps to less than 100 mm using permanent and structurally adequate construction. Eg Timber or perspex.

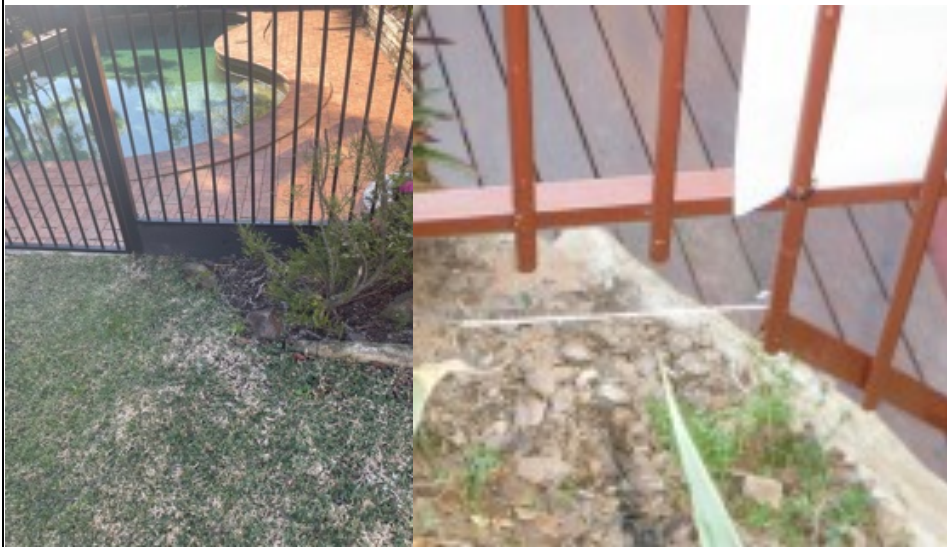
Below are some examples of ways to reduce gaps underneath a barrier.

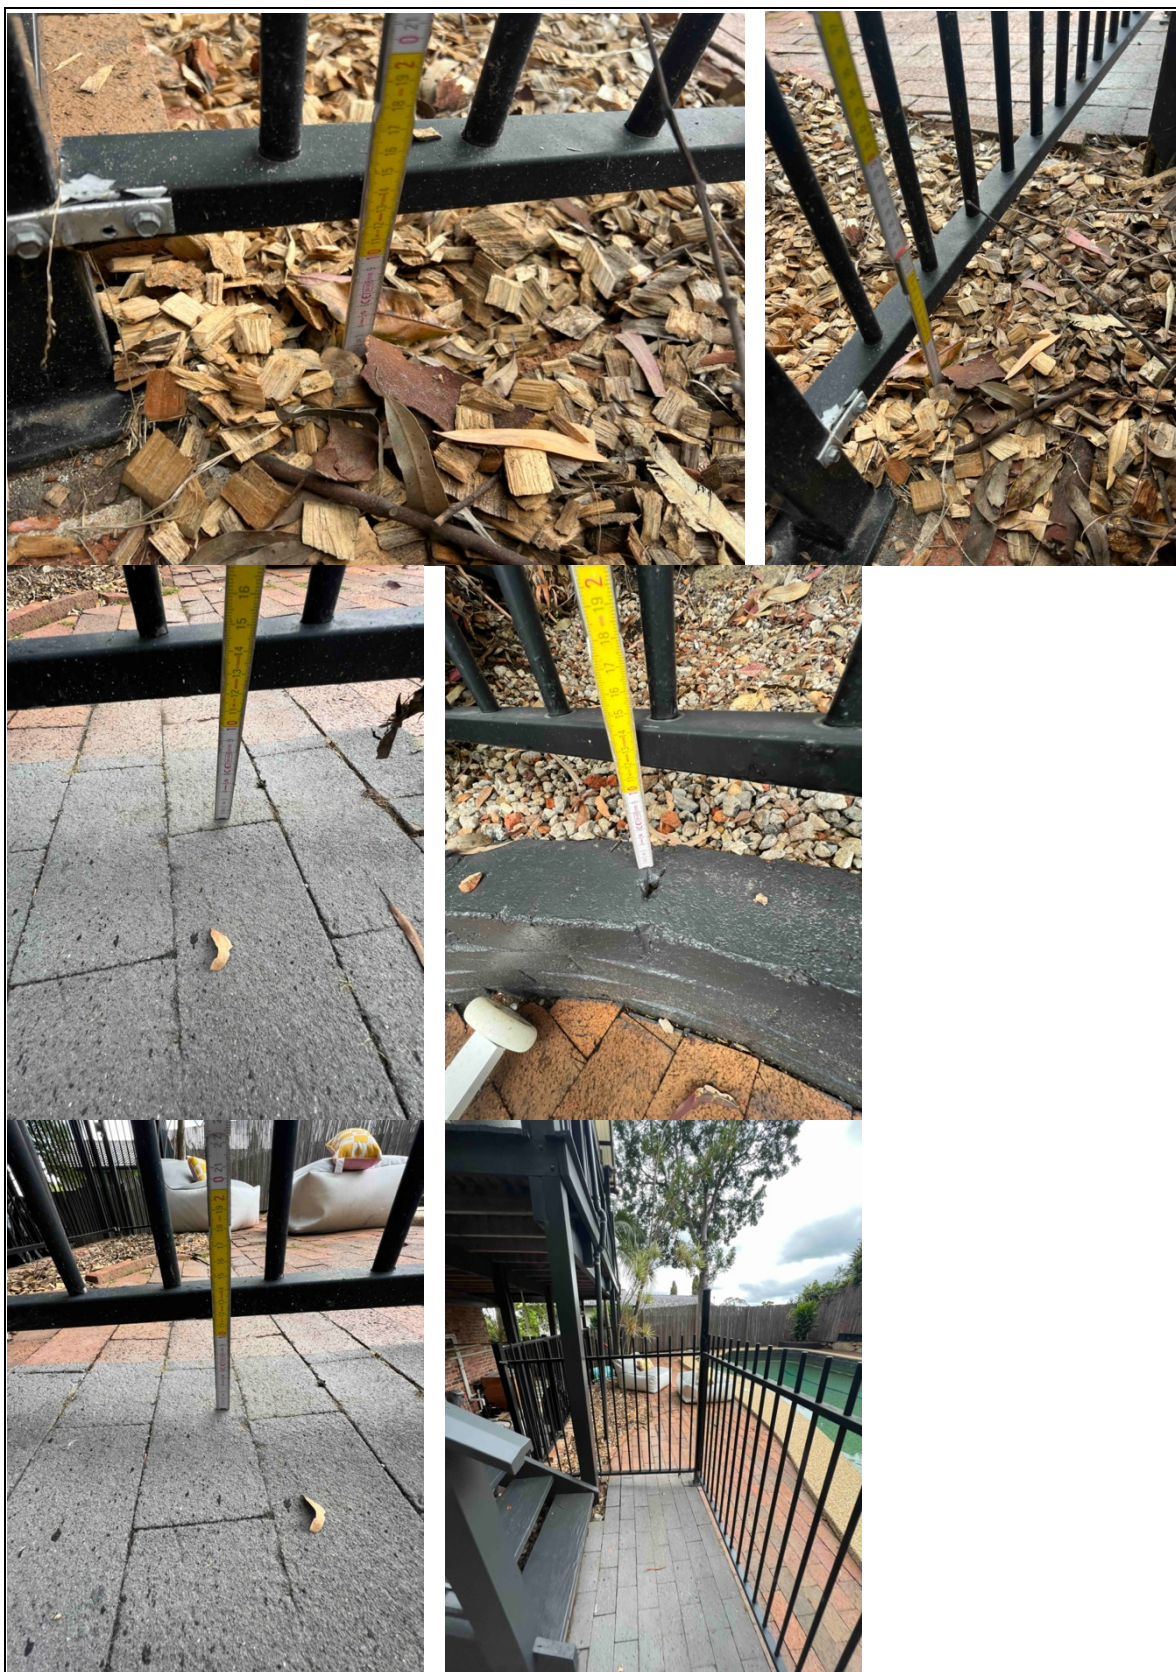
**11. Defect/non-compliance identified**

There were gaps under the internal pool fence greater than 100 mm. Gaps greater than 100 mm are not permitted in or under the pool fence.

Reduce all gaps under the pool fence to less than 100 mm using permanent and structurally adequate construction.

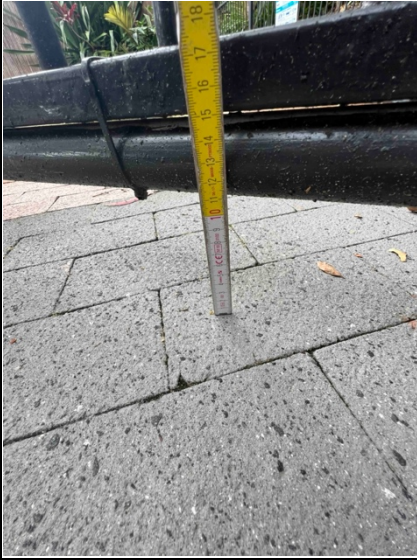
**12. Defect/non-compliance identified**

There was a gap greater than 100 mm under the pool gate. Gaps greater than 100 mm are not permitted in or under the pool barrier.

Reduce the gap under the gate so it is less than 100 mm by using permanent and structurally adequate construction. Eg timber or perspex.

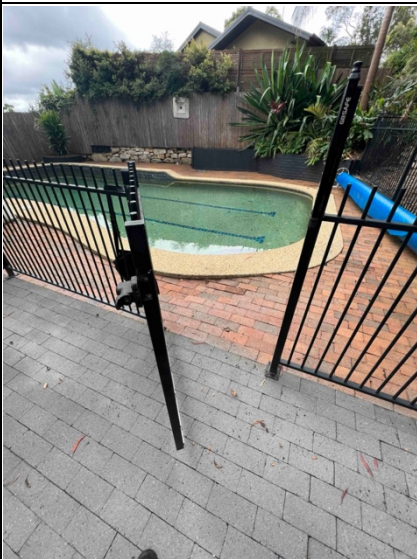
**13. Defect/non-compliance identified**

The pool gate did not self-close and self-latch.

The reason the gate did not self-close and self-latch was because the gate had one or more of the following defects:

- The latch on the gate post was not correctly aligned with the strike on the gate;
- The gate post was not stable enough to hold the gate in the correct position;
- The gate hinges or return spring did not have enough tension to close the gate;
- The gate jammed on the ground during its full open swing;
- The gate was being caught on the vegetation adjacent the gate; and/or
- The gate jammed on an object during its full open swing.

The pool gate must self-close and self-latch from any open position, including when the gate is resting on the latch.
