NOTICE OF SWIMMING POOL NON-COMPLIANCE
(Clause 22E, Swimming Pools Act 1992)

Premises to which this notice relates: 94 Bantry Bay Road Frenchs Forest.

Pool Installation Description: In-ground concrete swimming pool

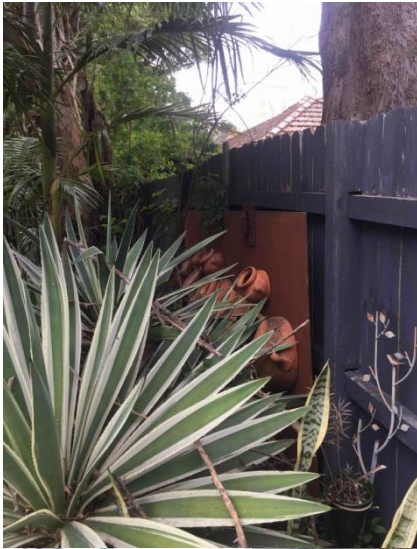
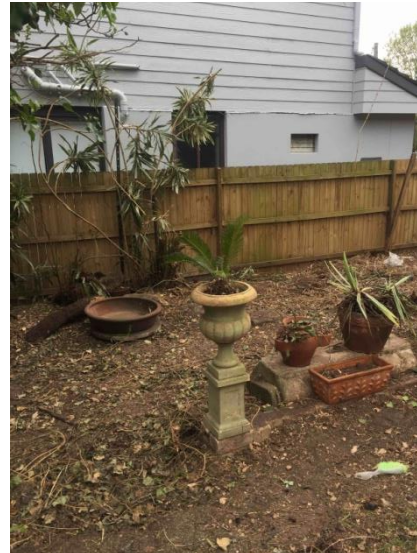
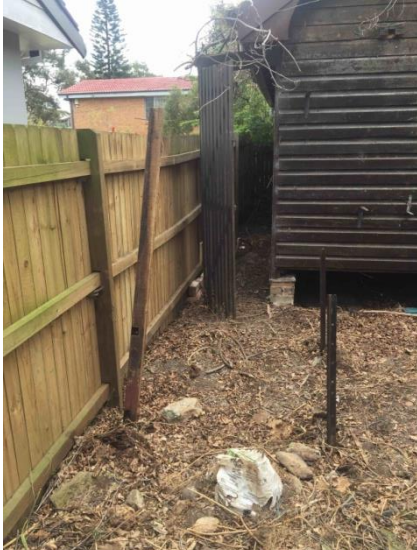
1. Defect/non-compliance identified

The boundary fence rails and timber and pot feature were located on the inside of the boundary fence that could be used as a foothold for children to climb down into the pool enclosure.

Suggested solution for rectification

Shield the fence rails and remove the timber and pot feature from within the 900 mm Non-Climb Zone (NCZ 5). Alternatively, the boundary fence could be raised to achieve the required 900 mm Non-Climb Zone (NCZ 5) clearance from the object. The NCZ 5 is a 900 mm arc measured from the top of the fence and is quarter-circle in shape.

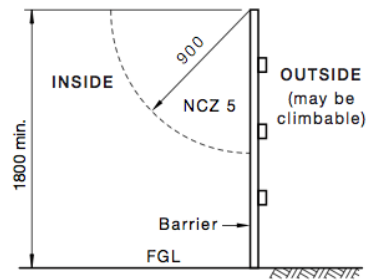
(a) Boundary barrier 1800 mm min.

See diagram below for NCZ 5

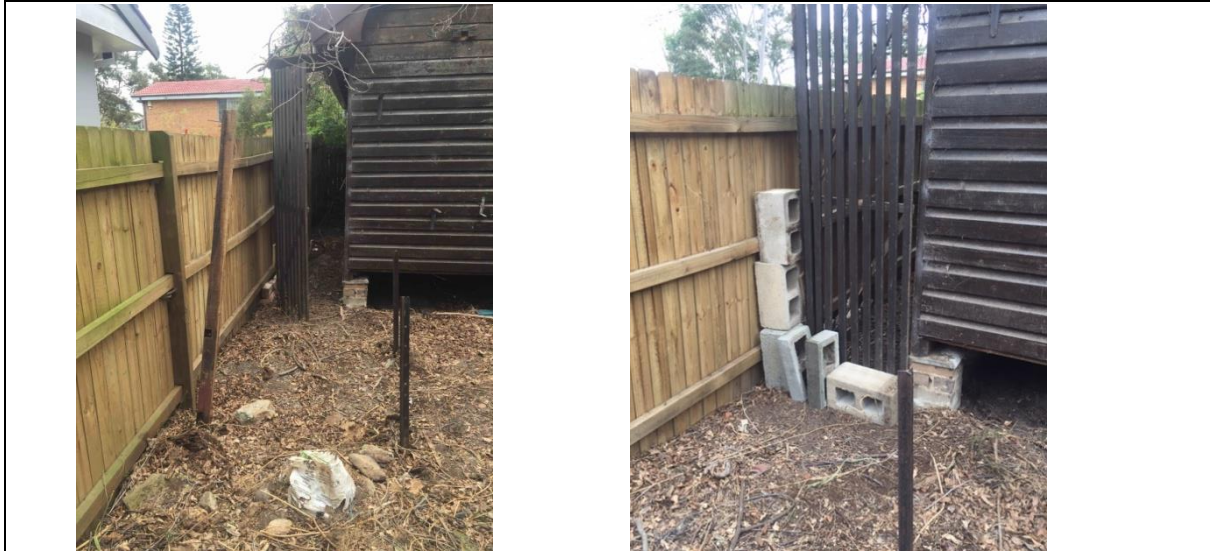
2. Defect/non-compliance identified

There was a gap greater than 100 mm between the pool fence and adjoining garage where the fence and building intersected. There is a old gate that opens into the pool area and is not serviceable. The gate is held closed by besser blocks to prevent entry and temporarily close the gap.

Suggested solution for rectification

Reduce the gap to less than 100 mm using permanent and secure construction. Alternatively, the gate could be repaired so it is functional and the gap between the gate and the fence reduced to less than 100 mm.

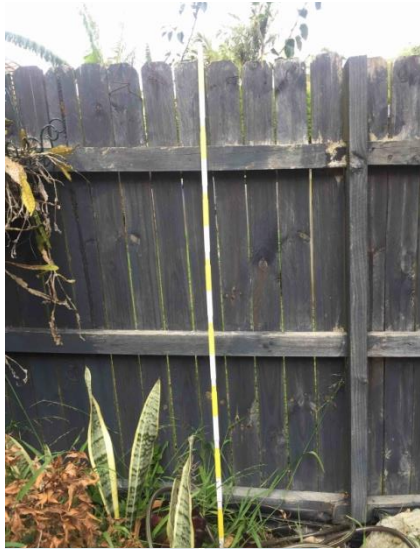
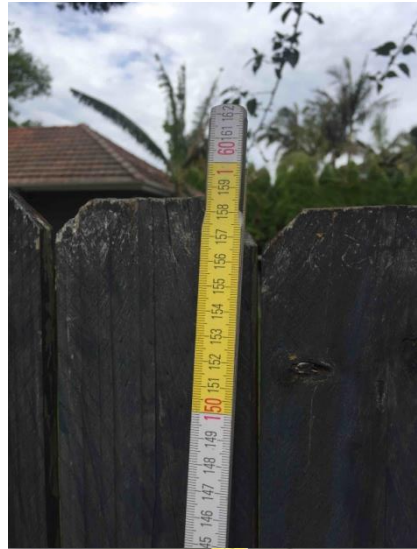
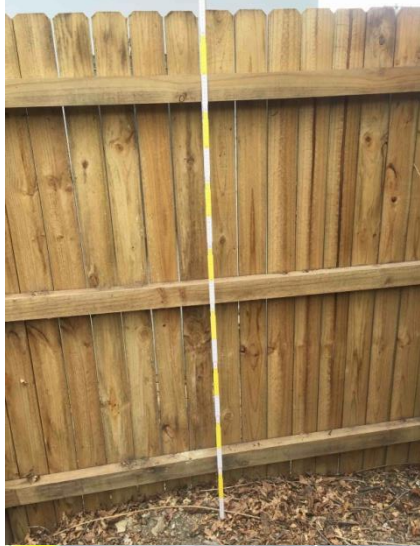
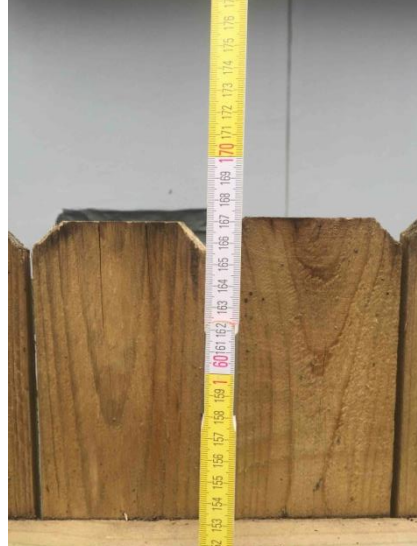
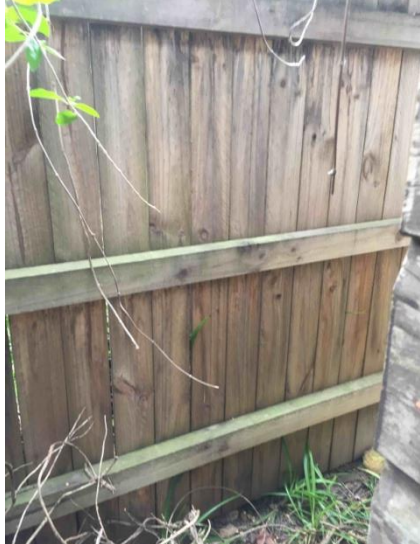
3. **Defect/non-compliance identified**

The effective height of the boundary fence was not 1800 mm or more. In some sections a garden bed had been built within 500 mm of the fence. The height of the fence was measured from the top of the fence to the surface of the ground or garden bed on the pool side of the fence. The fence also had climbable rails on the pool side of the fence.

Suggested solution for rectification

Replace the boundary fence with a boundary fence that has a height greater than 1800 mm when measured to the surface of the deck, or alternatively;

Raise the fence so it is 1800 mm or more in height above the surface level of the ground/ garden bed; or

The garden bed could be lowered so that the effective height of the fence is 1800 mm; or

The portion of the deck within 500 mm of the fence could be removed so that the 1800 mm effective height of the fence can be measured to the ground and not onto the surface of the soil.

Boundary fences must be provided with a 900 mm Non-Climb Zone (NCZ 5) which is located at the top of the fence (on the pool side of the fence). The boundary fence must be provided with a 900 mm NCZ 5 and any fence extension construction provided on top of the existing fence or rails etc (that have footholds greater than 10 mm wide) must not be within the 900 mm NCZ 5. Any climbable fence component within the 900 mm NCZ 5 will need to be either lowered removed or shielded to ensure that children cannot use any climbable fence component to assist them to climb into the pool enclosure.

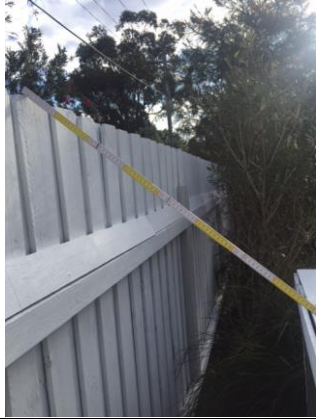
Example of 60 degree wedge on fence rails

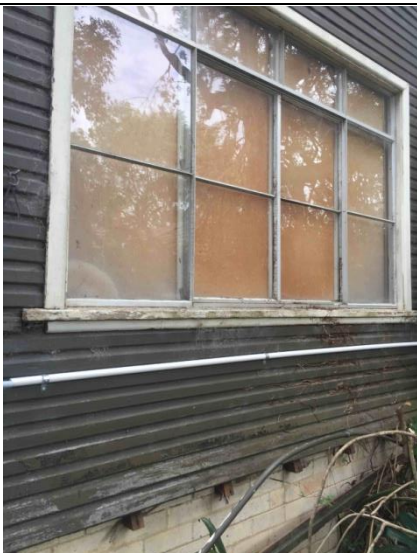
4. Defect/non-compliance identified

There was a window in the wall of the adjoining building that formed part of the pool's child resistant barrier. This window was not provided with a security screen or bars or a device to permanently restrict the windows from being opened more than 100 mm.

Suggested solution for rectification

Upgrade or modify the window so it complies with one of the following:

- a) Be provided with metal bars having a spacing not greater than 100 mm which are secured to the building with fasteners that can only be removed by the use of a tool; or
- b) Be provided with a metal security screen having openings not greater than 100 mm which are secured to the building with fasteners that can only be removed by the use of a tool; or
- c) Be prevented from opening to a width not greater than 100 mm by means of a device which has fasteners that can only be removed by the use of a tool.

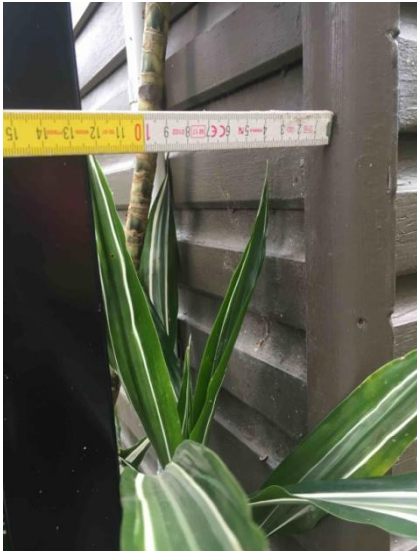
7. Defect/non-compliance identified

There was a gap greater than 100 mm between the boundary fence and the house

Suggested solution for rectification

Reduce the gap to less than 100 mm using permanent and secure construction.

Alternatively, the fence can be moved closer to the shed so that the gap is reduced to less than 100 mm.

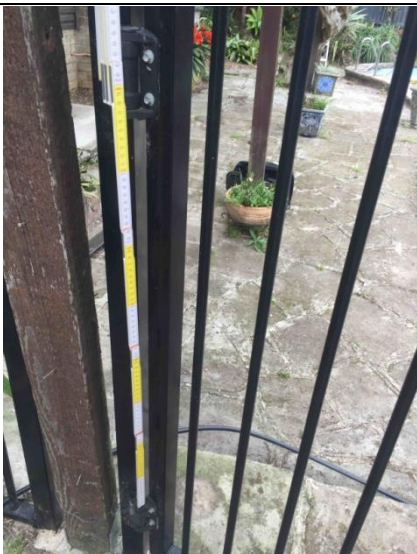
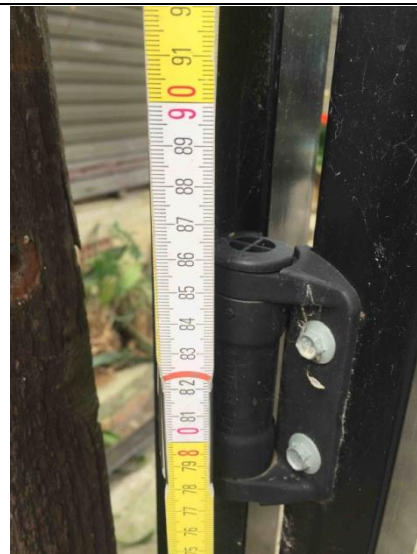
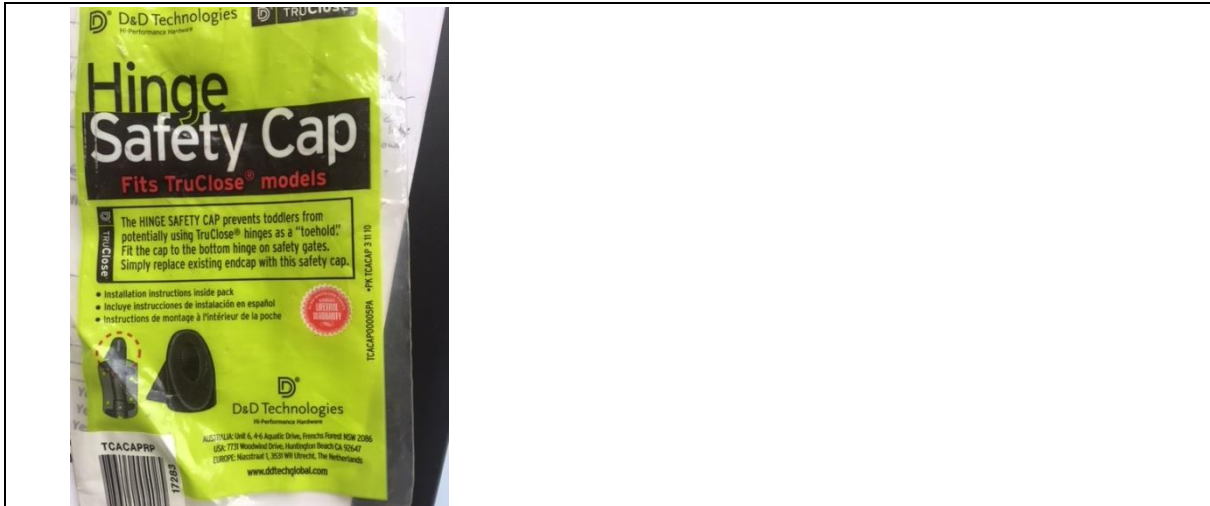
8. Defect/non-compliance identified

The hinges on the gate were too close together. The top surface of the top hinge must be 900 mm or more from the top surface of the bottom hinge.

Suggested solution for rectification

Move the hinges further apart or alternatively, some modern hinges can be fitted with a 60° hinge cap that could be fitted onto one or both of the hinges.

Click this link to view a diagram showing the requirements for the minimum distance required between hinges. <https://goo.gl/2A7obF>

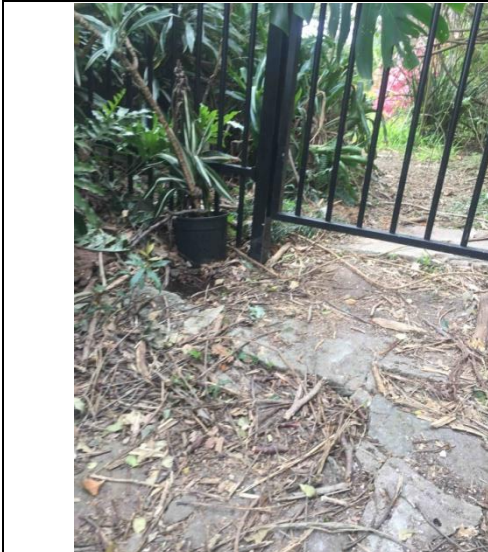
9. Defect/non-compliance identified

There were gaps greater than 100 mm under the pool gate. Gaps greater than 100 mm are not permitted in or under the pool barrier.

Suggested solution for rectification

Reduce the gaps under the gate so they are less than 100 mm by using permanent and structurally adequate construction.

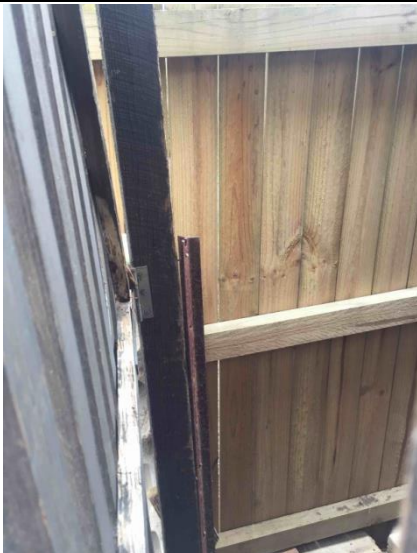
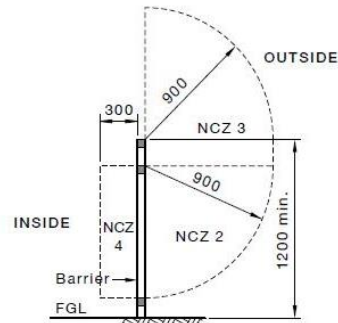
10. Defect/non-compliance identified

the rails on the new boundary fence near garage gate was within the 900 mm Non-Climb Zone (NCZ) on the outside of the pool fence. The 900 mm NCZ is required to be kept clear so that children cannot use any object close to the fence to assist them to climb into the pool enclosure. See diagram below for internal NCZ's

Suggested solution for rectification

Remove or relocate or shield the rails on boundary fence near garage gate outside the 900 mm NCZ so it cannot be used to assist children to climb over the fence and into the pool enclosure. The NCZ is a 900 mm arc measured outward from the top most rail on the fence (if there is an upper rail) or the top of the fence and also extends upward above the top of the fence. The NCZ is semi-circular in shape.

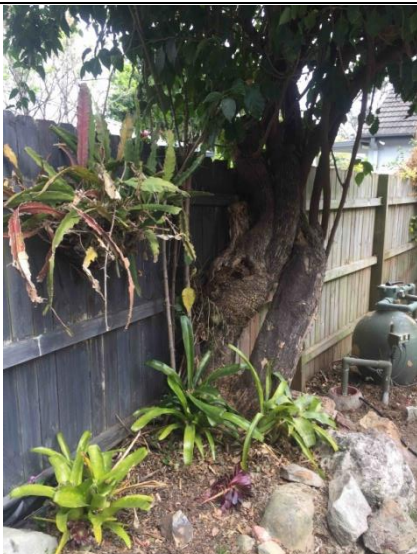
11. Defect/non-compliance identified

Vegetation was located on the inside of the boundary fence that could be used as a foothold for children to climb down into the pool enclosure.

Suggested solution for rectification

Remove or prune the Trees so that no climbable branches are within the 900 mm NCZ 5.

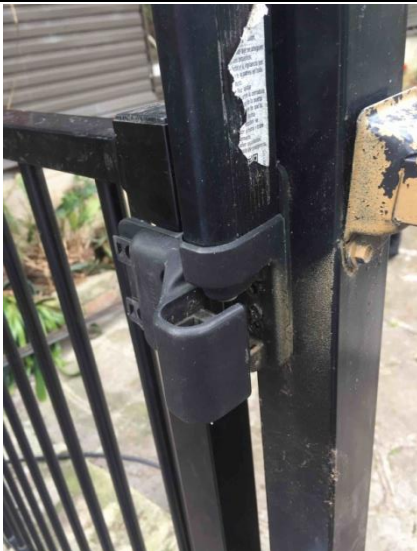
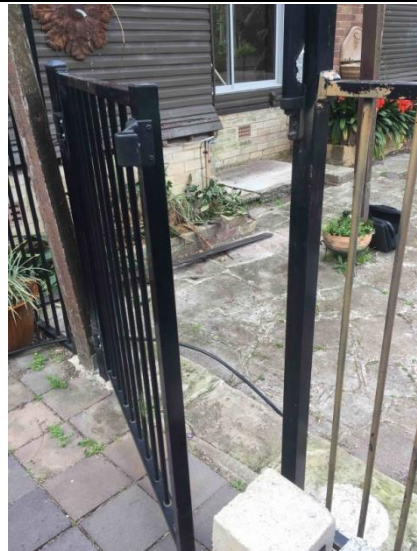
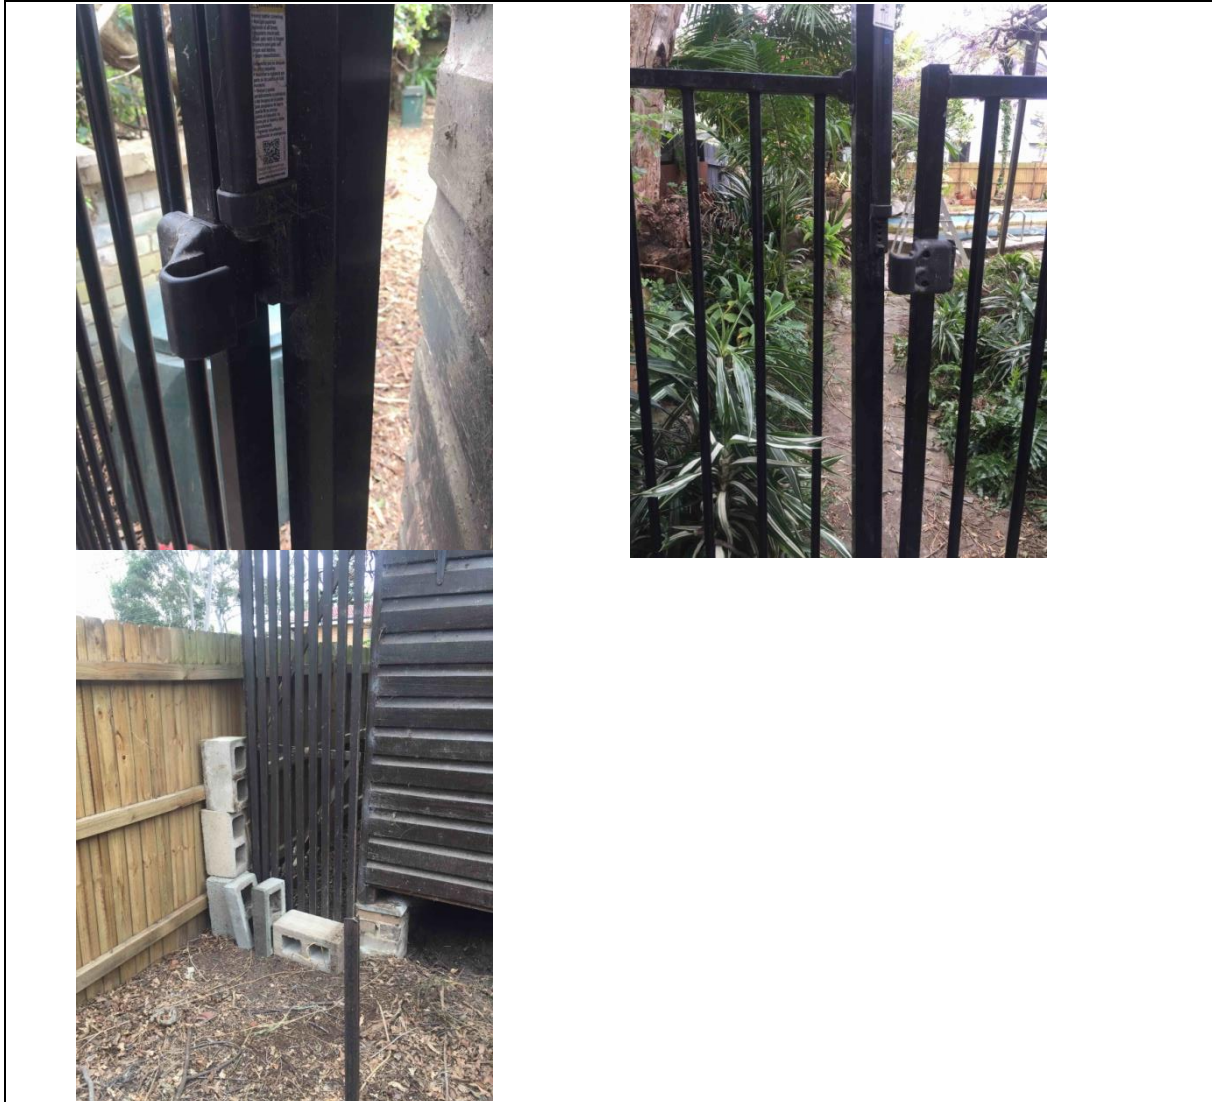
13. **Defect/non-compliance identified**
All 4 pool gates did not self-close and self-latch.

The reason the gates did not self-close and self-latch was because each gate had one or more of the following defects:

- The latch on the gate post was not correctly aligned with the strike on the gate;
- The gate post was not stable enough to hold the gate in the correct position;
- The gate hinges or return spring did not have enough tension to close the gate;
- There was no latch
- All pool gates must self-close and self-latch from any open position, including when the gates are resting on their latches.

Suggested solution for rectification
