C O N S E R V A T I O N  
M A N A G E M E N T P L A N

I O N A

( F O R M E R ) S T C O L U M B A ' S C O N V E N T

1 6 9 C U N N I N G H A M S T R E E T ,  
D A L B Y

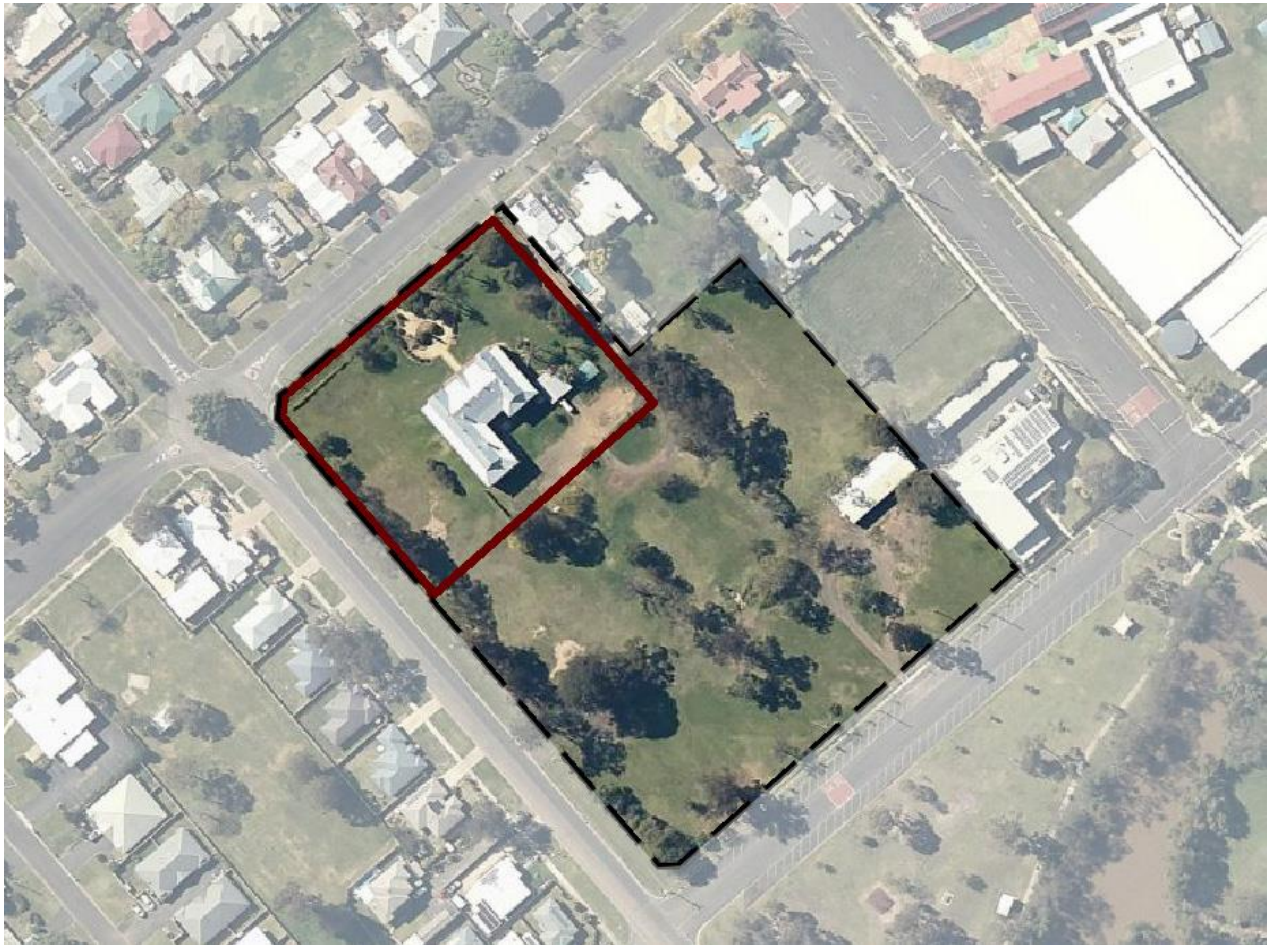
*Figure 5: The greater site (black dashed lines indicate the cadastral boundary) with the boundary of the heritage place indicated (red line). (Source: QGlobe)*

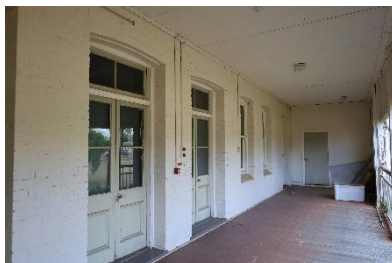
*Painted finish to facebricks.*

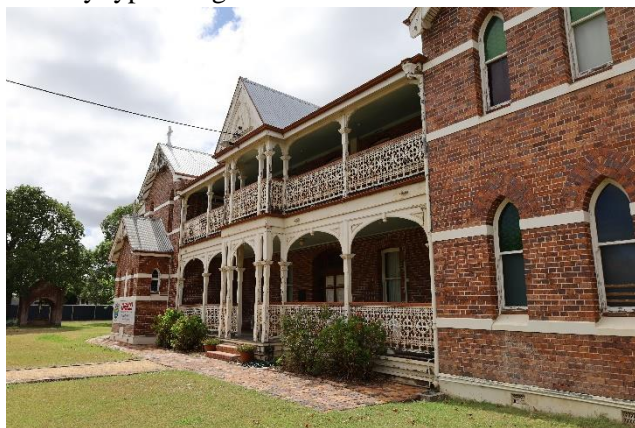
*Face brickwork with rendered stringer courses.*

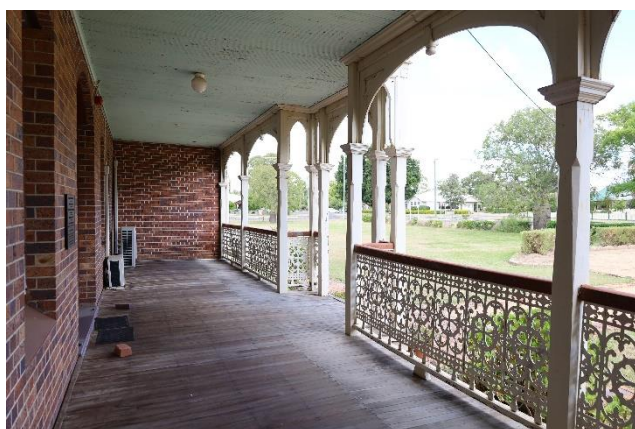
*Timber verandahs with cast iron or timber balustrades.*

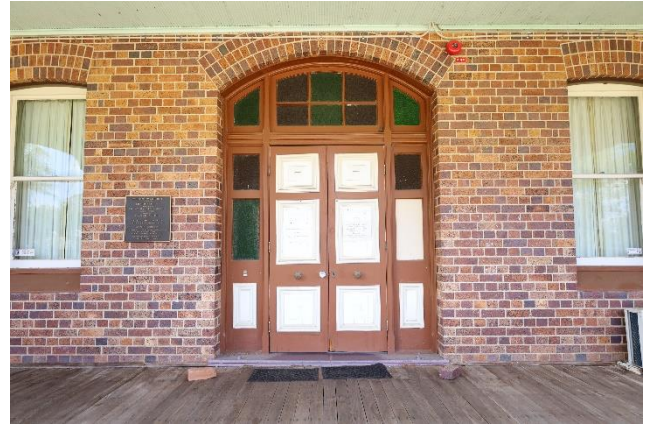
*Original doors and double hung windows (some with stained glass)*

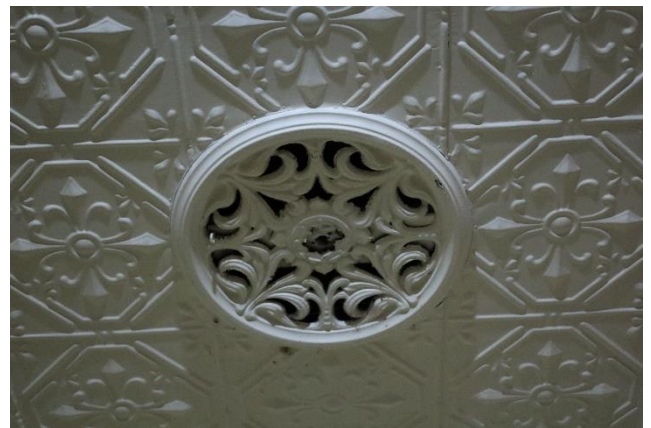
*Pressed metal ceilings, cornices and ceiling roses.*
