Jim's Building Inspections

Timber Pest Inspection Report

Inspection Date: Tue, 01 Oct 2019

Property Address: 77 Lady Davidson Circuit, Forestville NSW, Australia

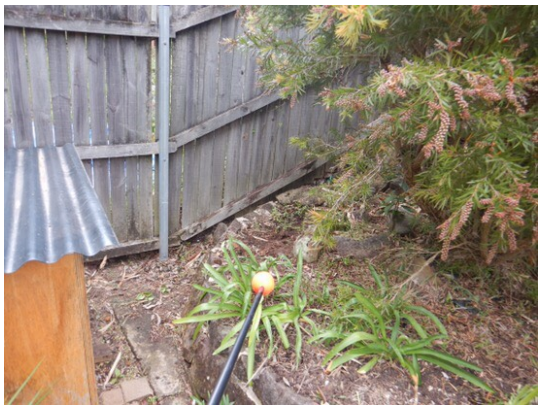
Building:	Main Building
Location:	All Areas
Finding:	In ground contact
Information:	Any timbers in direct ground contact provide opportunity for concealed termite entry and are likely to be subject to premature rot and decay as the soil retains moisture or damp conditions against the timbers. Remove untreated timber that is in direct contact with external grounds. Consider replacement with more durable materials i.e. treated timber or non timber elements. Frequent pest inspections are advised to readily identify any termite activity in these areas.

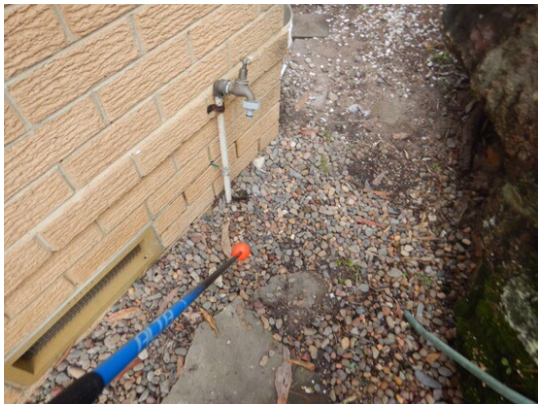
Building:	Main Building
Location:	All Areas
Finding:	Evidence of excessive moisture was present at the time of inspection
Information:	Excessive moisture can attract termites and produce conditions that promote termite attack fungal growth and wood decay. Excessive moisture is generally caused by deteriorated inadequate or missing roof drainage leaking plumbing pipes or fixtures poorly plumbed HWS overflows or condenser units and poor site drainage. It is highly recommended that all plumbing and drainage fixtures and fittings be maintained regularly in order to prevent excessive moisture being present in the external / internal property.

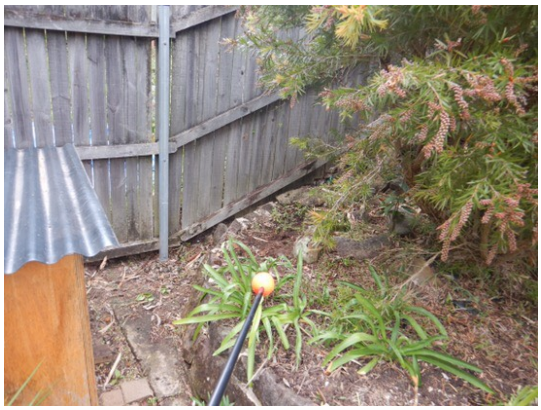
Finding: Additional Photos - Obstructions and Limitations

Information: These photographs are an indication of the obstructions and limitations which impeded full inspection of the property at the time of inspection.
