Jim's Building Inspections

Building and Timber Pest Inspection Report

Inspection Date: Mon, 20 Sep 2021

Property Address: 28 Bluegum Cres, Frenchs Forest NSW 2086, Australia

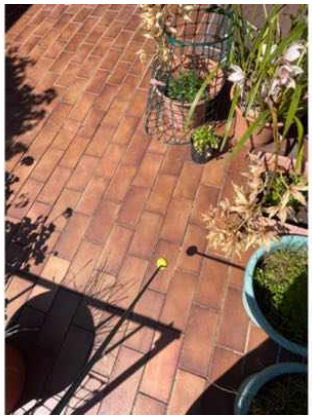
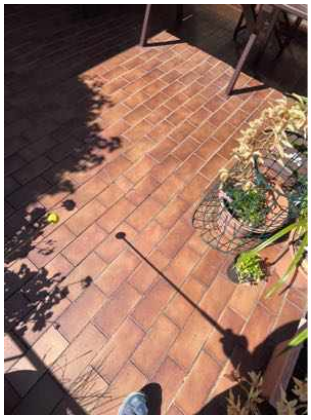
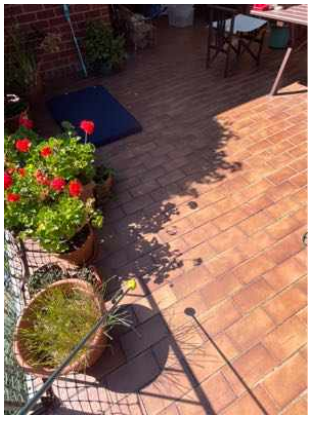
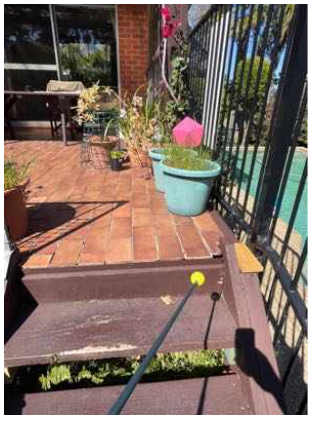
Defects 2.01

Building:	Building 1
Location:	Pergola > Rear
Finding:	Flooring - Uneven
Information:	The flooring in this area is out of level and uneven. Uneven flooring is likely to indicate minor defects such as expected movement of the foundations of the property, but may also indicate subsidence of the associated subfloor structure.

The flooring in the pergola area is out of level and uneven. Uneven flooring is likely to indicate minor defects such as expected movement of the foundations of the property, but may also indicate subsidence of the associated subfloor structure.

It is advised that the flooring be closely monitored to identify any further movement. Where flooring remains relatively unchanged for an extended period of time (i.e. several months), it is likely that this defect has been caused by expected movement of the foundations of the property.

However, where flooring is uneven further, potentially invasive inspection of the subfloor structures in this area is required. In this case, works to repair are likely to be required, and would be carried out by a builder.

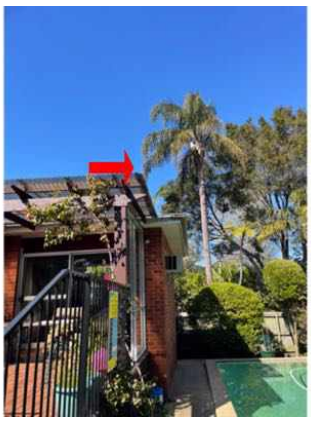
Defects 3.04

Building:	Building 1
Location:	All External Areas
Finding:	Trees - Overhanging and filling gutters
Information:	Overhanging trees often result in excessive amounts of leaf debris accumulating in gutters.

Gutters are a critical part of the building's management of storm water and rain. It is therefore important that they be kept clear to prevent secondary damage to associated building elements, including exterior and interior walls, ceiling linings and any adjoining building elements. Where gutters are blocked, pooling of rainwater is likely to occur, fast-tracking rust and corrosion of the roof plumbing elements.

It is advised that all overhanging tree branches be removed as soon as possible to prevent any further damage. Repair and/or replacement of sections of damaged guttering may also be required where the extent of the damage necessitates.

Such works should be performed by the homeowner; however, appointment of a landscape contractor or an arborist may be required. Consultation with a licensed roof plumber is required where guttering has been damaged.

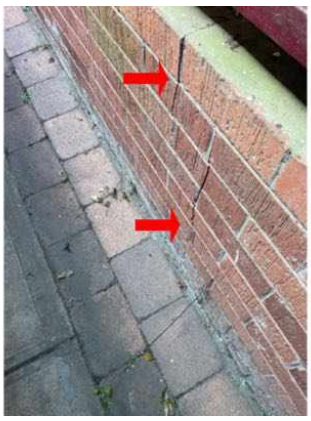
Defects 3.12

Building:	Building 1
Location:	Yard - Side
Finding:	Brickwork - Cracking [Fine]
Information:	Although fine cracks are quite noticeable, they are often only considered to be an appearance defect and usually do not indicate any structural damage. Generally, the cause of a fine crack is indicative of a separation between brickwork and mortar throughout the structure, but single bricks may also show cracks of this nature. Cracking of this nature can generally be repaired with minor filling and should be conducted by a qualified bricklayer. Always contact a builder should cracks widen lengthen or become more numerous.

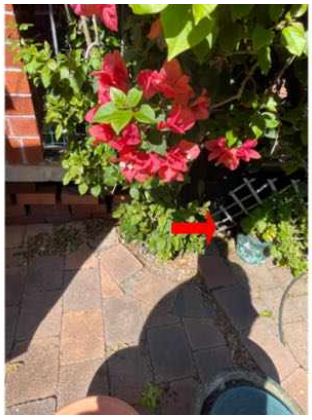
Noted Item

Building: Building 1
Location: All External Areas
Finding: Garden Beds - Conditions Conducive to Termites
Information:

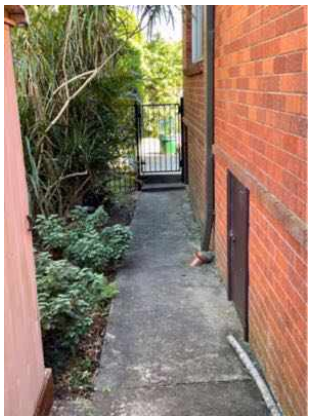
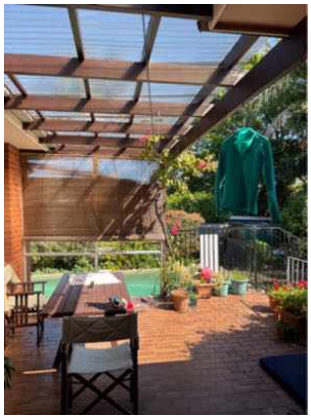
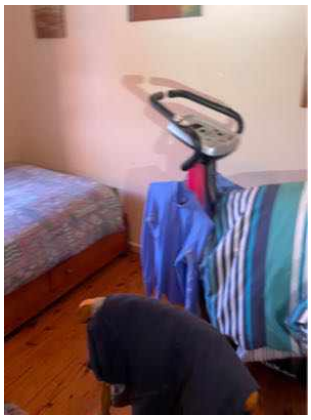
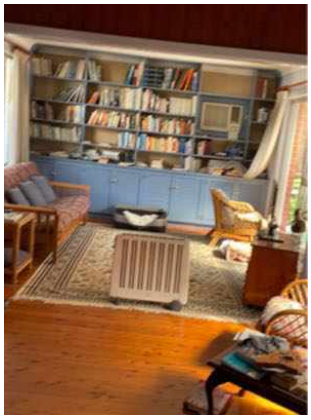
Noted Item

Building:	Building 1
Location:	All Areas
Finding:	Additional Photos - Obstructions and Limitations
Information:	These photographs are an indication of the obstructions and limitations which impeded full inspection of the property at the time of inspection. These obstructions can hide an array of defects and should be removed to allow full inspection to be carried out.
