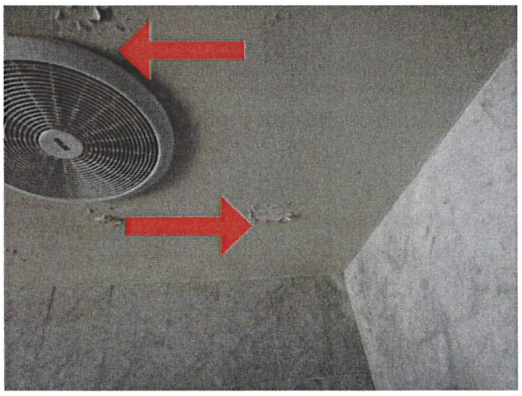
Defects 3.26

Building:	Main Building
Location:	Bathroom
Finding:	Painted surface - Bubbling
Information:	Sections of paint in this area was found to have bubbled and deteriorated. Paint bubbling is generally an indication of excessive moisture in the area, that is currently hidden by the painted surface. The presence of excessive moisture can have major implications on associated building elements if left unattended. While only seemingly minor at this stage, the damage cannot be determined due to the paint obstructing any further inspection of the damage. It is highly advised that the affected paint be cleaned to allow a further, more invasive inspection by a licensed plumber. Failure to act on this defect may necessitate major works in the future.

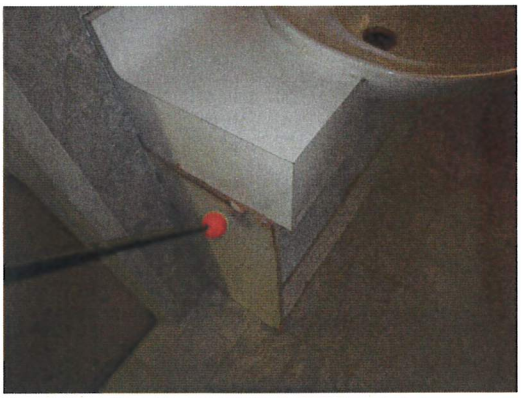
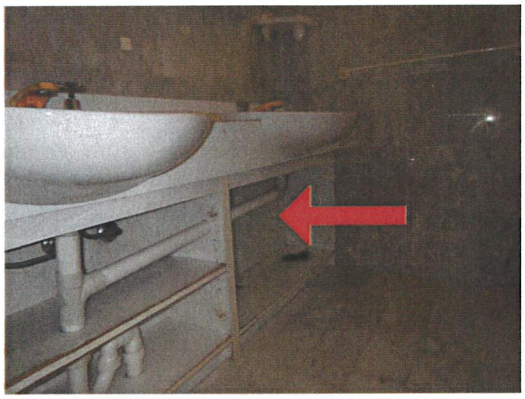
Defects 3.27

Building:	Main Building
Location:	Bathroom
Finding:	Cabinetry - Damaged
Information:	Evidence of damage was identified.

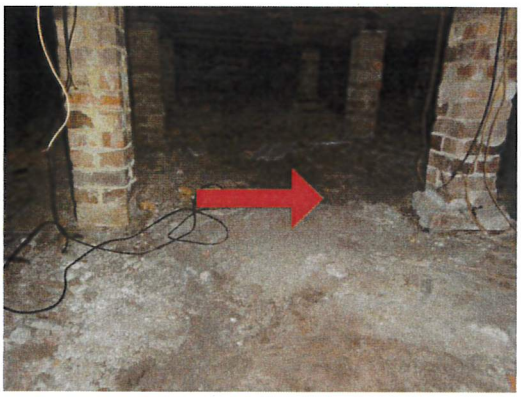
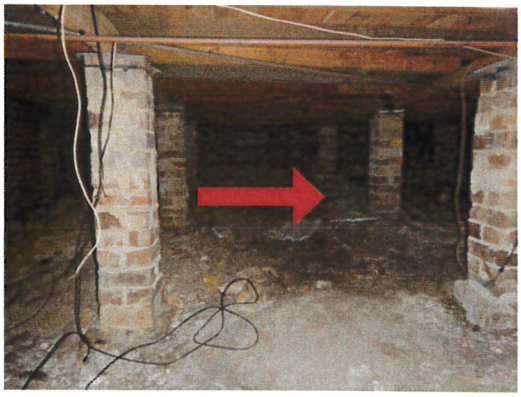
Defects 3.28

Building:	Main Building
Location:	Subfloor
Finding:	Mould - Present
Information:	Where evidence of mould growth was noted, there may be environmental, biological or health issues associated with the report. A specialist inspection by a suitably qualified environmental health inspector is warranted, where mould is extensive or where any queries regarding air quality spores or other related issues apply. Generally, the client is advised to ensure that the general environment is free of moisture and humidity to aid in the prevention of mould formation and development. Any mould found during the inspection should be cleaned immediately by a cleaning contractor or the homeowner as applicable. Please note that severely affected building elements may require replacement by a registered builder or qualified carpenter.

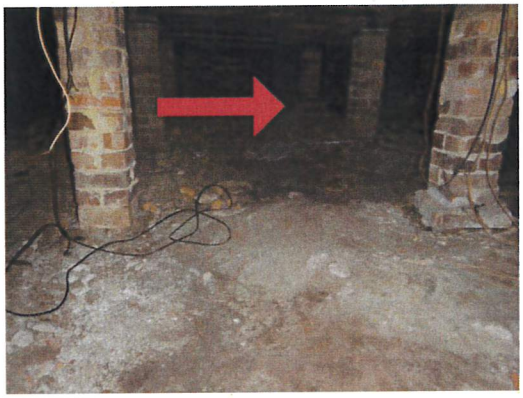
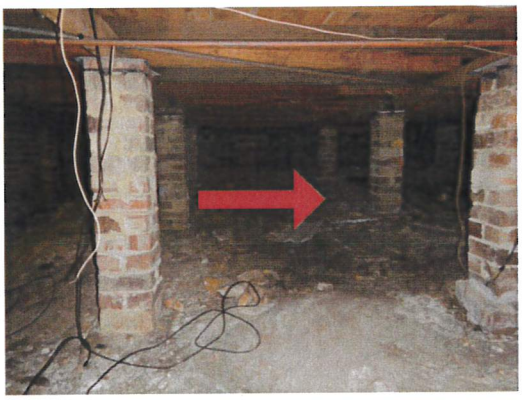
Defects 3.29

Building:	Main Building
Location:	Subfloor
Finding:	Evidence of excessive moisture was present at the time of inspection
Information:	Excessive moisture can attract termites and produce conditions that promote termite attack fungal growth and wood decay. It is recommended that all plumbing and drainage fixtures and fittings be maintained regularly in order to prevent excessive moisture being present in the external / internal property.

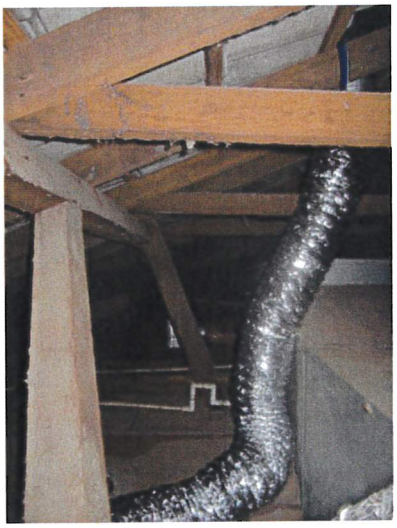
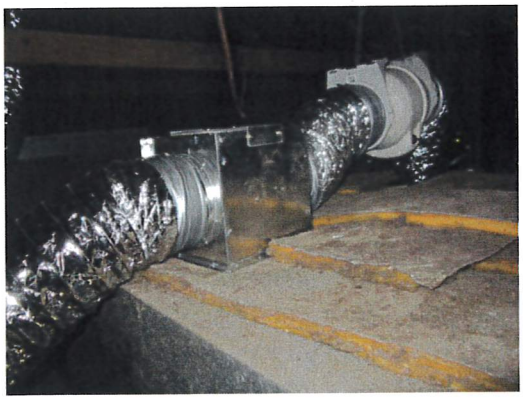
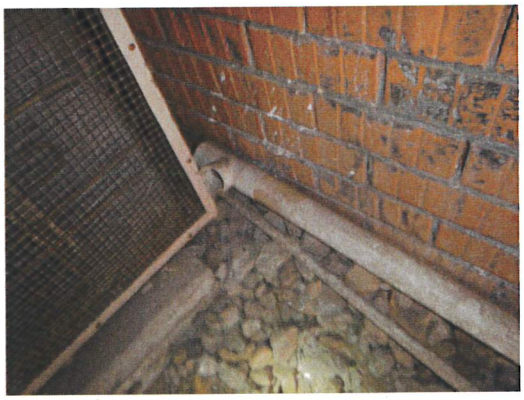
Building:
Location:
Finding: Additional Photos - Obstructions and Limitations
Information: These photographs are an indication of the obstructions and limitations which impeded full inspection of the property at the time of inspection.
