Jim's Building Inspections

Timber Pest Inspection Report

Inspection Date: Wed, 04 Mar 2020

Property Address: 124 Blackbutts Rd,Frenchs Forest NSW 2086, Australia

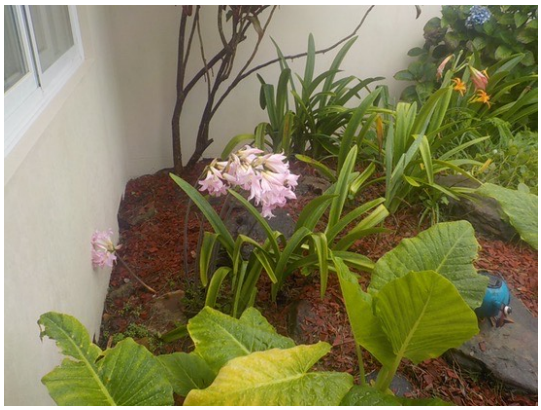
Building:	Main Building
Location:	All Areas
Finding:	Additional Photos - Obstructions and Limitations
Information:	These photographs are an indication of the obstructions and limitations which impeded full inspection of the property at the time of inspection.
