Jim's Building Inspections

Building and Timber Pest Inspection Report

Inspection Date: Mon, 7 Feb 2022

Property Address: 92 Dareen St, Frenchs Forest NSW 2086, Australia

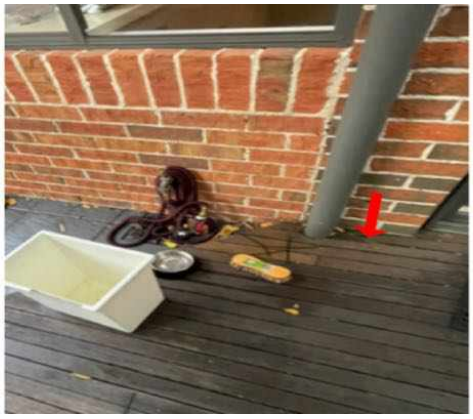
Building:	Building 1
Location:	All Areas
Finding:	Termite Management System - no evidence of a chemical installation
Information:	The application of a post-construction chemical termite barrier is highly recommended for all properties, particularly if live termite activity has been found on the site previously. Such barriers are highly effective in preventing termite attack on any timber building elements throughout the property. A durable notice should be placed in the switchboard unit to indicate current termite barriers. At the time of inspection, it appeared as though no termite management system has been installed, with no evidence to suggest preventative works taking place. The client may consider gaining further advice from a pest controller as to the costs and procedures involved with this application. It is recommended that obtaining such advice be a short-term priority.

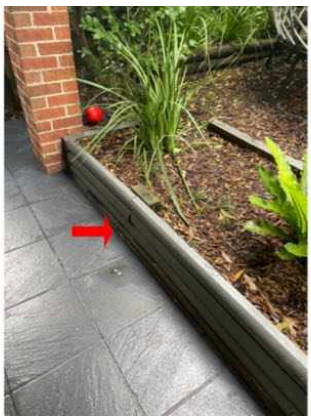
Building:	Building 1
Location:	All Areas
Finding:	Building materials in direct ground contact - conducive to termites
Information:	Where timber elements are in direct contact with the ground and consequently moisture or dampness they become conducive to termite activity. Whether timber is used as a building element part of a fencing structure or stored as an unused item they can provide an environment that is attractive to termite infestation. When met with excessive moisture timber begins to decay and develop wood rot. Any

timbers that are in direct contact with external grounds especially if left untreated or non- durable also provide ingress for subterranean termites into that particular element. The removal of any such materials that may be conducive to termite activity should be removed as soon as possible to minimise the risk of termite attack.

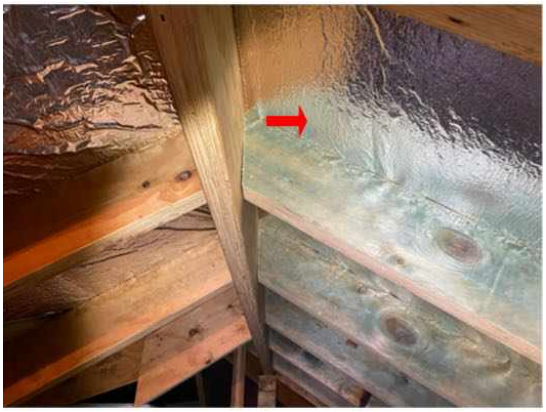
Building:	Building 1
Location:	Roof Void
Finding:	Sarking - installed
Information:	Sarking is under the roof sheeting. Sarking acts as an insulator that helps with noise reduction and protects against water penetration. Sarking plays a key role in the operation and function of the overall roofing structure and its performance.

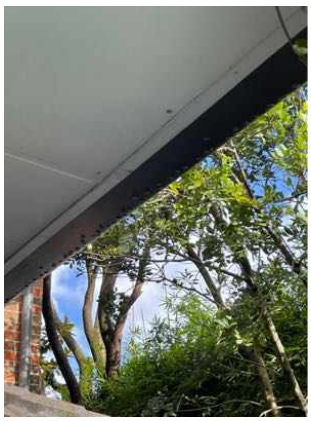
Building:	Building 1
Location:	All Areas
Finding:	Trees - Overhanging and filling gutters
Information:	Overhanging trees often result in excessive amounts of leaf debris accumulating in gutters.

Gutters are a critical part of the building's management of storm water and rain. It is therefore important that they be kept clear to prevent secondary damage to associated building elements, including exterior and interior walls, ceiling linings and any adjoining building elements. Where gutters are blocked, pooling of rainwater is likely to occur, fast-tracking rust and corrosion of the roof plumbing elements.

It is highly advised that all overhanging tree branches be removed as soon as possible to prevent any further damage. Repair and/or replacement of sections of damaged guttering may also be required where the extent of the damage necessitates.

Such works should be performed by the homeowner; however, appointment of a landscape contractor or an arborist may be required. Consultation with a licensed roof plumber is required where guttering has been damaged.

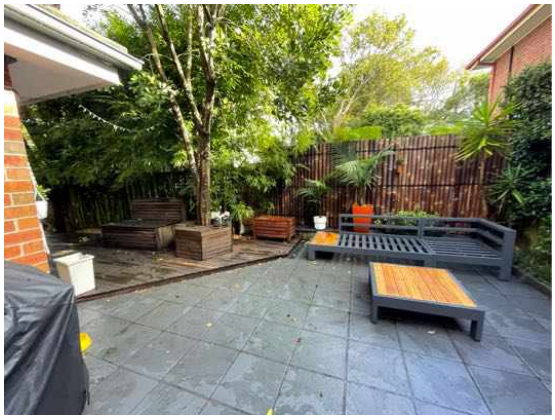
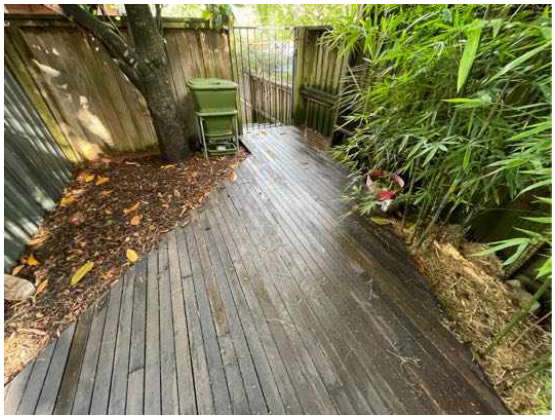
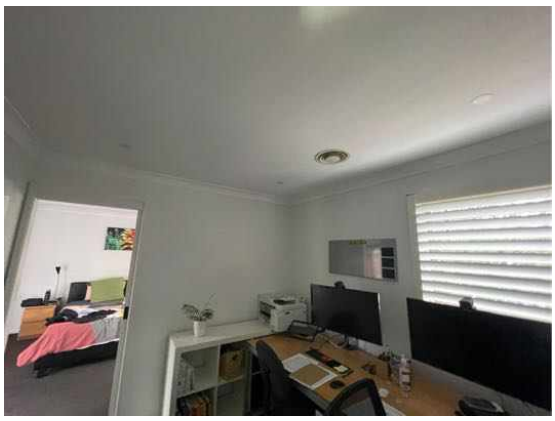
Building:	Building 1
Location:	All Areas
Finding:	Additional Photos - Obstructions and Limitations
Information:	These photographs are an indication of the obstructions and limitations which impeded full inspection of the property at the time of inspection.
