Building Inspection Report

Inspection Date: Thu, 13 Oct 2022

Property Address: 51A Iris St, Frenchs Forest NSW 2086,
Australia

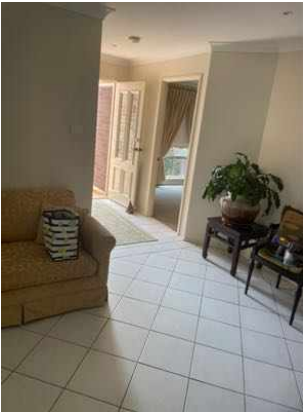
Noted Item

Building: Building 1
Location: All Areas
Finding: Moisture meter readings - low
Information: The moisture meter result for the areas inspected.

Levels between 25-30% indicate that there may be water ingress, meaning that remedial work could be required.
