Building and Timber Pest Inspection Report

Inspection Date: Thu, 23 Jun 2022

Property Address: 43 Ralston Ave, Belrose NSW 2085,
Australia

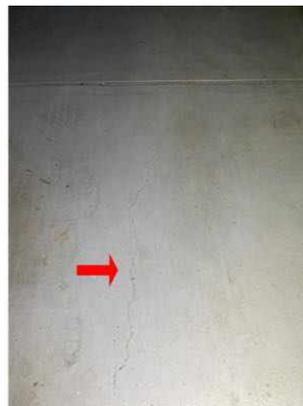
Defects 3.03

Building:	Building 1
Location:	All Areas
Finding:	Tiles - Cracked or damaged
Information:	Cracking was evident to the tiling in this area at the time of inspection. While the cracking appears to be minor, this area is frequently exposed to water, allowing potential for water penetration into adjoining sections of walls or flooring.

If left unmanaged, water penetration to these areas may lead to subsequent water damage, which is likely necessitate repair work to affected building elements.

A tiling contractor should be appointed to ensure that no further water damage occurs. The re-application of silicone and grouting throughout remaining tile work is also advised, to further protect the area against water penetration.

Where water penetration has led to water damage, appointment of a relevant tradesperson may be required to repair damaged building elements.

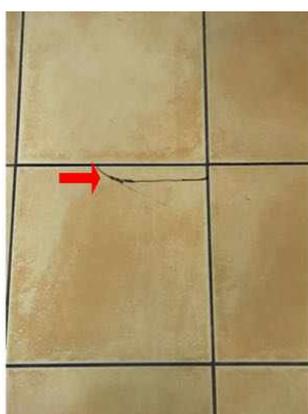
Defects 3.04

Building:	Building 1
Location:	Yard - Front
Finding:	Cracked pavers

Information: Cracking in the pavers was evident in this area at the time of inspection. It is suspected that this cracking has occurred as a result of minor settlement .

Cracked pavers detract from the overall appearance of the affected areas however it is unlikely to create or lead to any secondary defects.

While not considered a matter of urgency, replacement of pavers is recommended at the clients discretion.

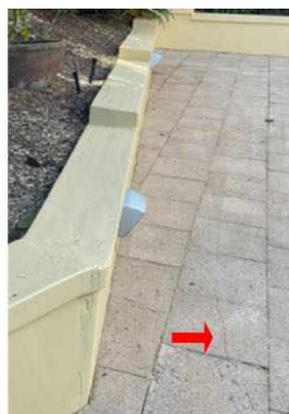
Defects 3.05

Finding: Sealant - missing/ deteriorated

Information: Flexible and mould resistant materials should be applied to affected areas to prevent any subsequent water damage that is likely to occur. Regular maintenance and replacement of damage or missing or damaged sealant and grout is highly recommended to the wet areas, as this is a regular wear and tear defect.

Sealant and grouting in areas that come into regular contact with water should be maintained for the long term care of your property. A sealant specialist or tiling contractor should be appointed to complete these works as soon as possible

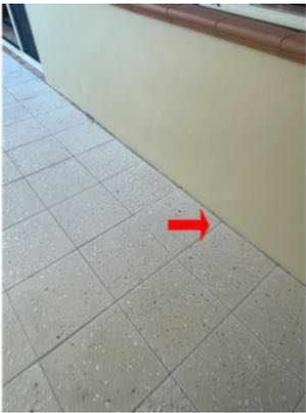
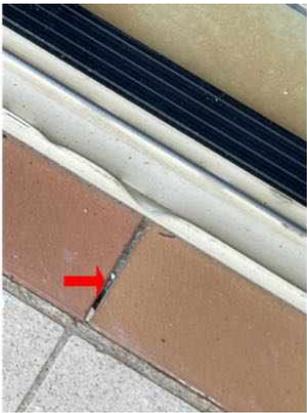
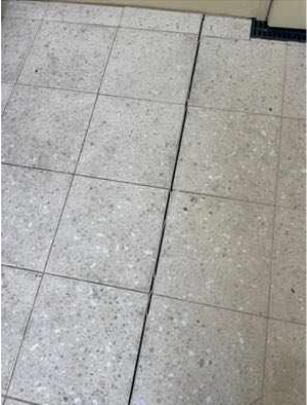
Defects 3.06

Building: Building 1
 Location: Yard - Front
 Finding: painting deteriorated
 Information: Whilst incomplete or missing paint finish is generally an appearance defect, it can also lead to the development of secondary building defects over time. Incomplete areas of paint finish exposes the area to moisture, potentially accelerating the deterioration of underlying building materials.

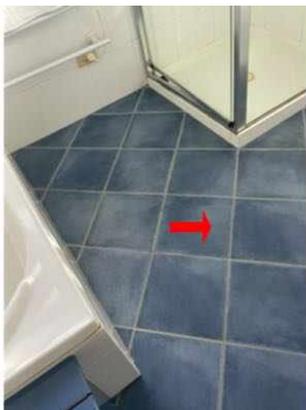
Defects 3.10

Building:	Building 1
Location:	Bathroom
Finding:	Sealant - missing/ deteriorated
Information:	Flexible and mould resistant materials should be applied to affected areas to prevent any subsequent water damage that is likely to occur. Regular maintenance and replacement of damage or missing or damaged sealant and grout is highly recommended to the wet areas, as this is a regular wear and tear defect.

Sealant and grouting in areas that come into regular contact with water should be maintained for the long term care of your property. A sealant specialist or tiling contractor should be appointed to complete these works as soon as possible

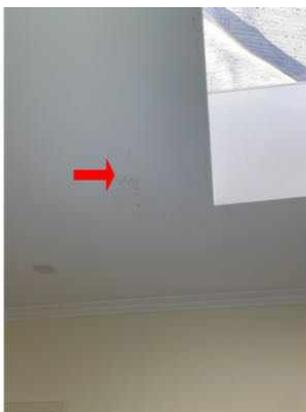
Defects 3.12

Building:	Building 1
Location:	All Areas
Finding:	Ceiling - Water stained
Information:	Water staining to ceiling linings in this area was evident at the time of inspection. Water staining indicates that surfaces have been exposed to excessive moisture over time. The minerals and other elements in the water lead to staining, which may graduate to corrosion and deterioration if left unmanaged.

While mostly an appearance defect, water staining can be indicative of more serious defects, which may be currently concealed by interior ceilings.

Where water staining is active, a licensed plumber must be consulted to identify the cause of the staining and to provide advice on any reparation works that may be required. Replacement of any damaged structures is advised.

Conversely, where water staining is old and inactive, affected building materials may be repaired or replaced at client discretion.

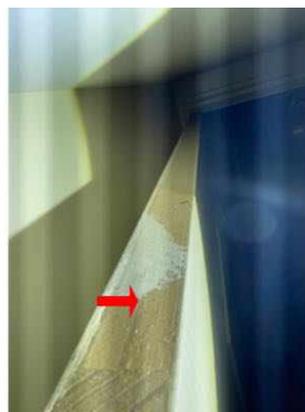
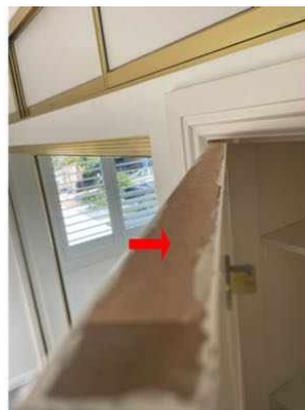
Defects 3.14

Information: Although detracting from the overall appearance, marked or stained surfaces do not indicate any operational or structural damage. This degree of surface damage is consistent with general wear and tear and is expected of a property of this age and condition.

Marked surfaces may be left as is at client discretion, as no repairs or replacement are necessarily required for this appearance defect. However, the client may wish to seek quotations for the cost to refurbish or replace the identified building element.

A painting or cleaning contractor may be appointed to rectify marked surfaces at the discretion of the client.

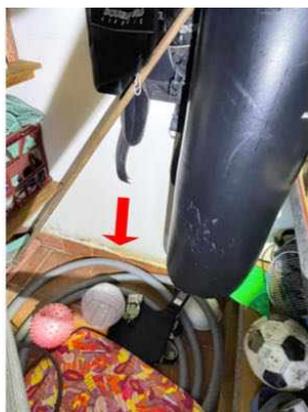
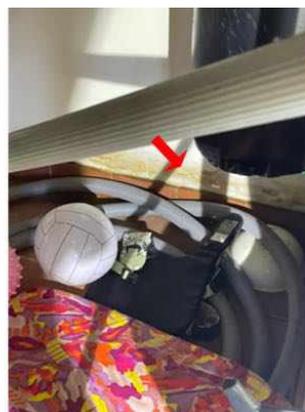
Defects 3.18

Building:	Building 1
Location:	Yard - Back
Finding:	Door Frame - damaged
Information:	Damage to door frame was identified during this inspection.

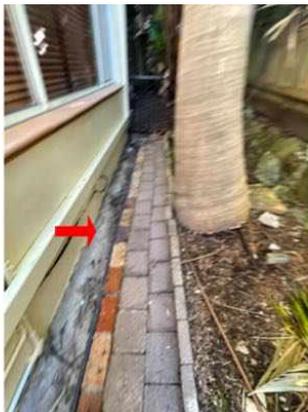
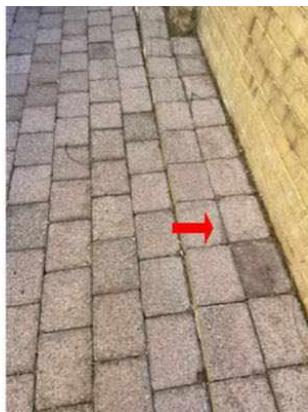
Defects 3.26

Building: Building 1
 Location: Yard - Side
 Finding: Overflow - Not plumbed for drainage
 Information: The overflow is not plumbed or connected to suitable drainage, which has resulted in the surrounding area becoming excessively damp. These damp conditions can lead to secondary defects such as rot, rust or corrosion of associated building elements, the formation of fungal decay, or even the creation of potential slip hazards. When coupled with poor site drainage, pooling of water may also attract termite activity to this area. It is highly recommended that a qualified plumber be appointed to install adequate

drainage to the overflow. These works will ensure that the area remains dry and free of any secondary defects.

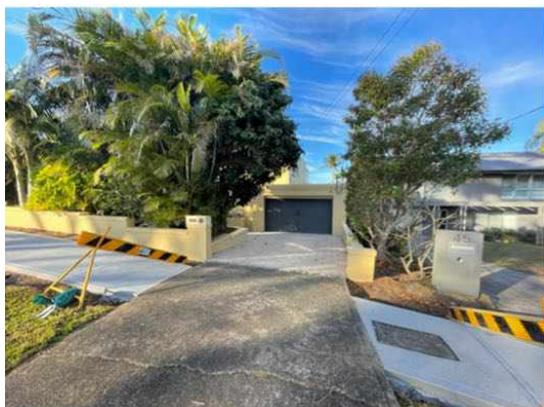
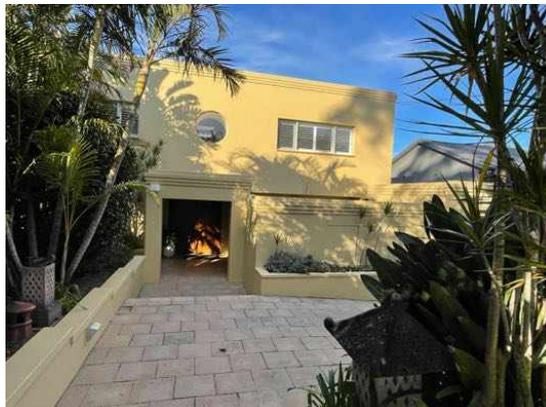
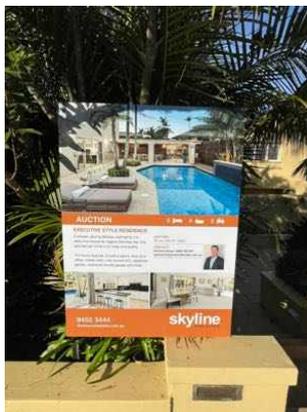
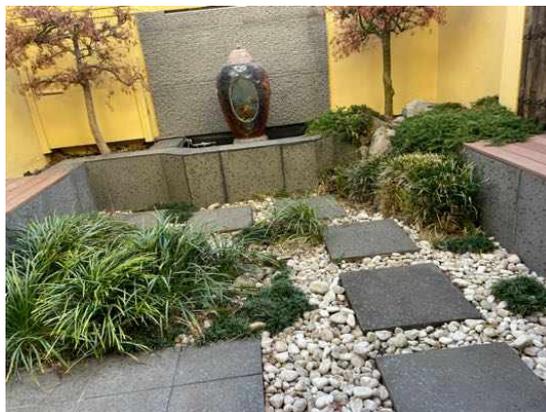
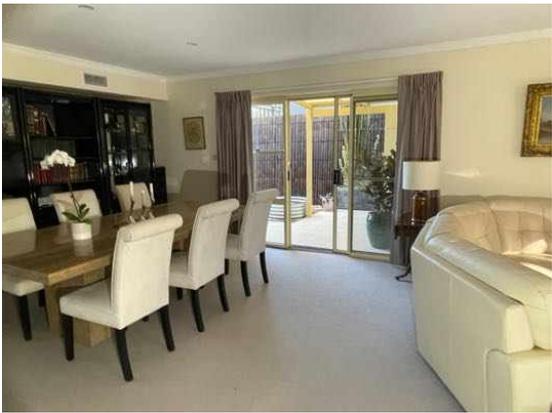
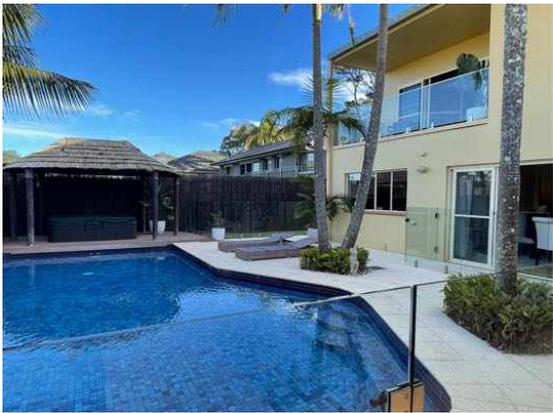
Noted Item

Building: Building 1
Location: All Areas
Finding: Additional Photos - Obstructions and Limitations
Information: These photographs are an indication of the obstructions and limitations which impeded full inspection of the property at the time of inspection. These obstructions can hide an array of defects and should be removed to allow full inspection to be carried out. A re-inspection is recommended once the areas are made accessible.

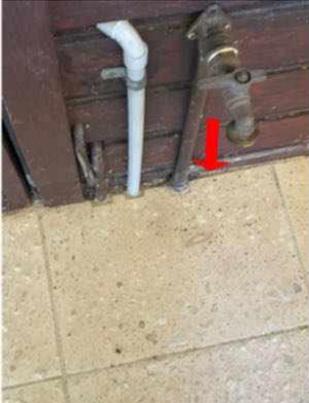
Building:	Building 1
Location:	All Areas
Finding:	Building materials in direct ground contact - conducive to termites
Information:	Where timber elements are in direct contact with the ground and consequently moisture or dampness they become conducive to termite activity.

When met with excessive moisture timber begins to decay and develop wood rot. Any timbers that are in direct contact with external grounds especially if left untreated or non- durable also provide ingress for subterranean termites into that particular element.

The removal of any such materials that may be conducive to termite activity should be removed as soon as possible to minimise the risk of termite attack.

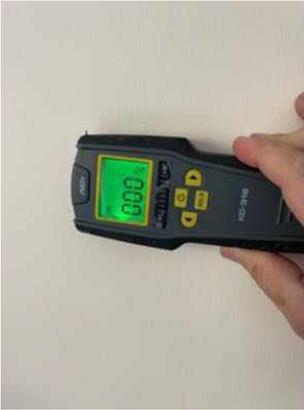
Building: Building 1
Location: All Areas
Finding: Moisture meter readings
Information: The moisture meter result for the areas inspected.

The moisture reading of 0-15% is quite normal and gives no cause for concern. However, moisture readings in excess of 15% indicate the need for further inspection.

Levels between 25-30% indicate that there may be water ingress, meaning that remedial work could be required.
