## Section D Significant Items

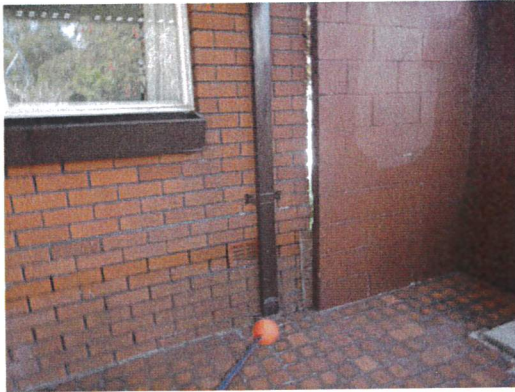
### Defects 3.13

Finding: Tiles - Cracked or damaged

Information: Cracking was evident to the tiling in this area at the time of inspection. While the cracking appears to be minor, this area is frequently exposed to water, allowing potential for water penetration into adjoining sections of walls or flooring.

Where water penetration has led to water damage, appointment of a relevant tradesperson may be required to repair damaged building elements.

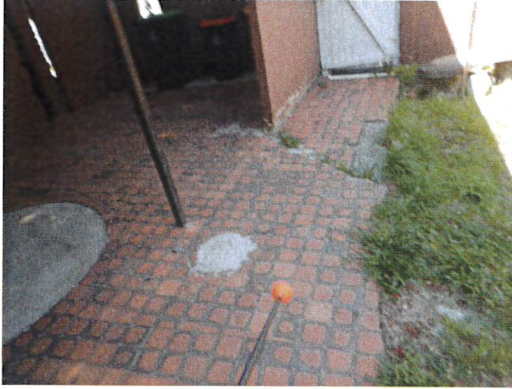
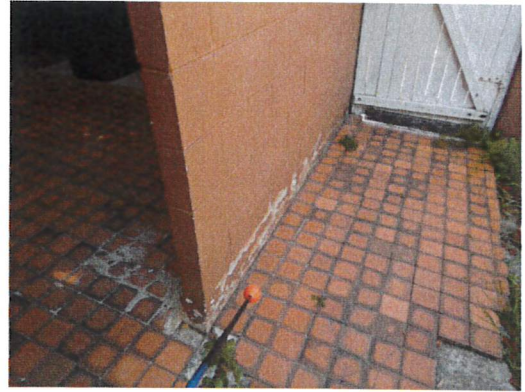
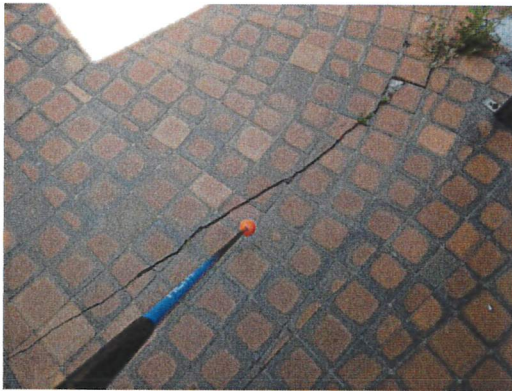
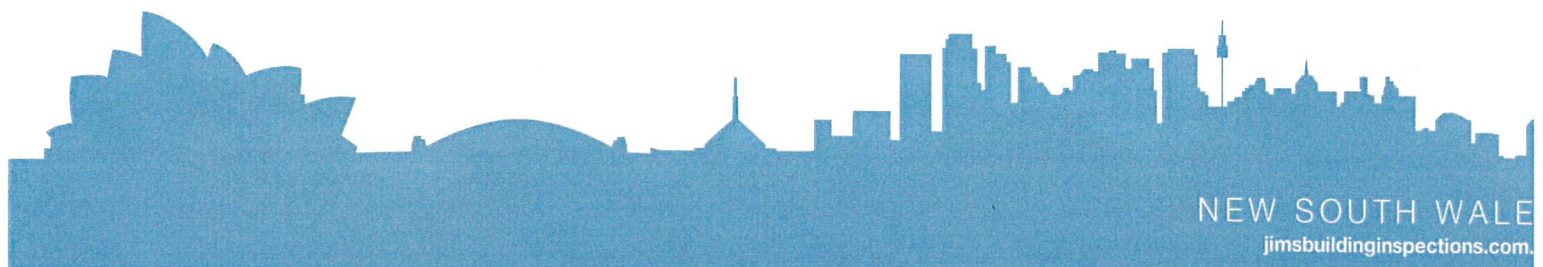
## Defects 3.14

Finding: External painting deteriorated

Information: Degraded paint finishes should be sanded back, filled, leveled and painted, as applicable. Where inadequate or missing paint protection has led to the deterioration of the associated building element, repair and/or replacement of this building element may be required.

A painting contractor should be appointed as soon as possible to perform necessary works to aid the appearance of the affected area and to ensure the area is protected against further deterioration. Alternatively, the homeowner following manufacturer instructions may perform these works.
