# Building and Timber Pest Inspection Report

Inspection Date: Mon, 8 Apr 2024

Property Address: 35 Sciberras Av, Schofields NSW 2762, Australia

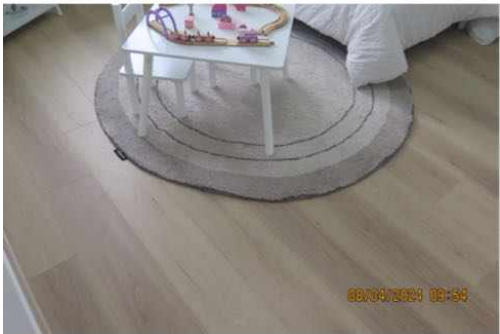
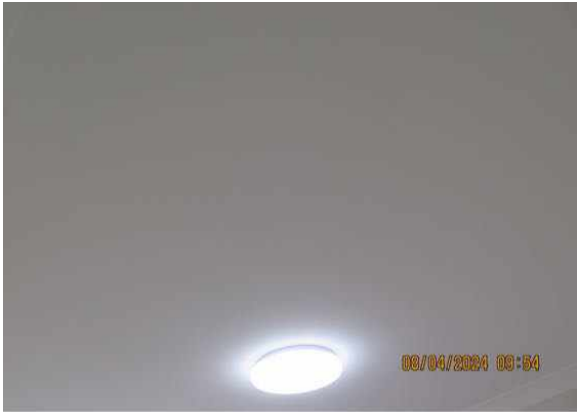
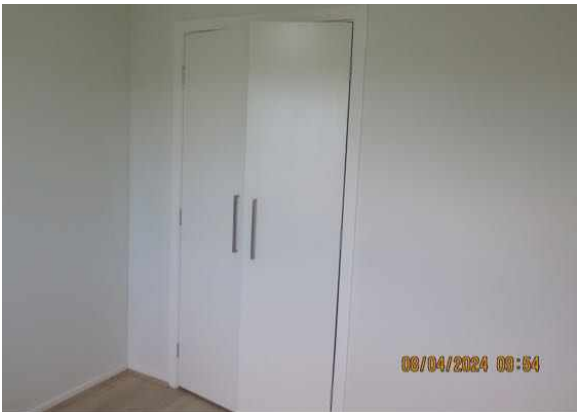
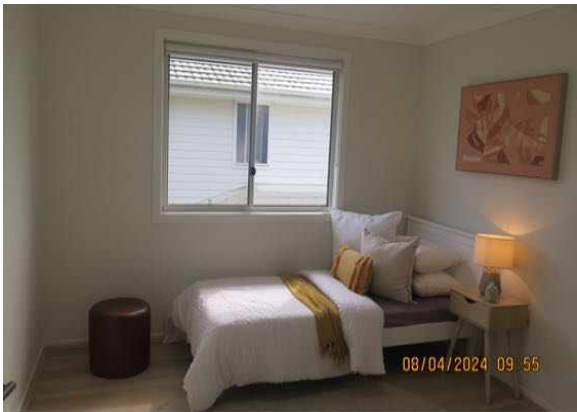
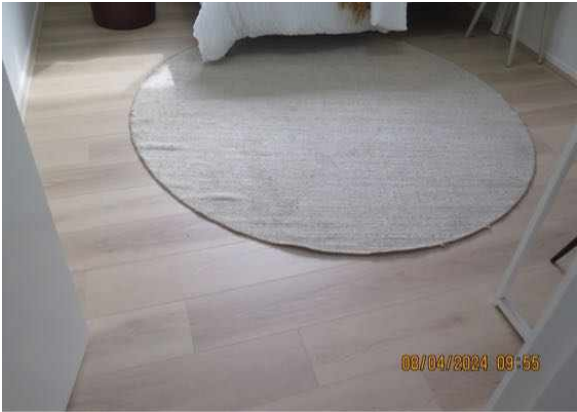
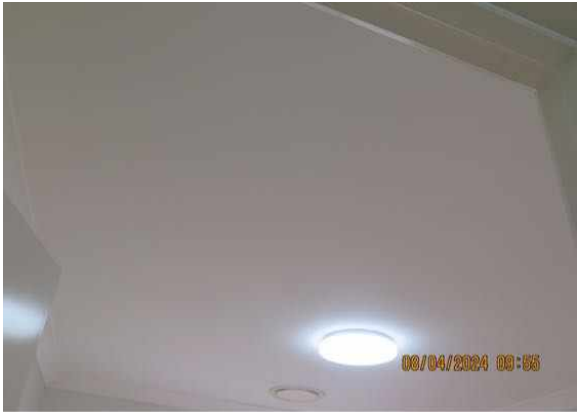
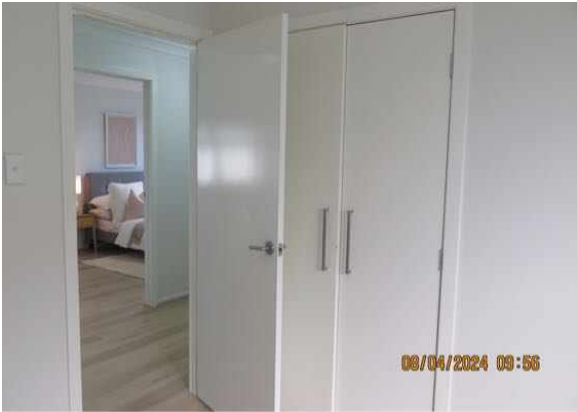
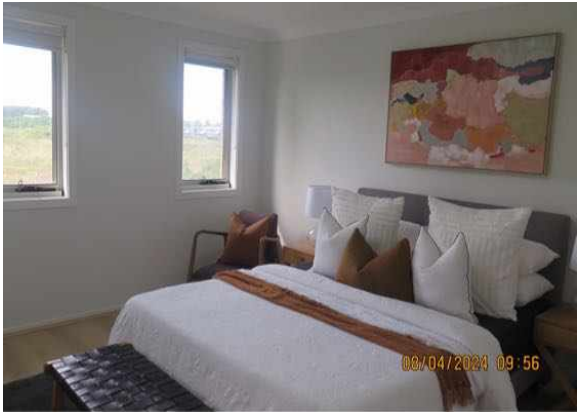
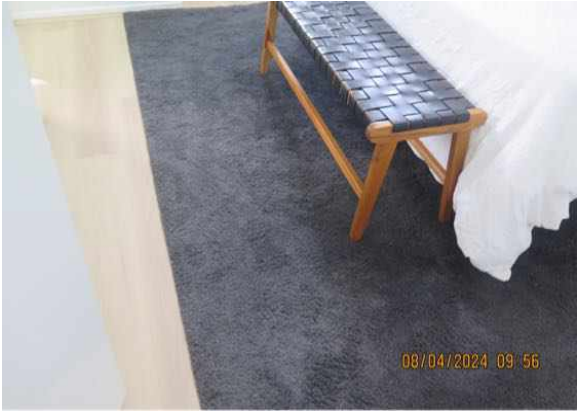
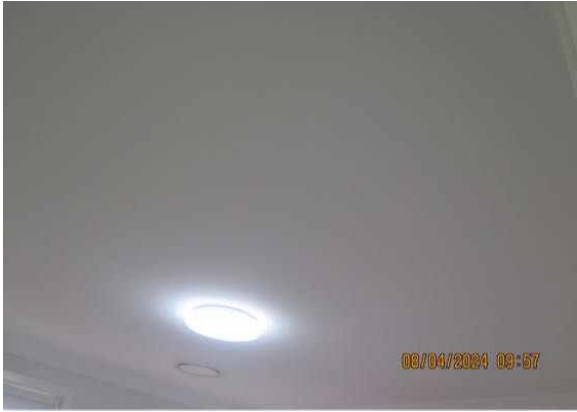
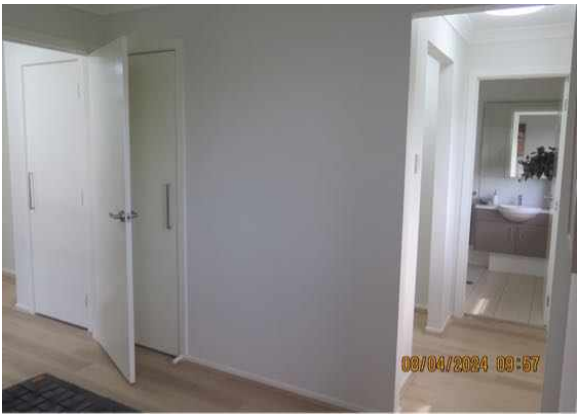
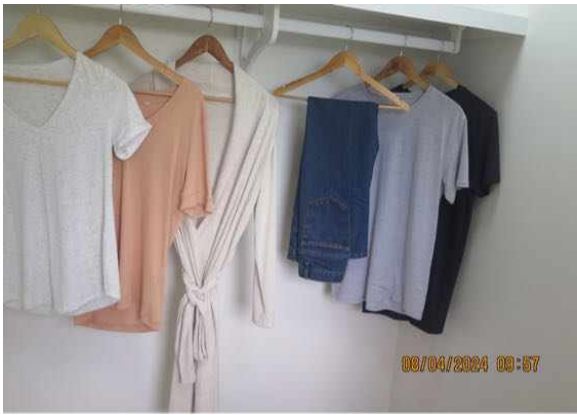
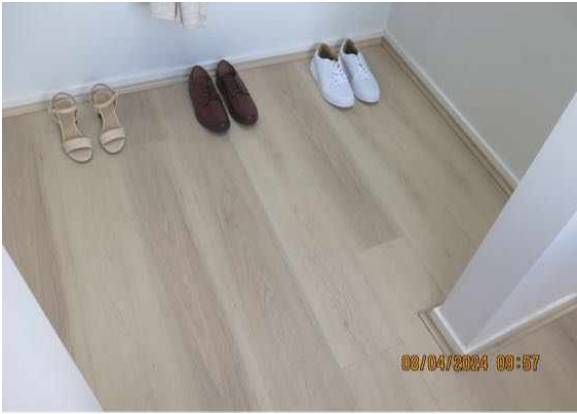
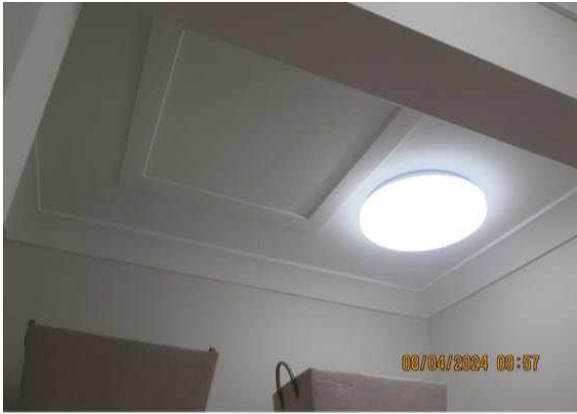
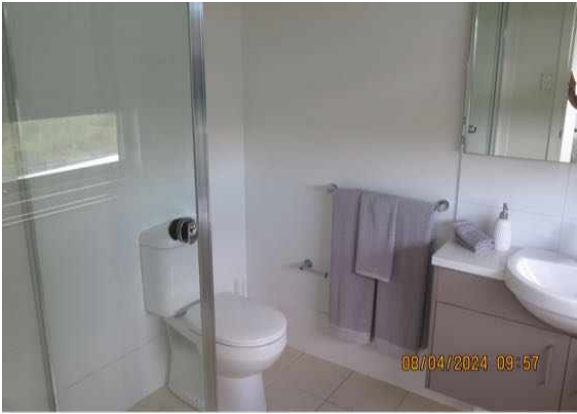
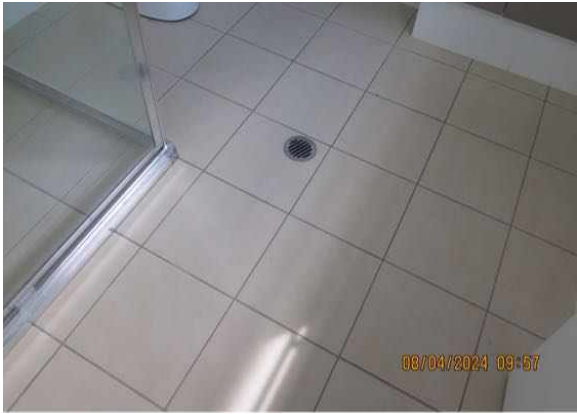
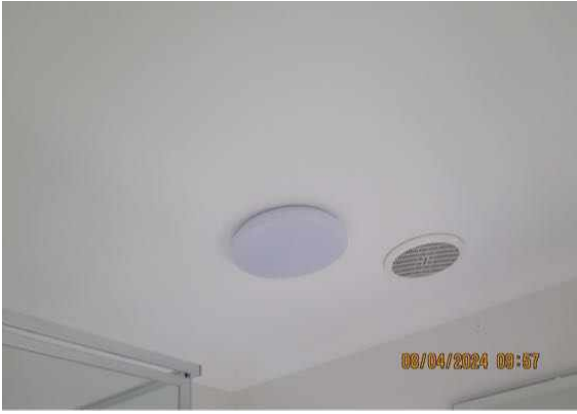
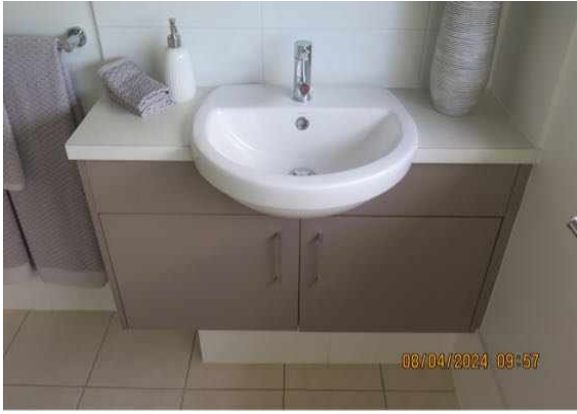
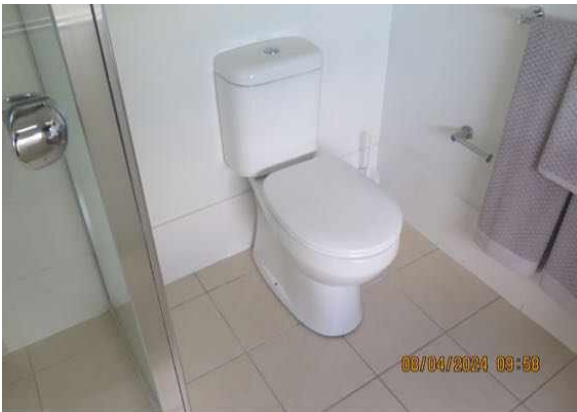
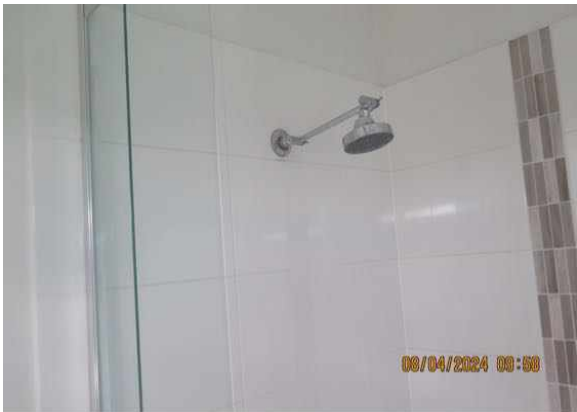
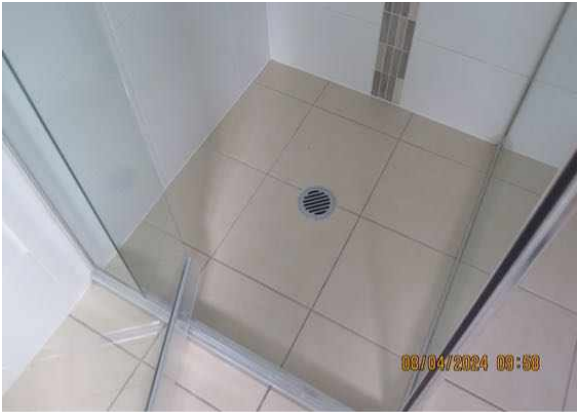
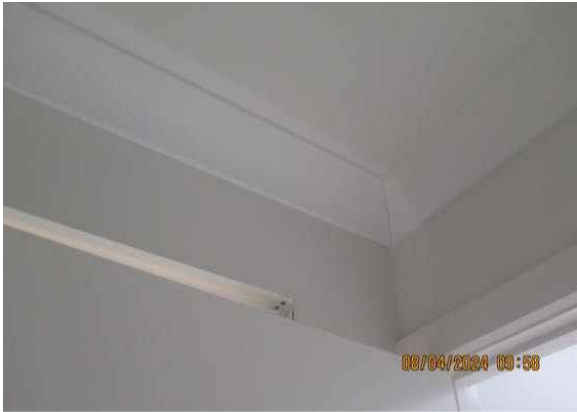
Building: Main Building  
Location: All Internal Areas  
Finding: Additional Photos #3  
Information: Additional photos are provided for your general reference

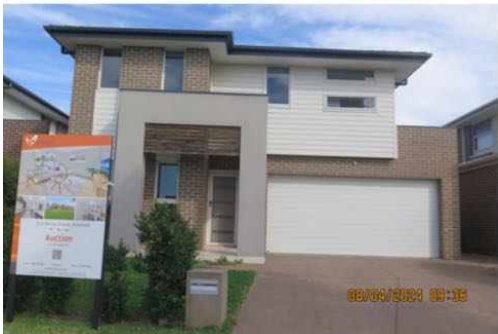
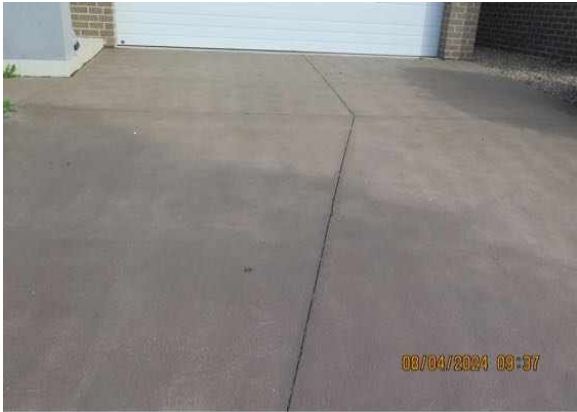
Building: Main Building  
 Location: All External Areas  
 Finding: Additional Photos  
 Information: Additional photos are provided for your general reference

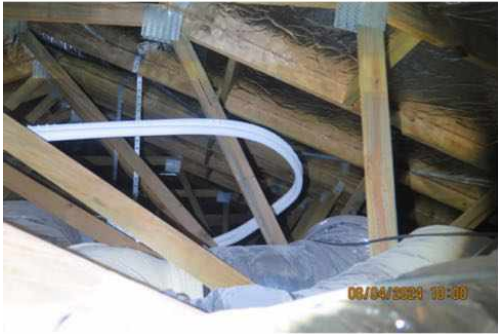
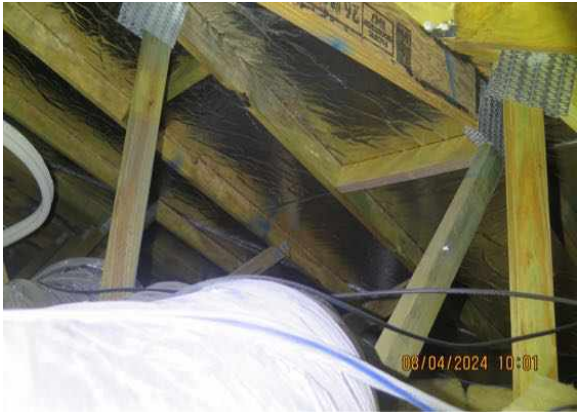
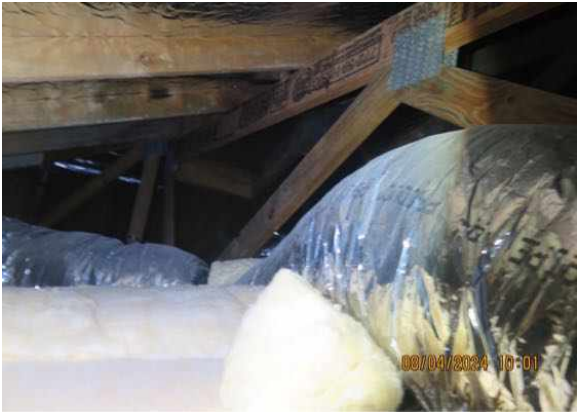
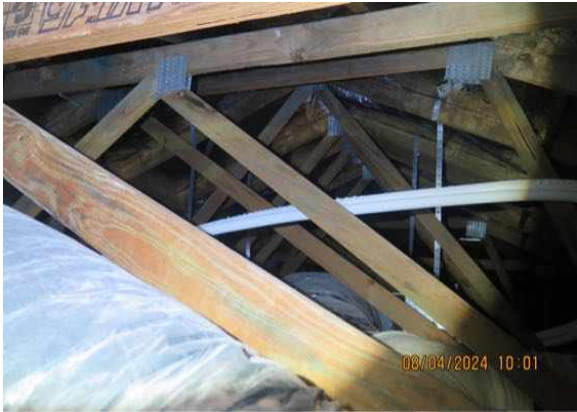
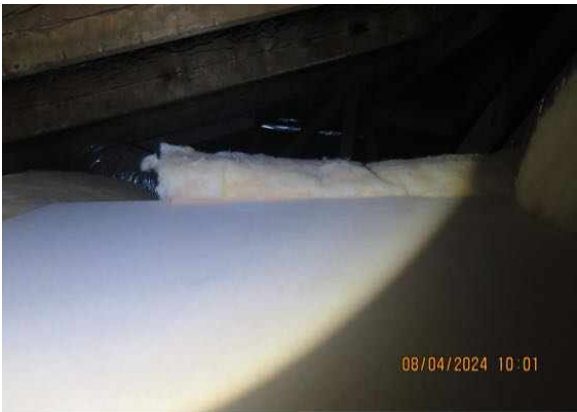
Building: Main Building  
Location: All Areas  
Finding: Additional Photos  
Information: Additional photos are provided for your general reference
