## Building Inspection Report

Inspection Date: Wed, 14 Apr 2021

Property Address: 10 Rounce Ave, Forestville NSW 2087,  
Australia

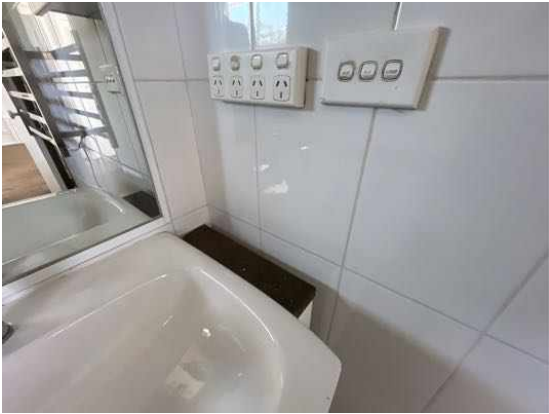
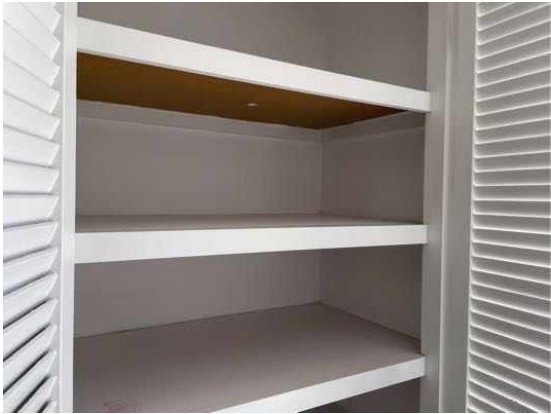
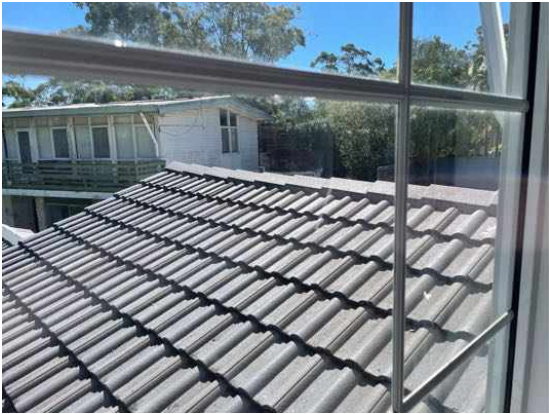
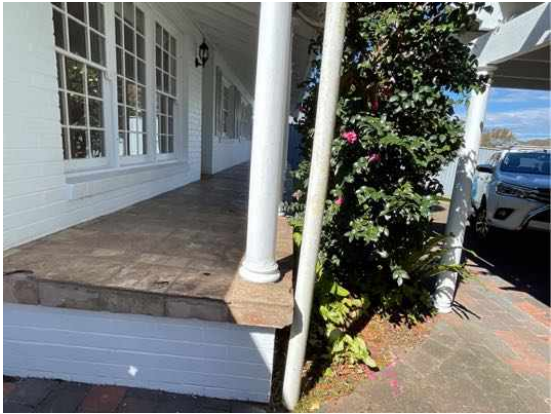
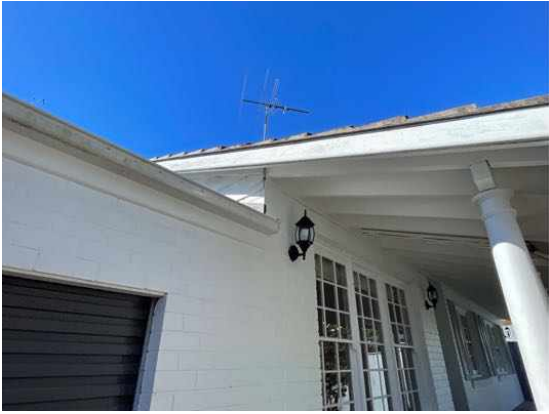
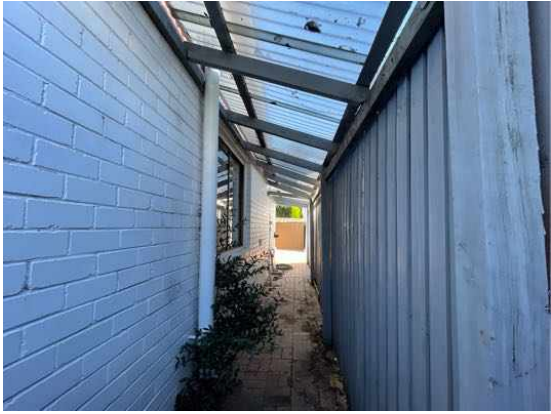
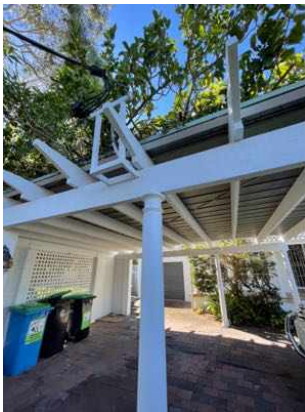
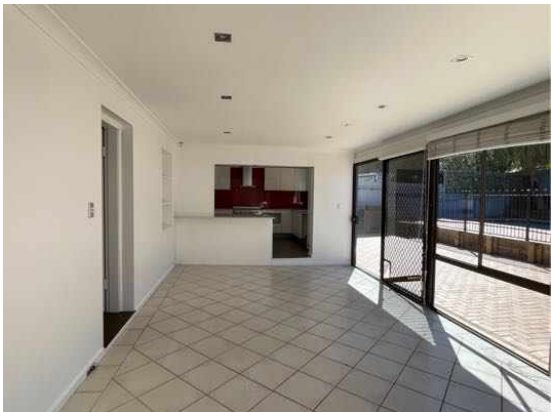
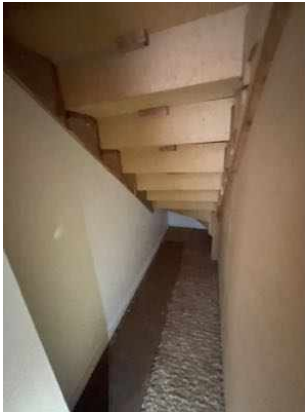
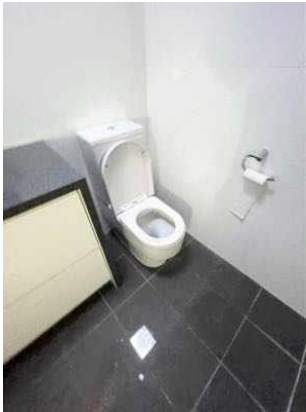
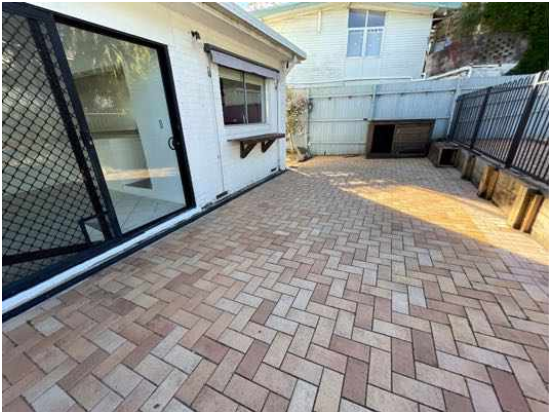
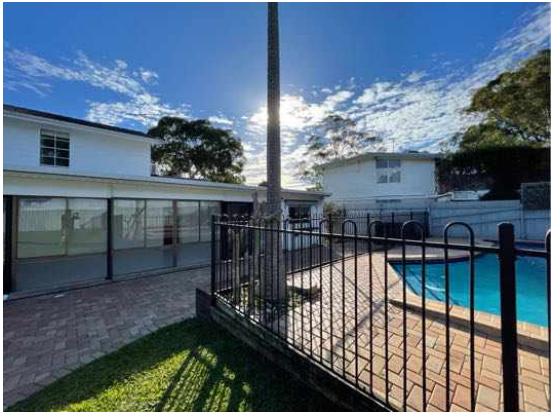
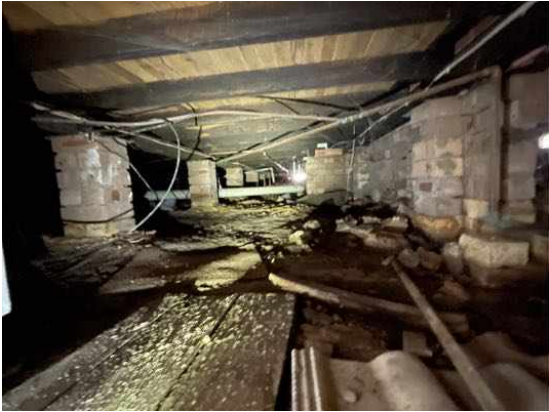
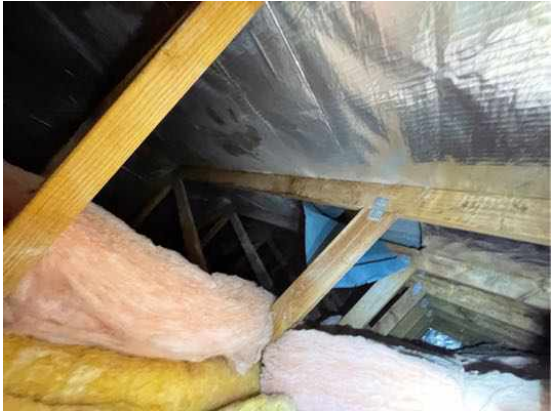
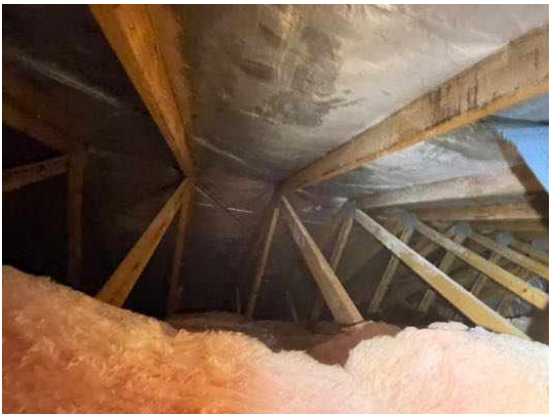
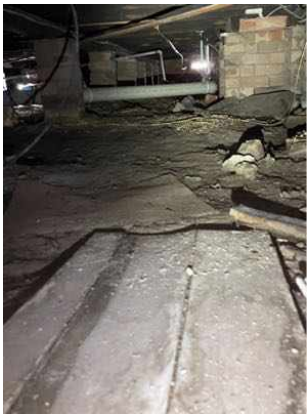
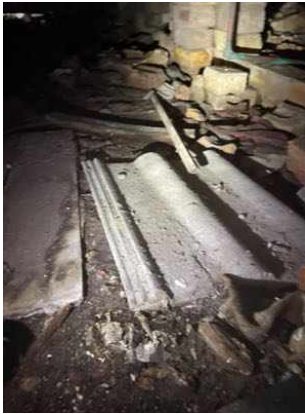
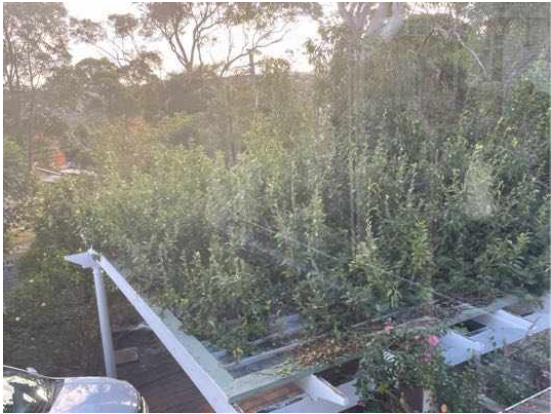
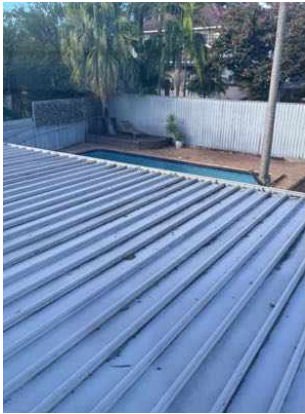
Building: Building 1  
Location: All Areas  
Finding: Additional Photos - Obstructions and Limitations  
Information: These photographs are an indication of the obstructions and limitations which impeded full inspection of the property at the time of inspection. These obstructions can hide an array of defects and should be removed to allow full inspection to be carried out.
