Building and Timber Pest Inspection Report

Inspection Date: Thu, 7 Oct 2021

Property Address: 43 Townsend Ave, Frenchs Forest NSW
2086, Australia

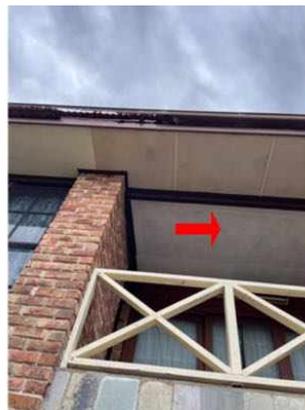
Defects 3.05

| Information: | External timbers that are frequently exposed to harsh weather conditions require adequate protection in order to maintain their condition. Where timbers have not been painted or treated adequately, general deterioration is likely to occur at an accelerated rate. |

If left unattended, replacement of these timbers is likely to be necessary in the short-term future. Adequate treatment of these timbers is required as soon as possible by a painting contractor or general handyman.

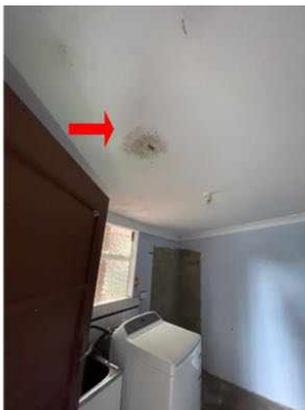
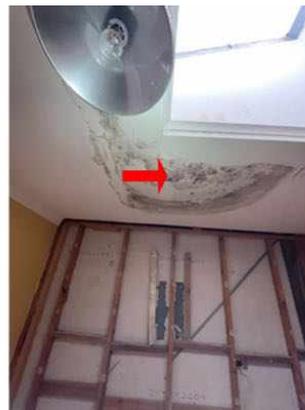
Defects 3.06

| Finding: | Ceiling - Water damaged |

Generally, the client is advised to ensure that the general environment is free of moisture and humidity to aid in the prevention of mould formation and development. Any mould found during the inspection should be cleaned immediately by a cleaning contractor or the homeowner as applicable.

Please note that severely affected building elements may require replacement by a registered builder or qualified carpenter.

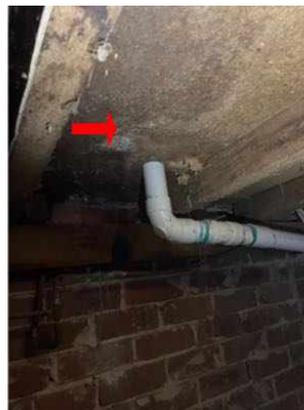
Defects 3.15

| Finding: | Flooring - Evidence of water damaged |
| Information: | Water damage to the flooring is generally an indication of excessive moisture being present in the floor. Rectification works may include replacement of flooring depending on the extent of the damage. |

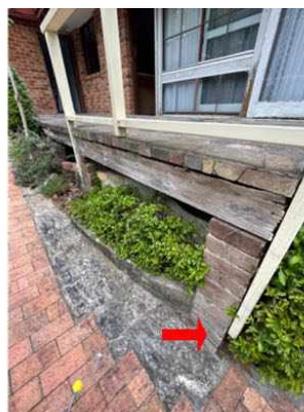
Building: Building 1
 Location: All External Areas
 Finding: Building materials in direct ground contact - conducive to termites
 Information: Where timber elements are in direct contact with the ground and consequently moisture or dampness they become conducive to termite activity. Whether timber is used as a building element part of a fencing structure or stored as an unused item they can provide an environment that is attractive to termite infestation. When met with excessive moisture timber begins to decay and develop wood rot. Any timbers that are in direct contact with external grounds especially if left untreated or non- durable

also provide ingress for subterranean termites into that particular element. The removal of any such materials that may be conducive to termite activity should be removed as soon as possible to minimise the risk of termite attack.
