## Building and Timber Pest Inspection Report

Inspection Date: Wed, 13 Oct 2021

Property Address: 678 Warringah Rd, Forestville NSW 2087,  
Australia

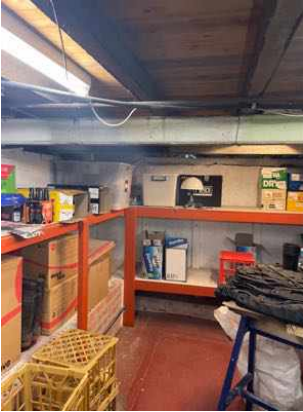
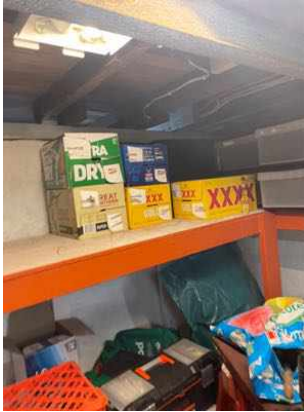
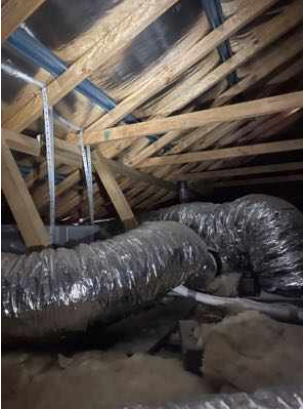
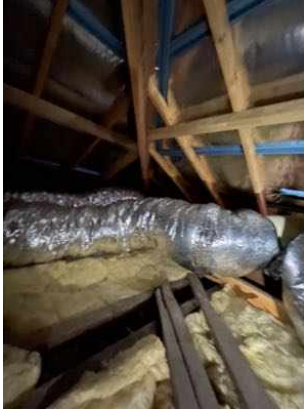
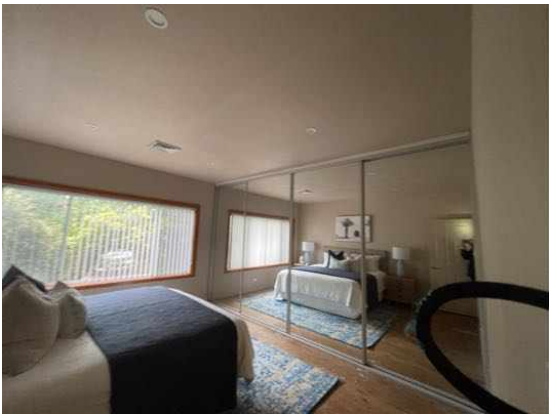
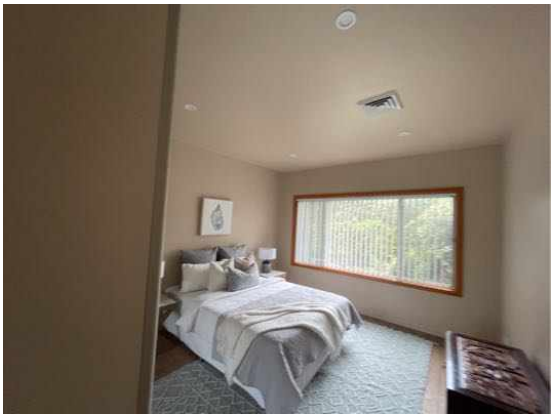
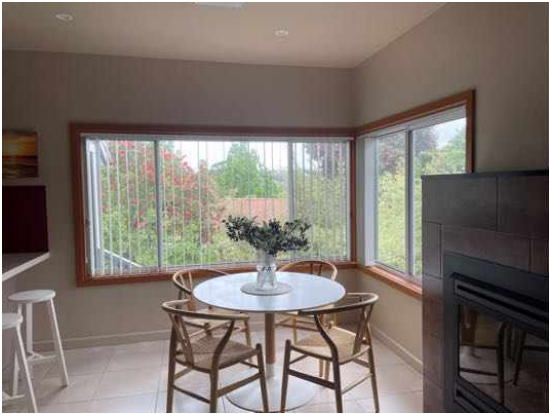
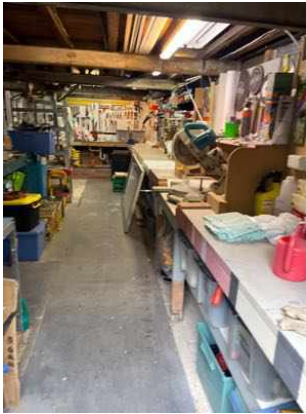
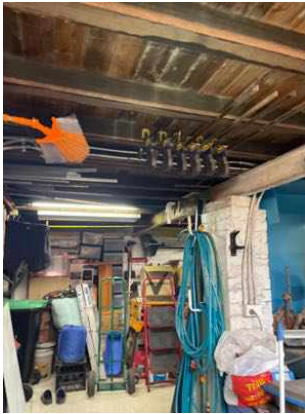
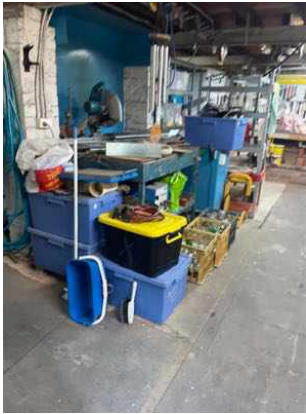
Building:	Building 1
Location:	All Areas
Finding:	Additional Photos - Obstructions and Limitations
Information:	These photographs are an indication of the obstructions and limitations which impeded full inspection of the property at the time of inspection. These obstructions can hide an array of defects and should be removed to allow full inspection to be carried out.
