Section D Significant Items

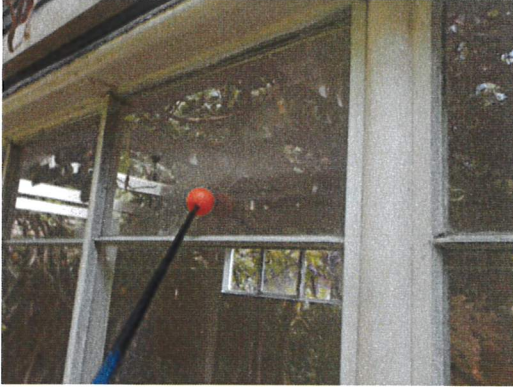
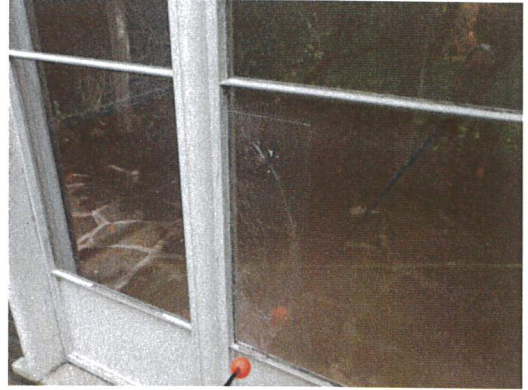
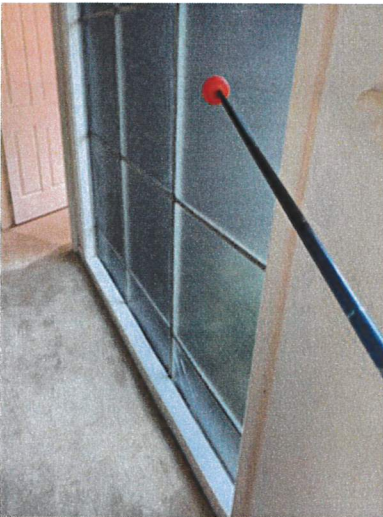
Defects 3.04

Building: Main Building
Location: All Areas
Finding: Evidence of excessive moisture was present at the time of inspection
Information: Excessive moisture can attract termites and produce conditions that promote termite attack fungal growth and wood decay.

Excessive moisture is generally caused by deteriorated inadequate or missing roof drainage leaking plumbing pipes or fixtures poorly plumbed HWS overflows or condenser units and poor site drainage.

It is highly recommended that all plumbing and drainage fixtures and fittings be maintained regularly in order to prevent excessive moisture being present in the external / internal property.

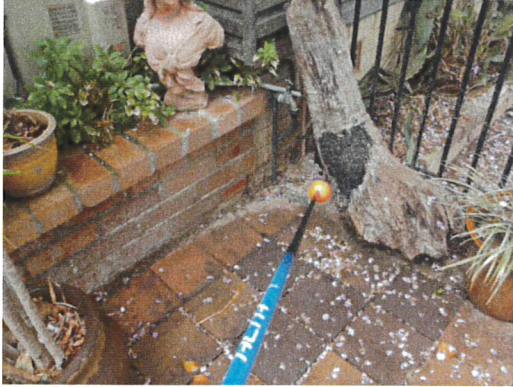
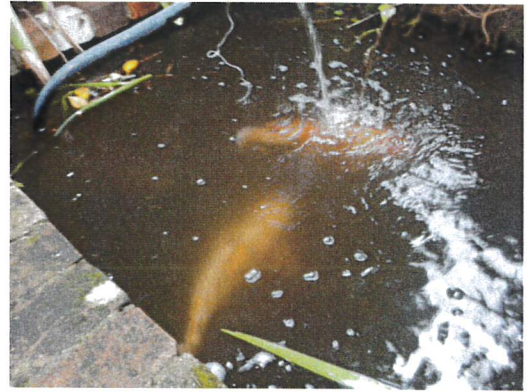
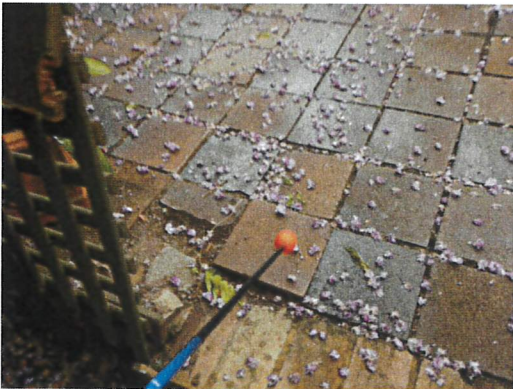
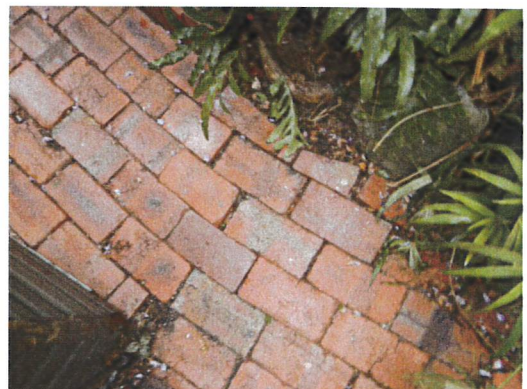
Defects 3.06

Building: Garage
Location: All Areas
Finding: Building element - Damaged
Information: [MUST EDIT]

Evidence of damage was identified. Include findings, identify causes, potential implications if left unmanaged and suggest trade responsible for rectification.
