# Building and Timber Pest Inspection Report VR

Inspection Date: Wed, 19 Jun 2024

Property Address: 8 Eclipse St, Schofields NSW 2762,  
Australia

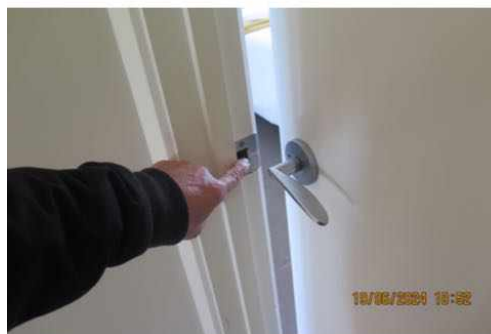
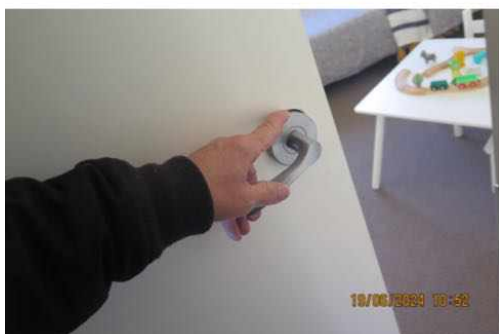
Building: Main Building  
 Location: Toilet (WC)  
 Finding: Door handle - Not latching and lock requires tightening  
 Information: It was noted that the door in this area was not latching during operation at the time of inspection. Whilst detracting from the functionality of this building element, this minor defect may also be a security risk, and may therefore have serious implications if left unattended.

It is suspected that this defect has occurred due to minor issues with the associated hinges. Such damage is identified as general wear and tear, which is expected for building elements of this age.

A qualified carpenter or general handyperson may be appointed to perform rectification works as necessary, at client discretion. If left unattended, further functional impairment is likely to occur.

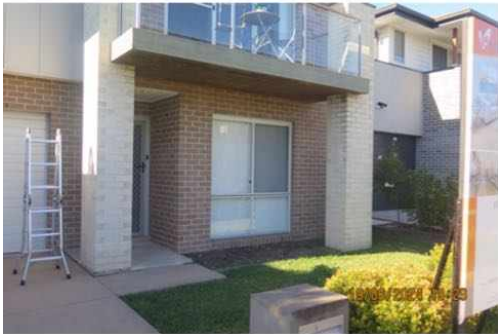
If the slab edge is not properly exposed there is a high risk of termite attack. Sometimes, in order to determine the type of slab, a suitably qualified person such as an architect or builder may be required to consult the construction plans.

Where the slab edge cannot be properly inspected, it is highly recommended that termite or timber pest inspections be carried out every 6-12 months to aid protection of the property against infestation.

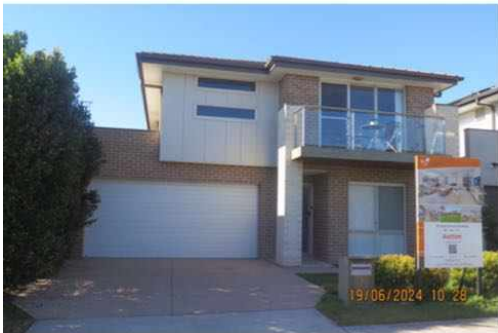
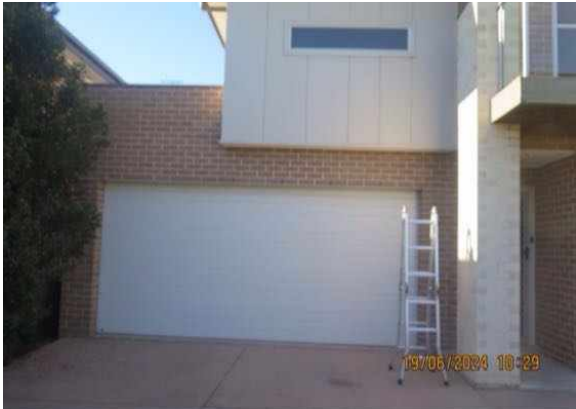
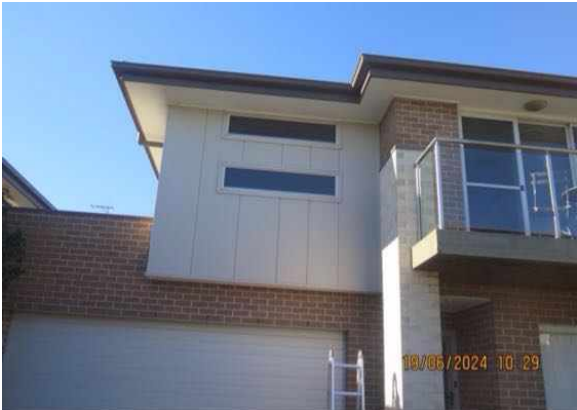
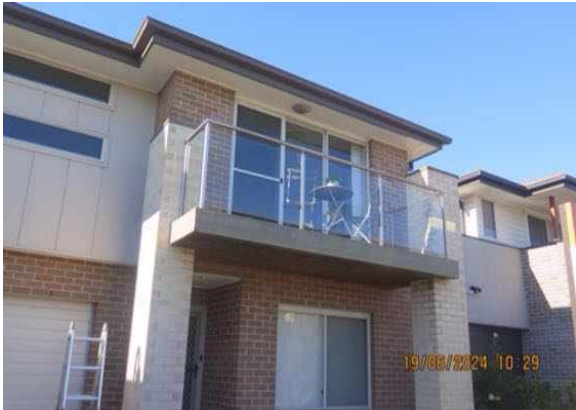
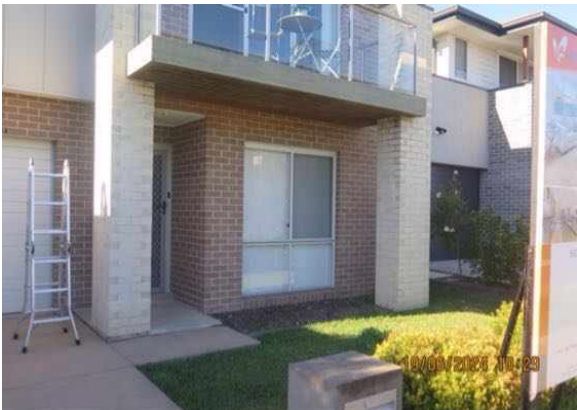
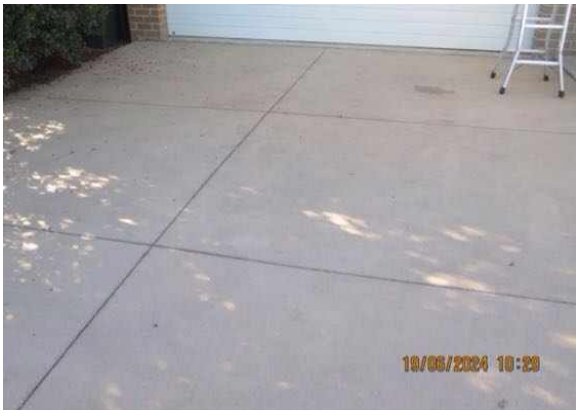
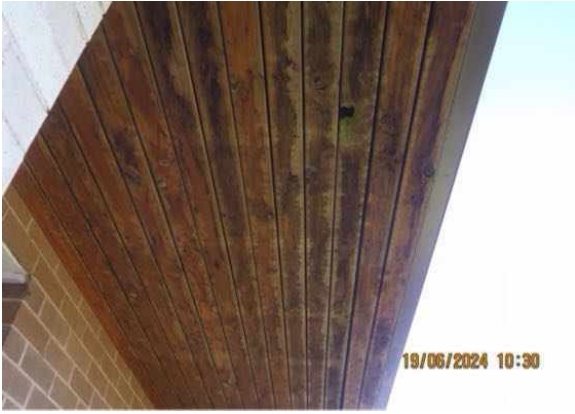
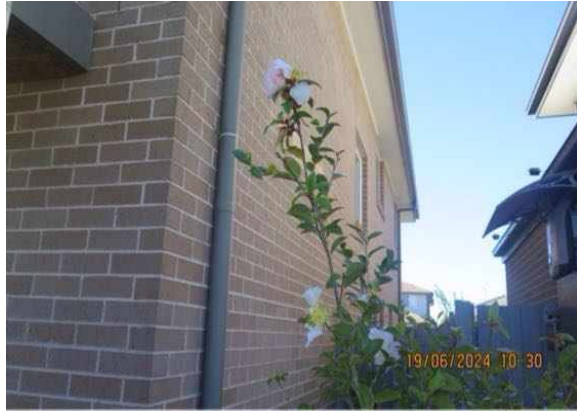
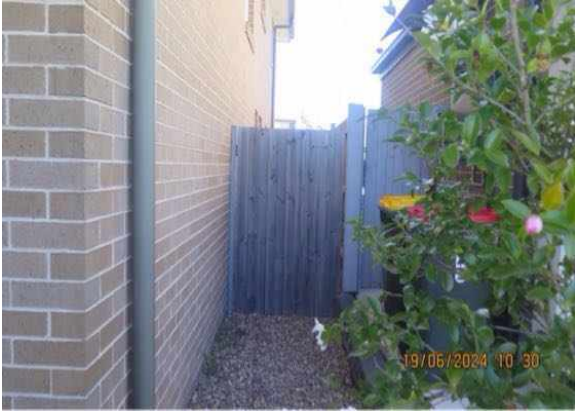
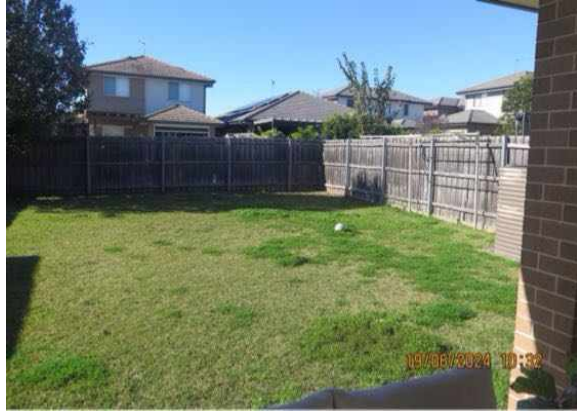
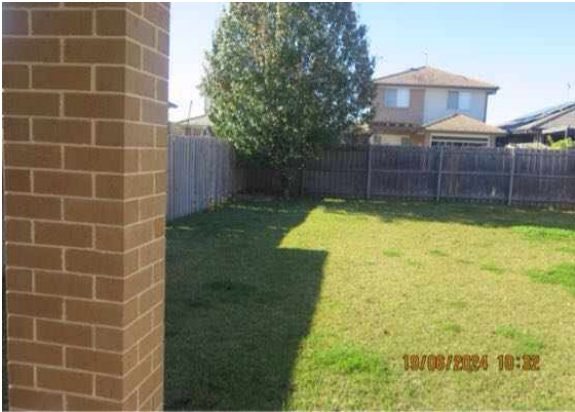
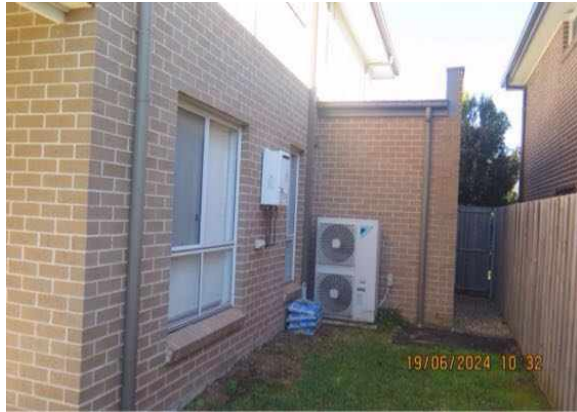
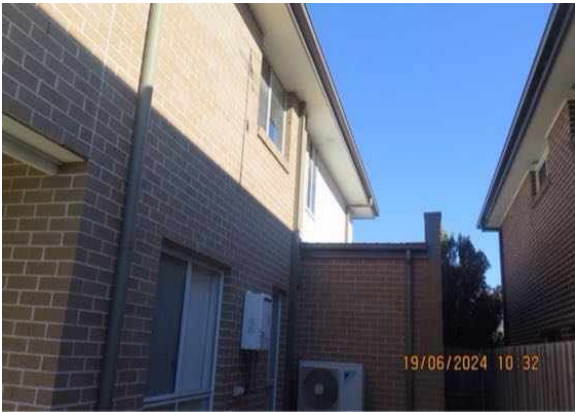
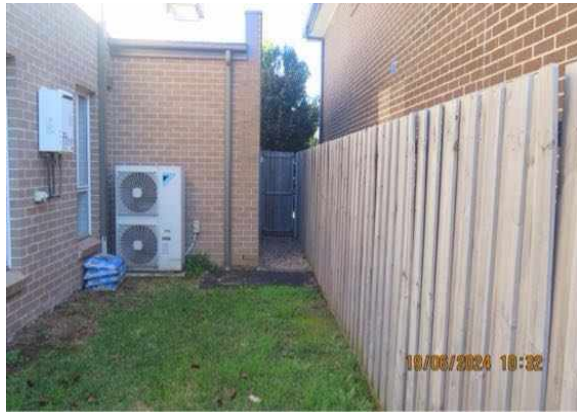
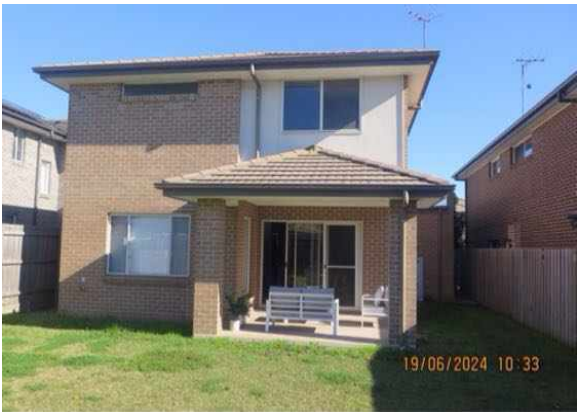
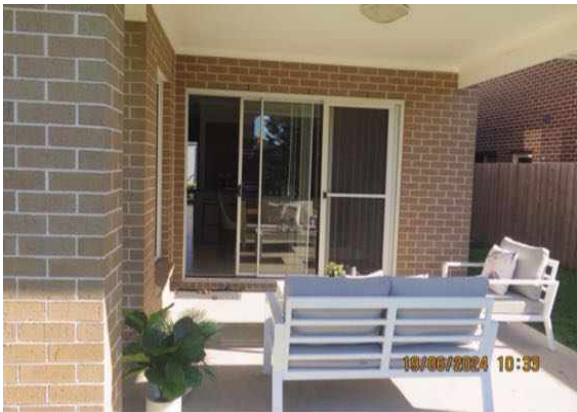
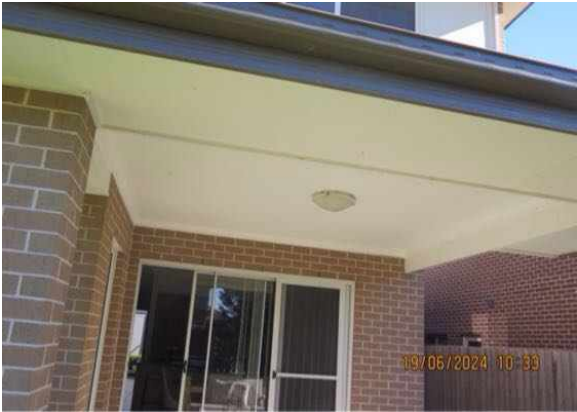
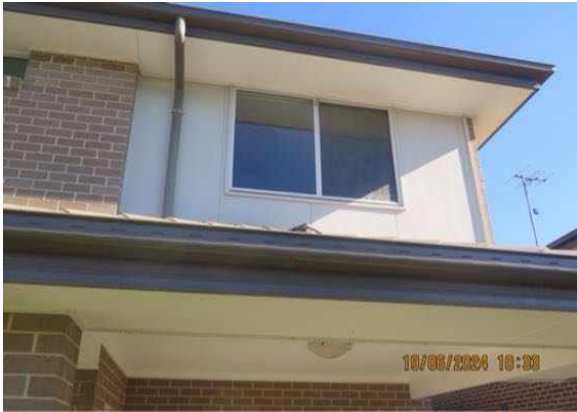
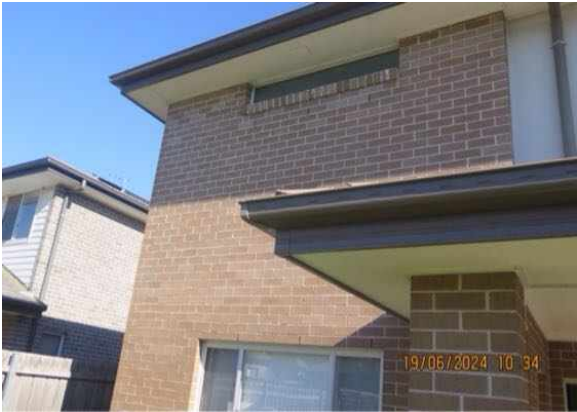
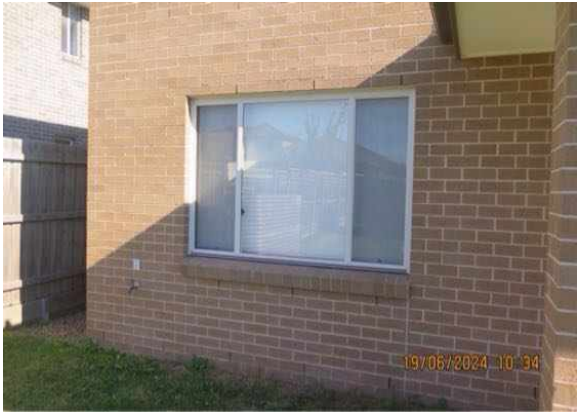
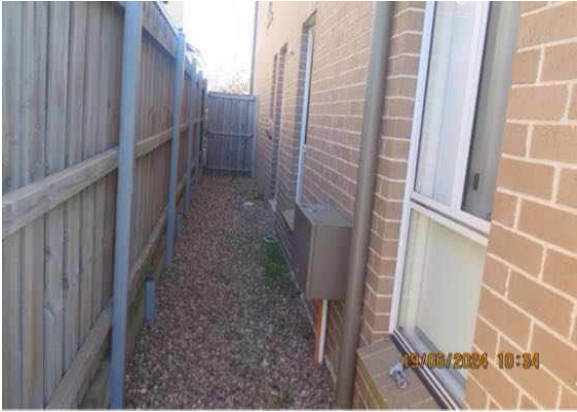
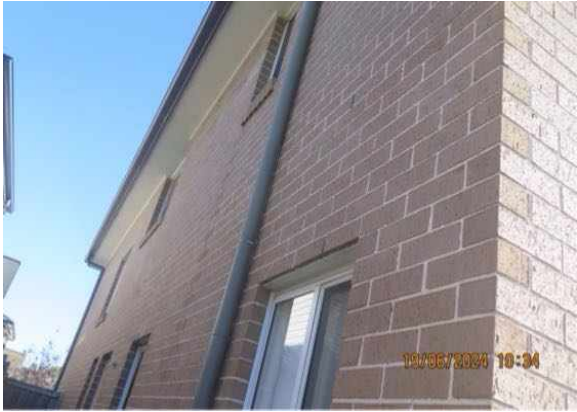
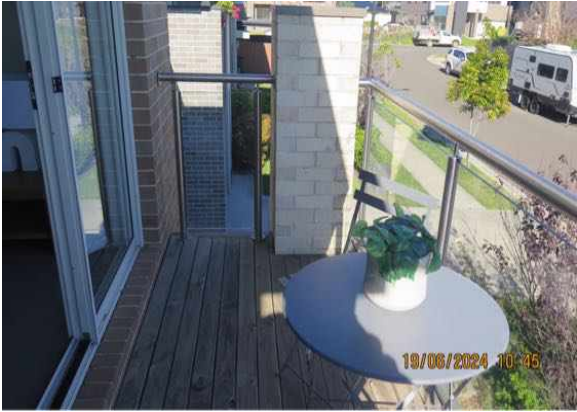
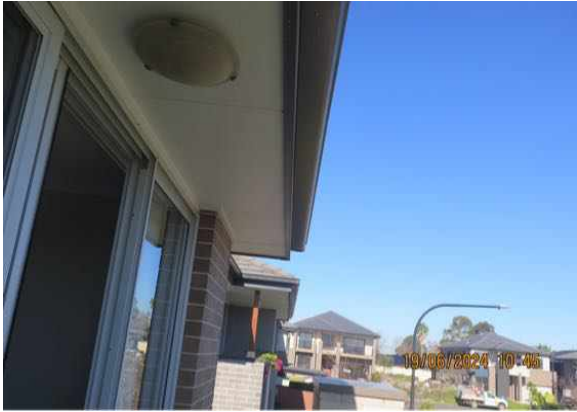
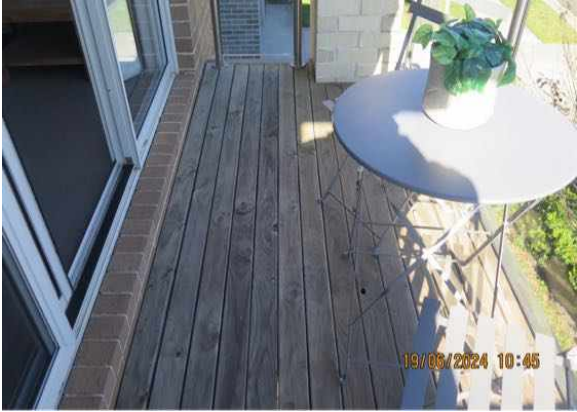
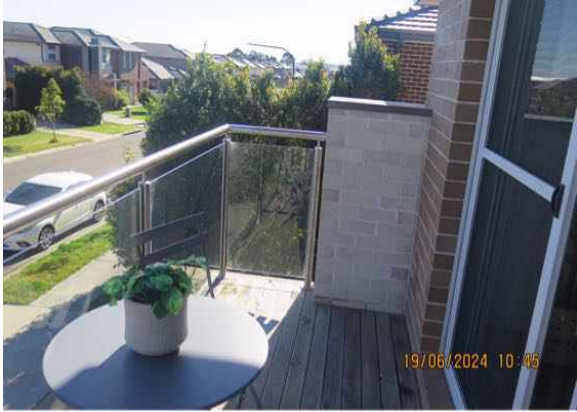
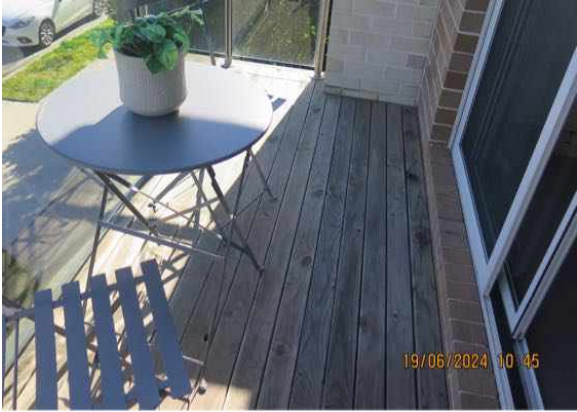
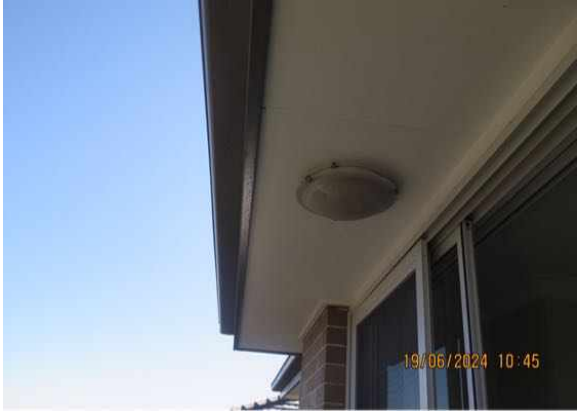
Building: Main Building  
Location: All External Areas  
Finding: Additional Photos  
Information: Additional photos are provided for your general reference

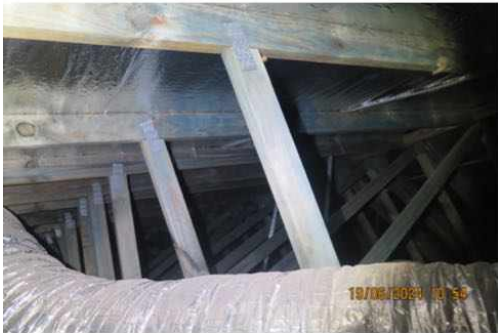
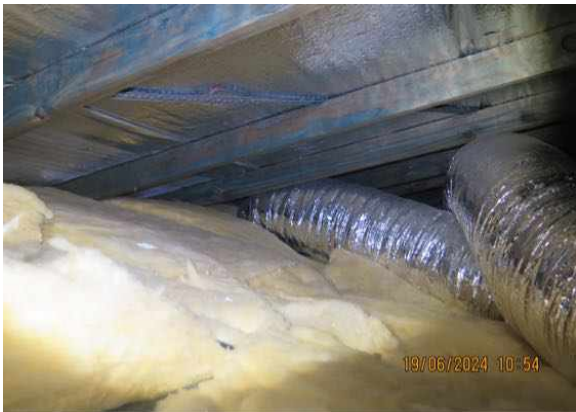
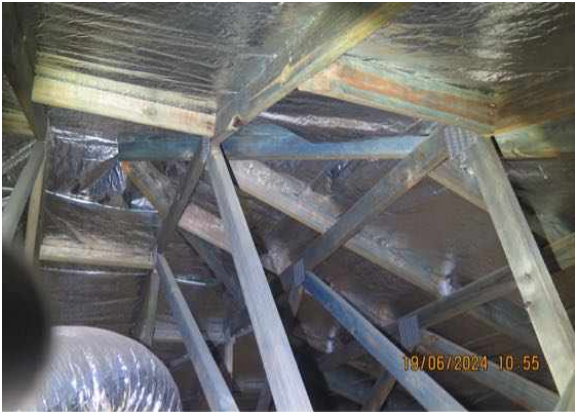
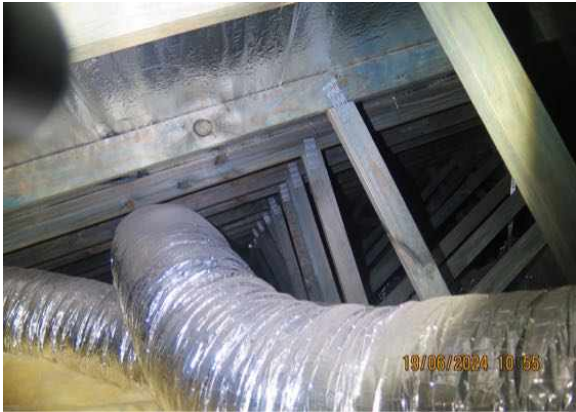
Building: Main Building  
Location: All Areas  
Finding: Additional Photos  
Information: Additional photos are provided for your general reference
